# Catchment Health Indicator Program

2014–15

Written and produced by the Upper Murrumbidgee Waterwatch team:

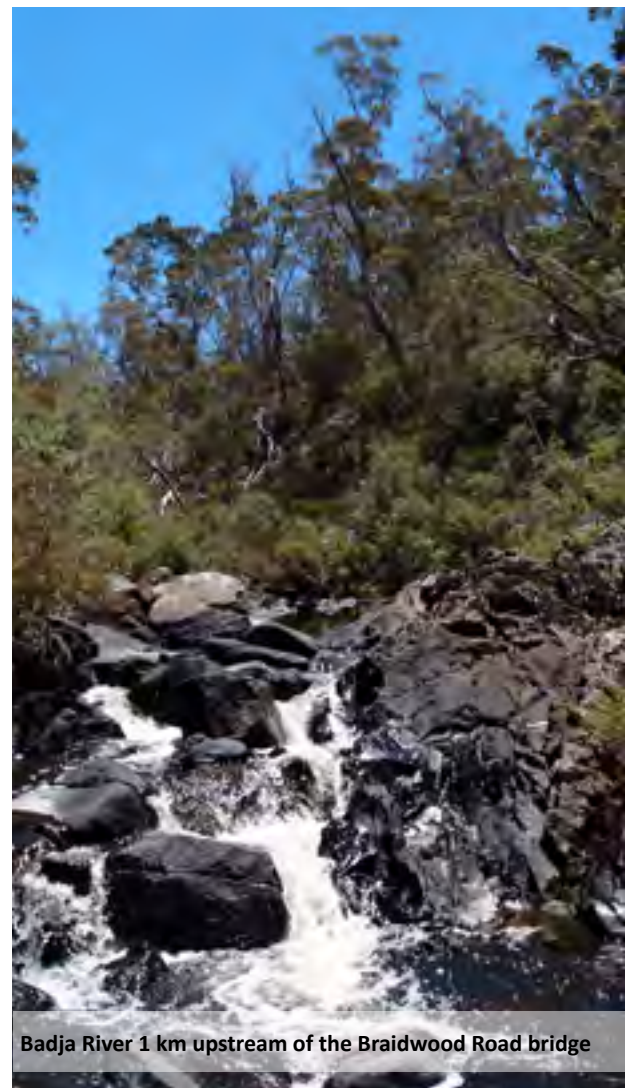
Badja River 1 km upstream of the Braidwood Road bridge

The water bug score indicated 'good' stream health. Riparian surveys found that riparian condition was 'good' overall, including high levels of ground cover, good native vegetation cover and presence of habitat features such as River Tussock and debris.

The top of this reach is the area known as the Big Badja Swamps which is listed on the directory of important wetlands in Australia. Carp sightings are not recorded for this reach.

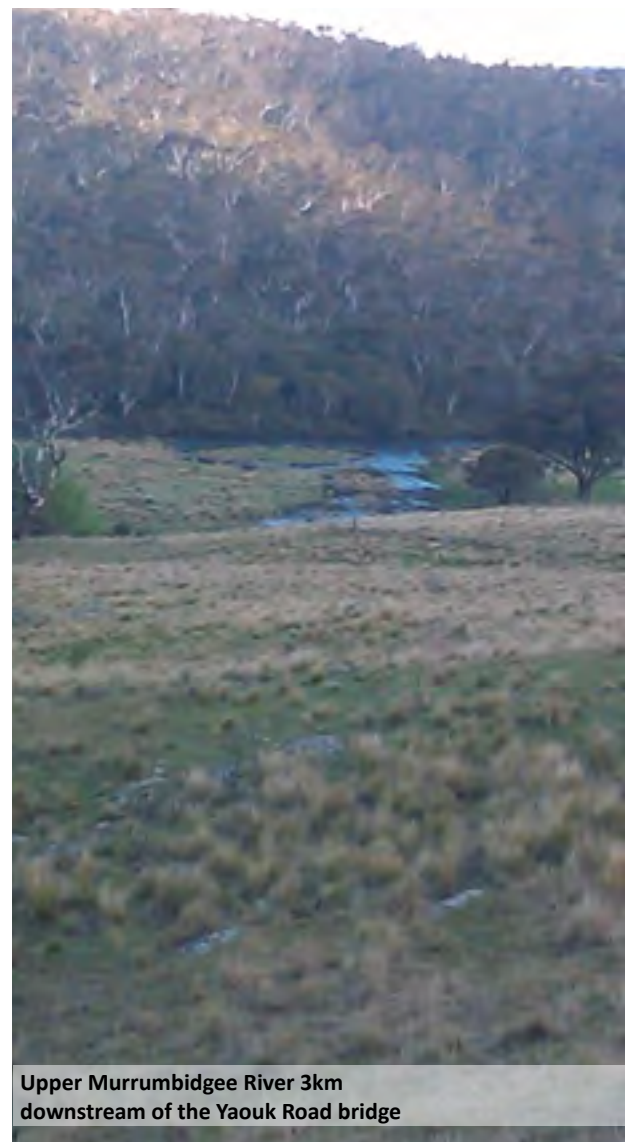
Upper Murrumbidgee River 3km downstream of the Yaouk Road bridge

Water bug surveys indicate that stream condition is rated as 'good'. Riparian surveys for the reach were carried out in areas which are characterised by 'open valley floor' type country and condition was rated as 'poor'. These scores were influenced by the lack of canopy cover (may be natural) and the lack of understory (perhaps lost due to grazing) and habitat features such as River Tussock and debris.

Regular water quality monitoring is required to improve confidence in the condition score.

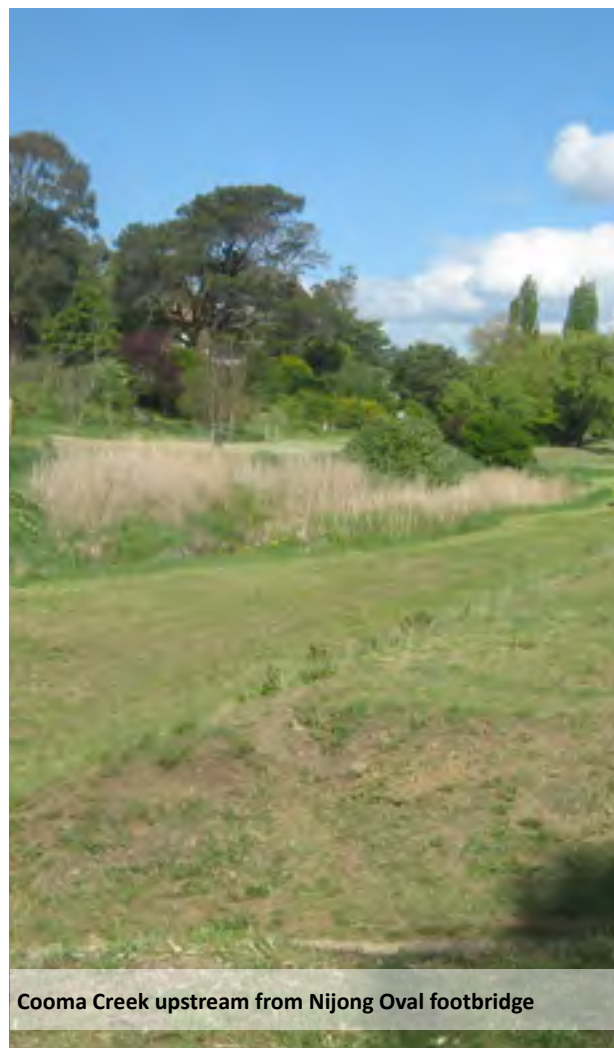
Cooma Creek upstream from Nijong Oval footbridge

Riparian areas are mown and grass clippings may contribute to total phosphorus inputs. Litter is associated with stormwater drains in the Cooma CBD area along this reach. Platypus, Water Rats and Gambusia are recorded in this reach.

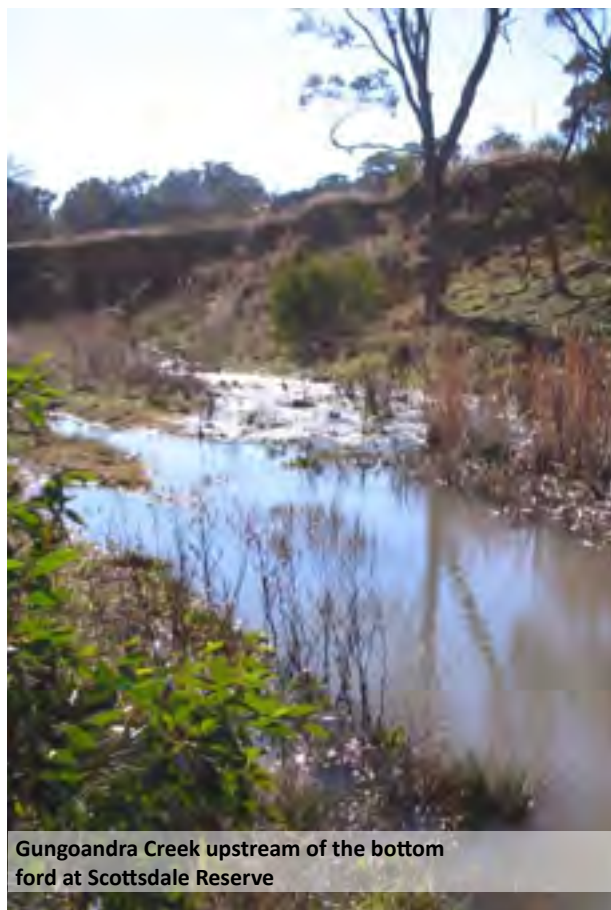
Gungoandra Creek upstream of the bottom ford at Scottsdale Reserve

ACWA works have been carried out at Scottsdale including stabilisation of an instream nick-point, which is improving water quality. Carp have been sighted at the bottom end of this reach.

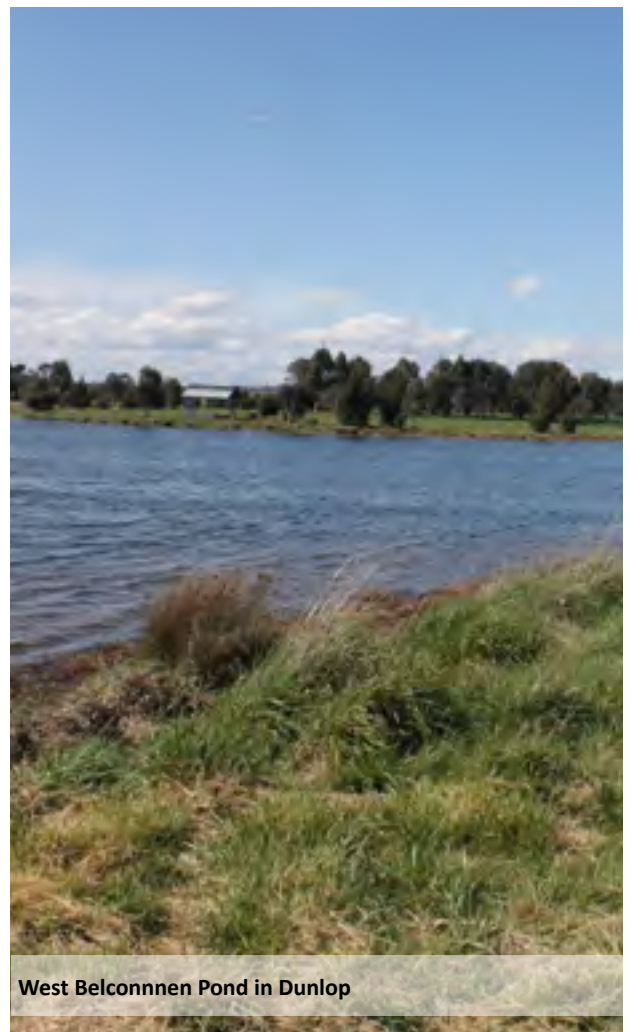
West Belconnen Pond in Dunlop

Total phosphorus can vary between 'excellent' and 'poor', while nitrates are generally good. Dissolved oxygen levels can vary greatly, with oxygen saturation consistently below 100% (range: 69-89%). Further planting of riparian vegetation is required to improve the riparian condition score for this site.

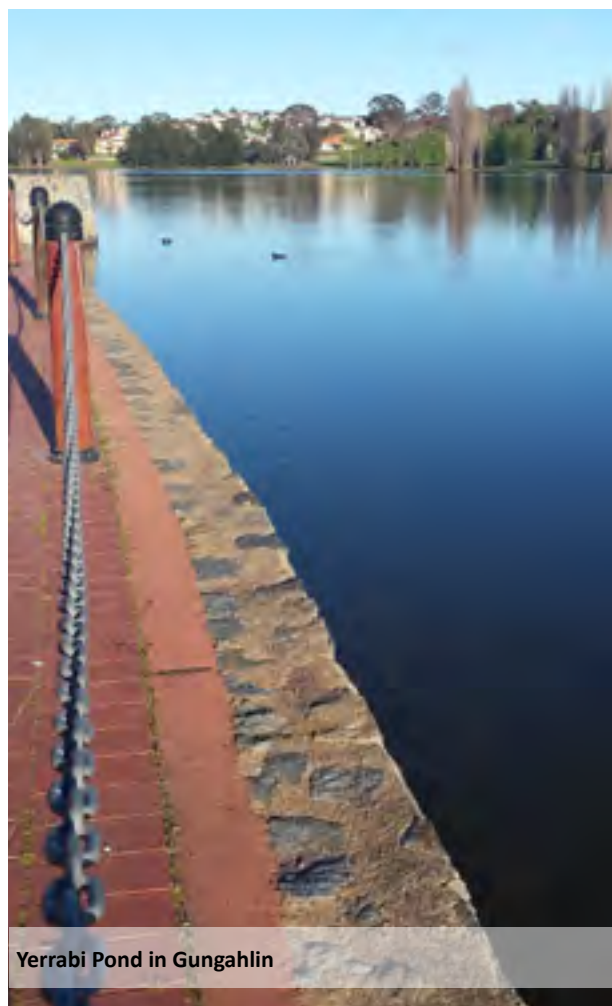
Yerrabi Pond in Gungahlin

Riparian vegetation scores were 'poor' due to largely exotic species in all three layers of habitat. Scores were dragged down by a concrete channel site which is part of this reach. The Pond itself is more in the 'fair' range with some better habitat areas. The poor habitat values occur in the more managed/modified areas.

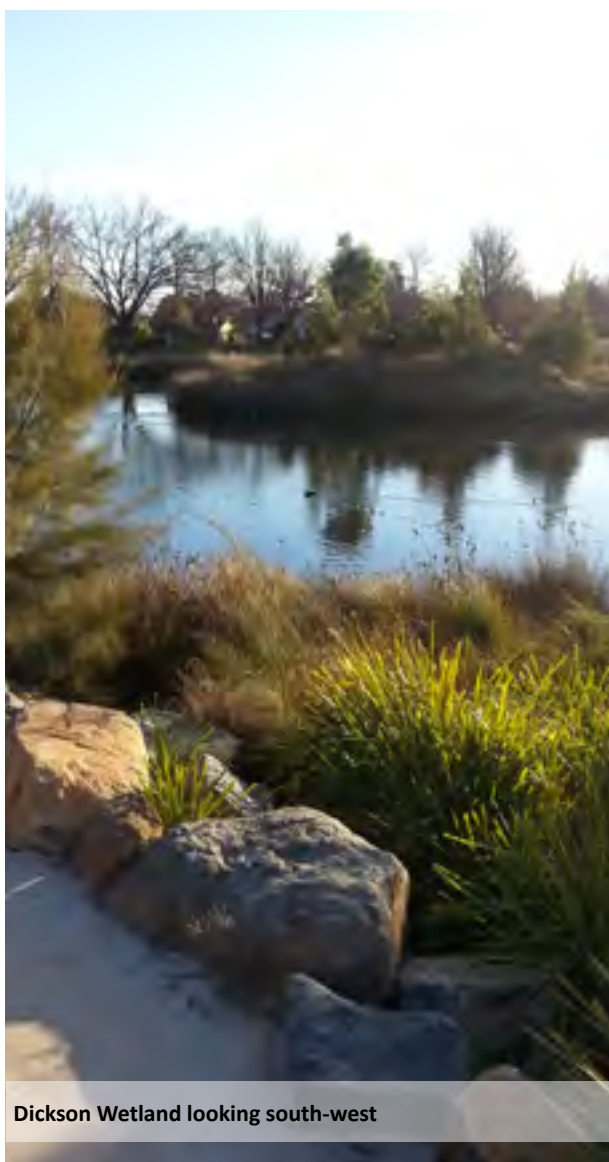
Dickson Wetland looking south-west

Water bugs indicated 'good' results, but the riparian vegetation assessment indicated 'poor' habitat. However, extensive plantings around Dickson Wetlands undertaken by volunteers from the Dickson Wetlands Carers group will grow and result in improved riparian condition over time.

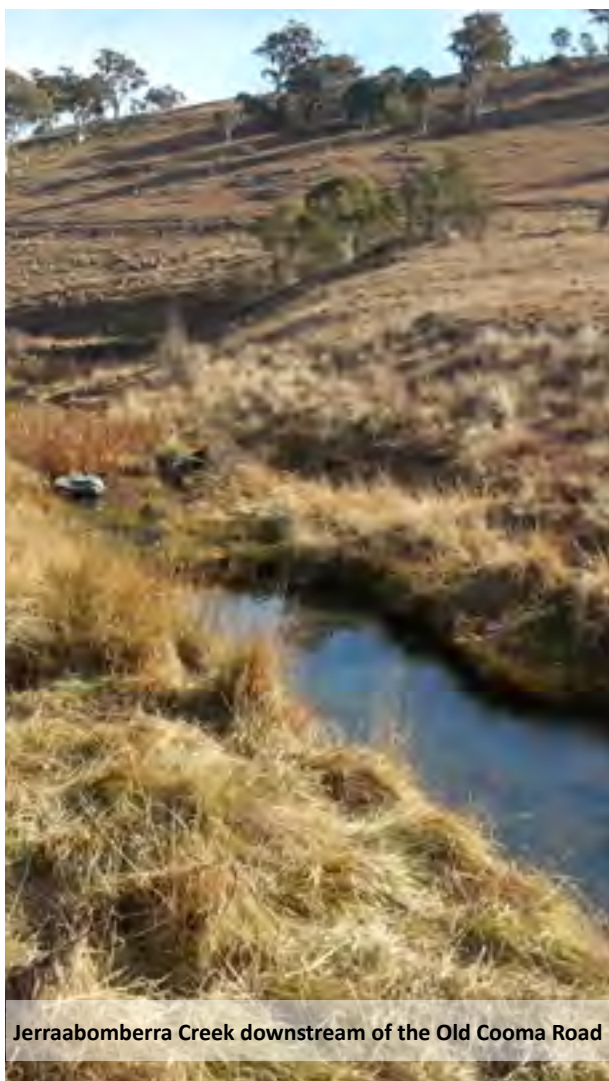
Jerrabomberra Creek downstream of the Old Cooma Road

Water bugs on this reach indicated 'good' condition, but the combined riparian vegetation assessments over the reach were 'poor', reflecting large sections of cleared land. Royalla Landcare have been undertaking revegetation activities for many years and the upper section of this reach had a 'fair' riparian assessment, which is likely to improve over time as the vegetation matures. This reach provides a useful reference for the rest of the Jerrabomberra Creek catchment.

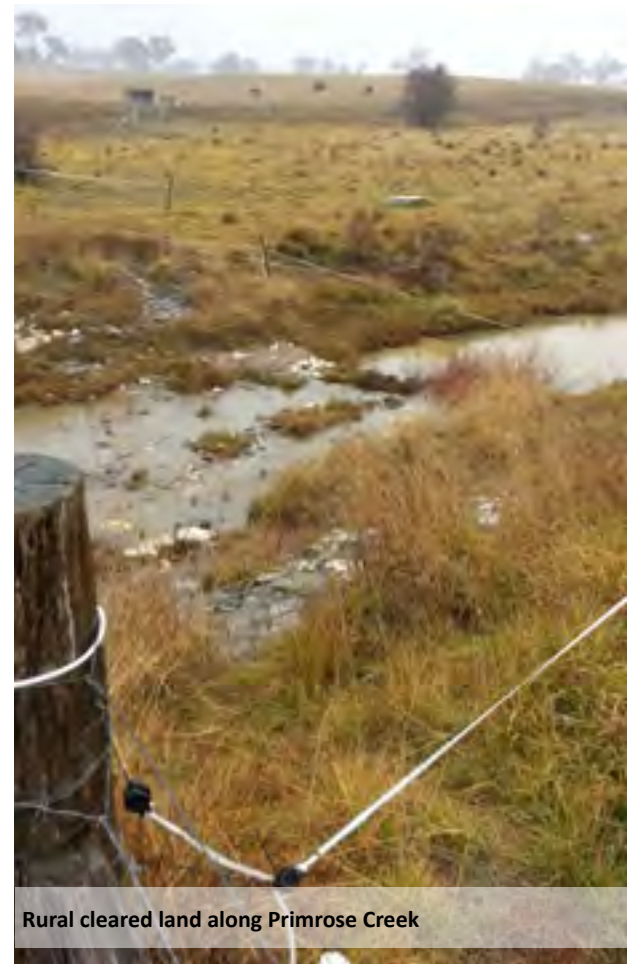
Rural cleared land along Primrose Creek

Apart from the conservation areas in the upper catchment, there is very little or no riparian vegetation along these creeks and stock generally have free access to the creeks. The riparian assessment score was one of the worst in the catchment, however Mountain galaxids (a small native fish) have been observed in this reach in recent times.

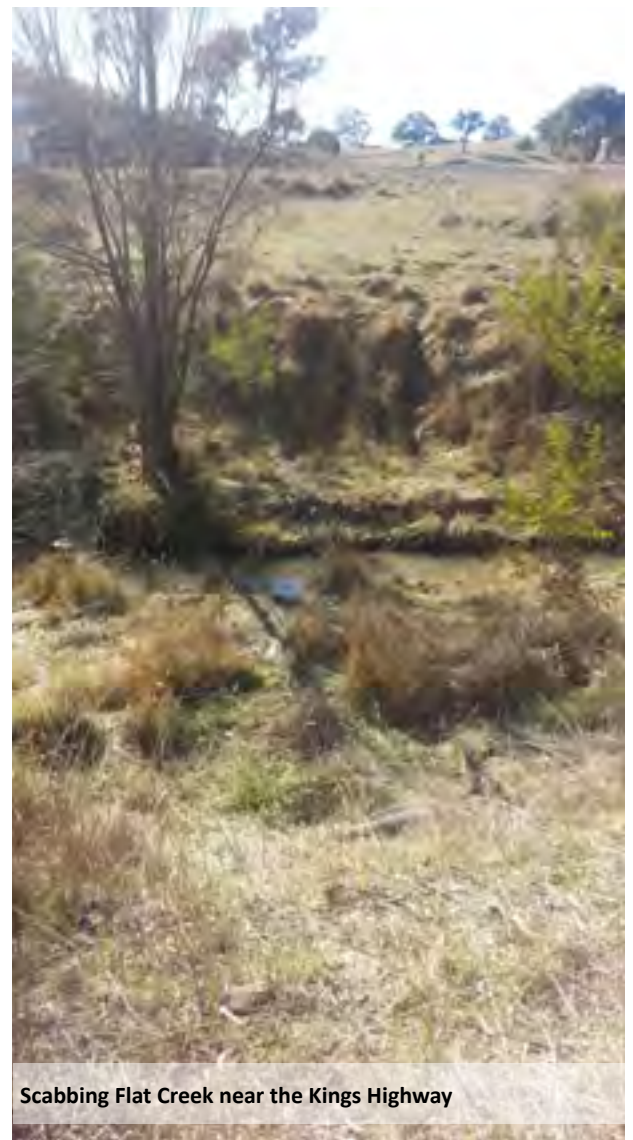
Scabbing Flat Creek near the Kings Highway

There is a council storage of tree roots, chunks of concrete and fill above the sample site which has the potential to impact the creek if not managed. The recent closing off of this area will reduce the risk of impacts from illegal dumping.

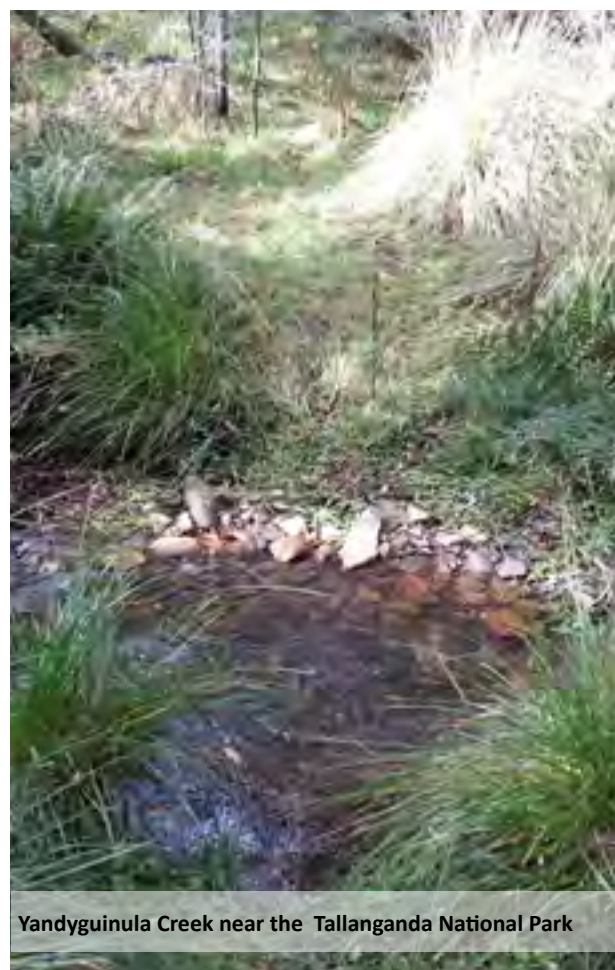
Yandyguinula Creek near the Tallaganda National Park

There was an apparent pollution event in the lower part of this reach during this reporting period. Local landholders reported fish and water bug deaths to the EPA and dissolved oxygen measurements over 2 months were extremely low (35%). Unfortunately no cause was found for the event.
