Catchment Health Indicator Program

2020

Executive Summary

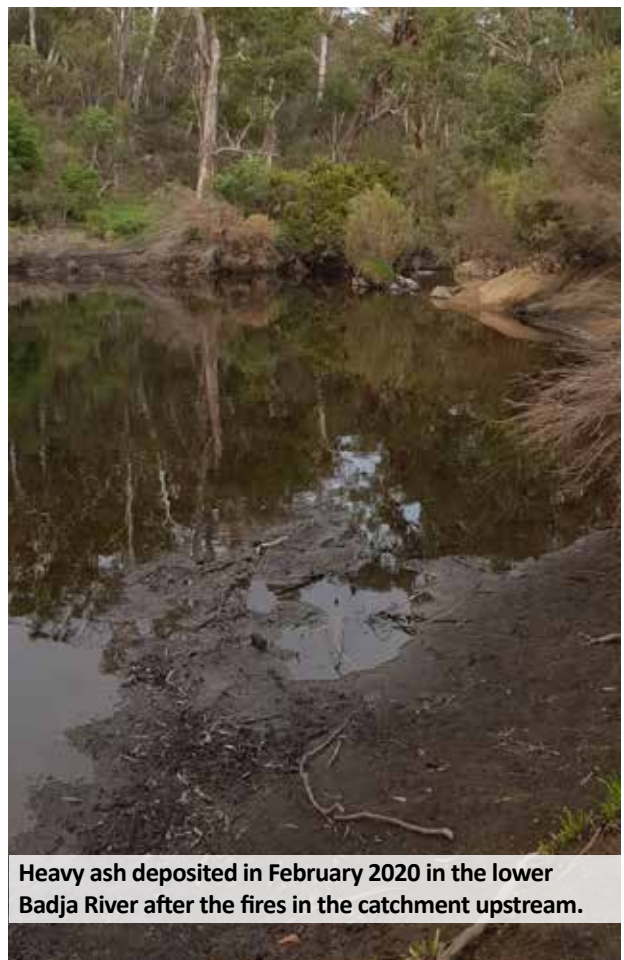
The 2019-2020 summer bushfires heavily impacted the catchment in the upper section of this reach. Heavy rains directly following the fires turned the river into a flowing stream of thick, black ash with large dead Carp seen floating in the backwaters. High phosphorous readings resulted with readings of 0.15mg/L recorded in the months directly following the fires. Our volunteer noted *“river banks [were] covered in deposited black sediment from fires and floods”*. This ash will continue to compromise in-stream habitat and adversely affect water quality for the foreseeable future.

Heavy ash deposited in February 2020 in the lower Badja River after the fires in the catchment upstream.

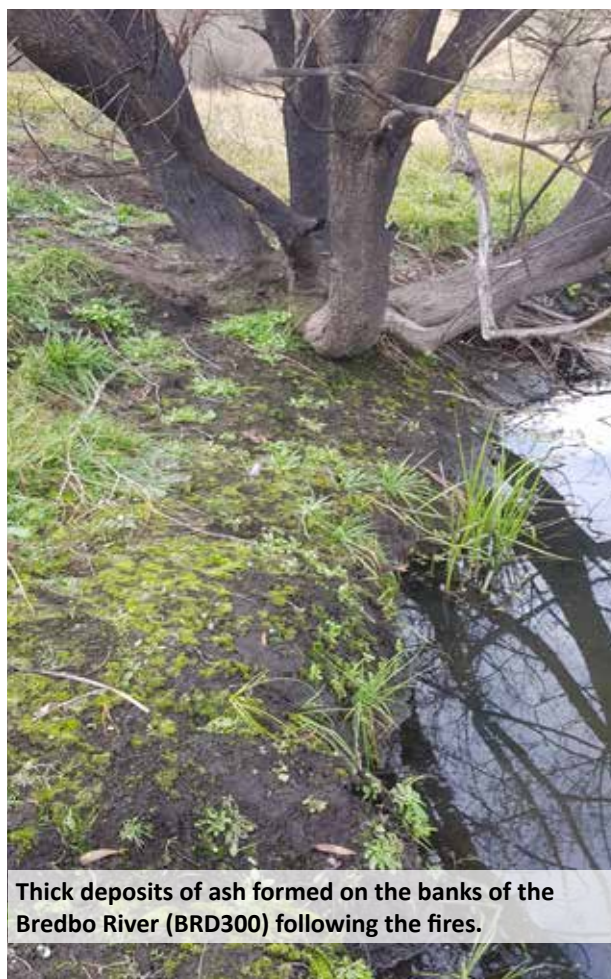
The extremely dry conditions saw much of this reach reduced to isolated pools towards the end of 2019, followed by bushfire impacting a large part of the upper Bredbo and part of the Cowra Creek catchments in early 2020. When rains came after the fire, a thick layer of ash was deposited on banks and this can still be seen a year later. Water quality also declined with high turbidity seen during run-off events and high phosphorous levels persisting throughout the year. Despite some rain in the catchment, water levels at both sites have remained low for the majority of the year. This suggests this catchment has received less rain than others in the region.

Thick deposits of ash formed on the banks of the Bredbo River (BRD300) following the fires.

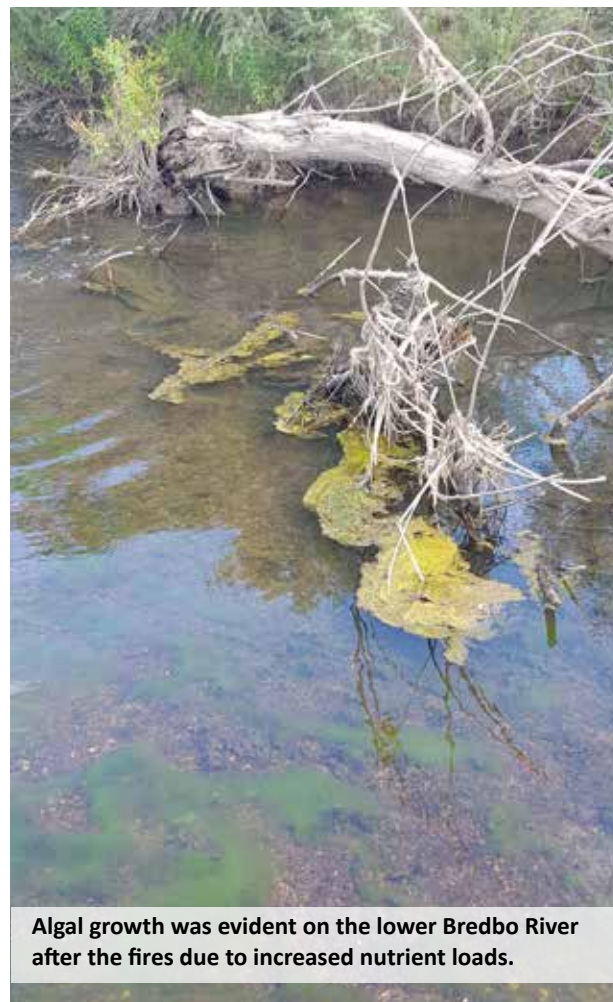
Although the area surrounding this reach was not burnt in the 2019-2020 bushfires, thick deposits of ash were washed down from the fireground upstream and these remain on the riverbanks and at the bottom of pools. This ash is a source of phosphorous which resulted in this reach being affected by algal growth when water levels were low and warm conditions experienced.

Algal growth was evident on the lower Bredbo River after the fires due to increased nutrient loads.

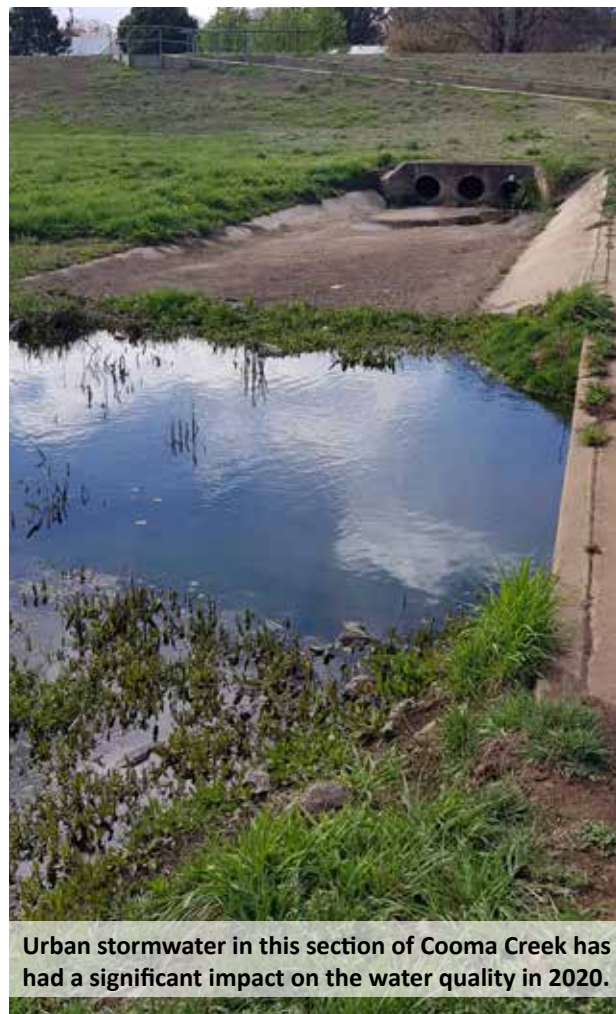
There was below average rainfall in the catchment during 2020 and low/no flows were recorded at our sites for two-thirds of the year. The lack of flows from the upstream catchment has meant water flows and quality in the creek has been largely influenced by stormwater inputs for much of the year. This included *degraded* concentrations of phosphorus being regularly detected at 0.25mg/L which is the upper limit of measurement for the phosphorus kits.

Urban stormwater in this section of Cooma Creek has had a significant impact on the water quality in 2020.

Improving the habitat and health of Cooma's creeks is a focus of the Cooma Landcare Group in partnership with Snowy Monaro Regional Council and Cooma Waterwatch. This includes regular litter clean-ups along this reach. It's pleasing to report that the number of plastic bags, bottles and drink cans found are much reduced now that the single use plastic bag ban and the NSW container deposit scheme have been put in place.

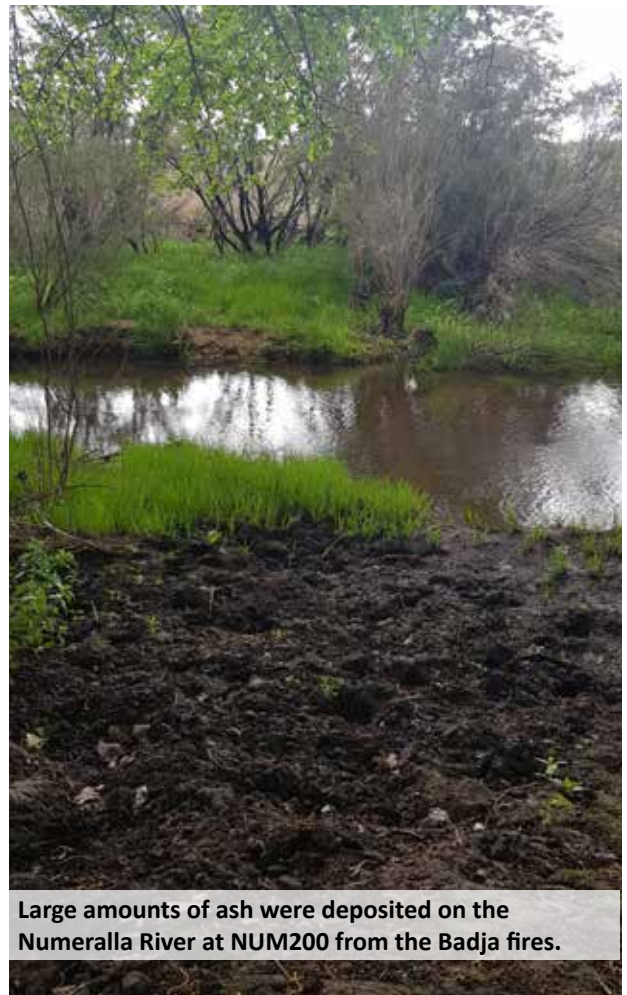
There were large amounts of ash washed into the downstream section of this reach near the confluence of the Badja River – a catchment which was almost entirely burnt during the summer bushfires. The ashen deposits at NUM200 were up to 30cm deep and remain exposed on the riverbed and banks a year after the fires. This had an adverse affect on water quality, leading to increased phosphorous levels as well as and a reduction of waterbug diversity. Despite wetter conditions in the wider region, river levels in this reach have remained low for the first half of the year, drying to pools over winter.

Large amounts of ash were deposited on the Numeralla River at NUM200 from the Badja fires.

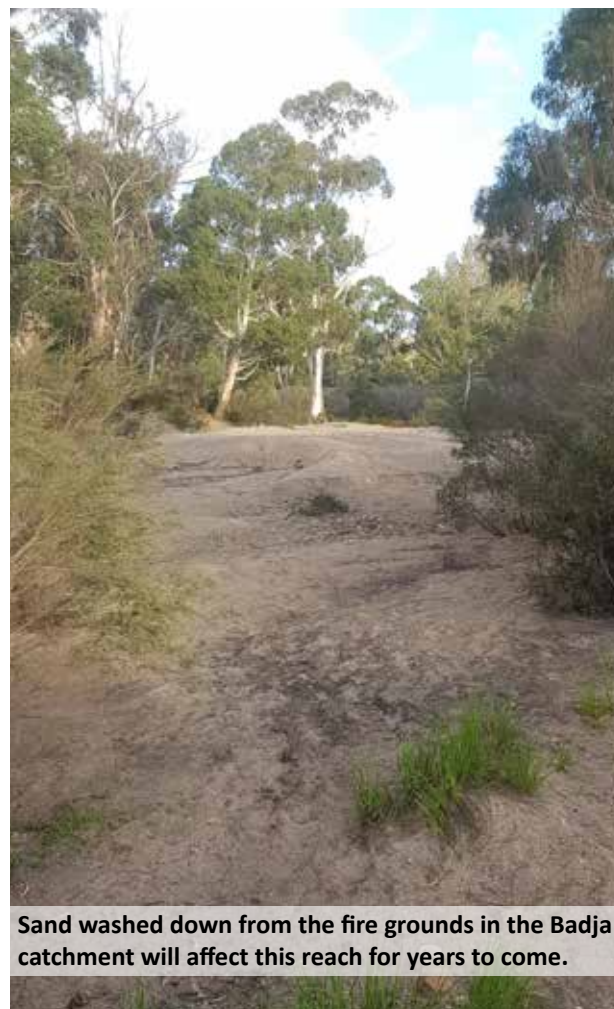
Water quality and river levels are influenced by the inflows of the Badja River at the top of this reach. Hence, this section of the Numeralla River was inundated with heavy ash and sand deposits from the fire grounds in the Badja catchment at the start of 2020. This resulted in *degraded* levels of phosphorus, electrical conductivity, nitrate and turbidity directly following the fires in January. The poor water quality was short lived, however as higher than average rainfall in the headwaters of the Badja River resulted in high flows and improved water quality after the initial ash plume was washed through.

Sand washed down from the fire grounds in the Badja catchment will affect this reach for years to come.

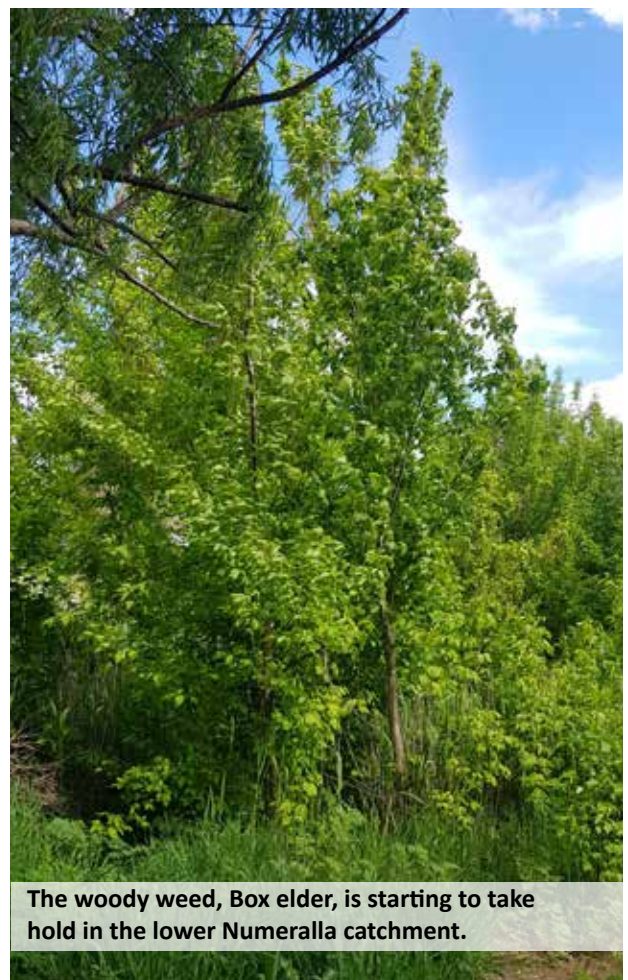
The woody weed, Box elder, is starting to take hold in the lower Numeralla catchment.

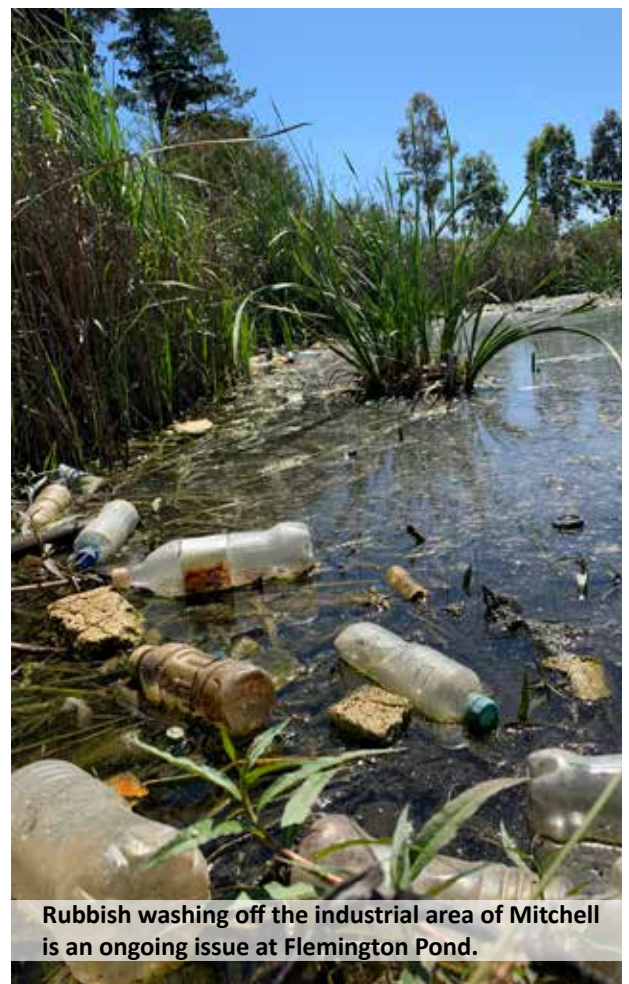
Rubbish washing off the industrial area of Mitchell is an ongoing issue at Flemington Pond.

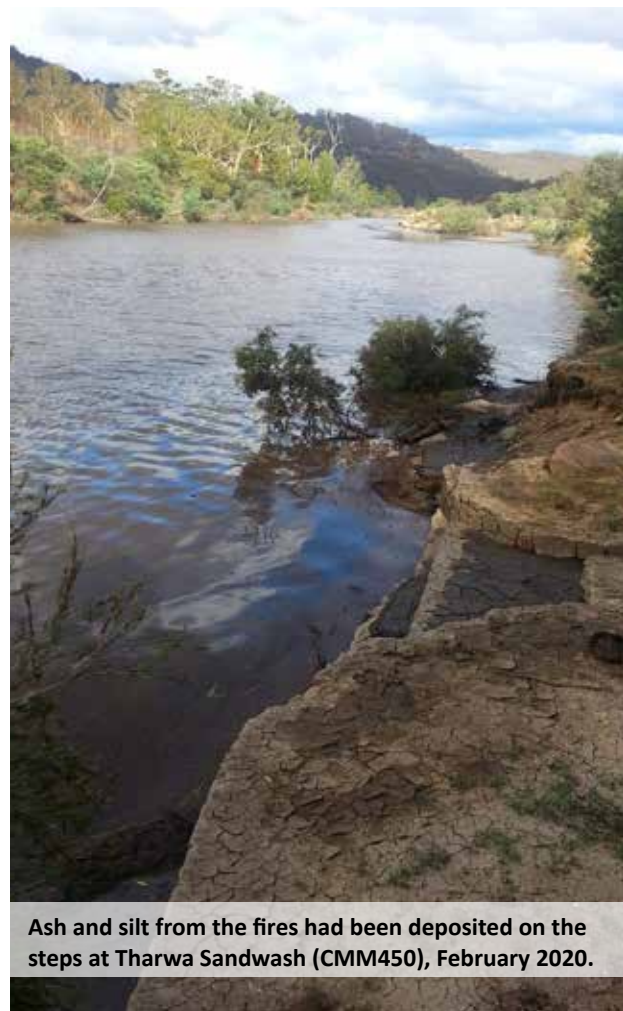
Ash and silt from the fires had been deposited on the steps at Tharwa Sandwash (CMM450), February 2020.

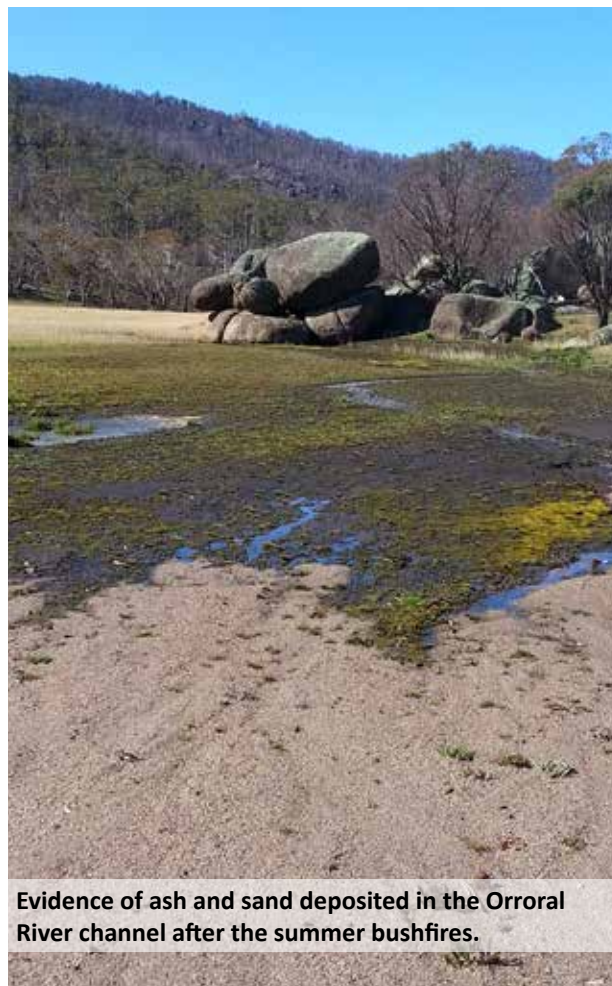
Evidence of ash and sand deposited in the Orroral River channel after the summer bushfires.

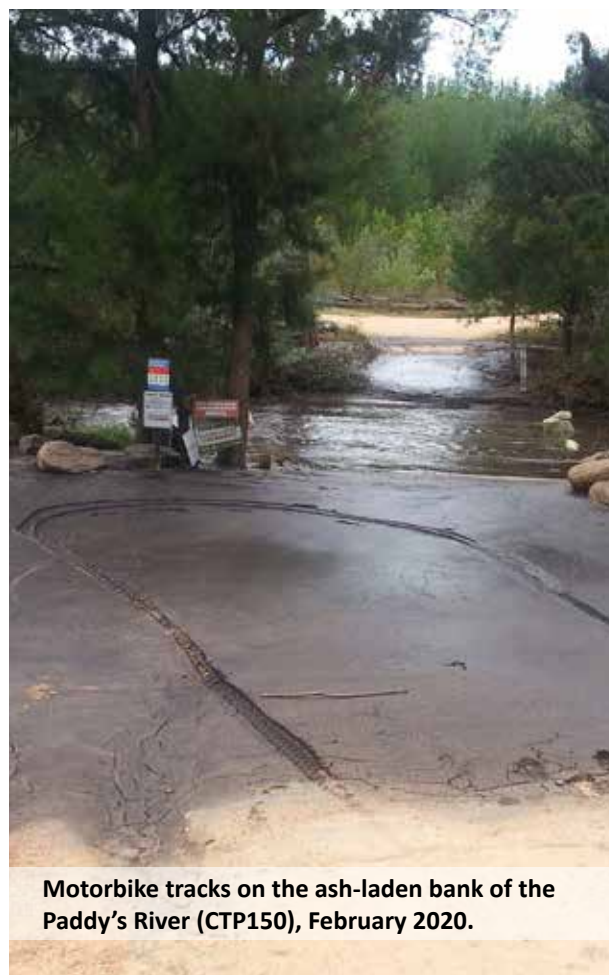
Motorbike tracks on the ash-laden bank of the Paddy's River (CTP150), February 2020.

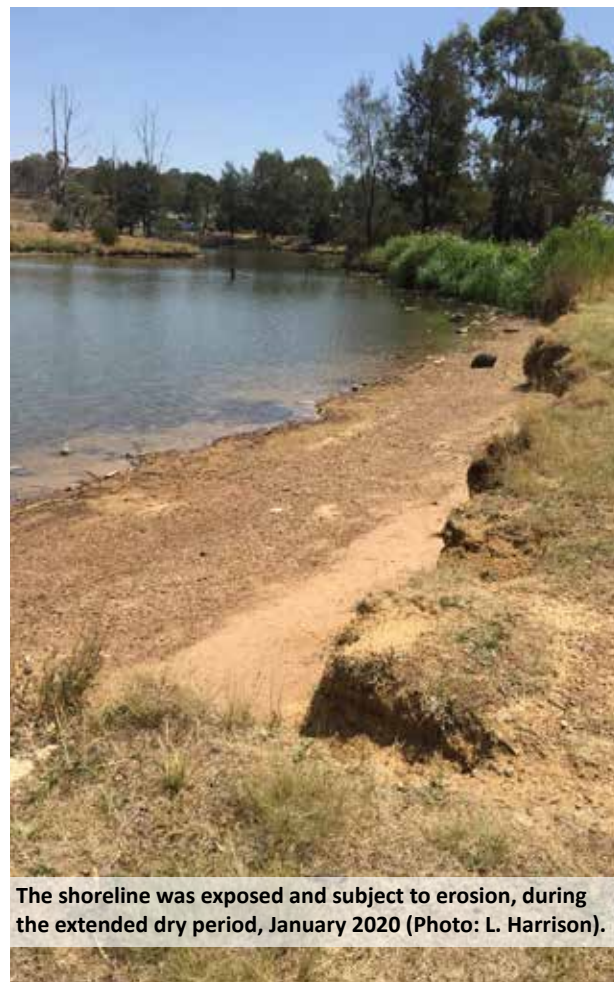
The shoreline was exposed and subject to erosion, during the extended dry period, January 2020 (Photo: L. Harrison).

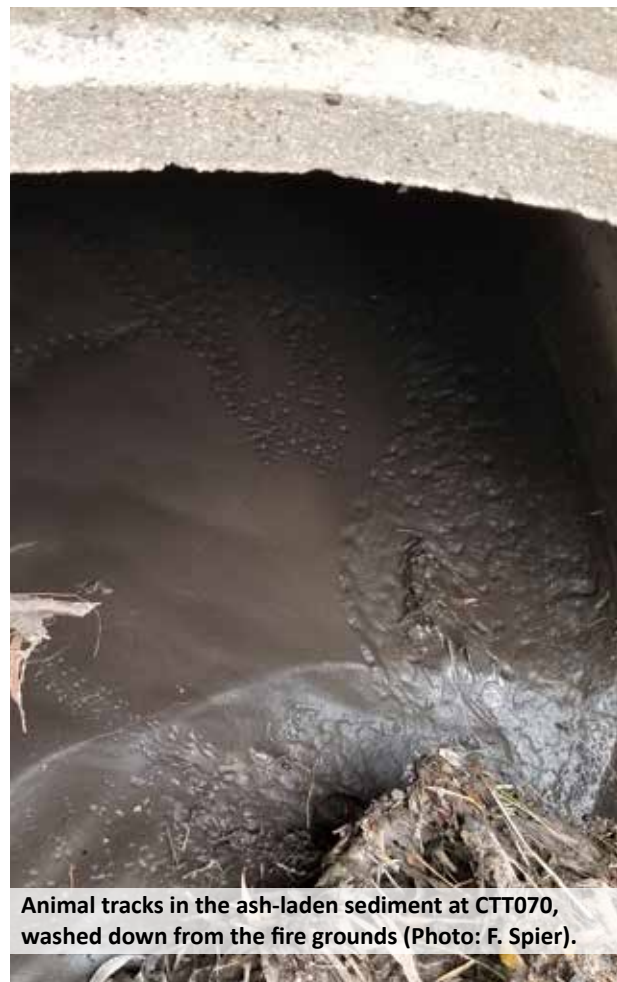
Animal tracks in the ash-laden sediment at CTT070, washed down from the fire grounds (Photo: F. Spier).

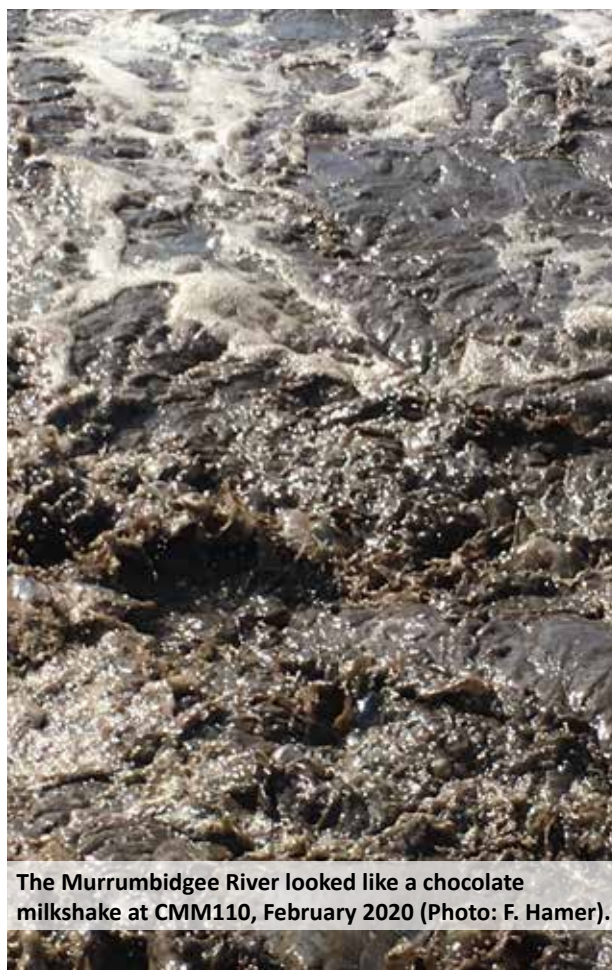
The Murrumbidgee River looked like a chocolate milkshake at CMM110, February 2020 (Photo: F. Hamer).

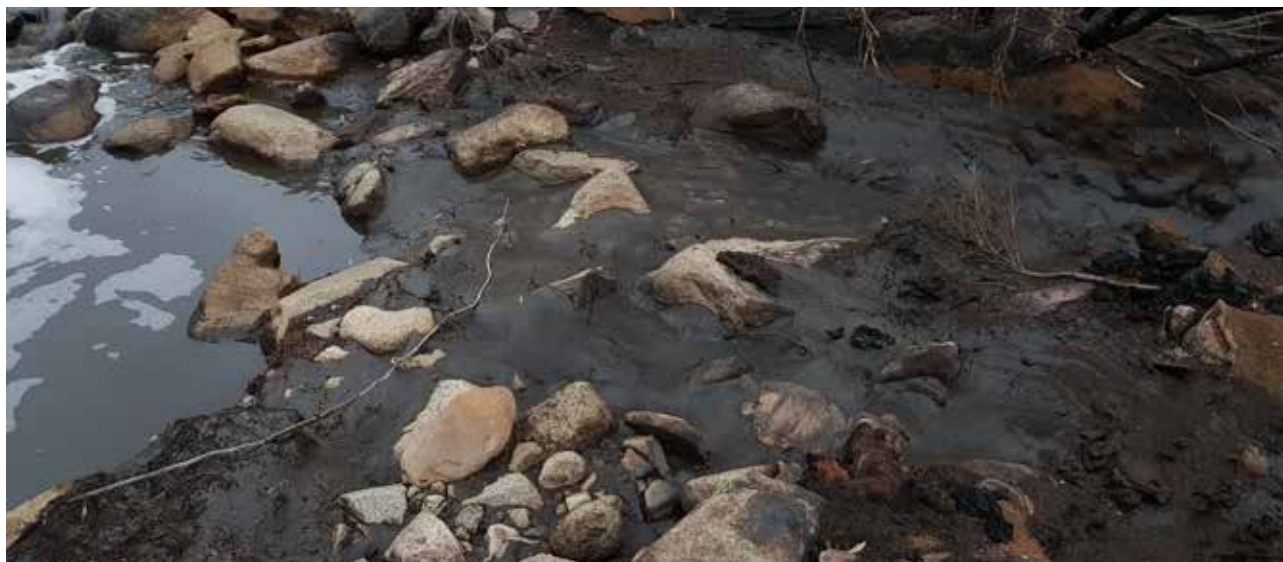
Ash flow from the fireground affected the lower Badja River (Photo: A. Brademann)

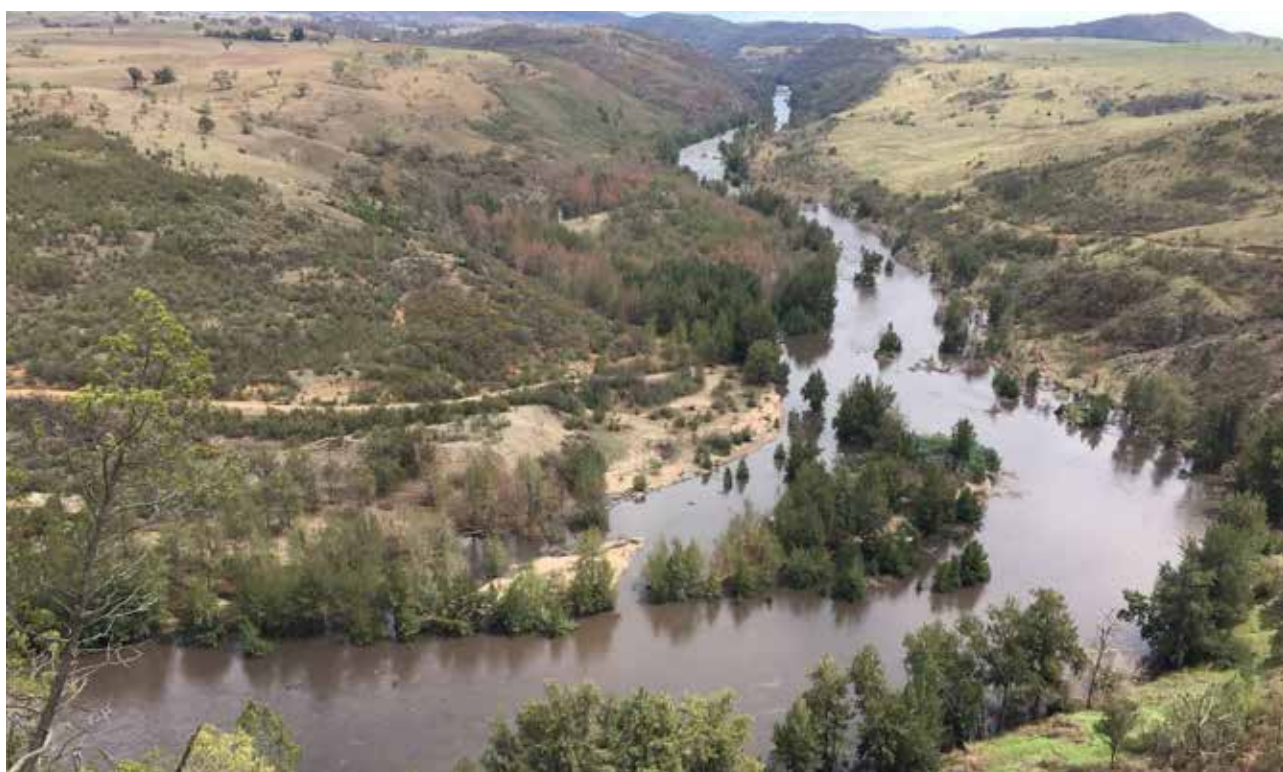
The Murrumbidgee River running brown with ash and sediment in February 2020 (Photo: W. O'Reilly).
