**WATERWATCH**

**Upper Murrumbidgee**

# Catchment Health Indicator Program

2015–16

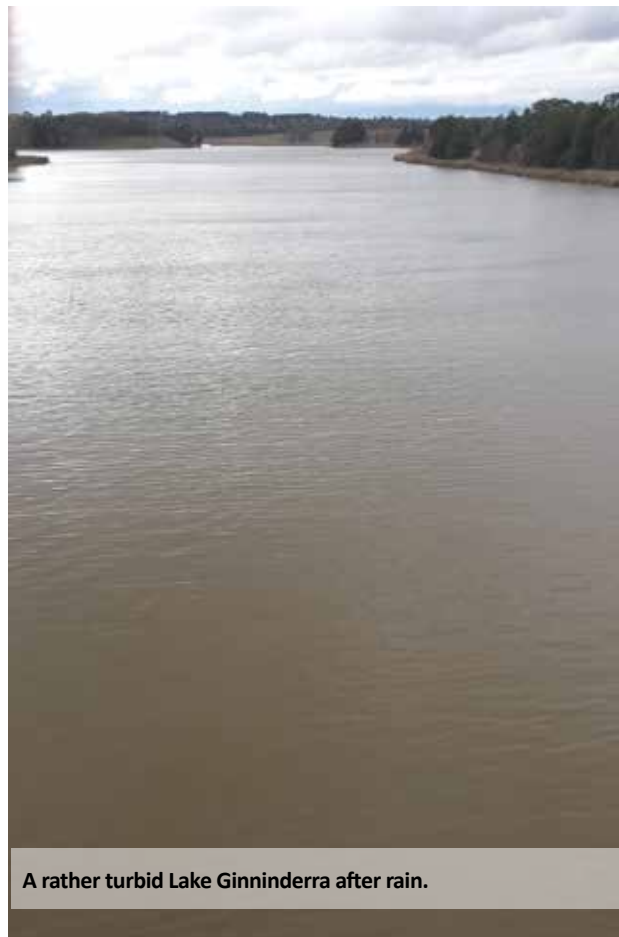
Riparian condition scores were 'poor' and reflect the parkland nature of this Lake reach. Habitat features are particularly low including debris and native vegetation in many areas. There is scope for improvement in areas that are not required for visitor access and do not need to be maintained in a "neat and tidy" manner.

A rather turbid Lake Ginninderra after rain.

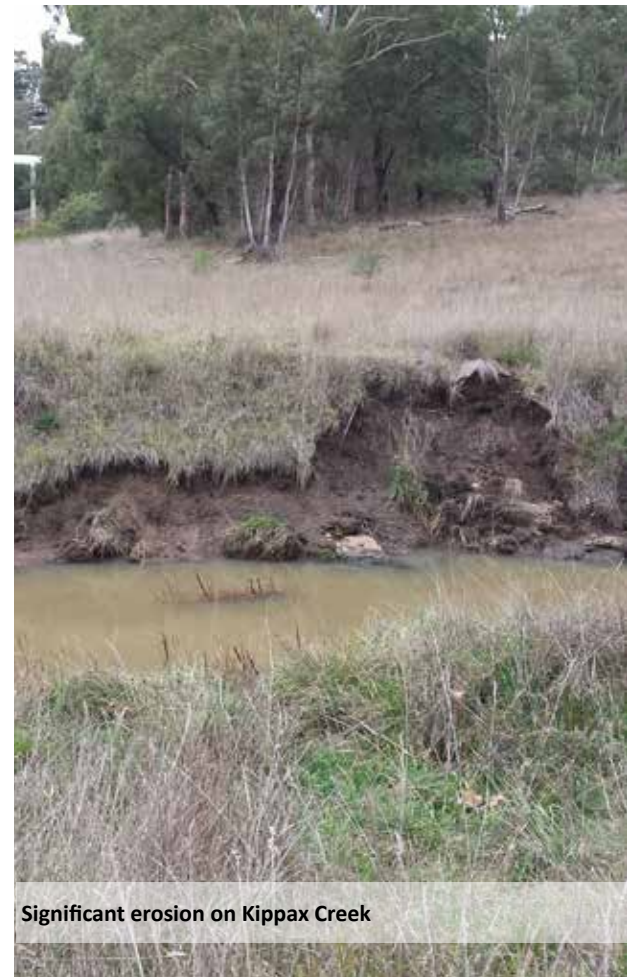
Riparian condition was patchy, overall the reach lacks native ground cover complexity in structure of layers and habitat features.

Significant erosion on Kippax Creek

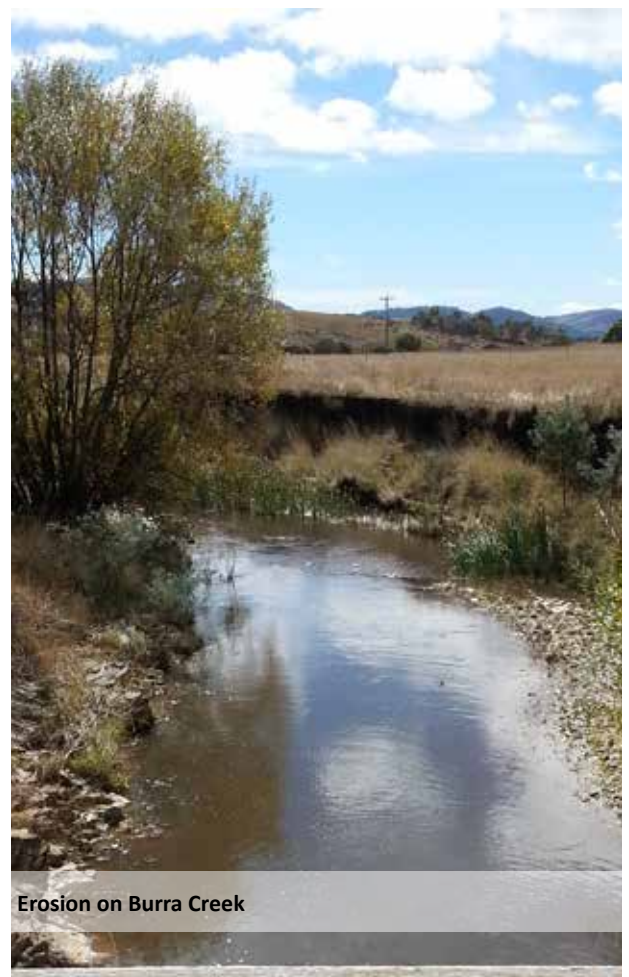
Erosion on Burra Creek
