# Catchment Health Indicator Program

2022

This document can be cited as: Upper Murrumbidgee Waterwatch (2022) Catchment Health Indicator Program: Report Card 2022. Canberra.

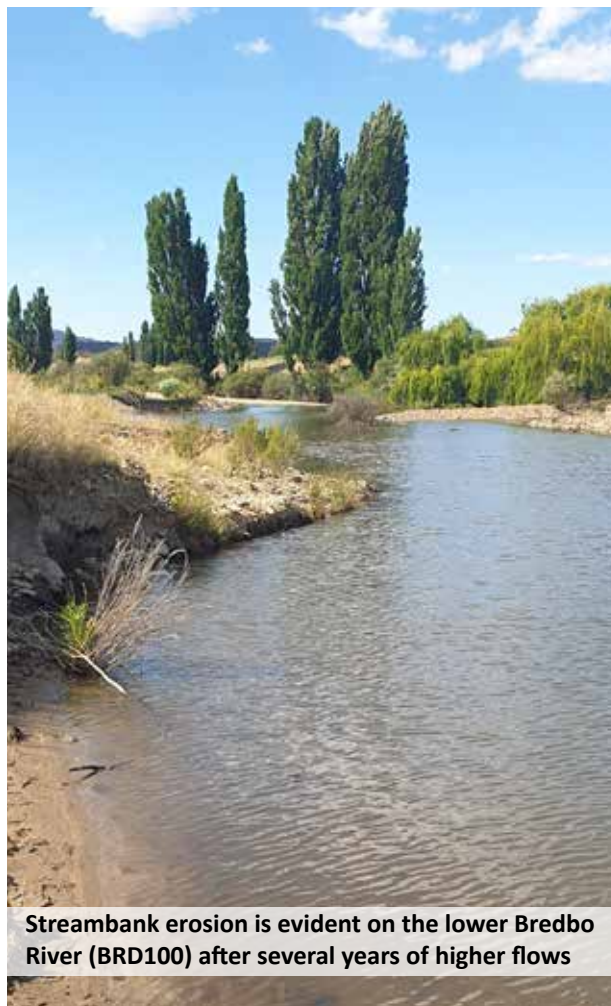
High flows continued throughout 2022 which saw ongoing streambank erosion along this reach, especially in areas where deep rooted native vegetation is limited. Successive flood events saw new deposits of sand and ash at the confluence, indicating the ongoing mobility of both fine and gross sediment in the system. This year's waterbug survey results reflected this with the majority of bugs found belonging to the Orders of Hemiptera (true bugs) and Diptera (fly larvae) which are tolerant of both poor habitat and water quality.

Streambank erosion is evident on the lower Bredbo River (BRD100) after several years of higher flows

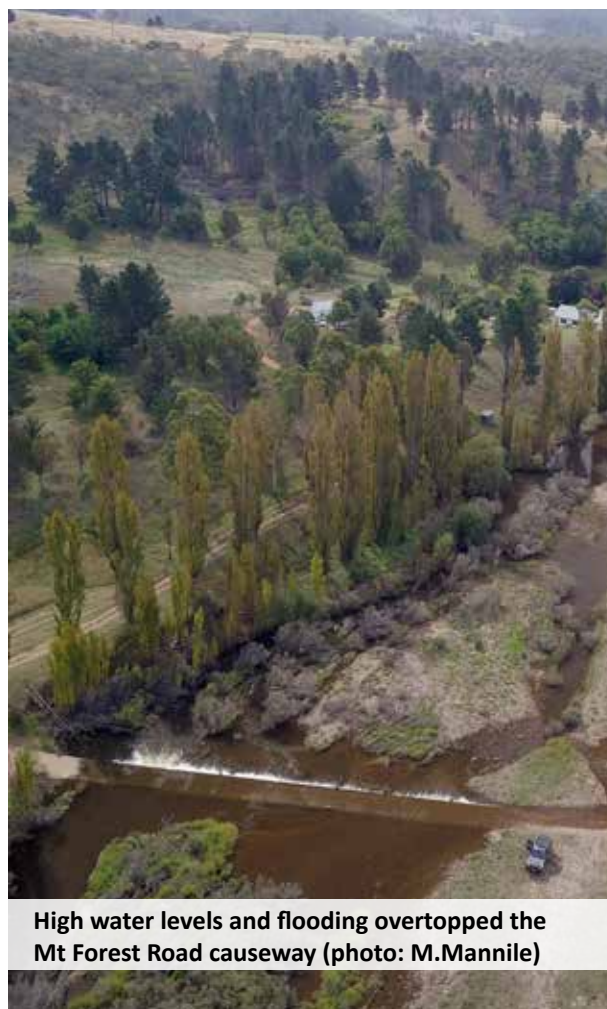
**High water levels and flooding overtopped the Mt Forest Road causeway (photo: M.Mannile)**

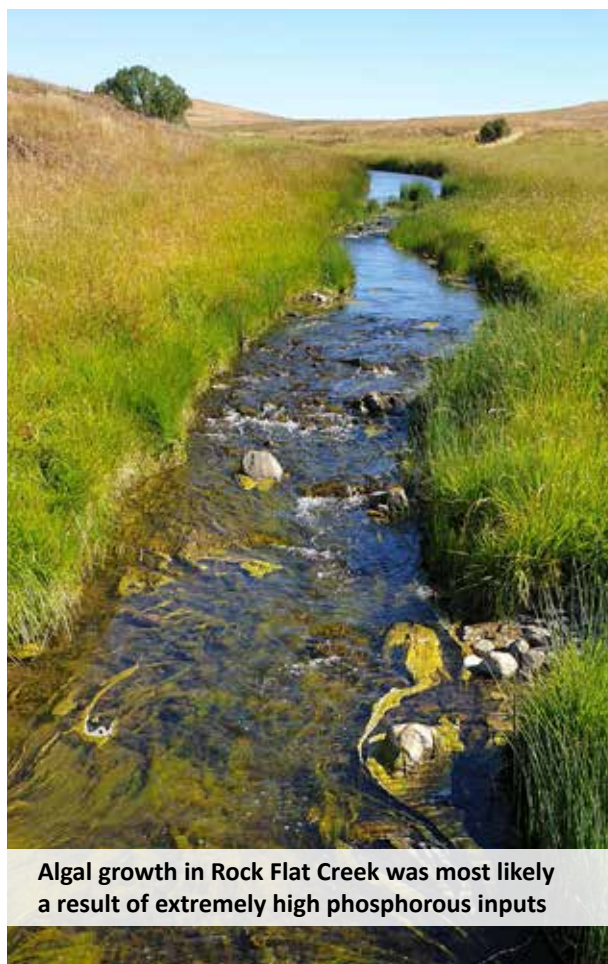
Increased nutrients have increased algal growth in the creek and were often noted by Mike, especially at ROC400. Waterbug survey results showed a decline this year compared to last year especially in the Spring survey which yielded a *poor* result due to low diversity. High numbers of mayflies, a pollution-sensitive waterbug, and the more tolerant fly larvae, dominated the sample.

Algal growth in Rock Flat Creek was most likely a result of extremely high phosphorous inputs

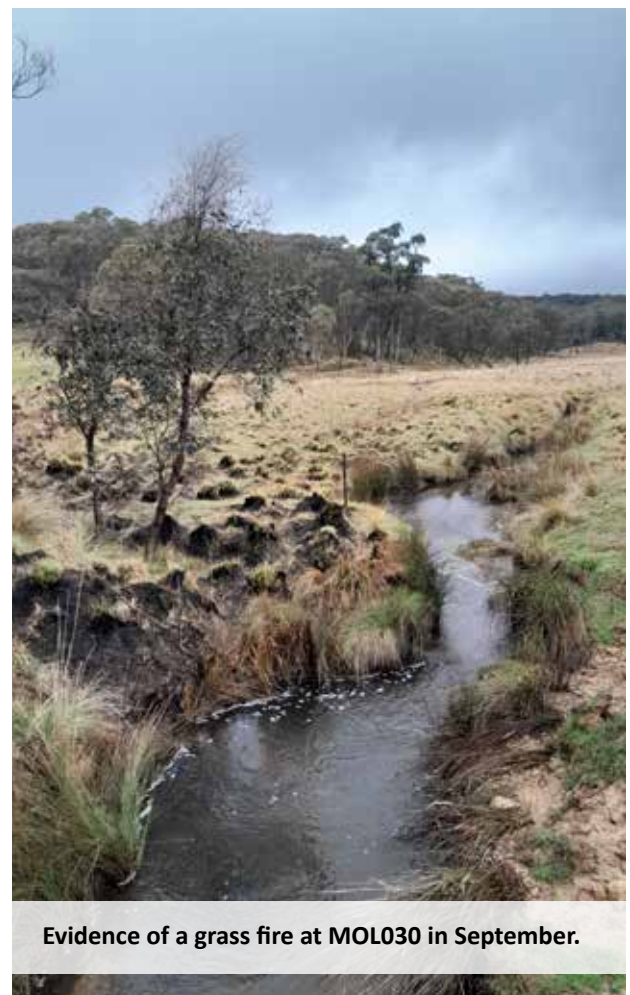
Evidence of a grass fire at MOL030 in September.

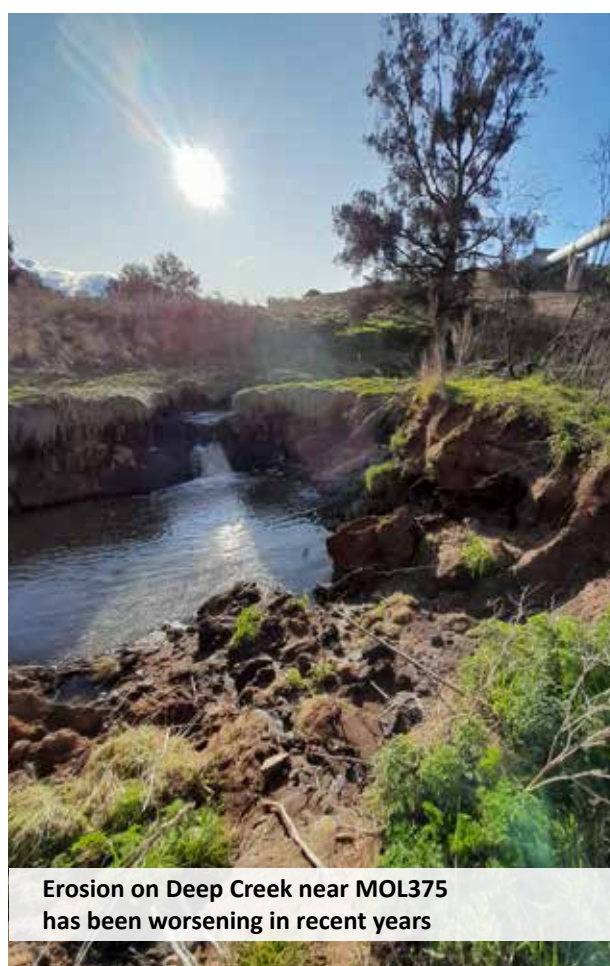
Erosion on Deep Creek near MOL375 has been worsening in recent years

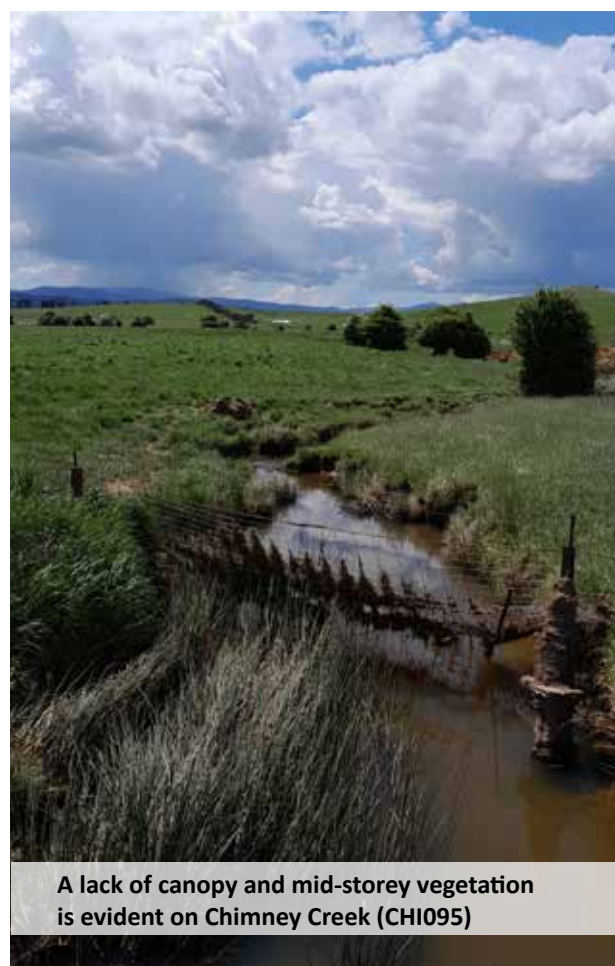
A lack of canopy and mid-storey vegetation is evident on Chimney Creek (CHI095)

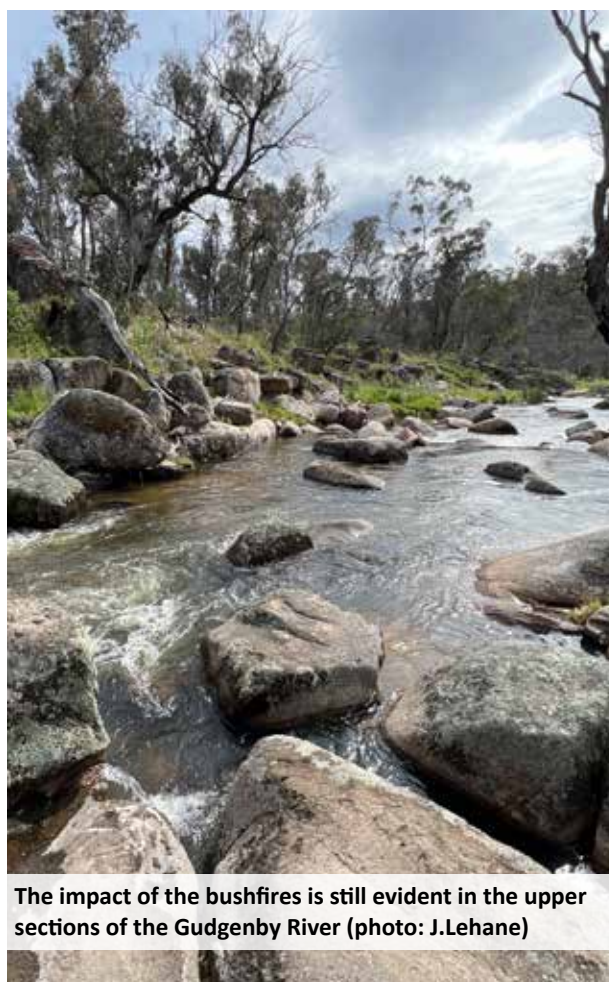
The impact of the bushfires is still evident in the upper sections of the Gudgenby River (photo: J.Lehane)

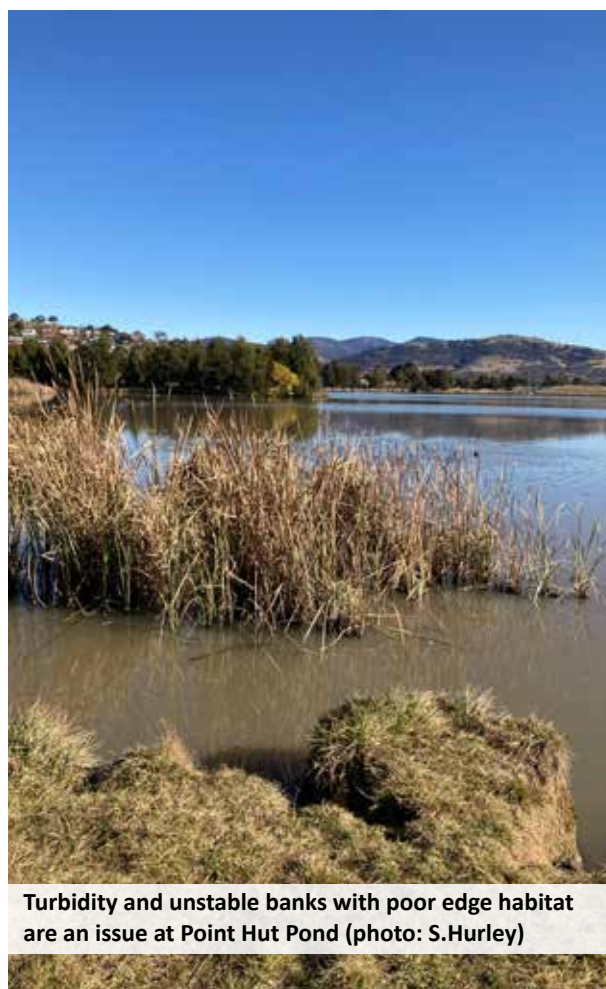
Turbidity and unstable banks with poor edge habitat are an issue at Point Hut Pond (photo: S.Hurley)

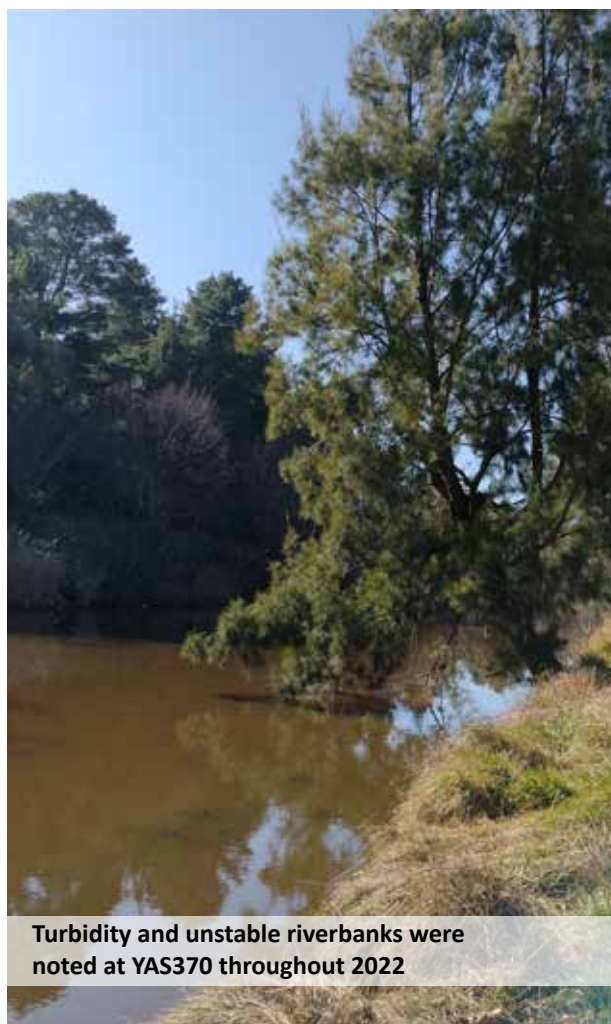
**Turbidity and unstable riverbanks were noted at YAS370 throughout 2022**

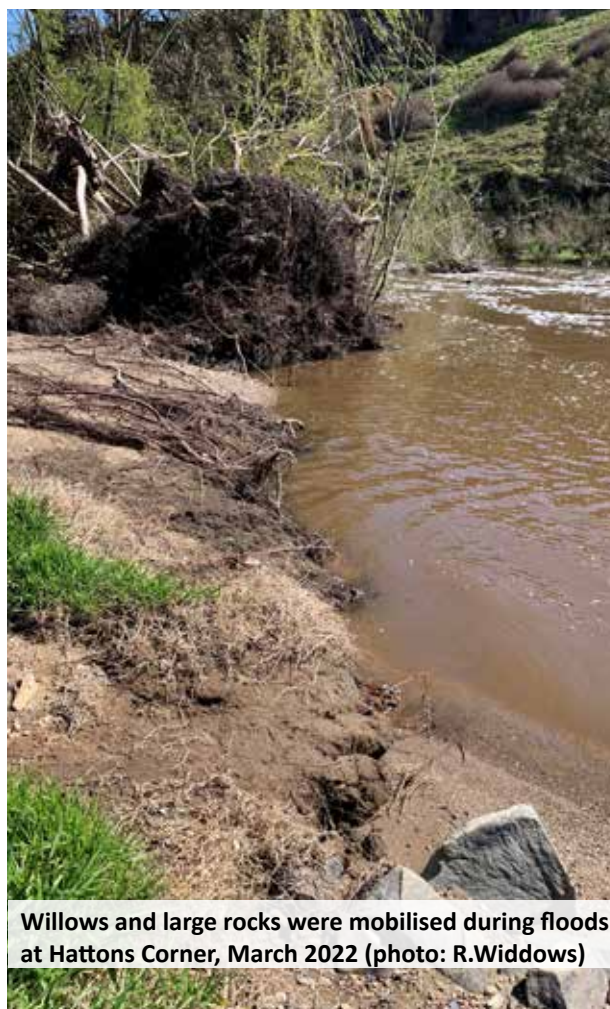
**Willows and large rocks were mobilised during floods at Hattons Corner, March 2022 (photo: R.Widdows)**
