CHIP

Catchment Health Indicator Program
Report Card 2013/14

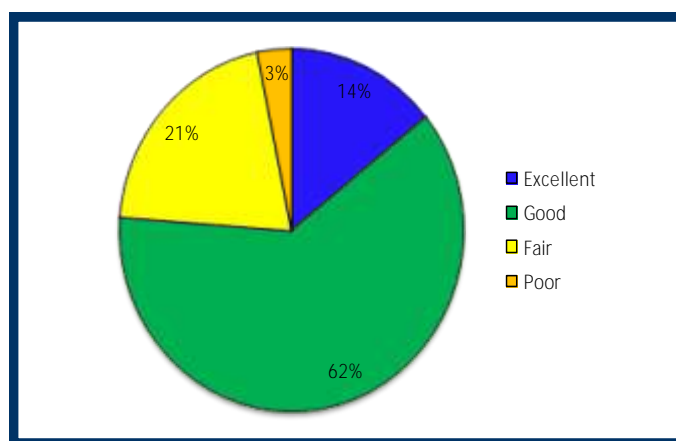
Across the 63 sampled sites, CHIP scores varied from Excellent to Poor as per the rating system. No reaches were rated as Degraded which is the lowest rating (**Figure 1**). Nine reaches (14%) were classified as being in excellent health, with four of these coming from the headwater sections of rivers in the Molonglo catchment, two in Southern ACT, and three in Cooma catchments. Conversely, no reaches within the Ginninderra catchment were classified as excellent. This is perhaps not surprising, given the high degree of urbanisation in this catchment.

The vast majority (62%) of reaches were classified as good, with more than 50% of reaches in Cooma, Molonglo, Ginninderra and Southern ACT falling into this classification. There were considerably fewer reaches classified as either Fair (21%) or Poor (3%) (**Figure 1**).

Figure 1: Ratings given to the 63 reaches sampled in the 2013/14 CHIP report. No reaches were rated as 'Degraded'.
