Catchment Health Indicator Program

2020

Executive Summary

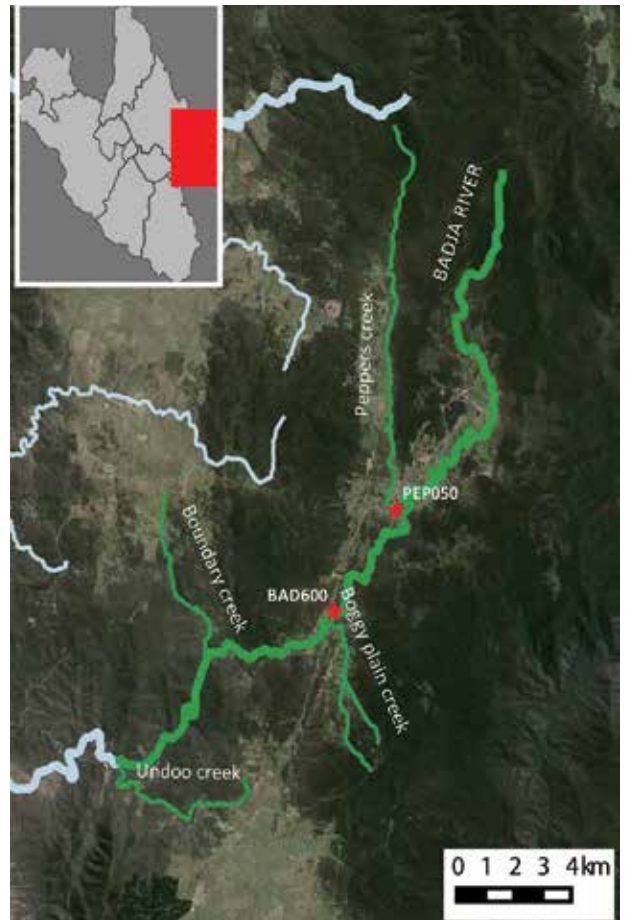
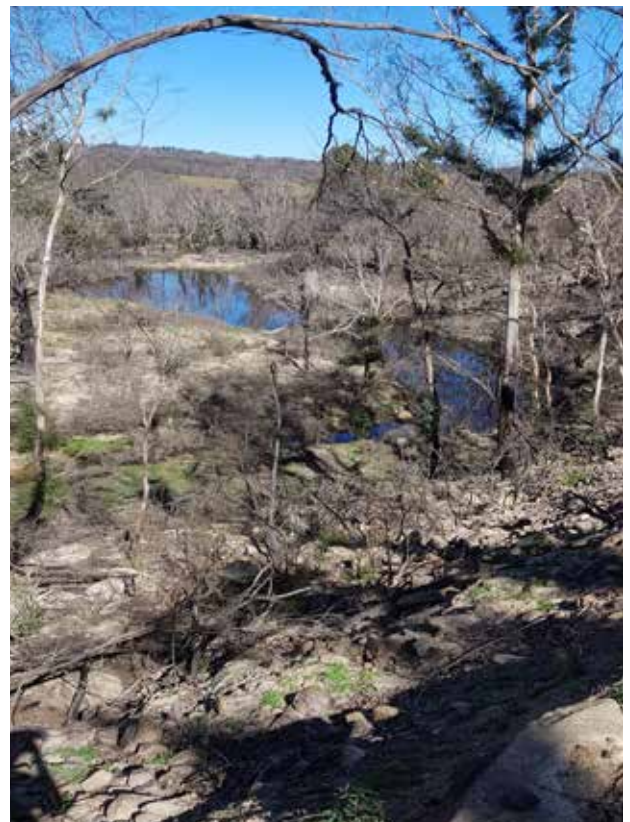
The 2019-2020 bushfires, however, greatly impacted this reach with fire burning out most of the catchment. After the fire, the Waterwatch volunteer noted that the banks and *"most of (the) surrounding catchment has been predominately burnt at all levels...canopy/shrub/ground"*. It took many months for groundcover to re-establish and the November waterbug survey found that most riparian vegetation had not yet recovered. The riparian condition score noted in this report, however, is pre-fire as sites are surveyed every two years.

Once the rains did come the river turned into a flow of thick black mud and isolated fish kills (trout) were seen as dissolved oxygen levels plummeted. Luckily, during February the reach received three times its average monthly rainfall, restoring flows and water quality as the ash was flushed downstream. Good follow up rains in winter positively influenced waterbug scores but our surveys did show a decline in diversity and abundance compared to previous years.

A year has past since the fires at BAD600 and recovery remains slow.

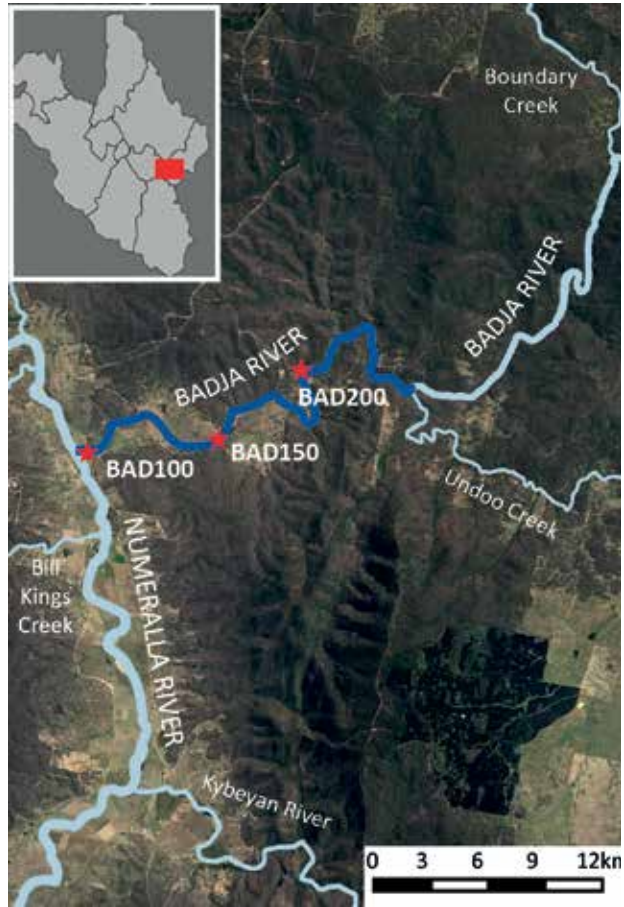
The 2019-2020 summer bushfires heavily impacted the catchment in the upper section of this reach. Heavy rains directly following the fires turned the river into a flowing stream of thick, black ash with large dead Carp seen floating in the backwaters. High phosphorous readings resulted with readings of 0.15mg/L recorded in the months directly following the fires. Our volunteer noted *“river banks [were] covered in deposited black sediment from fires and floods”*. This ash will continue to compromise in-stream habitat and adversely affect water quality for the foreseeable future.

Heavy ash deposited in February 2020 in the lower Badja River after the fires in the catchment upstream.

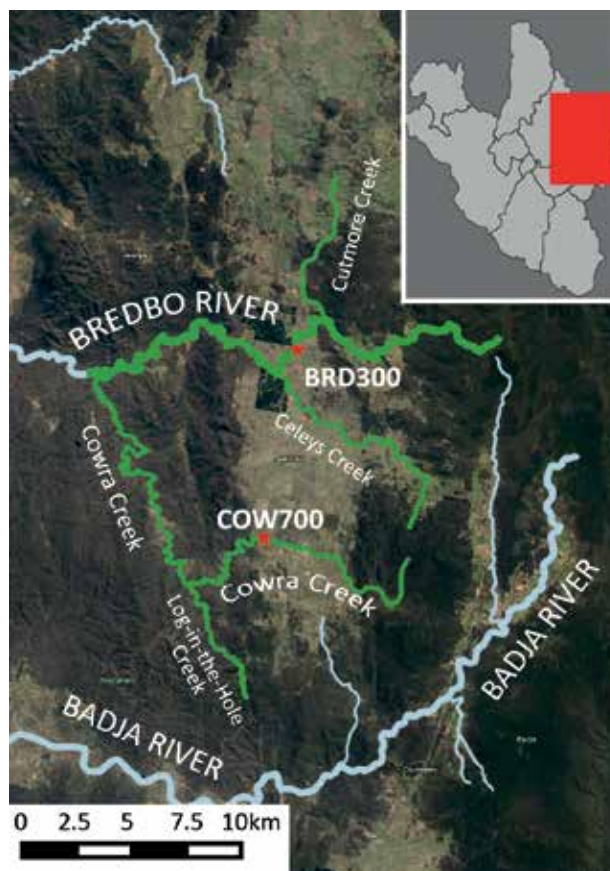
The extremely dry conditions saw much of this reach reduced to isolated pools towards the end of 2019, followed by bushfire impacting a large part of the upper Bredbo and part of the Cowra Creek catchments in early 2020. When rains came after the fire, a thick layer of ash was deposited on banks and this can still be seen a year later. Water quality also declined with high turbidity seen during run-off events and high phosphorous levels persisting throughout the year. Despite some rain in the catchment, water levels at both sites have remained low for the majority of the year. This suggests this catchment has received less rain than others in the region.

Thick deposits of ash formed on the banks of the Bredbo River (BRD300) following the fires.

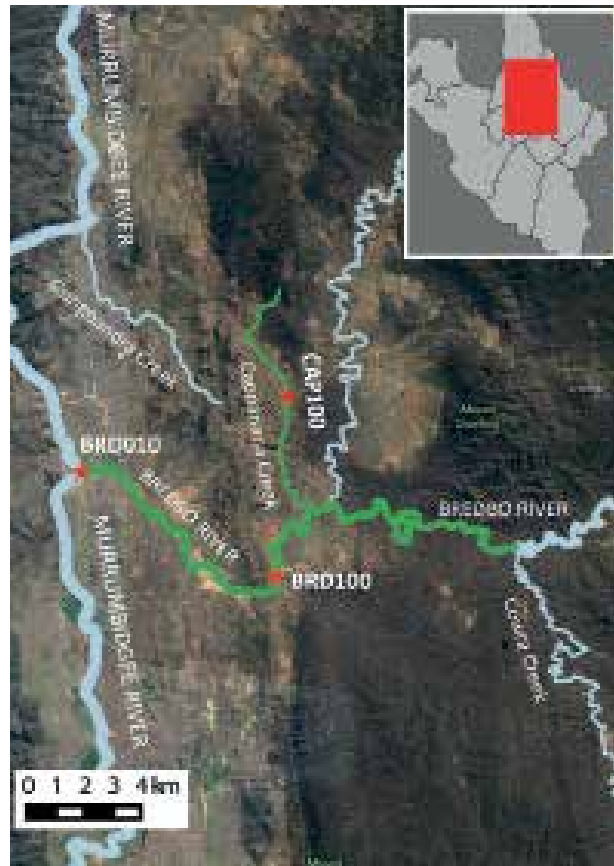
Although the area surrounding this reach was not burnt in the 2019-2020 bushfires, thick deposits of ash were washed down from the fireground upstream and these remain on the riverbanks and at the bottom of pools. This ash is a source of phosphorous which resulted in this reach being affected by algal growth when water levels were low and warm conditions experienced.

Algal growth was evident on the lower Bredbo River after the fires due to increased nutrient loads.

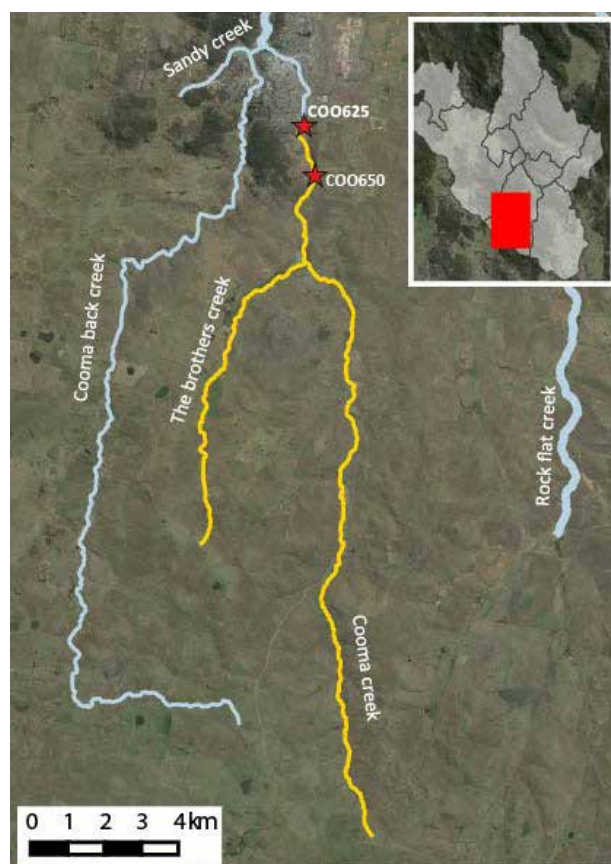
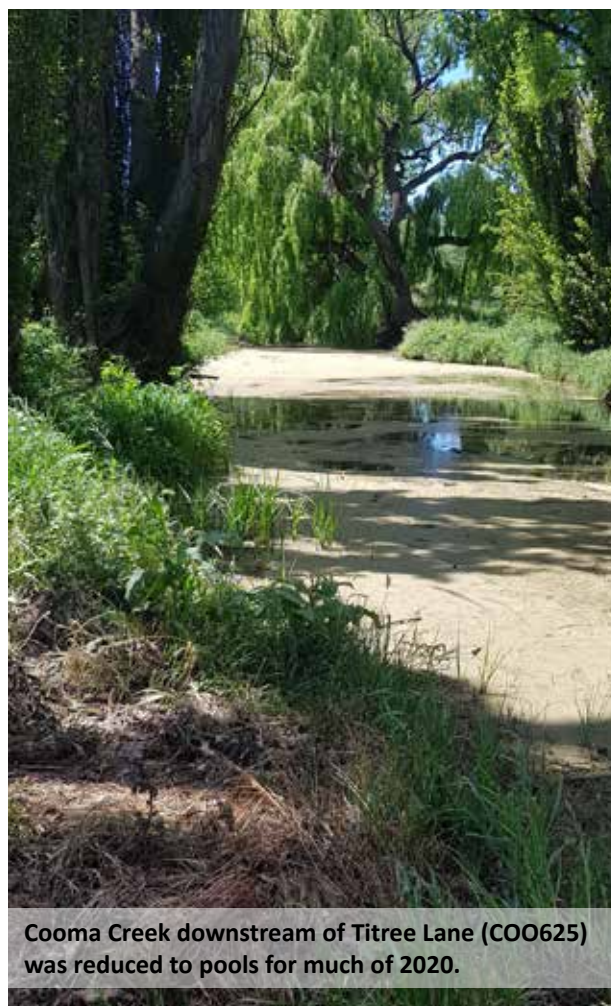
Water quality, lack of in-stream habitat and flows at our waterbug site contributed to the *fair* waterbug score for this reach. The site was dry in autumn and no survey could be conducted.

Cooma Creek downstream of Titree Lane (COO625) was reduced to pools for much of 2020.

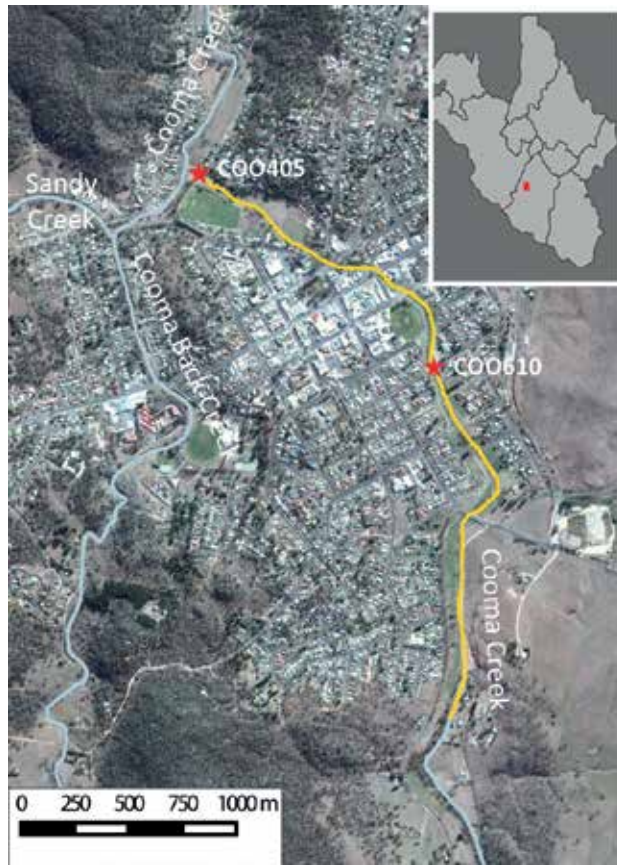
There was below average rainfall in the catchment during 2020 and low/no flows were recorded at our sites for two-thirds of the year. The lack of flows from the upstream catchment has meant water flows and quality in the creek has been largely influenced by stormwater inputs for much of the year. This included *degraded* concentrations of phosphorus being regularly detected at 0.25mg/L which is the upper limit of measurement for the phosphorus kits.

Urban stormwater in this section of Cooma Creek has had a significant impact on the water quality in 2020.

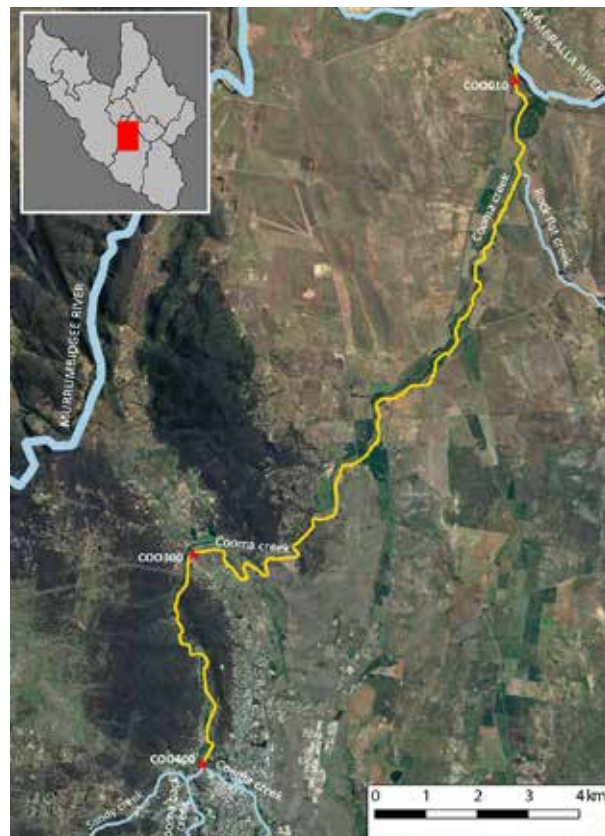
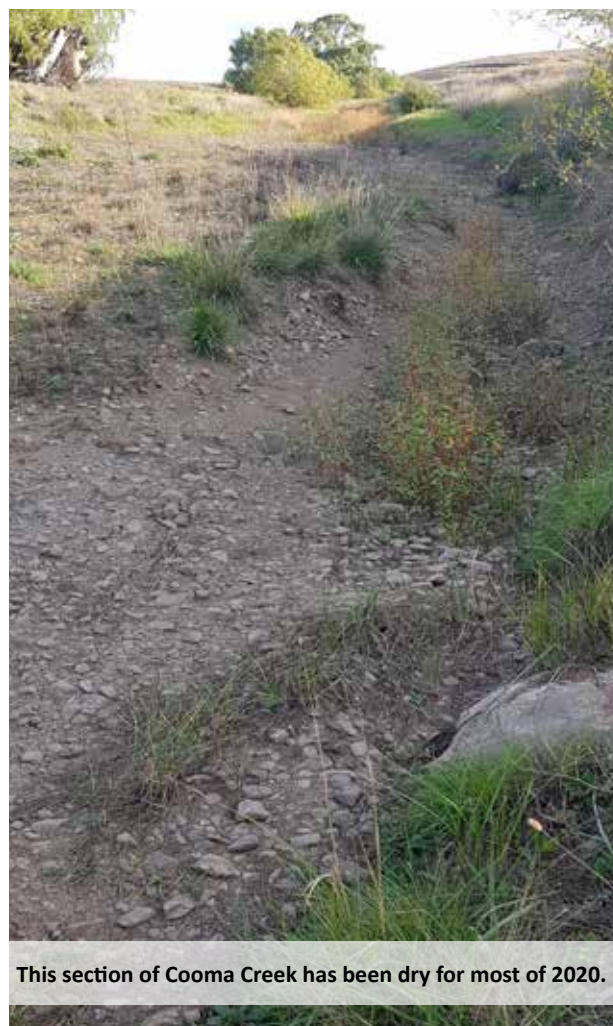
Flows have been very low in 2020 and so Cooma's sewage treatment plant (located near the top of this reach) and urban inflows from upstream have provided the main flows throughout the year. This has influenced water quality in the reach including high nitrate levels, which have been recorded as high as 20mg/L at COO300. The bottom end of the reach was dry for more than half of the year and could not be surveyed for waterbugs in autumn and spring. Hence, waterbug surveys were carried out COO300 (the next site upstream) in spring and this likely resulted in the improvement in the overall reach score.

This section of Cooma Creek has been dry for most of 2020.

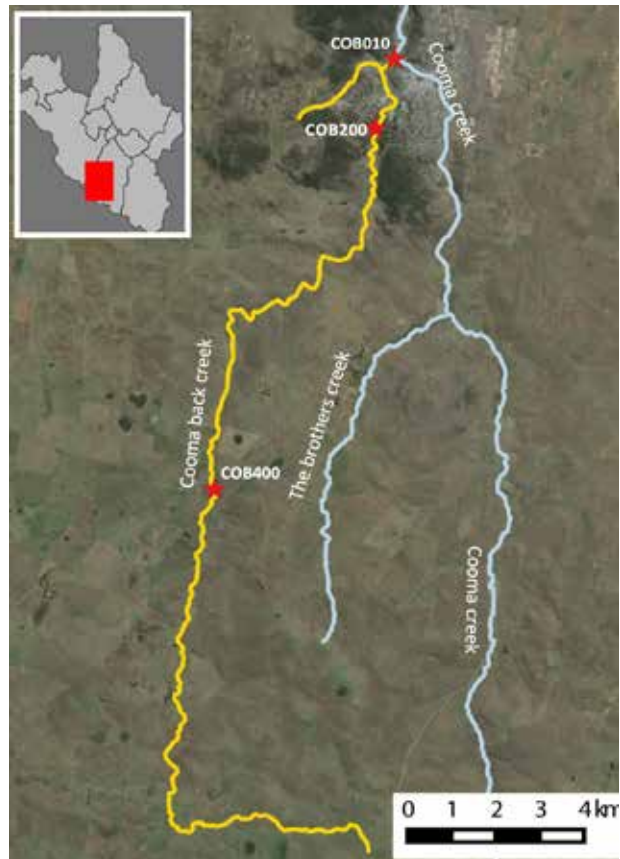
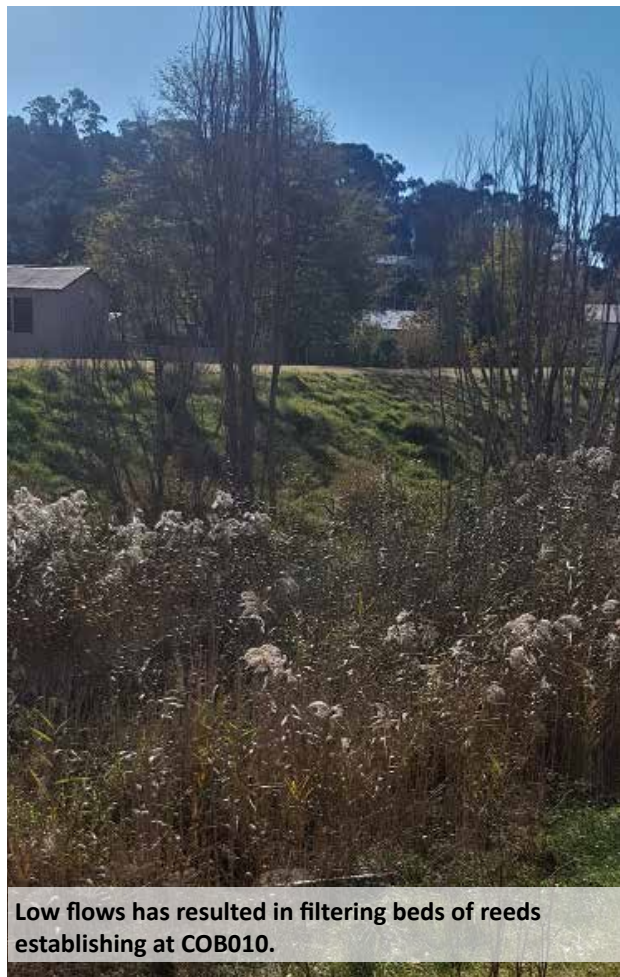
Low flows has seen our waterbug survey site becoming colonised by in-stream vegetation which is beneficial for the creek, providing filtering and stabilising effects as well as improving habitat. Waterbugs found there include mostly tolerant bug types benefitting from the still waters and rich organic matter accumulating as a result.

Low flows has resulted in filtering beds of reeds establishing at COB010.

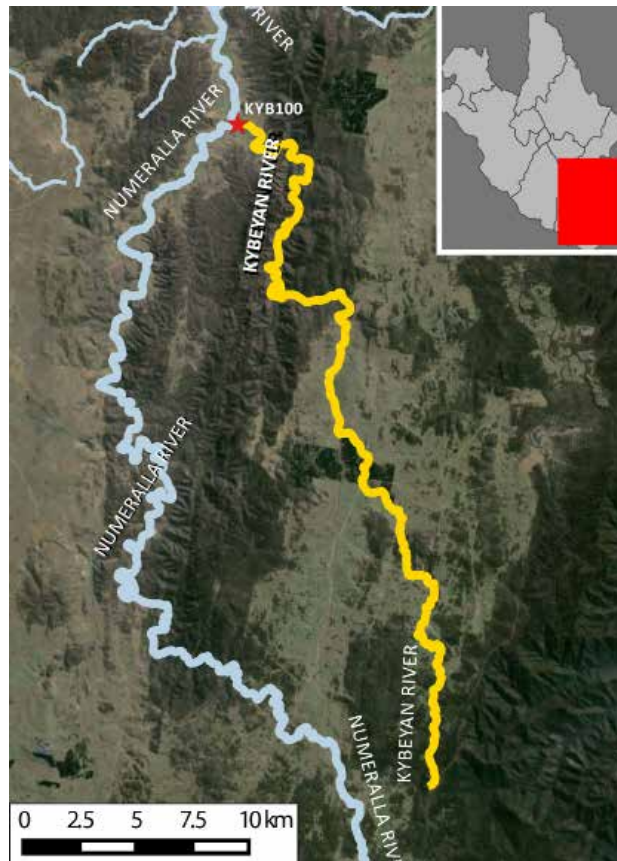
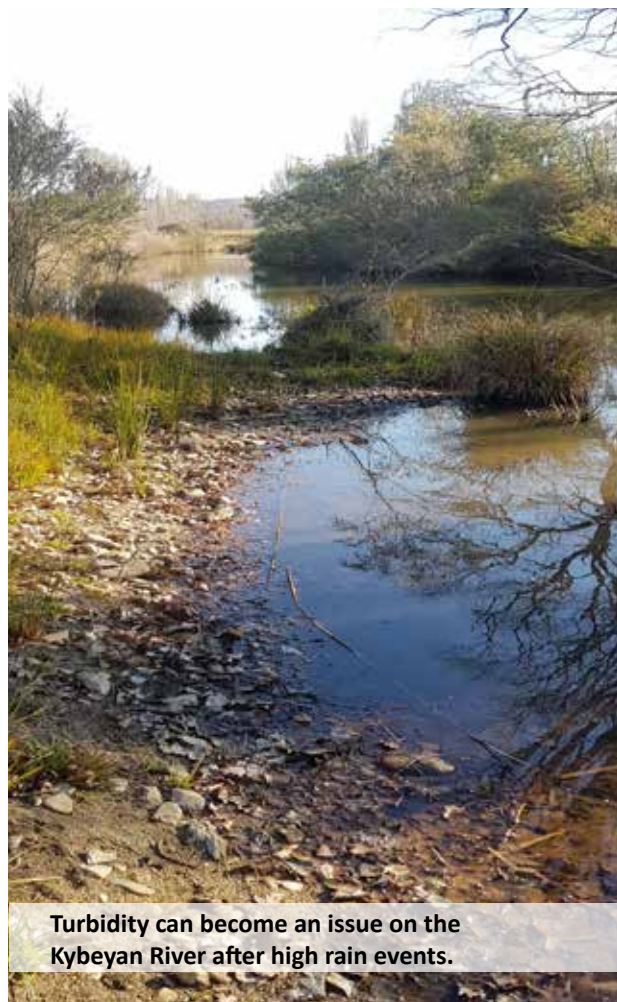
Turbidity can become an issue on the Kybeyan River after high rain events.

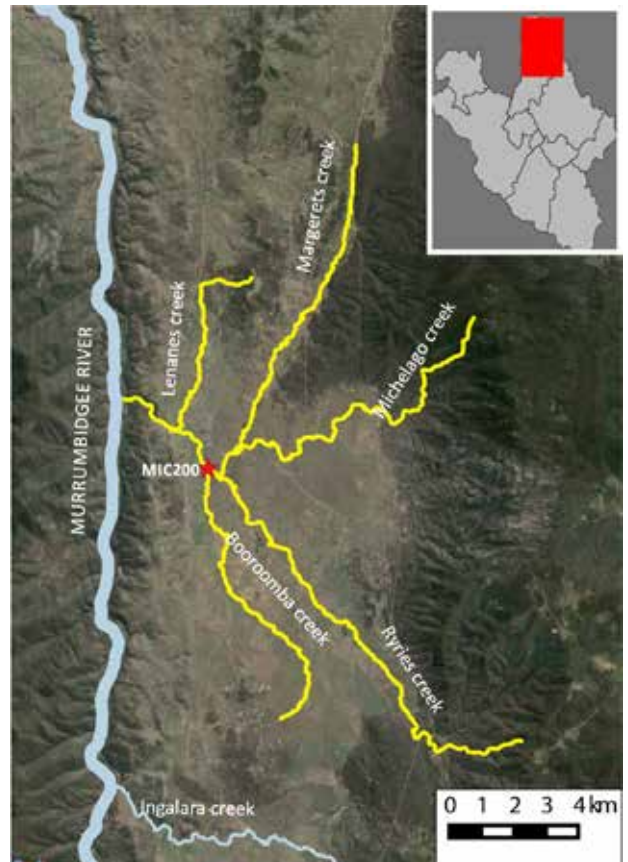
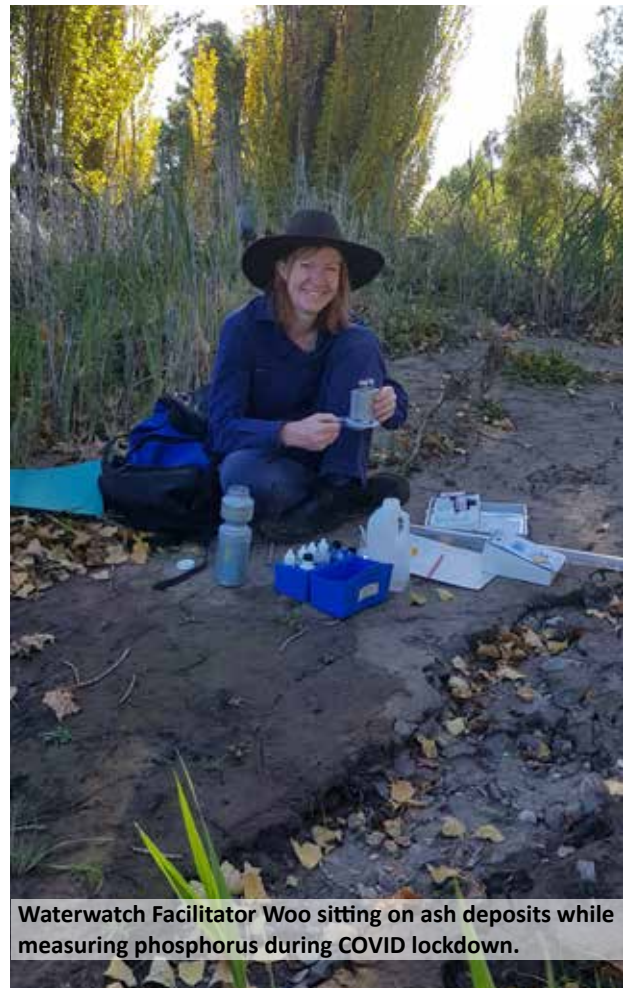
Thick deposits of ash ten metres up the bank were seen at the Waterwatch site after the summer bushfires burnt out the top of the Ryries Creek catchment. This resulted in elevated phosphorous concentrations which is unusual for this reach. Electrical conductivity is naturally high in this reach due to the geology of the catchment. This year, levels were further elevated because of the fire impact, with conductivity regularly reaching over 700µS/cm in the months following the fires. Despite this, waterbug scores were better than in previous years which may be associated with increased flows in 2020.

Waterwatch Facilitator Woo sitting on ash deposits while measuring phosphorus during COVID lockdown.

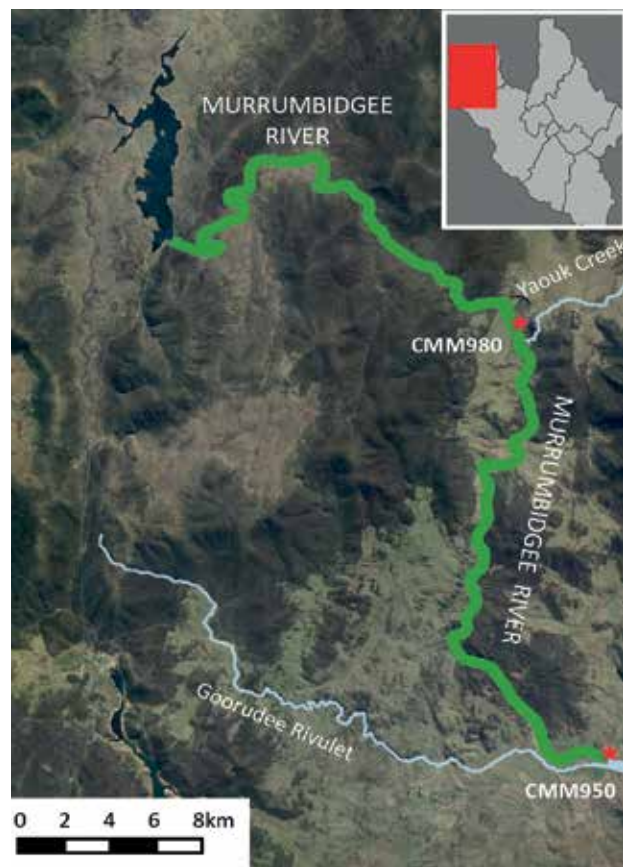
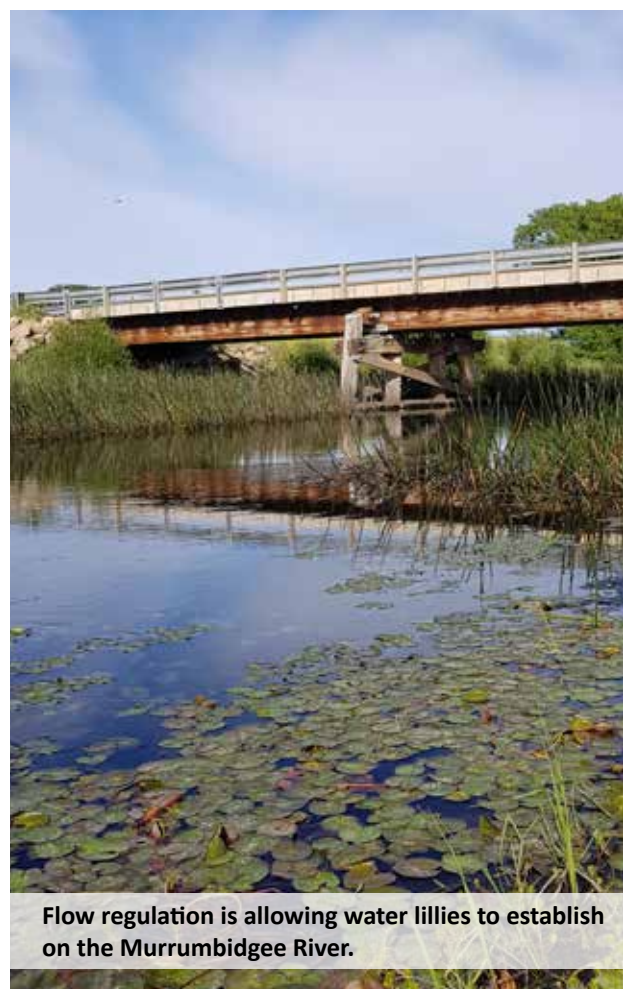
Tantangara Dam diverts 95% of river flows to Eucumbene Dam as part of the Snowy Mountains scheme. The river also receives a small environmental flow allocation each year, dependent on inflows received the year before. The impact of flow regulation is very evident with instream habitat and aquatic species present exhibiting the characteristics of slower flowing ecosystems rather than a fast flowing upland stream. For example, water-lillies are growing at the edges and there is fine sediment build-up in-stream. Waterbug surveys consistently show high numbers of tolerant bug types which thrive in silt/organic matter such as segmented worms and freshwater snails.

Flow regulation is allowing water lillies to establish on the Murrumbidgee River.

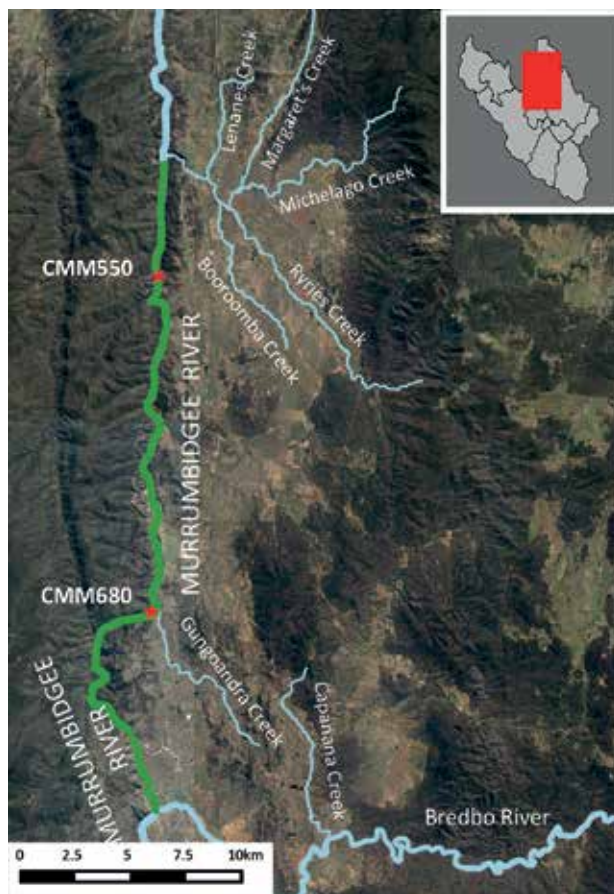
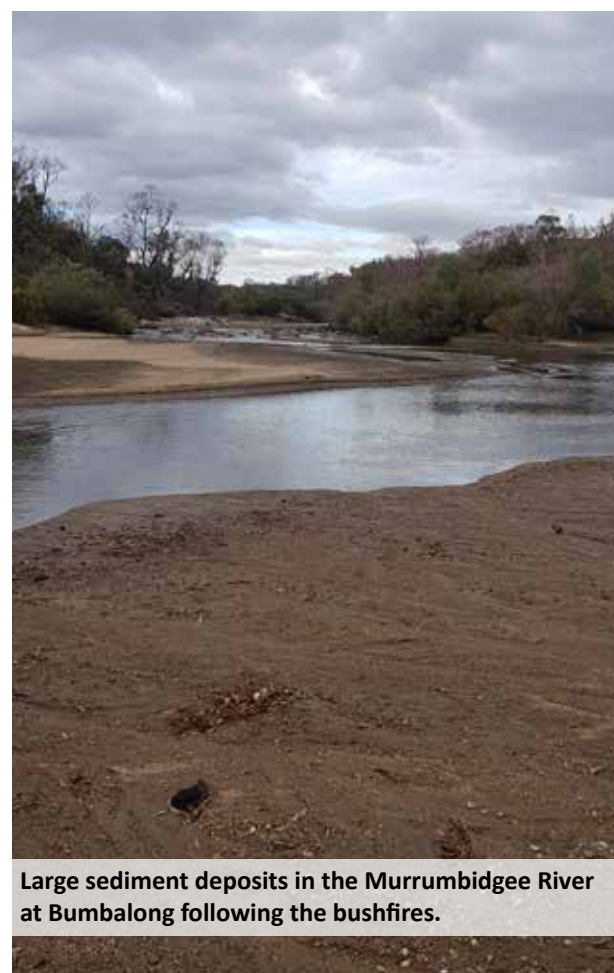
This reach was heavily impacted by bushfire in February, 2020. Subsequent rains resulted in the mass movement of ash and sediment into the river corridor, smothering habitat and elevating phosphorous, nitrate and turbidity levels. Heavy deposits of ash and sediment remain on the banks and instream, and there is more sediment in tributary gullies at risk of further erosion.

Large sediment deposits in the Murrumbidgee River at Bumbalong following the bushfires.

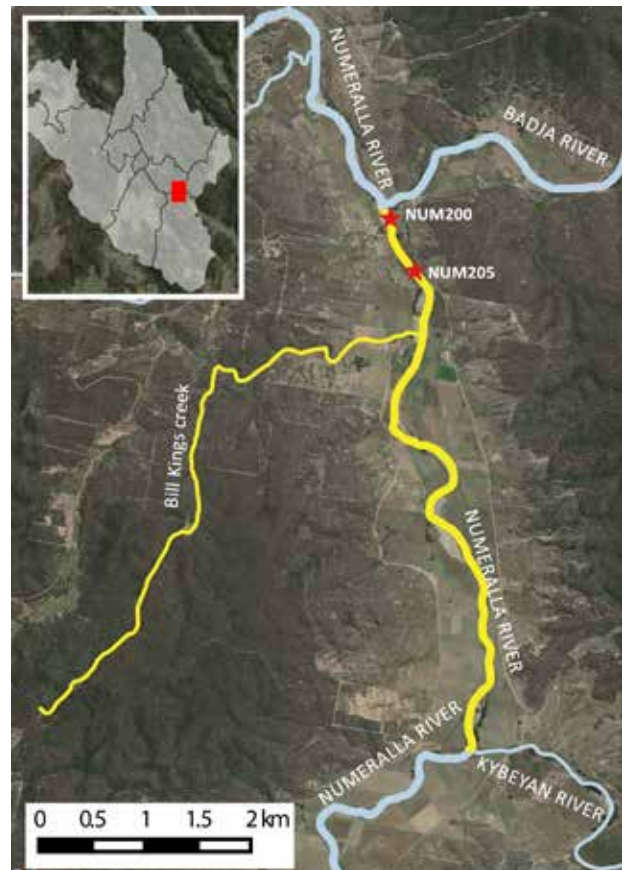
There were large amounts of ash washed into the downstream section of this reach near the confluence of the Badja River – a catchment which was almost entirely burnt during the summer bushfires. The ashen deposits at NUM200 were up to 30cm deep and remain exposed on the riverbed and banks a year after the fires. This had an adverse affect on water quality, leading to increased phosphorous levels as well as and a reduction of waterbug diversity. Despite wetter conditions in the wider region, river levels in this reach have remained low for the first half of the year, drying to pools over winter.

Large amounts of ash were deposited on the Numeralla River at NUM200 from the Badja fires.

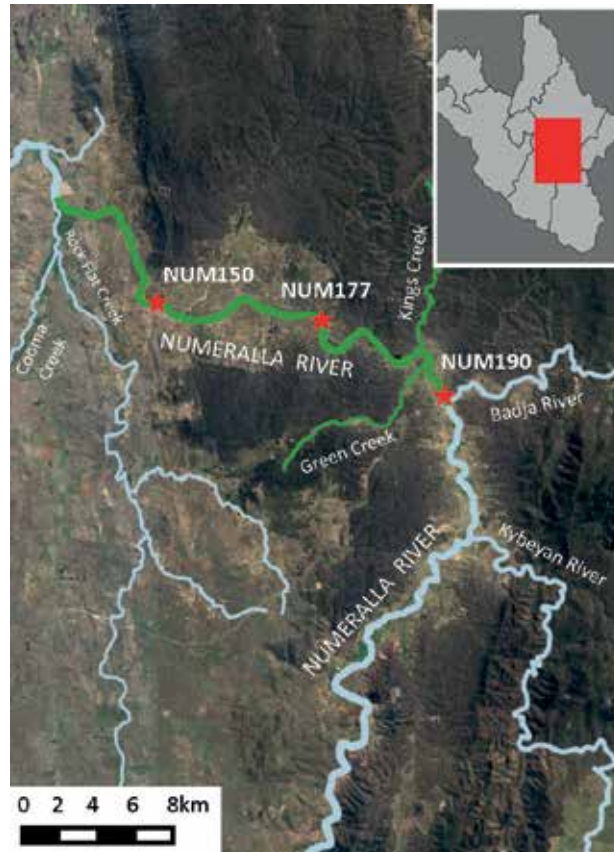
Water quality and river levels are influenced by the inflows of the Badja River at the top of this reach. Hence, this section of the Numeralla River was inundated with heavy ash and sand deposits from the fire grounds in the Badja catchment at the start of 2020. This resulted in *degraded* levels of phosphorus, electrical conductivity, nitrate and turbidity directly following the fires in January. The poor water quality was short lived, however as higher than average rainfall in the headwaters of the Badja River resulted in high flows and improved water quality after the initial ash plume was washed through.

Sand washed down from the fire grounds in the Badja catchment will affect this reach for years to come.

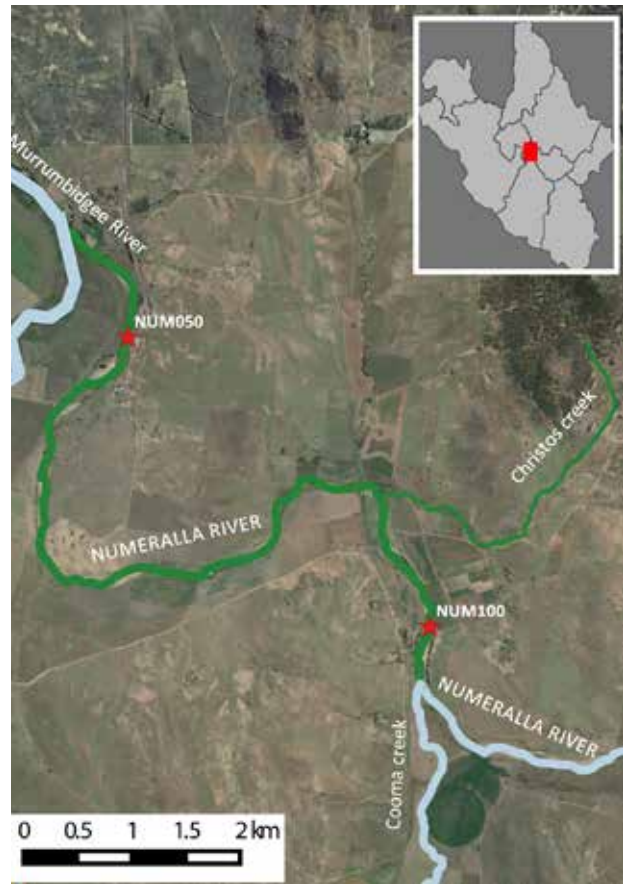
The woody weed, Box elder, is starting to take hold in the lower Numeralla catchment.

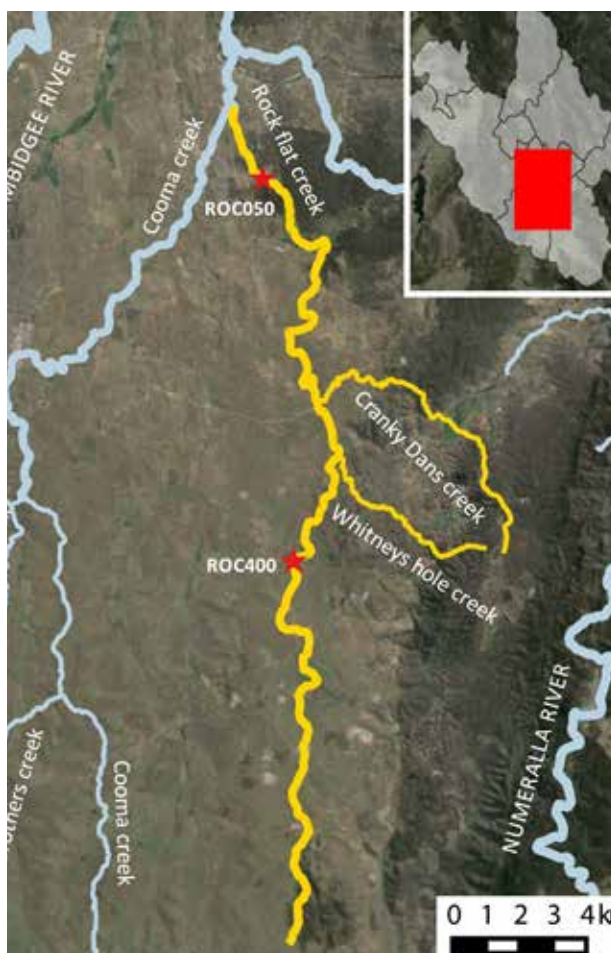
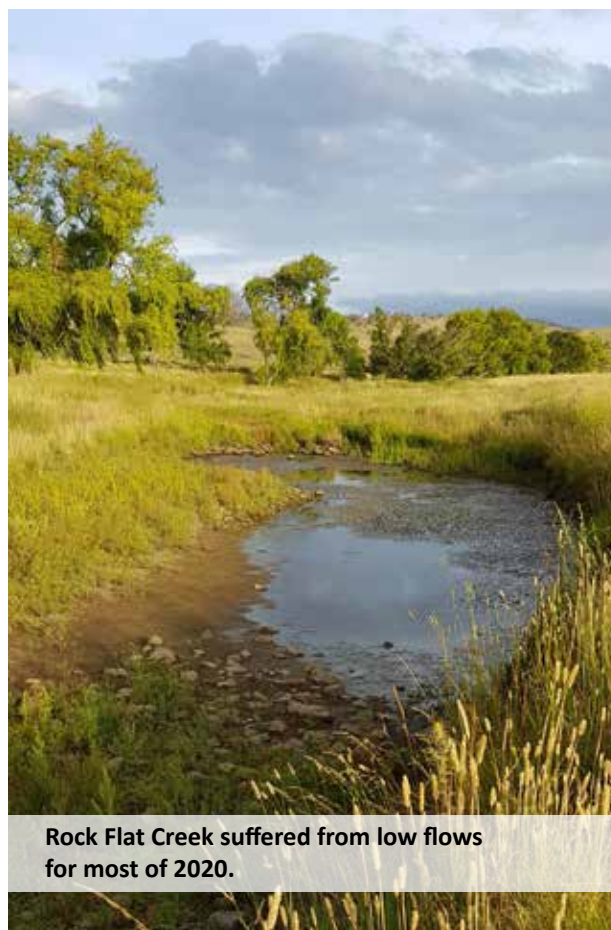
Water levels have been very low during the last few years and the creek has been reduced to a series of pools. This situation has continued throughout 2020 because this catchment has missed out on much of the higher rainfall experienced in other parts of our region. Phosphorus levels around 0.07mg/L were regularly detected as was dissolved oxygen at super saturated levels. Waterwatcher Micheal noted that this was most likely a byproduct of the large amounts of algae present at the site over much of the year.

Rock Flat Creek suffered from low flows for most of 2020.

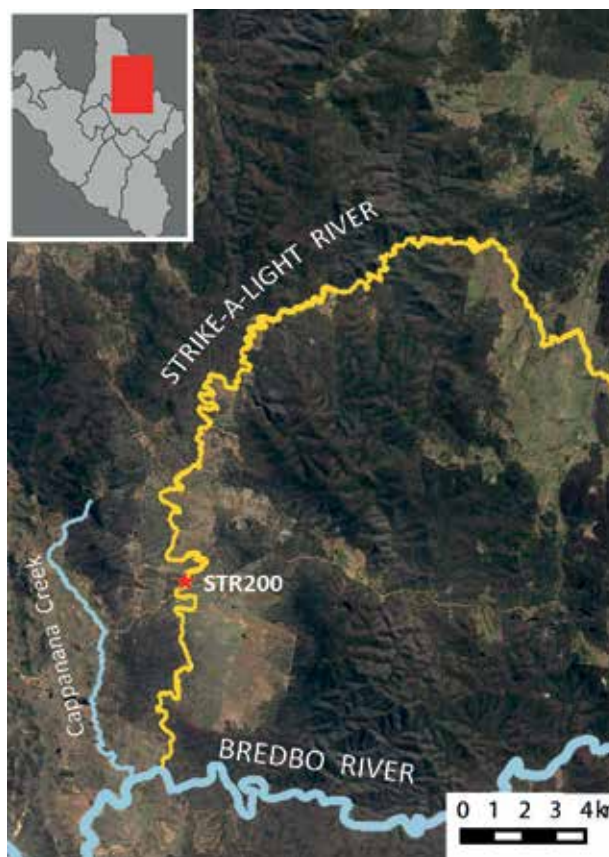
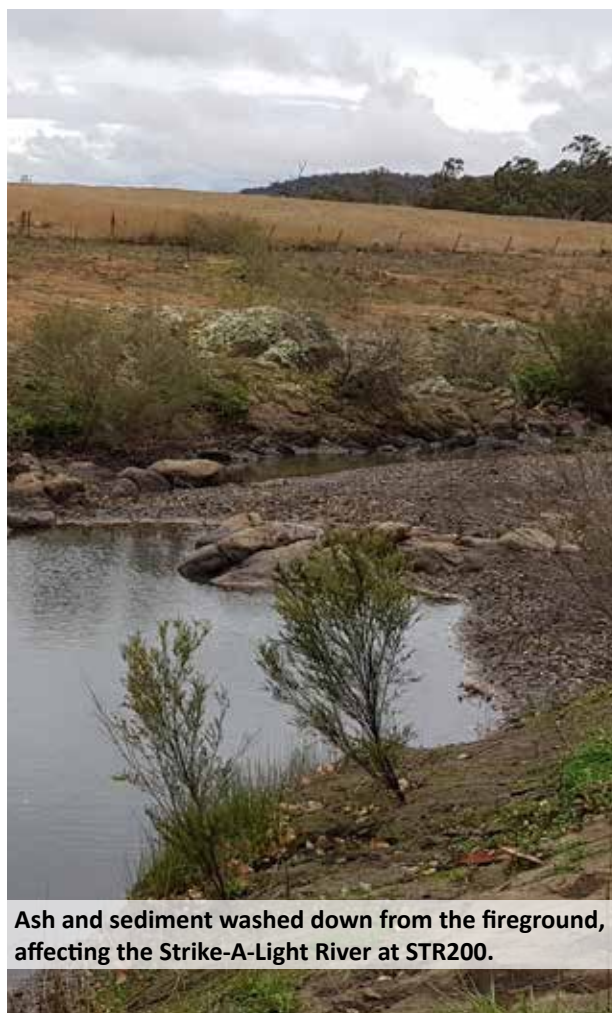
Ash and sediment washed down from the fireground, affecting the Strike-A-Light River at STR200.

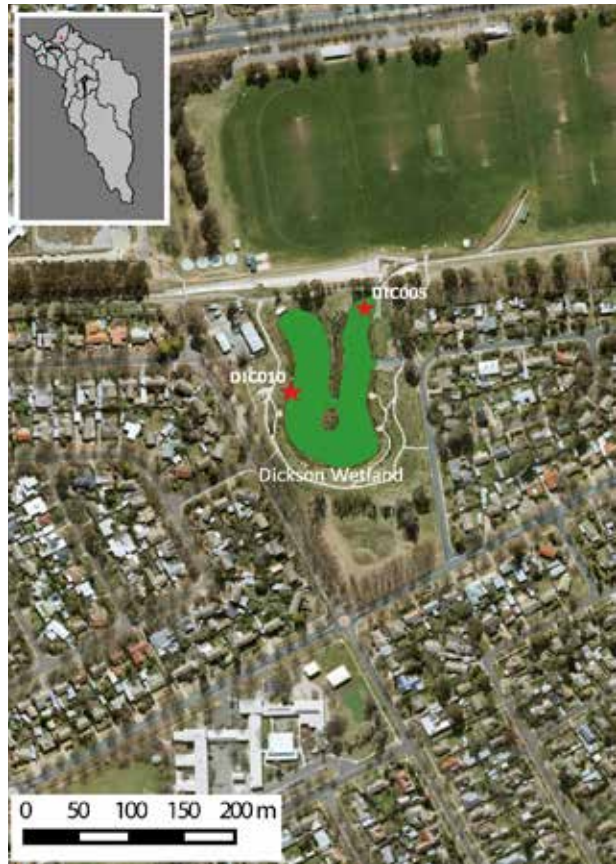
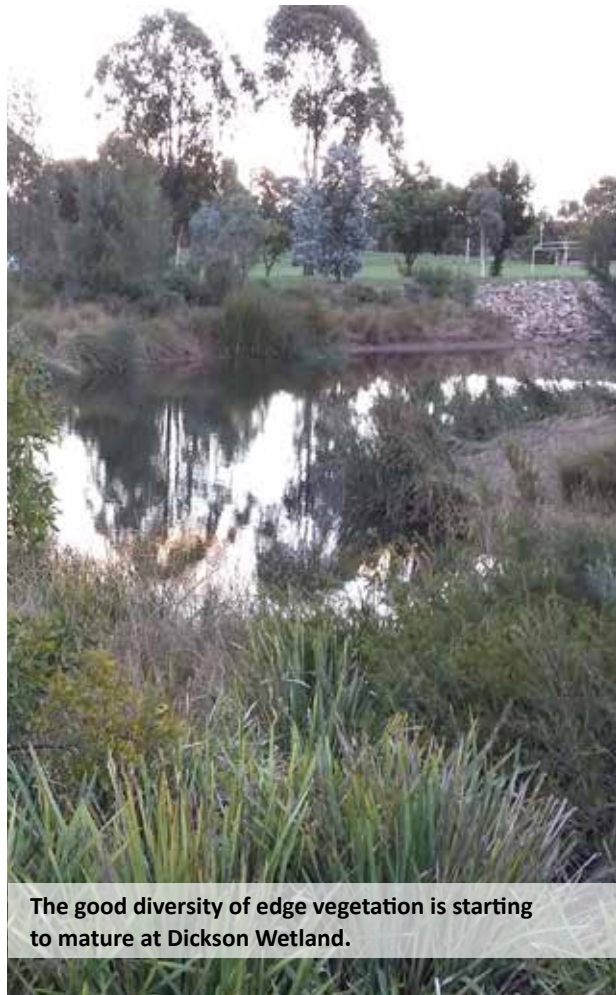
The good diversity of edge vegetation is starting to mature at Dickson Wetland.

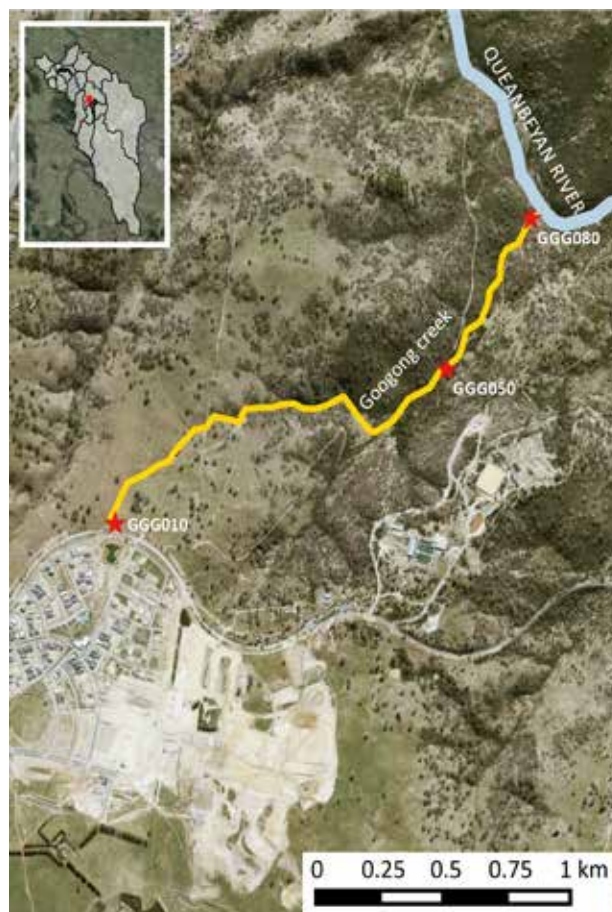
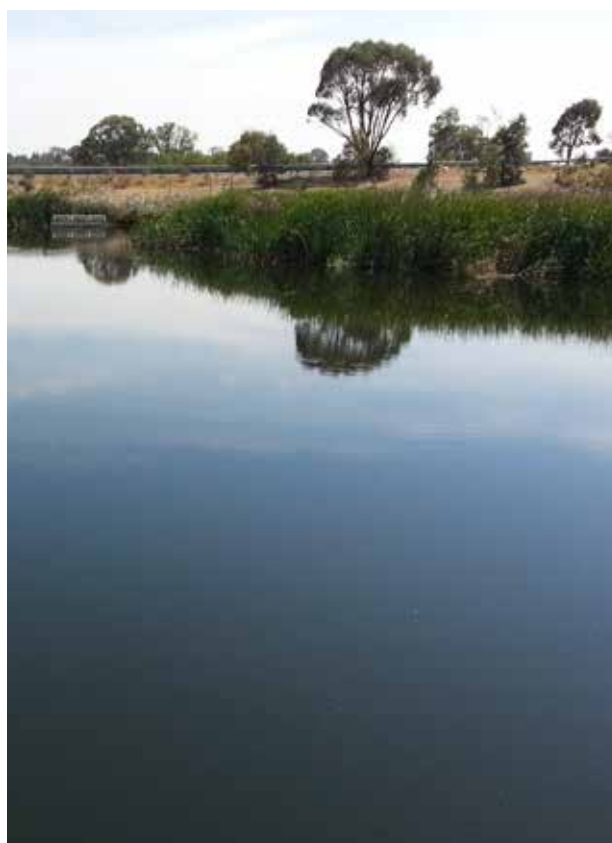
Beltana Pond (GGG010) captures stormwater off the Googong township.

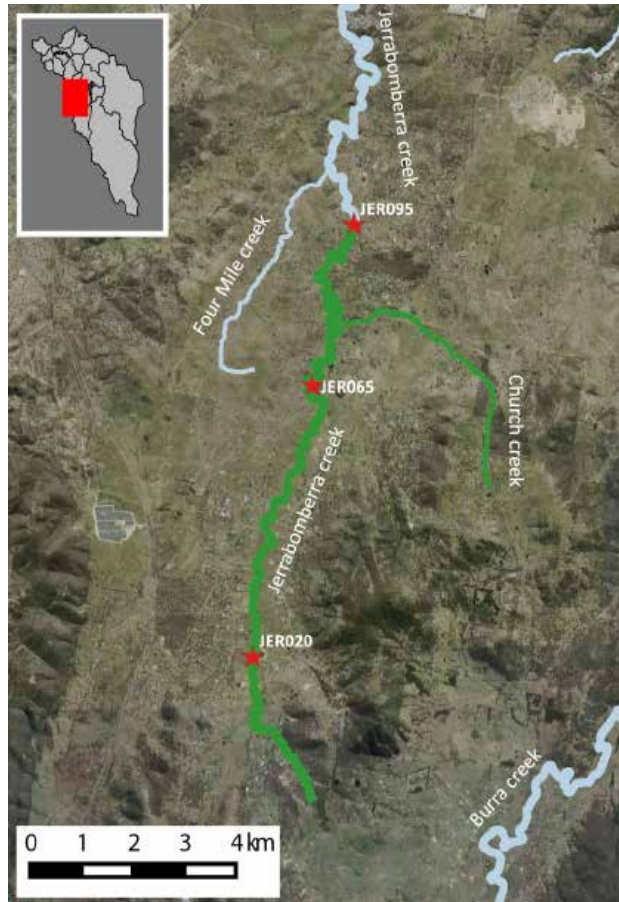
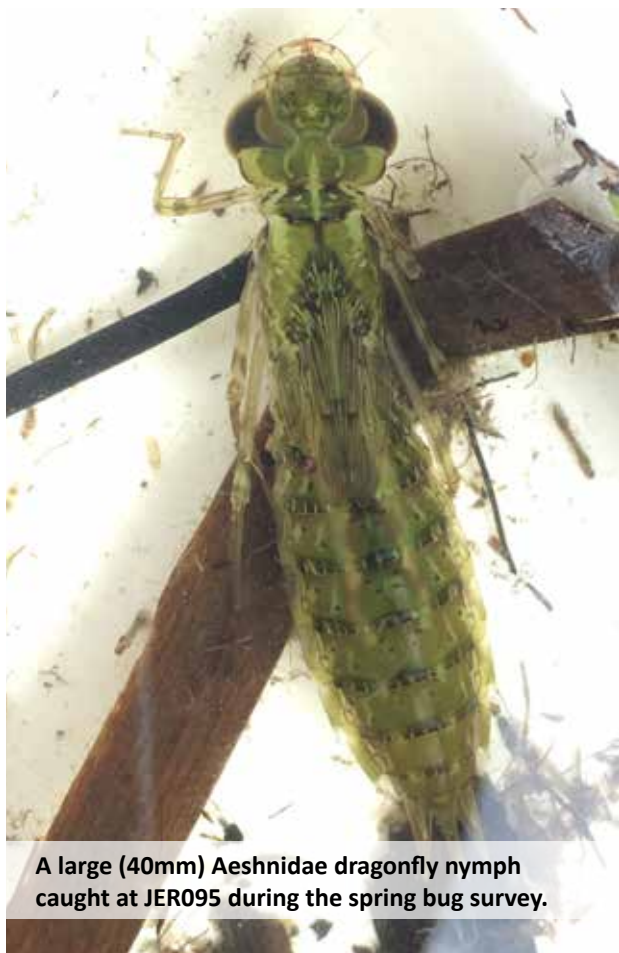
A large (40mm) Aeshnidae dragonfly nymph caught at JER095 during the spring bug survey.

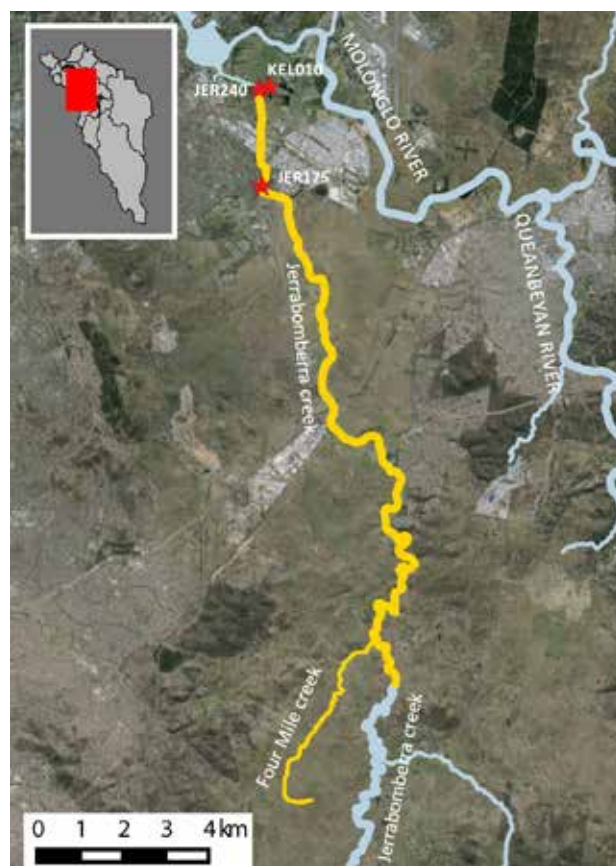
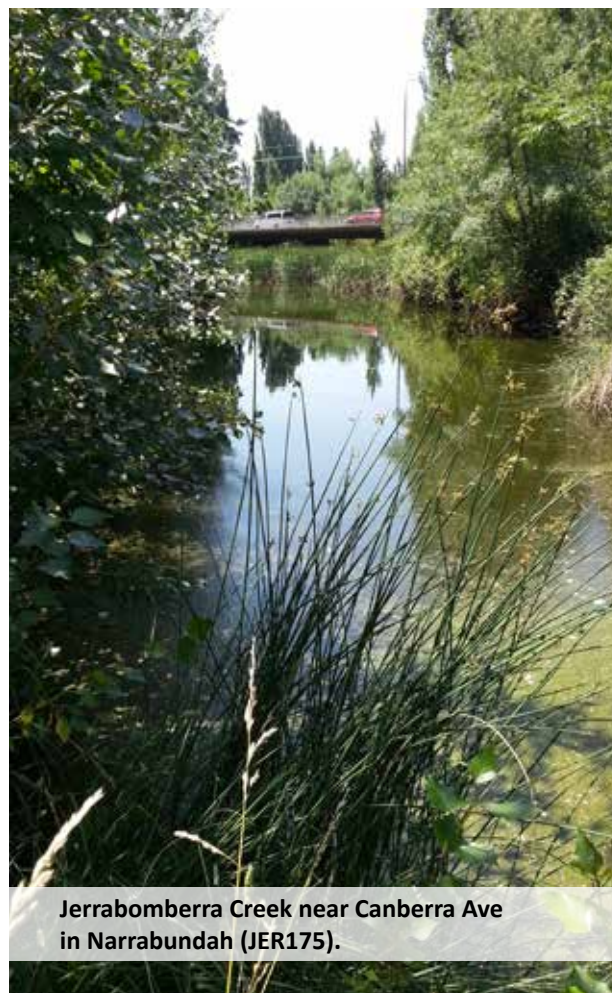
Jerrabomberra Creek near Canberra Ave in Narrabundah (JER175).
