Catchment Health Indicator Program

2020

Executive Summary

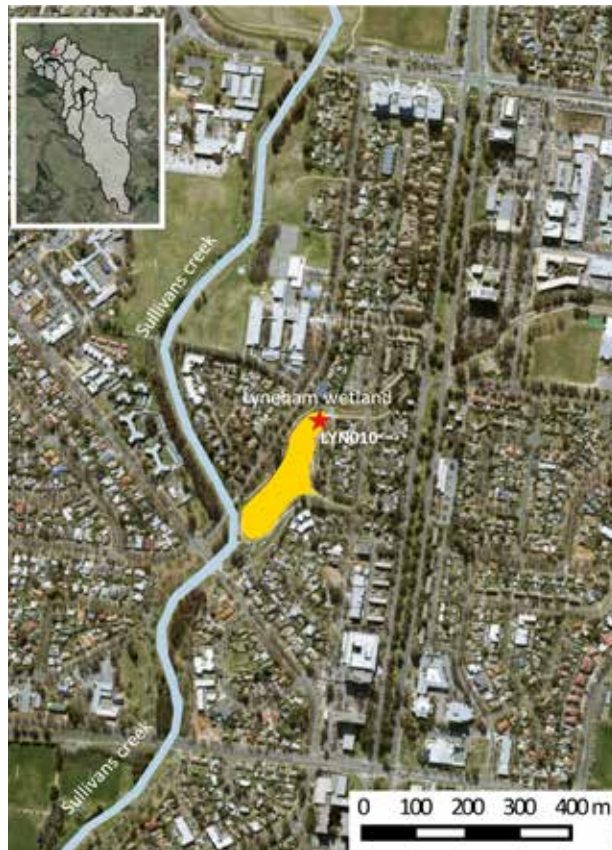
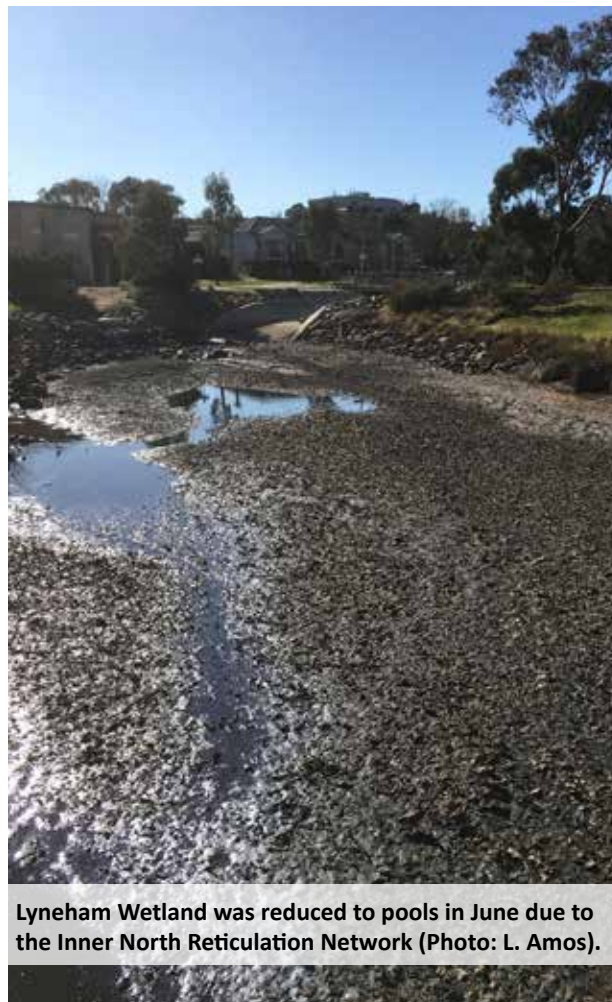
Waterbugs consistently score poorly at this wetland, with limited habitat being one of the main factors. This is partly because this wetland has water pumped from it as part of the Inner North Reticulation Network and provides temporary storage in order to irrigate sports ovals. In June the local Waterwatchers noted the wetland was drawn down to muddy pools. Thus, if the water level drops, leaving plants at the water’s edge high and dry, available habitat for waterbugs is limited. Getting the balance between water recycling, water quality treatment and biodiversity can be a challenging in urban wetlands with multiple uses, such as this one.

Lyneham Wetland was reduced to pools in June due to the Inner North Reticulation Network (Photo: L. Amos).

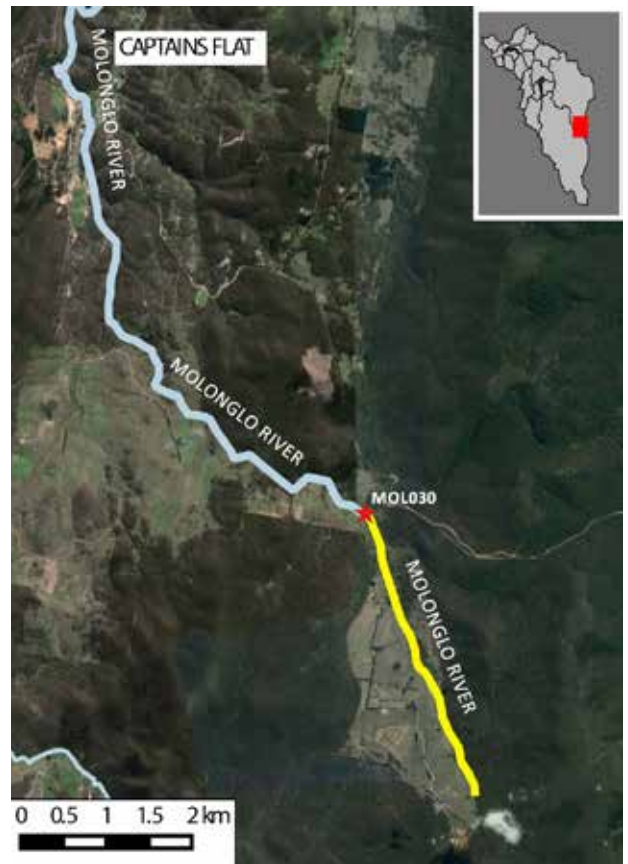
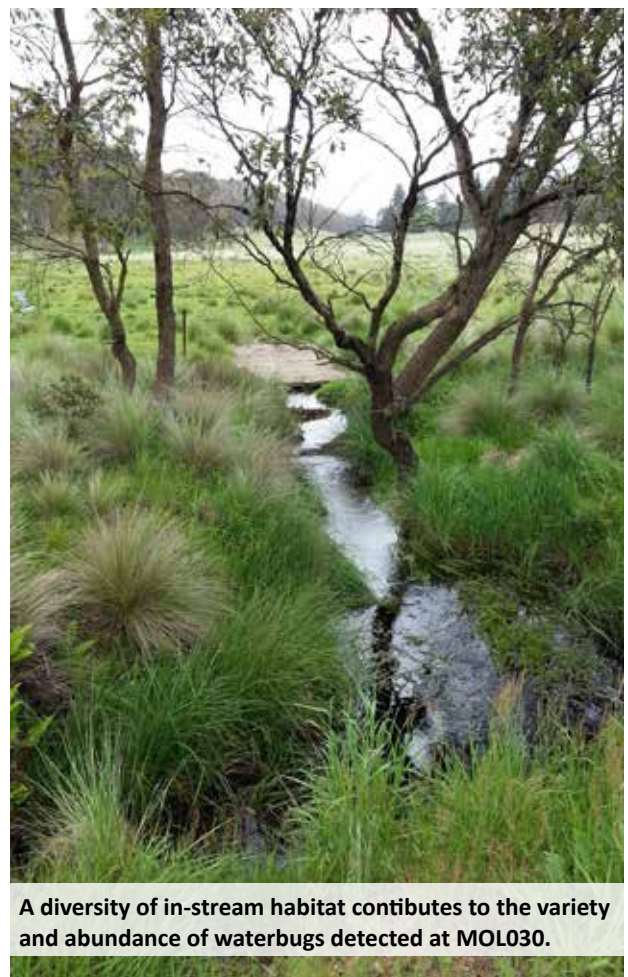
A diversity of in-stream habitat contributes to the variety and abundance of waterbugs detected at MOL030.

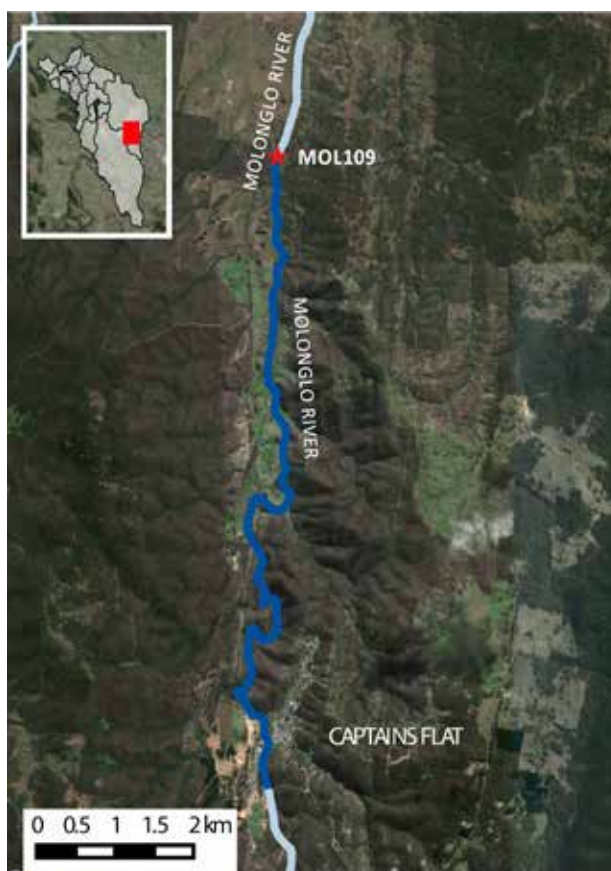
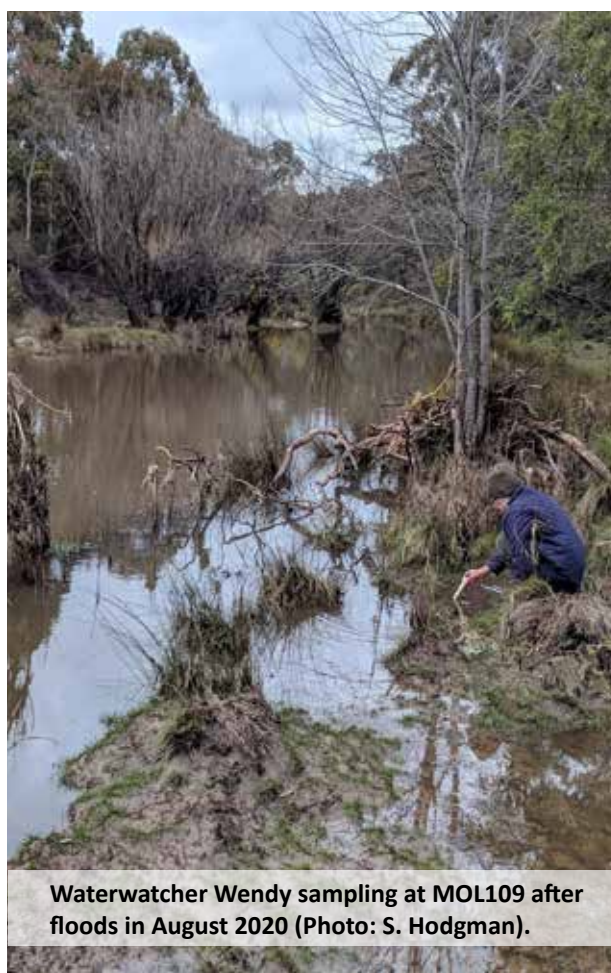
Waterwatcher Wendy sampling at MOL109 after floods in August 2020 (Photo: S. Hodgman).

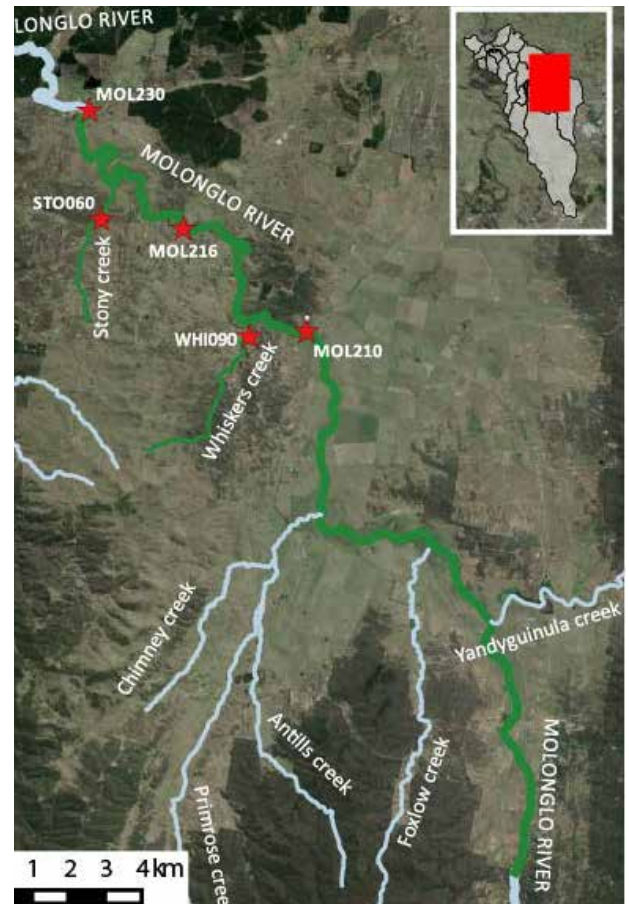
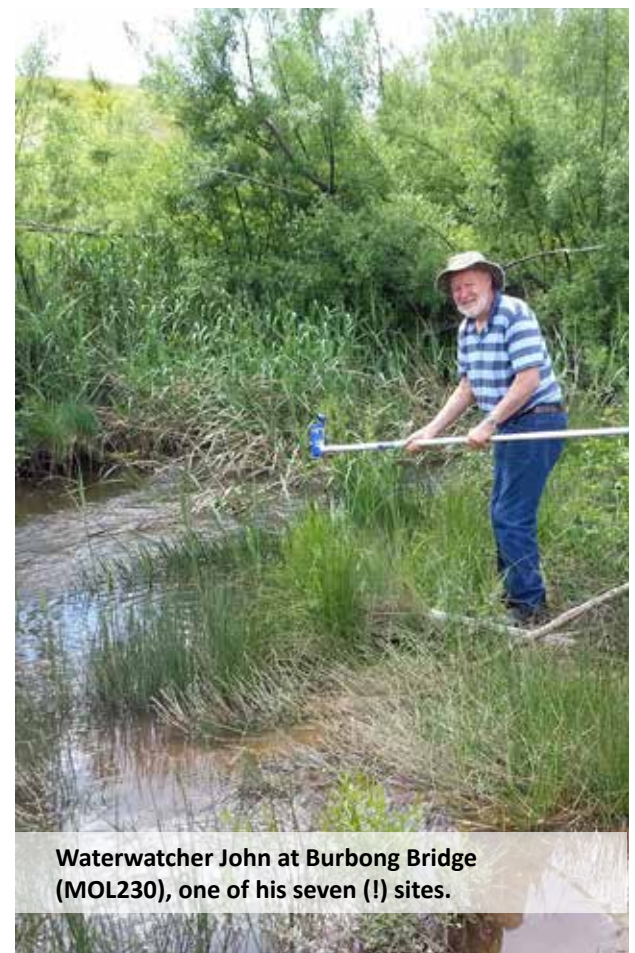
Willows continue to re-establish along this reach, and riverside vegetation is often dominated by exotic species or absent for large stretches. Large rural properties with highly cleared landscapes dominate the main river channel, but some of the smaller creeks have better vegetation condition. Weeds at Burbong bridge, in the rail corridor, are varied and extensive.

Waterwatcher John at Burbong Bridge (MOL230), one of his seven (!) sites.

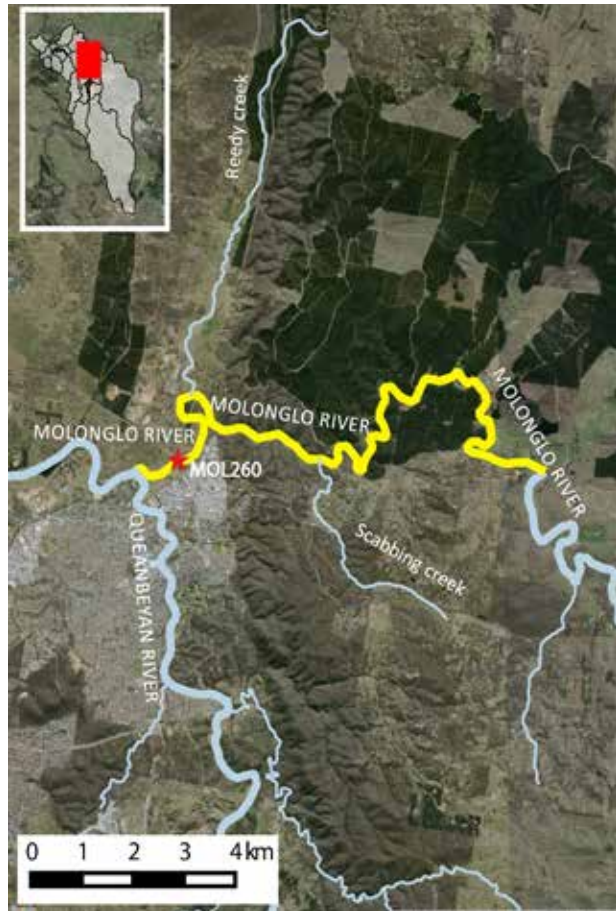
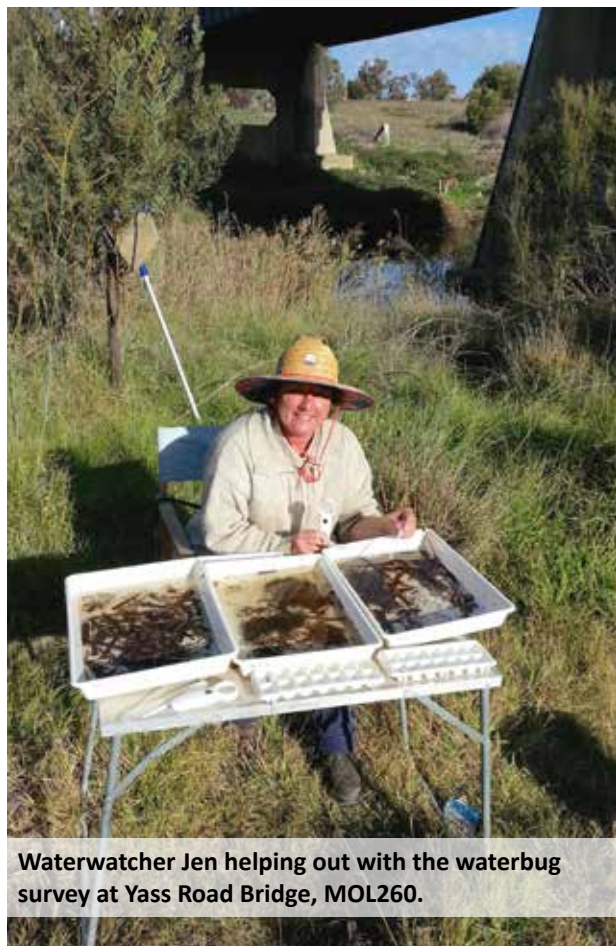
Waterwatcher Jen helping out with the waterbug survey at Yass Road Bridge, MOL260.

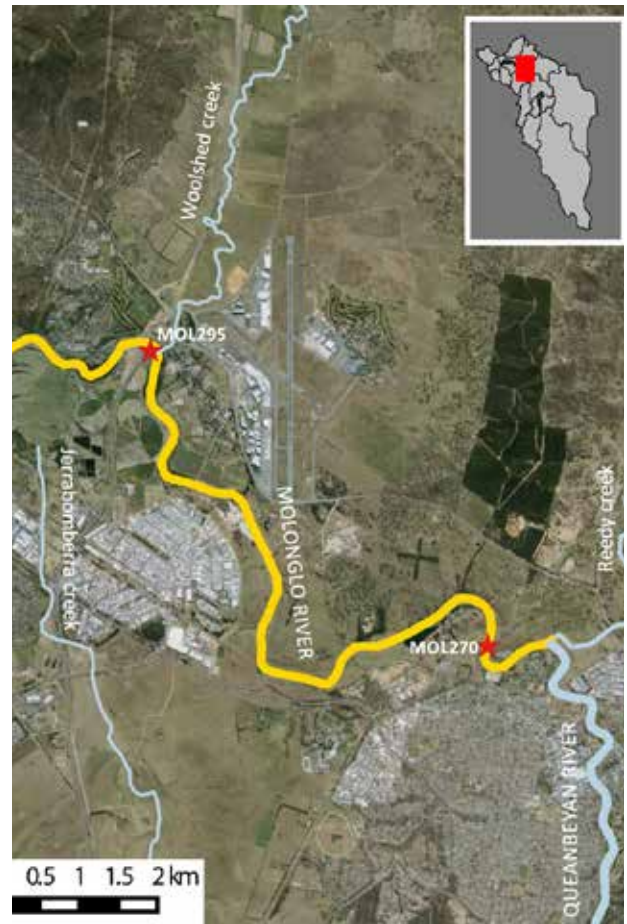
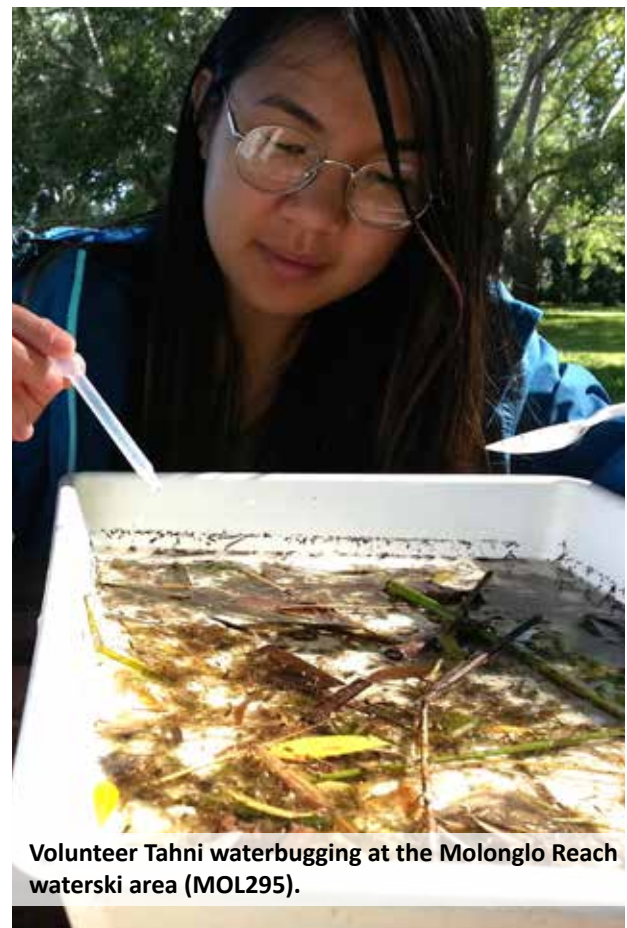
Volunteer Tahni waterbugging at the Molonglo Reach waterski area (MOL295).

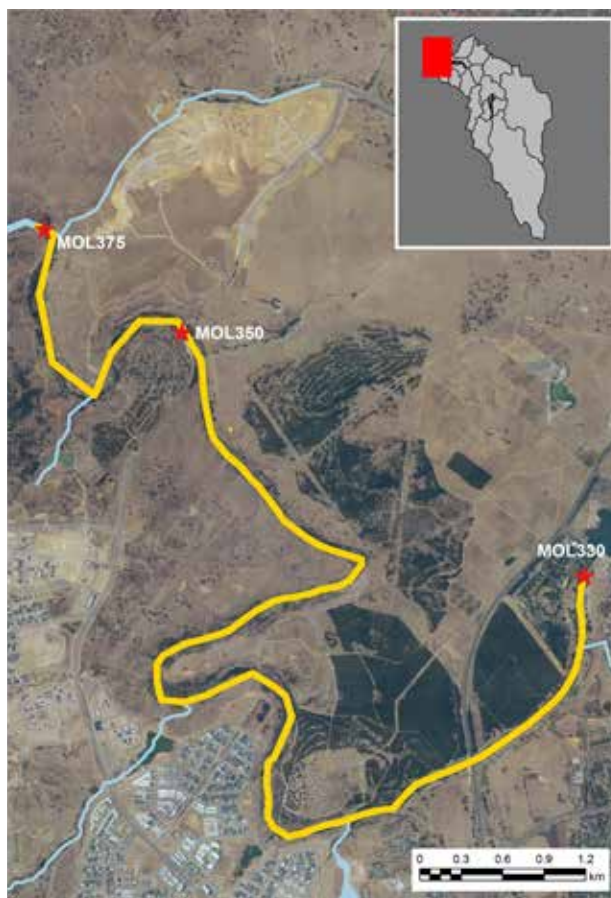
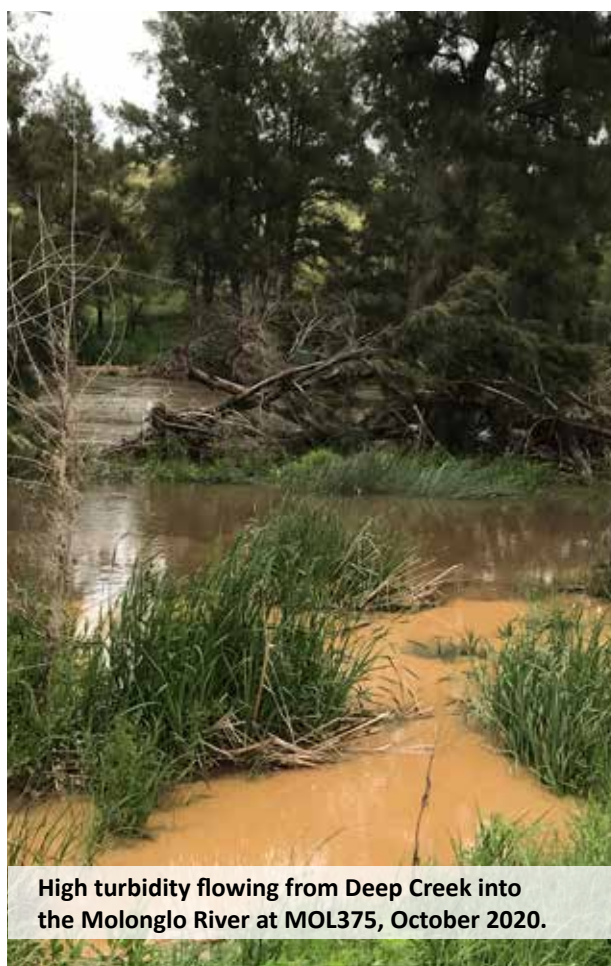
As the development of the suburb of Whitlam continues, high turbidity was observed on several occasions by the Waterwatch volunteers flowing down Deep Creek and into the Molonglo River at MOL375. Extreme turbidity of 100-400+ NTU was recorded on three separate occasions at this site in 2020 and were reported to the Environmental Protection Agency. Such inputs of sediment have many adverse effects on rivers including smothering the rocky river substrate where many waterbugs live. Waterbugs are the main food source of Platypus and native fish such as Murray cod - both are which are found in this reach.

High turbidity flowing from Deep Creek into the Molonglo River at MOL375, October 2020.

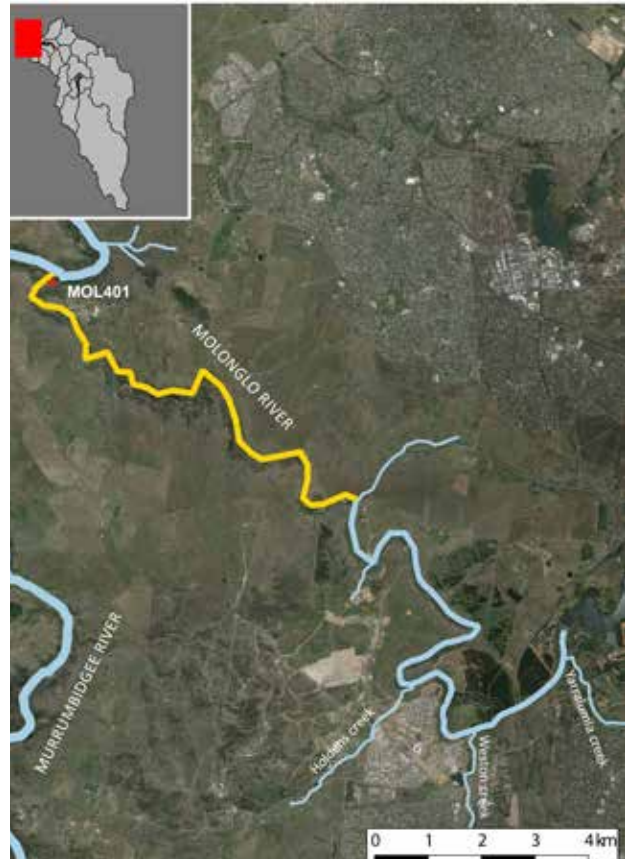
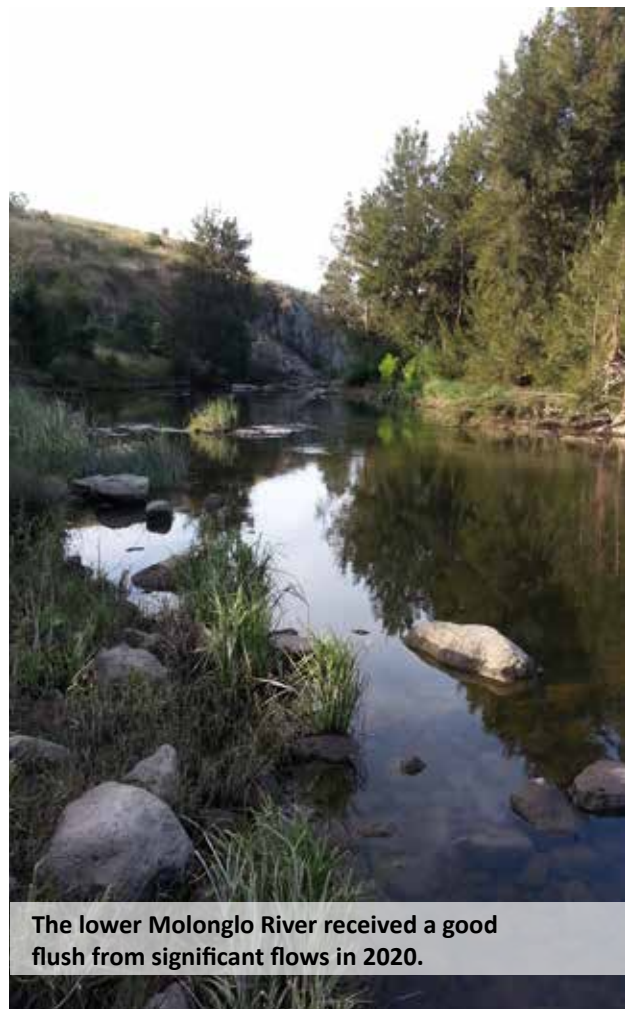
The lower Molonglo River received a good flush from significant flows in 2020.

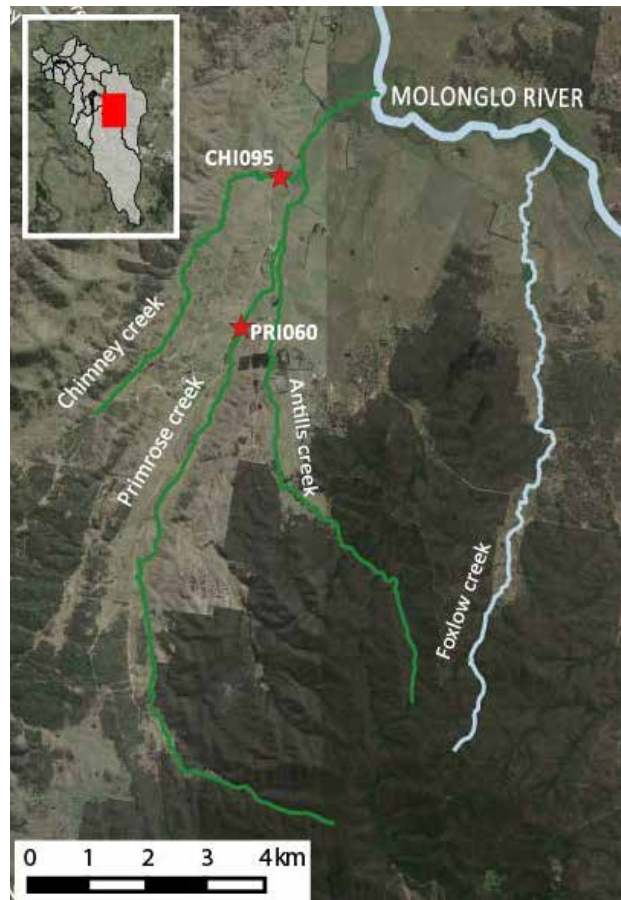
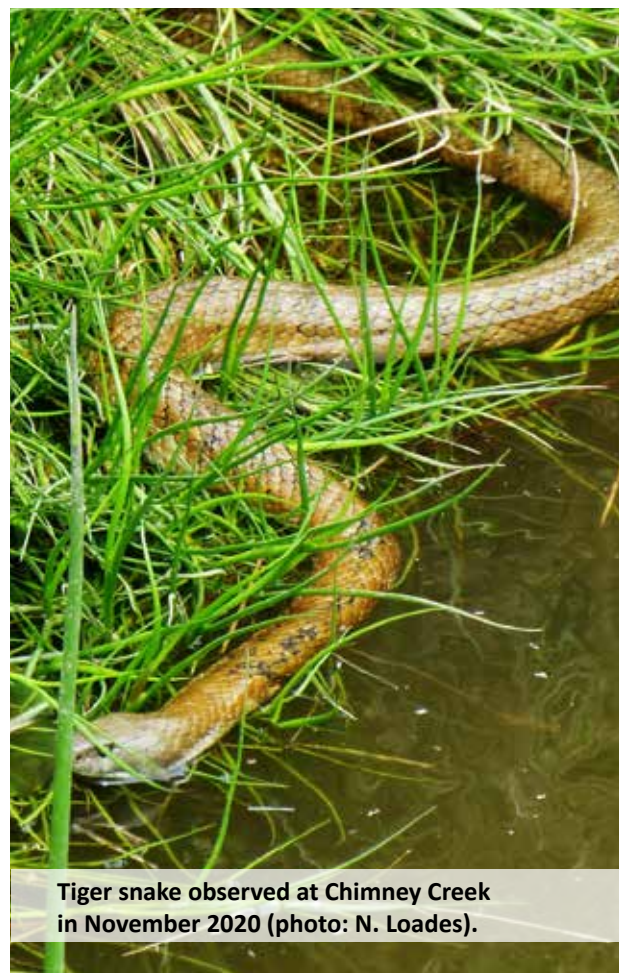
Tiger snake observed at Chimney Creek in November 2020 (photo: N. Loades).

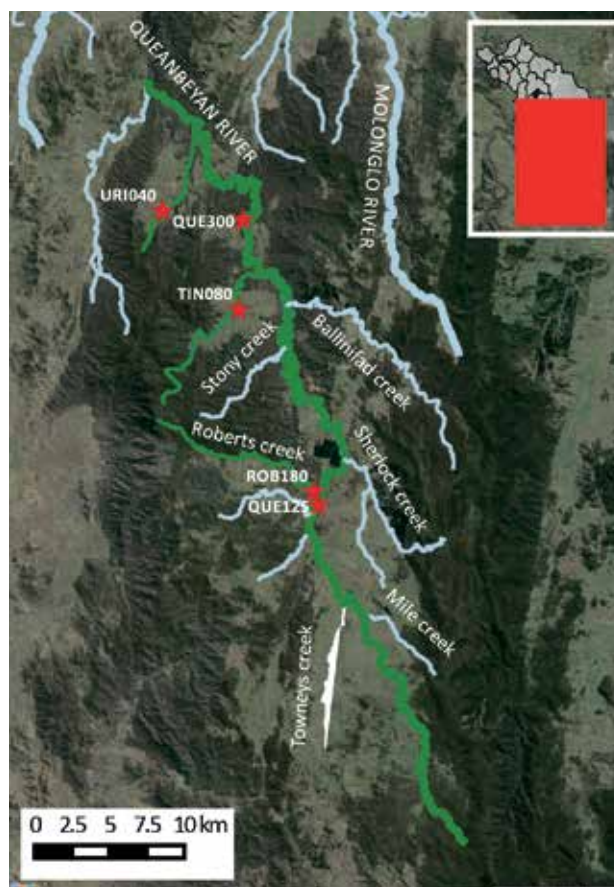
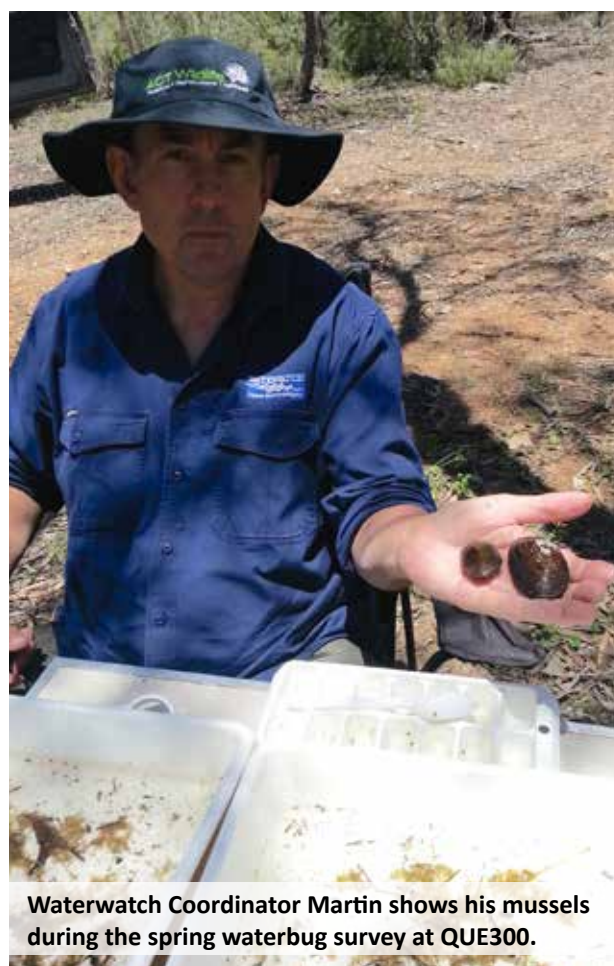
Waterwatch Coordinator Martin shows his mussels during the spring waterbug survey at QUE300.

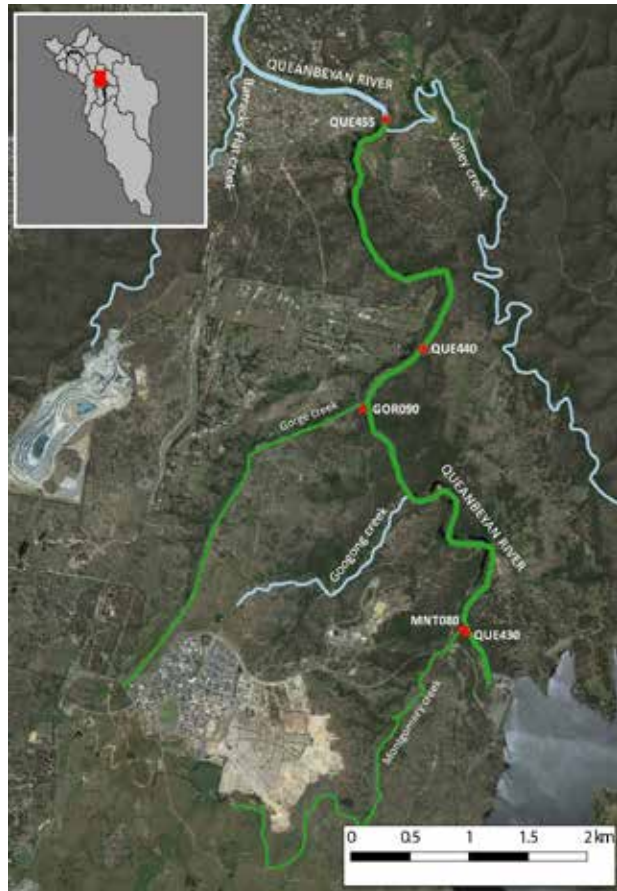
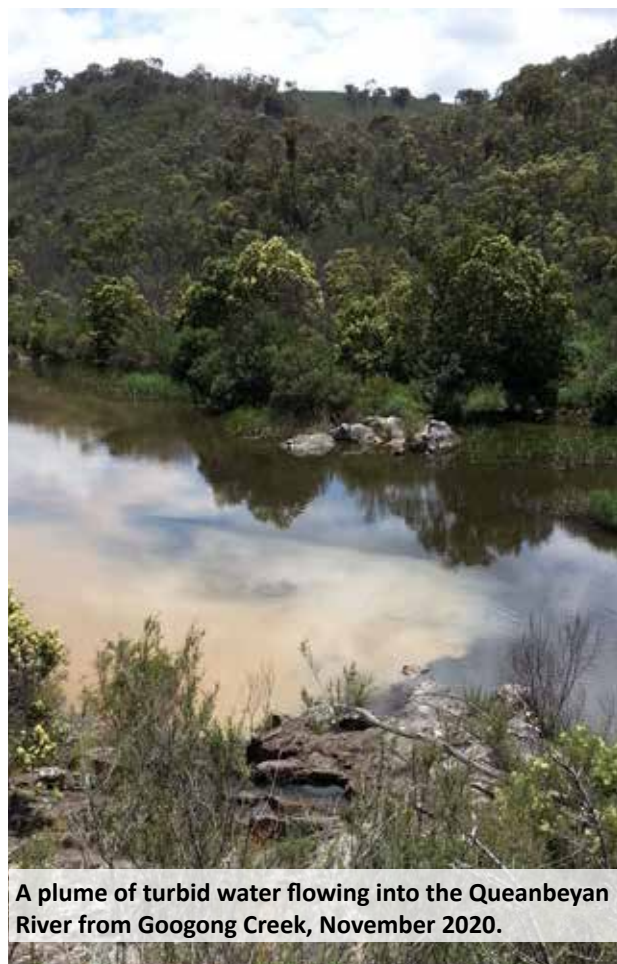
There was sediment pollution events in October and November, with turbid plumes coming down Googong Creek into the Queanbeyan River, measuring 90 and 100NTU respectively. Googong Creek has extensive development occurring at the top of the sub-catchment and when not properly contained, continues to put pressure on our waterways.

Platypus are regularly sighted in this reach and such high levels of turbidity reduce available habitat for their prime food source – waterbugs. Many waterbugs live in the small rock crevices along these cobbly-bottomed rivers and cannot persist there when sediment clogs up these crevices.

A plume of turbid water flowing into the Queanbeyan River from Googong Creek, November 2020.

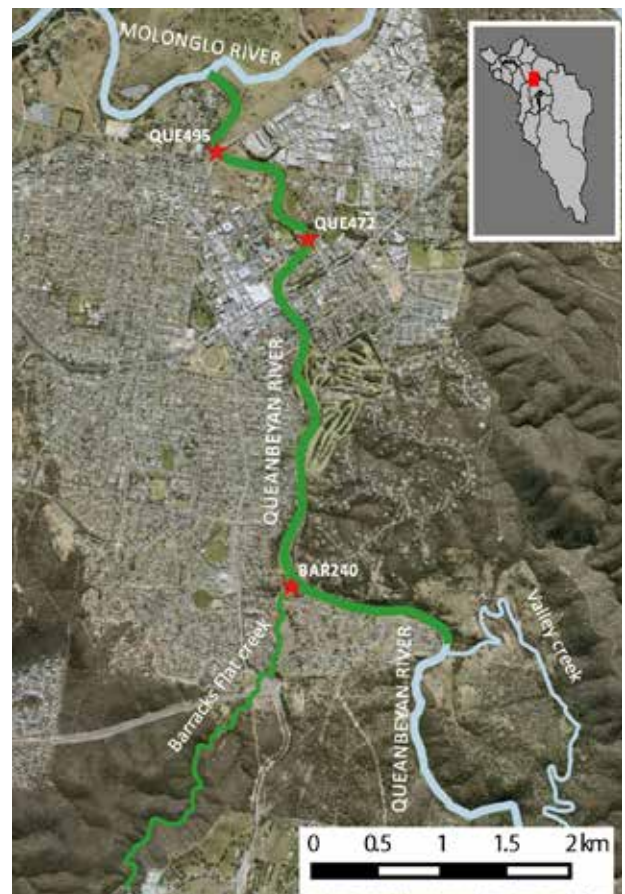
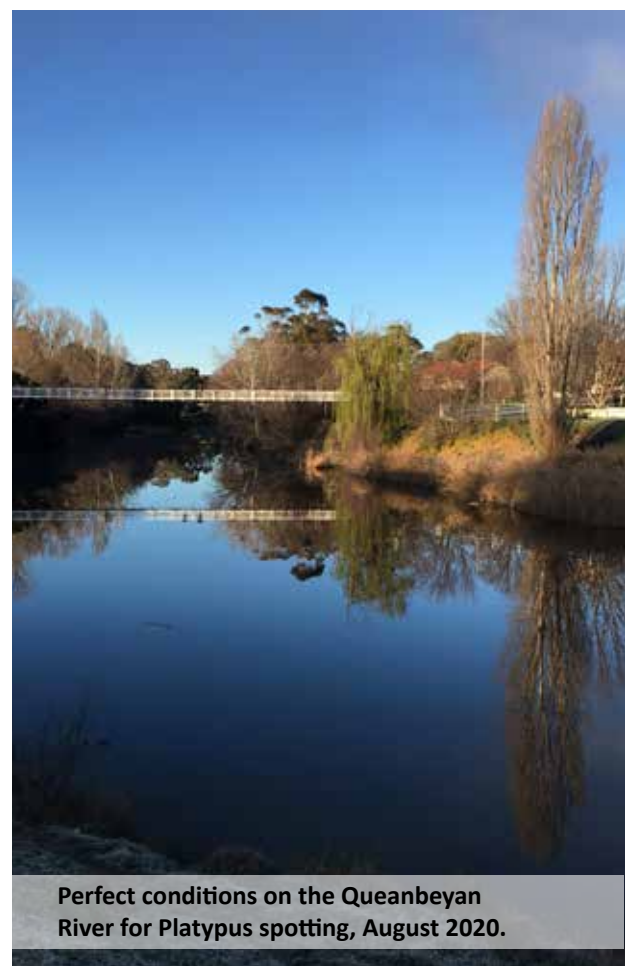
Perfect conditions on the Queanbeyan River for Platypus spotting, August 2020.

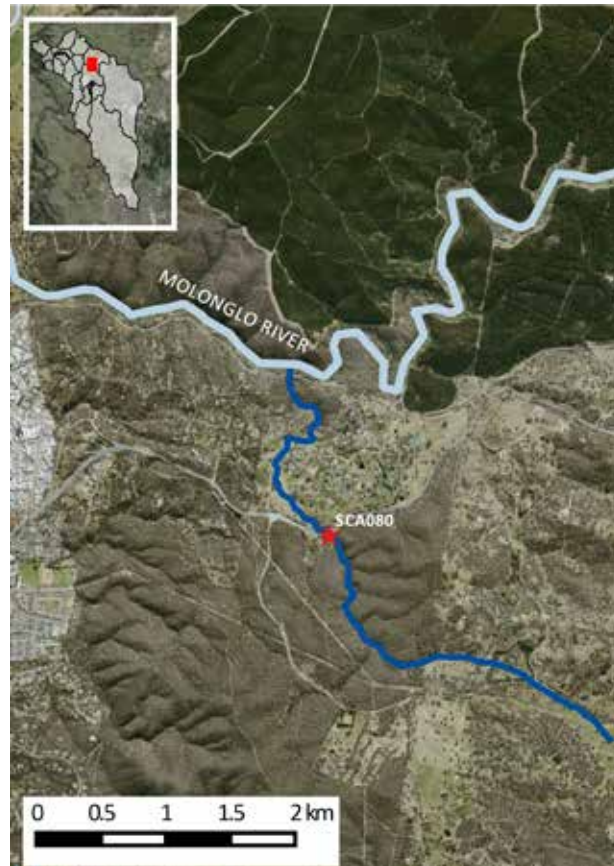
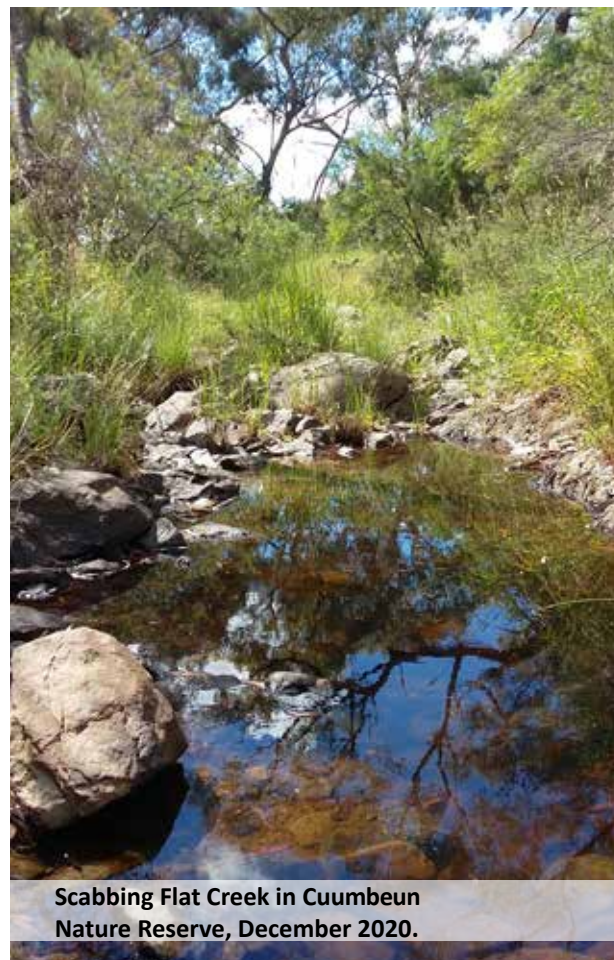
Scabbing Flat Creek in Cuumbeun Nature Reserve, December 2020.

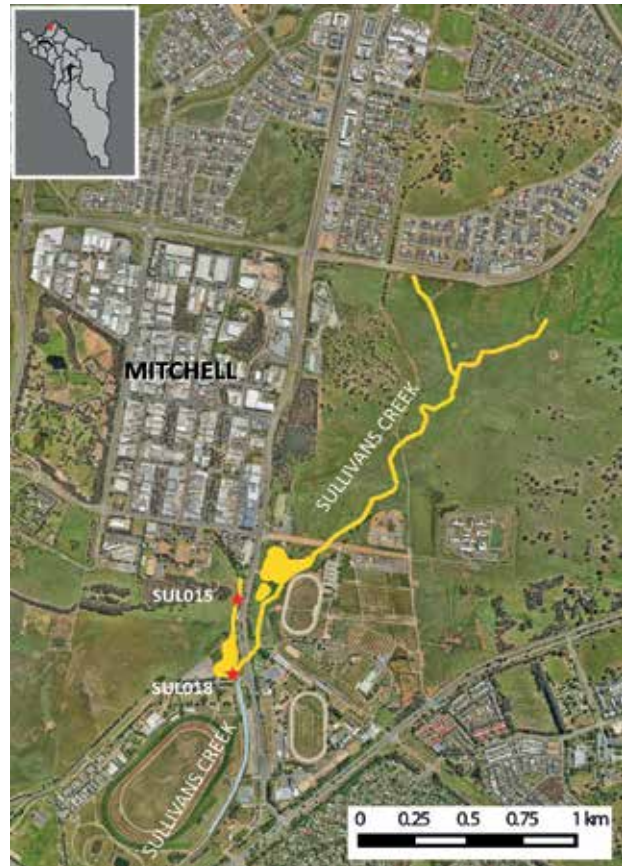
Rubbish washing off the industrial area of Mitchell is an ongoing issue at Flemington Pond.

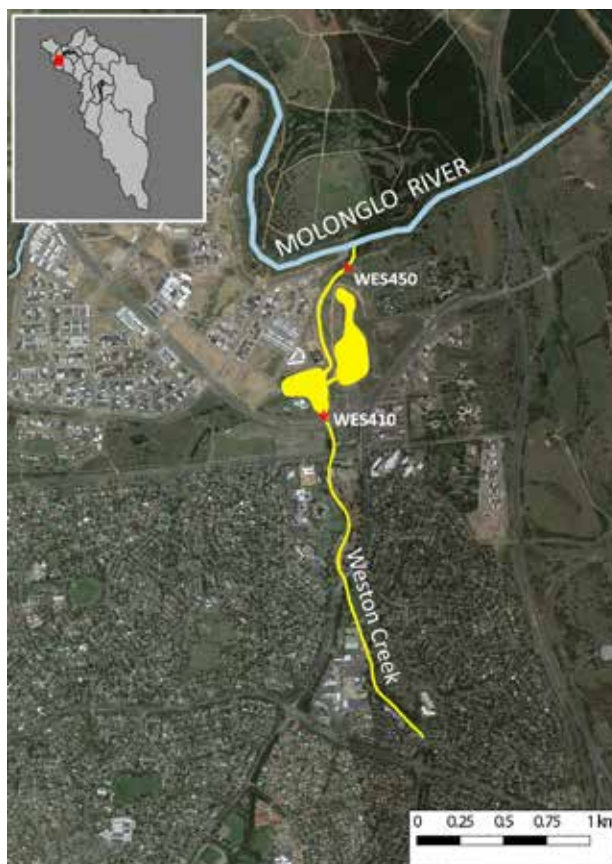
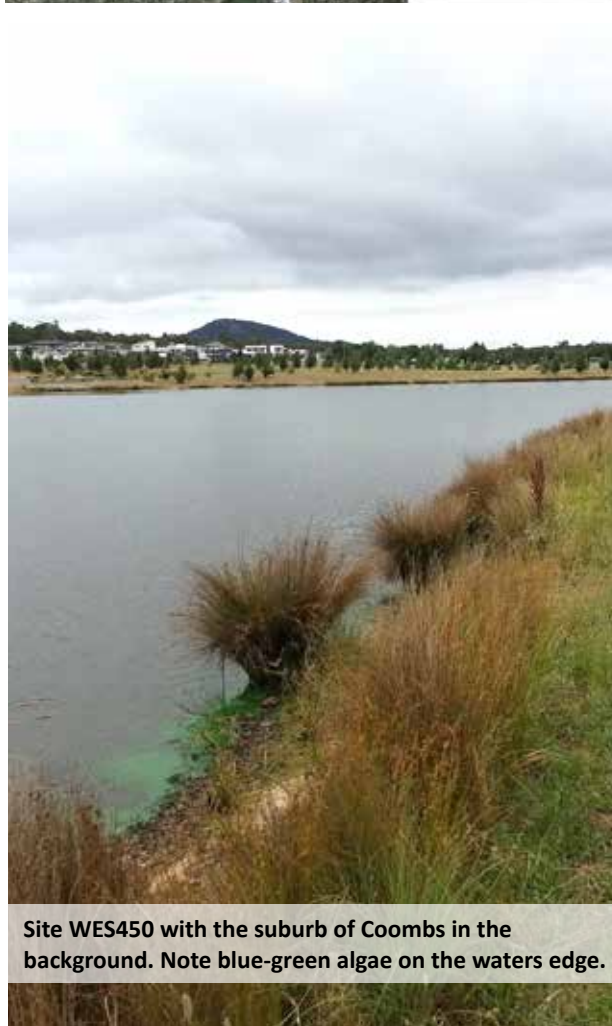
Phosphorus is an ongoing concern in this reach as well as spikes in nitrate, increasing the chances of algal blooms.

Site WES450 with the suburb of Coombs in the background. Note blue-green algae on the waters edge.

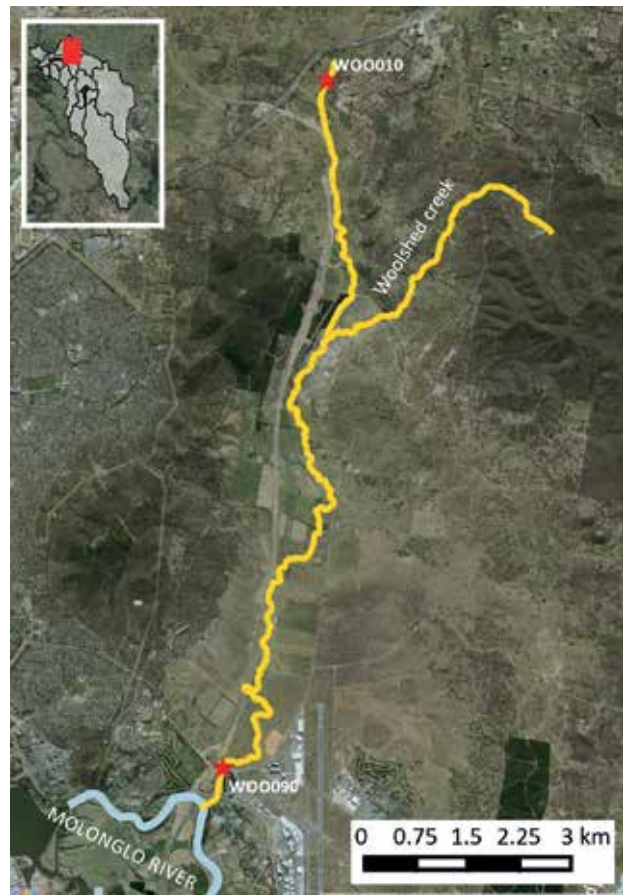
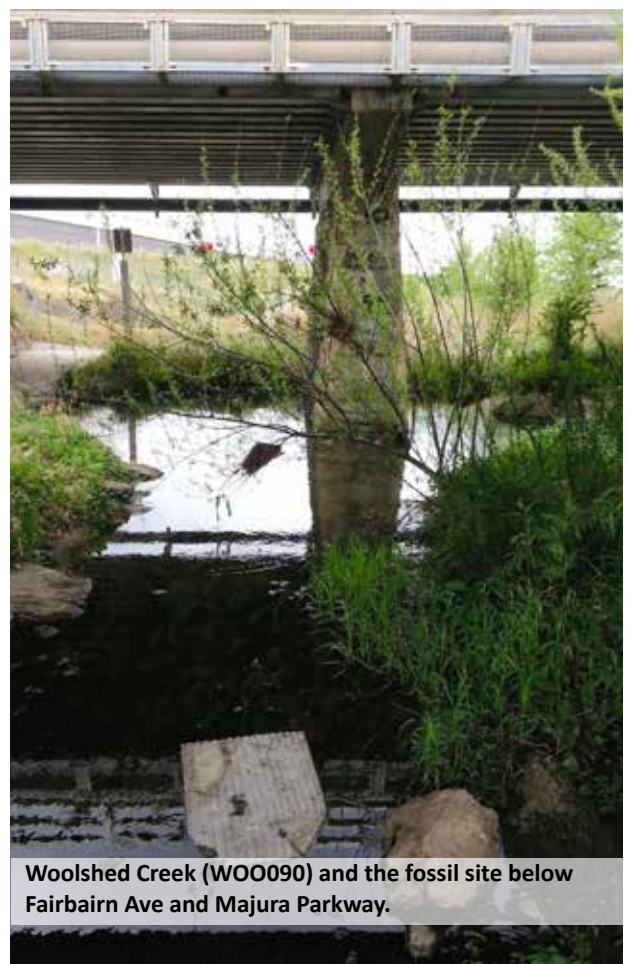
This reach has the poorest vegetation condition score in the Molonglo catchment. In addition, a very busy road system adjacent to the downstream site presents challenges for this small but ecologically important creek. Rubbish washes in from road drains and there is considerable dust and fumes with the high volume of traffic.

Woolshed Creek (WOO090) and the fossil site below Fairbairn Ave and Majura Parkway.

Native plantings conducted in recent years upstream may help to reduce salt loads over time, but plantings along much more of the creek and its tributaries would greatly improve habitat, flow regimes and water quality. Having said that, there are many sections of the reach with dense in-channel vegetation, though the plant diversity is limited.

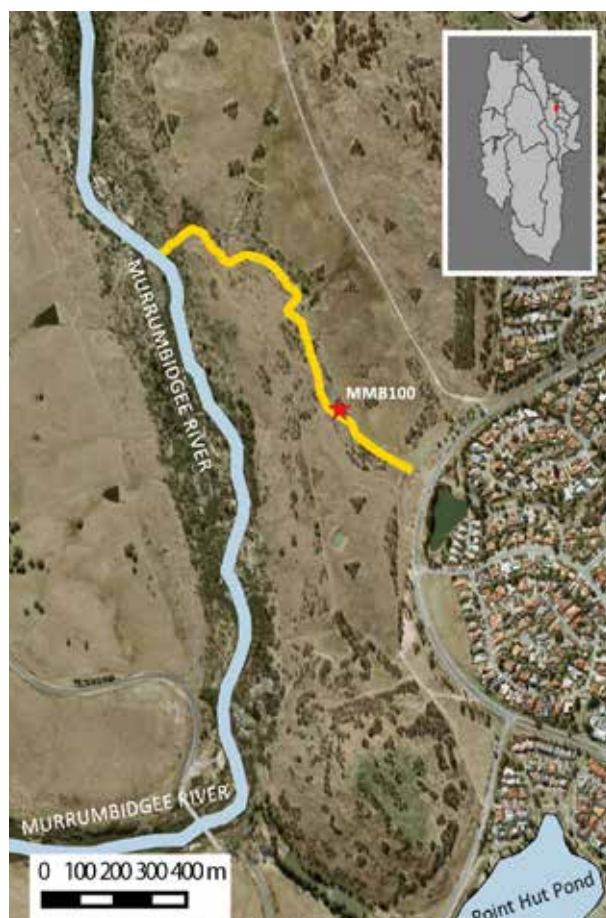
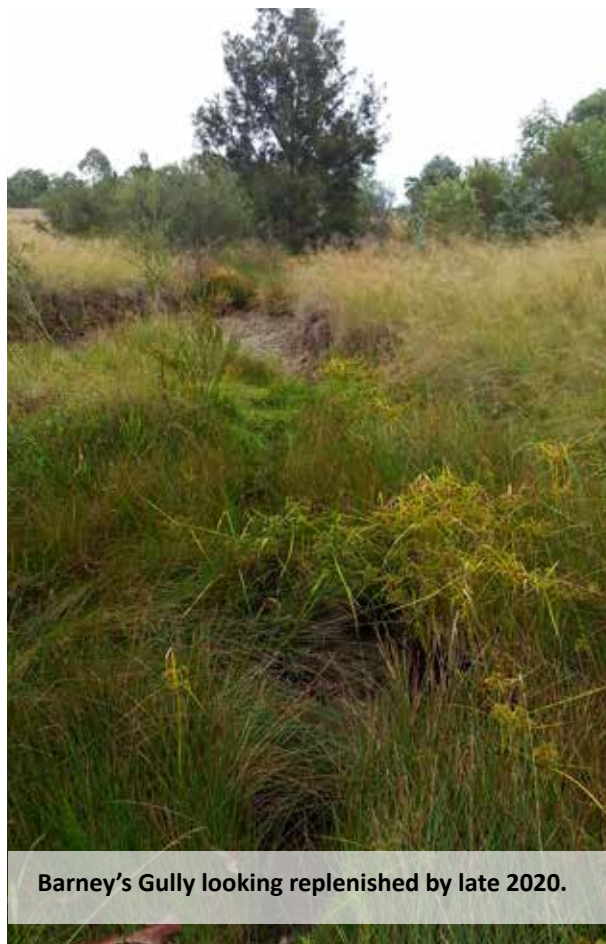
Clouds of "fine, fluffy, slimy green algae" were observed by Waterwatcher Deb in May and increased through the winter. By September this made the waterbug survey challenging and only seven Orders were found. Unfortunately there was no sign of the yabbies that have been seen in abundance in the past, although a crayfish symbiot, a type of flatworm that lives on yabbies, was detected in April.

Barney's Gully looking replenished by late 2020.

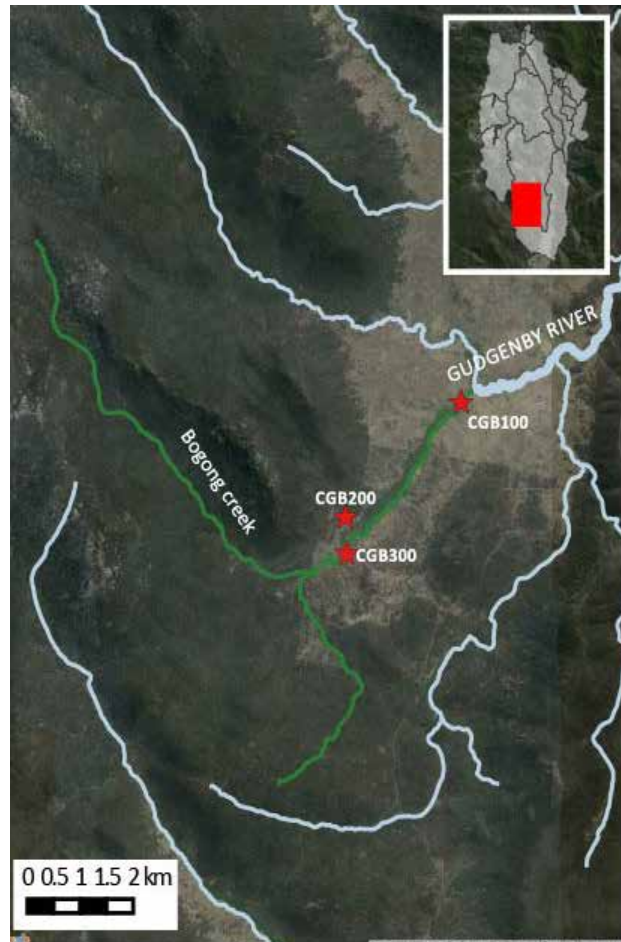
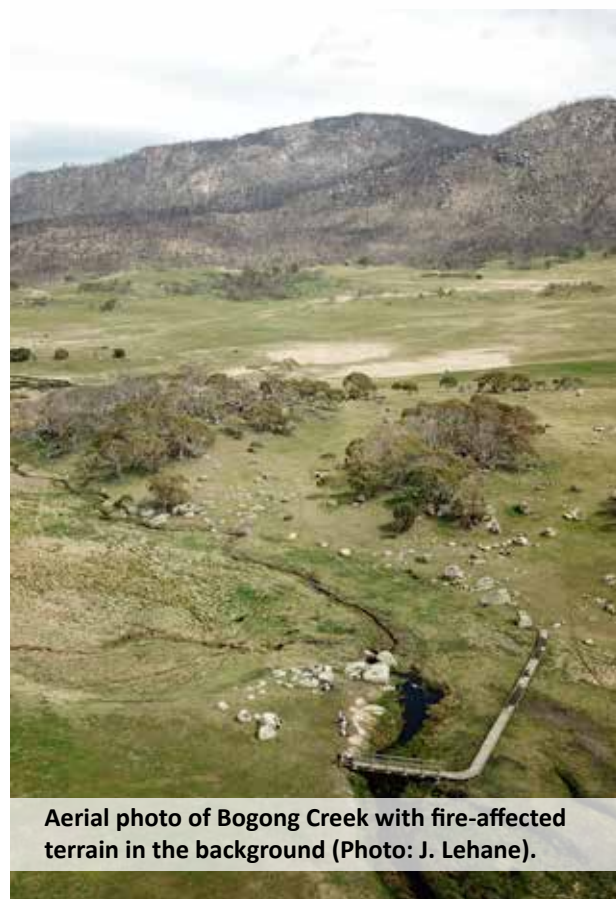
Major sections of this creek's catchment were burnt by bushfires in February 2020. Volunteer Vance, leader of the Brindabella Venturers, described being "shocked" after seeing the fires and in particular "the silting up of the southern Bogong site, where before there had always been that deep pool.. now barely a handspan deep."

Riparian condition scored *fair* due to the complete loss of shrubs and forest debris at fire-affected sites. These are vital components of healthy waterway ecosystems. Herbaceous weeds were noted in high numbers by the end of the year.

Dissolved oxygen levels remained low after the fires (as low as 2mg/L) and soluble nutrient levels rose. There was also a threefold increase in electrical conductivity between the upstream (50µS/cm) and downstream sites (150µS/cm).

Aerial photo of Bogong Creek with fire-affected terrain in the background (Photo: J. Lehane).

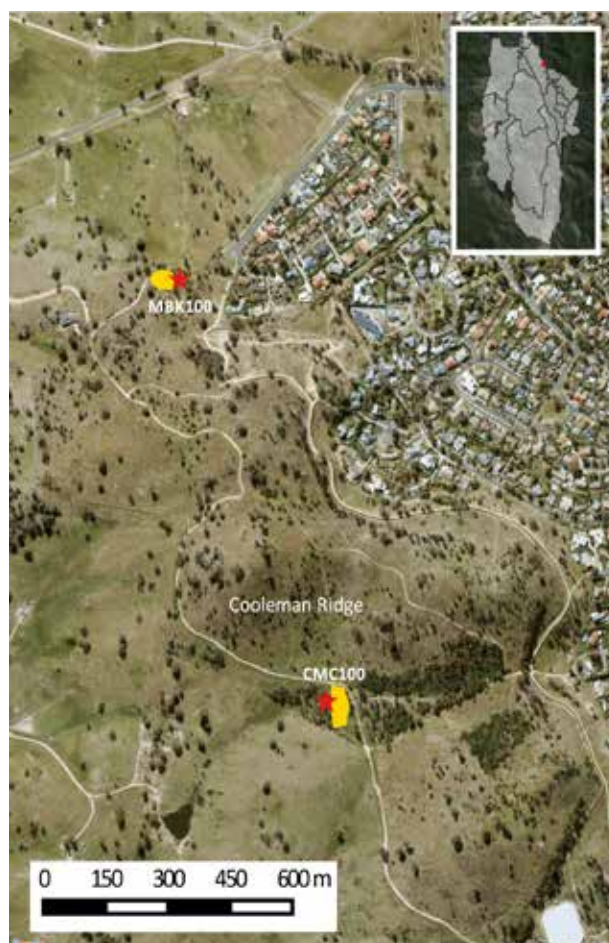
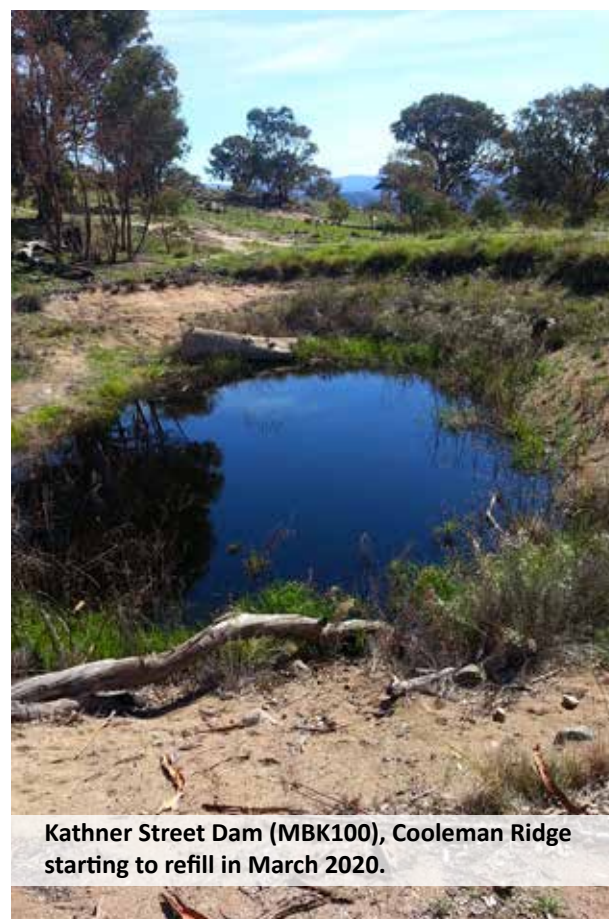
Water quality improved after the dams filled and regular rain runoff continued to flush the dams. That said, the dissolved oxygen levels remained low and P continued to be well above *degraded* concentrations. EC reduced because of dilution from regular rainfall and improved from *degraded* last year to *good* in 2020.

Kathner Street Dam (MBK100), Coolleman Ridge starting to refill in March 2020.
