Catchment Health Indicator Program

2020

Executive Summary

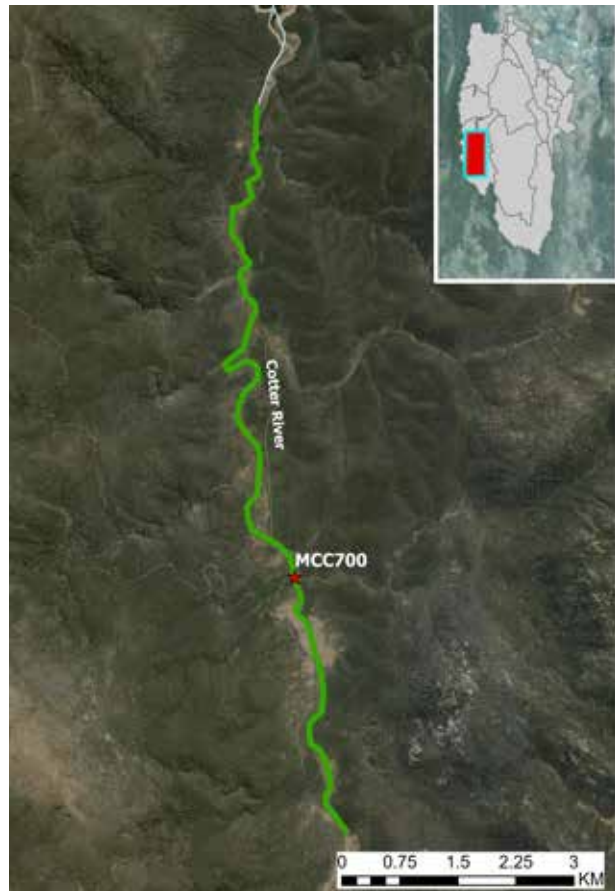
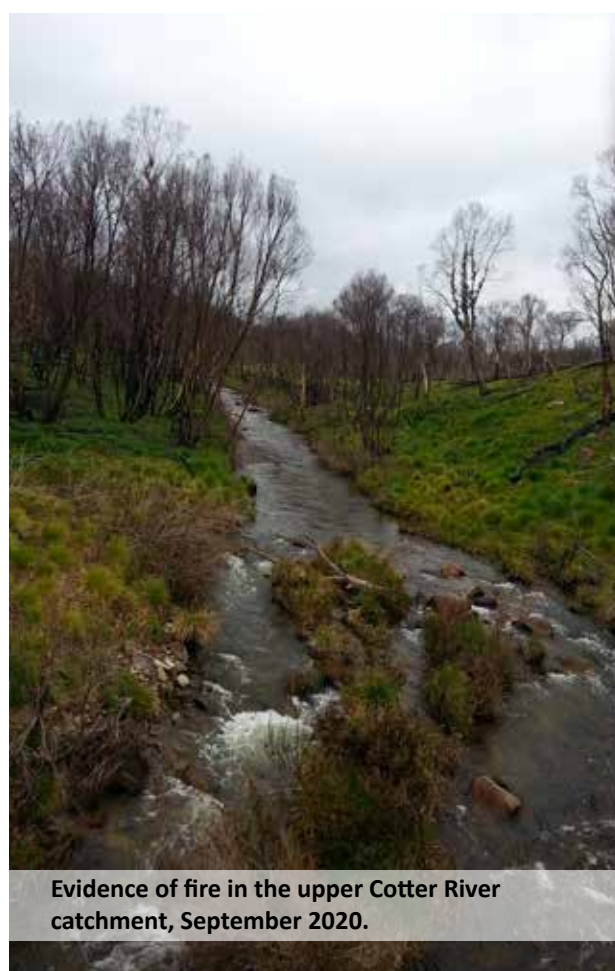
The surrounding catchment was affected by fire in February 2020. All layers of vegetation were burnt with the understorey (shrubs), logs, and most of the leaf litter debris significantly reduced as a result. Epicormic regrowth from surviving trees was only beginning to emerge in September. Pleasingly, many native shrub seeds survived the fires and signs of regeneration were also observed.

Evidence of fire in the upper Cotter River catchment, September 2020.

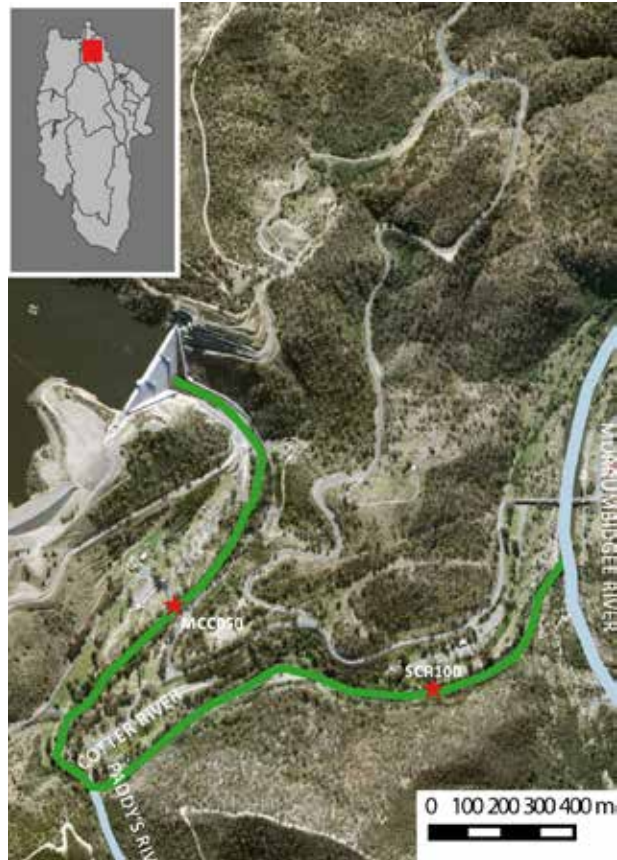
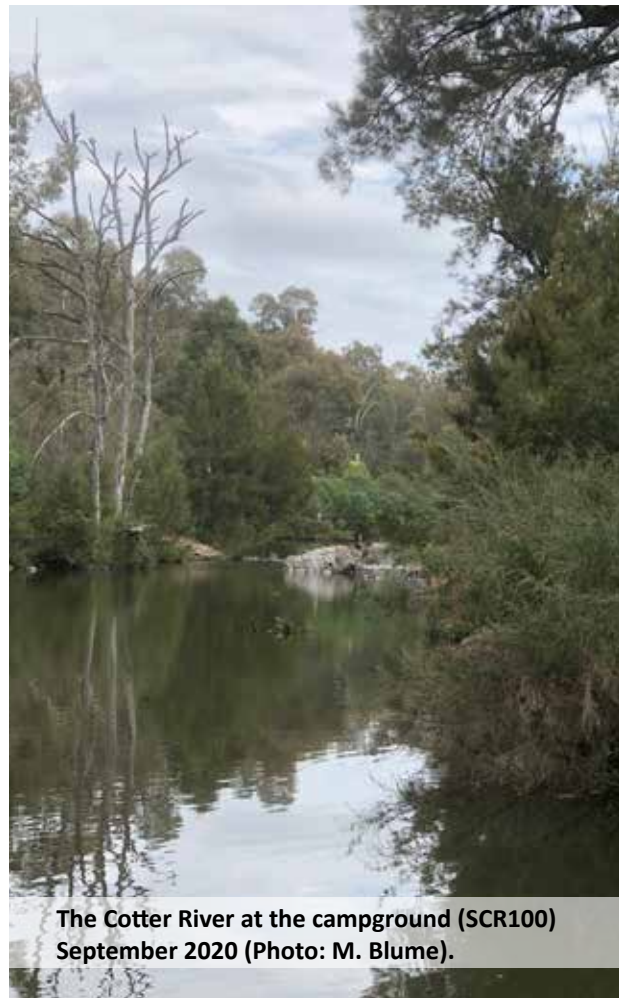
The most dramatic measurement, however, was from the Paddy's river after the heavy rain in February. It brought with it a slurry of ash laden sediment that turned the water black (500NTU) and coated the banks near the campground (SCR100). Luckily this turbid water was diluted by the Cotter flush in time to support a *good* spring waterbug survey result.

The Cotter River at the campground (SCR100)
September 2020 (Photo: M. Blume).

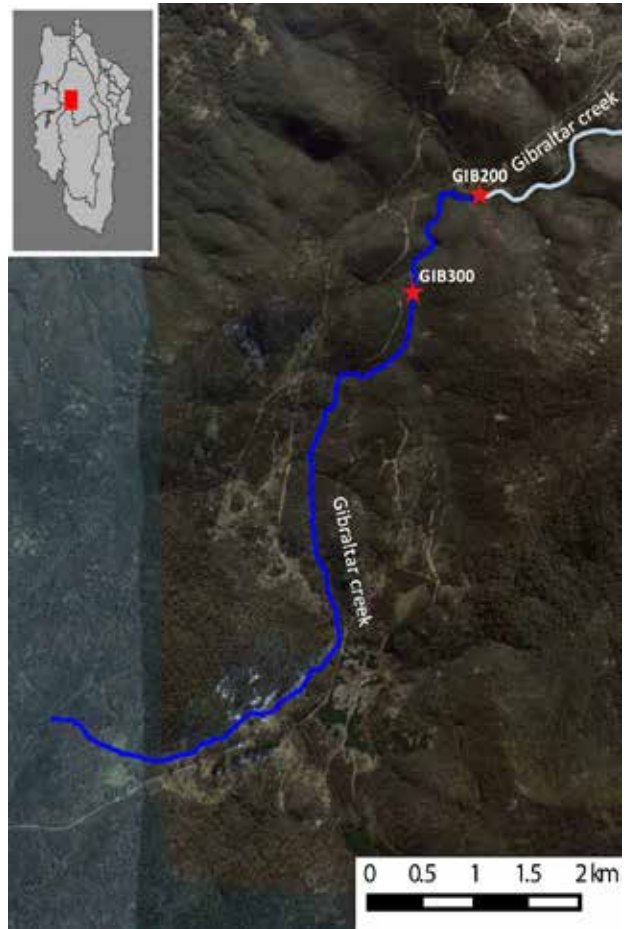
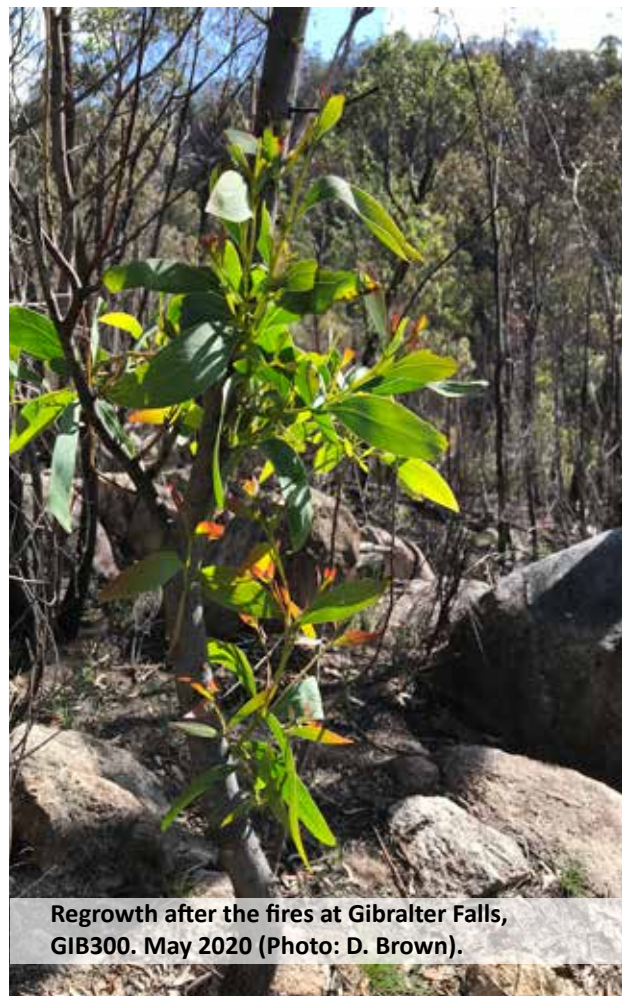
Large amounts of sandy sediment were deposited in the creek after the fires. This had a major impact on waterbug populations in autumn with only seven Orders found. The spring survey was back to revealing *excellent* levels of diversity with lots of naked caddisfly larvae, three different types of mayfly nymphs and reasonable numbers of stonefly. All of these are very sensitive to pollution.

Regrowth after the fires at Gibraltar Falls, GIB300. May 2020 (Photo: D. Brown).

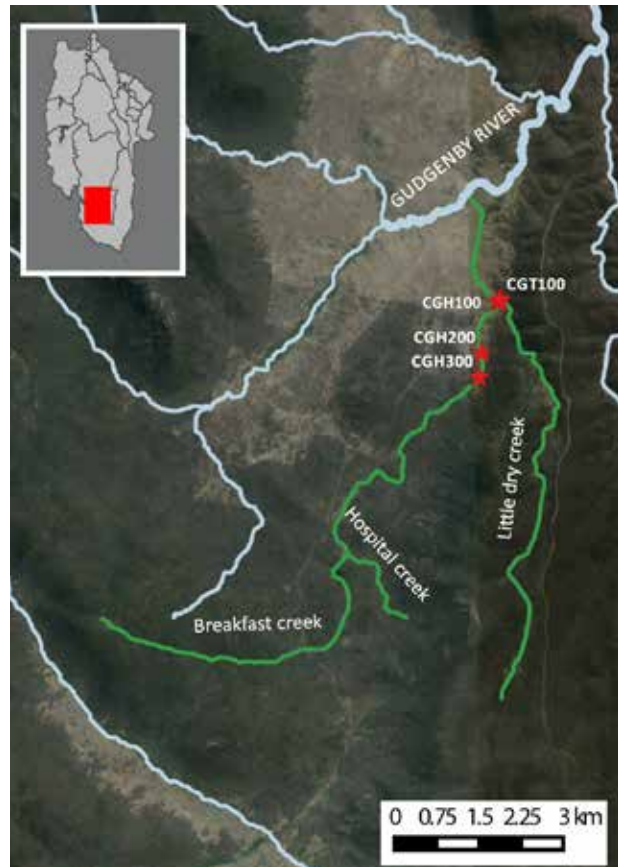
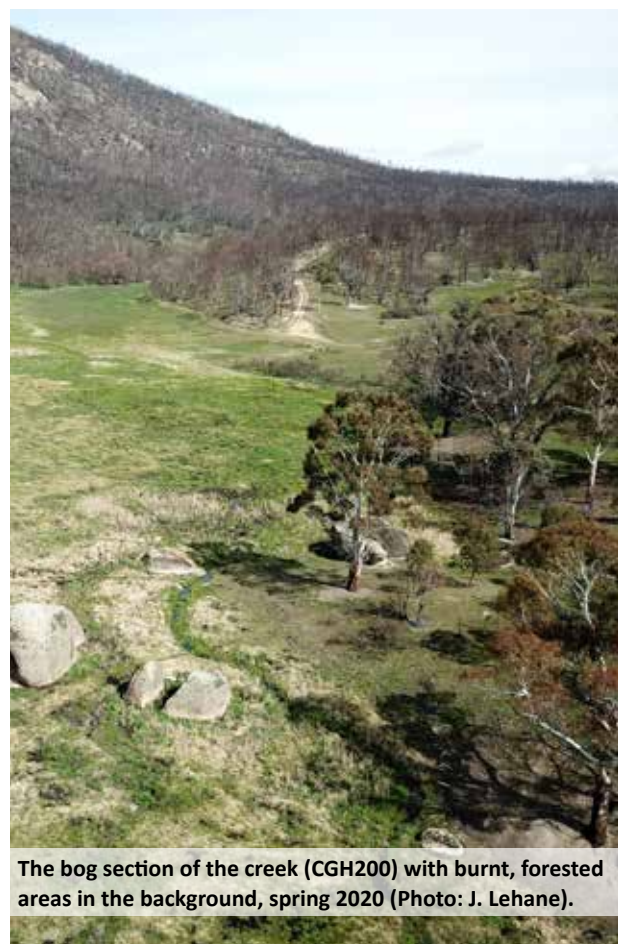
There was evidence of many spot fires around the bog areas as well as a “*drastic reduction in vegetation*” at the southern site (CGH300) according to the volunteers. The riparian surveys in July found near total loss of shrubs, no regrowth apart from weeds and epicormic buds on surviving trees. Leaf litter was mostly absent, standing trees were burnt and many were dead. By the end of the year invasive weeds, such as nodding thistle, had become “*chest deep*” near the forested sites.

The bog section of the creek (CGH200) with burnt, forested areas in the background, spring 2020 (Photo: J. Lehane).

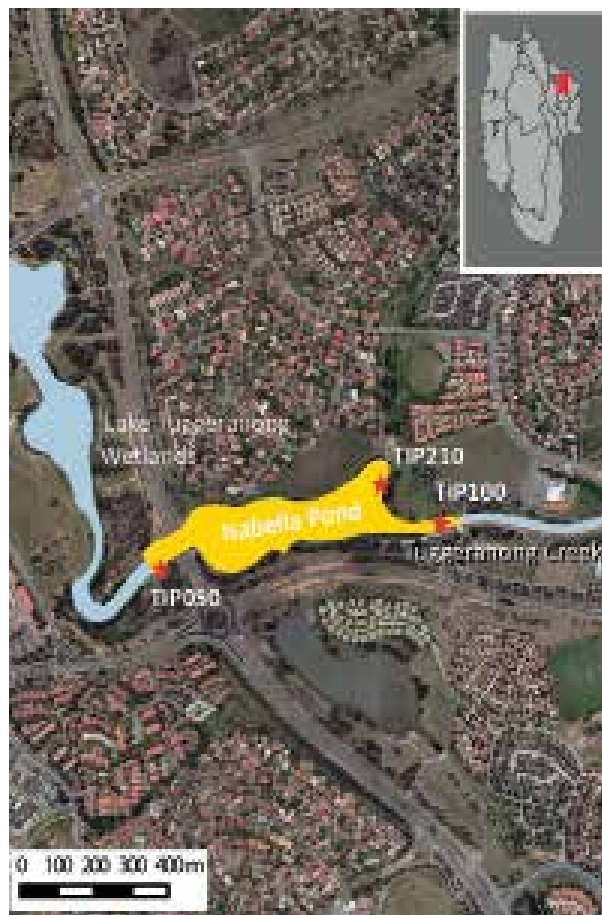
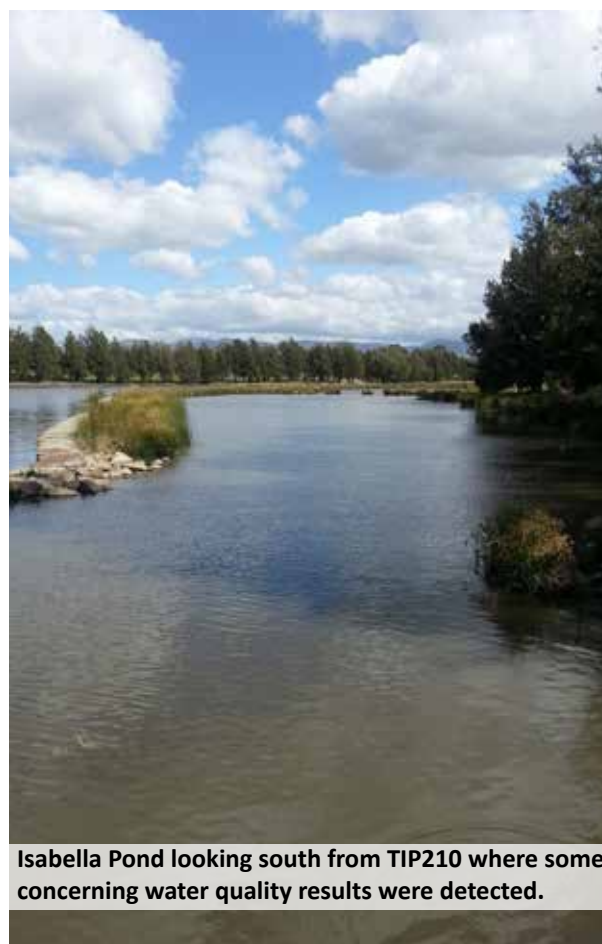
Interpreting the results at this wetland proved challenging in 2020 given the variable range of water quality flowing off this highly urbanised landscape. The wetland appears to be meeting its aim, with phosphorus, nitrate and turbidity levels all lower at the downstream site (TIP050) than at the two inlet sites. That said, dissolved oxygen levels were very unstable, swinging between a low of 22% saturation to in excess of 110% super saturation on six occasions. Electrical conductivity (EC) was also a problem with some very high levels around 500µS/cm detected at TIP210. This site in particular had some of the highest phosphorus and EC readings and is a sub-catchment that may warrant further investigation.

Isabella Pond looking south from TIP210 where some concerning water quality results were detected.

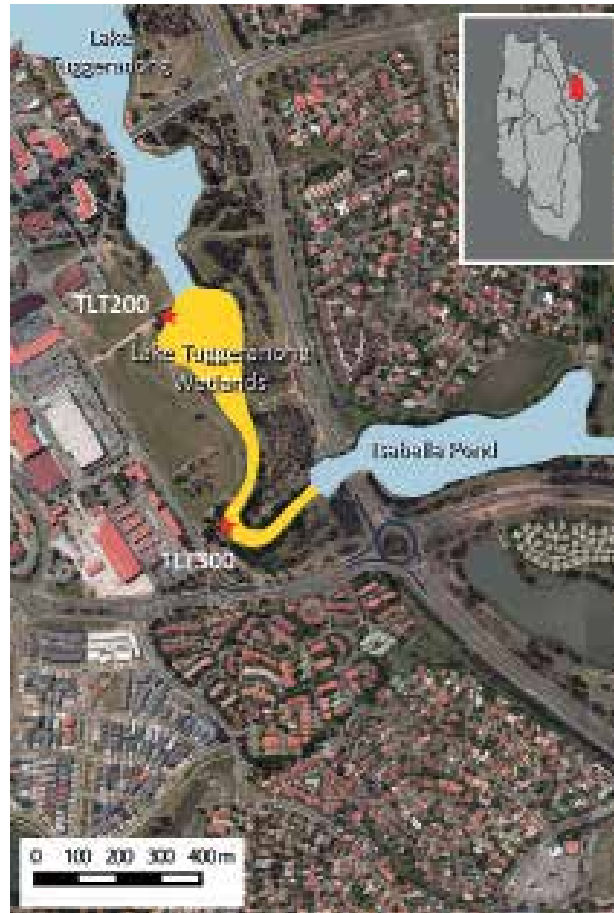
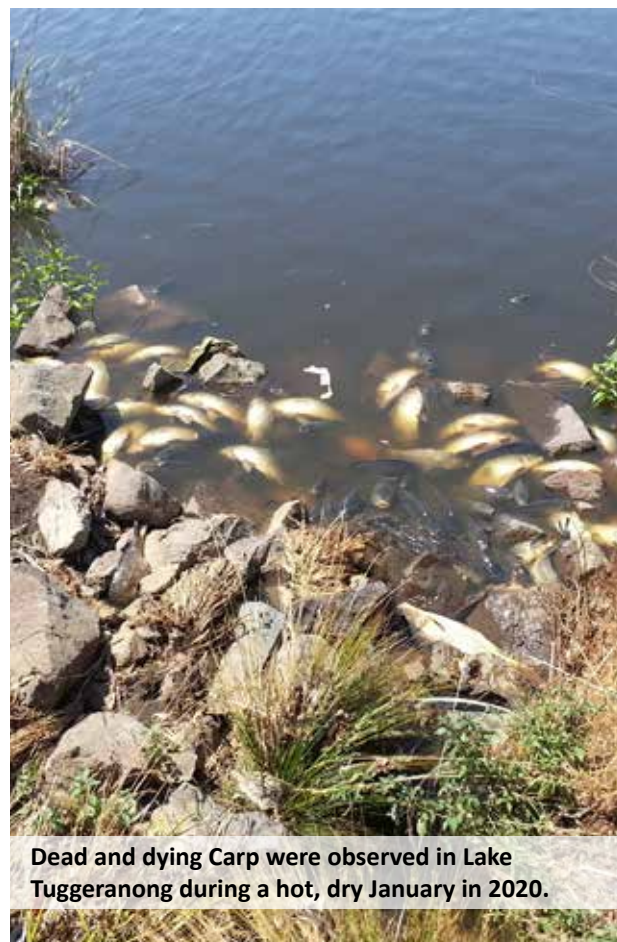
Water quality this year saw an improvement in turbidity, but an increase in phosphorus with levels regularly reaching 0.07mg/L. Also dissolved oxygen (D.O) levels were low and went from *excellent* last year to *degraded* in 2020. In January, during the period of heavy bushfire smoke engulfing Canberra, D.O dropped to 39% saturation. A large fish kill event, of mostly feral Carp, occurred in this reach at that time.

Dead and dying Carp were observed in Lake Tuggeranong during a hot, dry January in 2020.

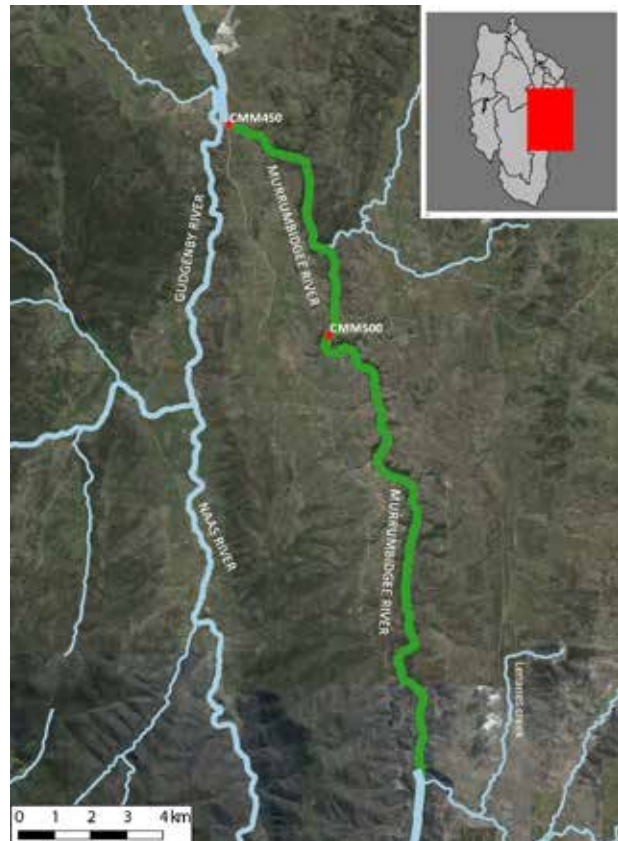
The start of 2020 saw flows reduced to a trickle. The water had a greenish brown colour and the reach was “smokey” from the NSW bushfires. In February high rainfall in the burnt, upstream catchment in NSW sent a plume of ash, silt and charcoal down the river. This resulted in *degraded* levels of turbidity (>400NTU) and phosphorus (0.8mg/L) in this reach. The water had a strong smell of ash and a thick layer of “fine dark sticky mud” settled on the steep banks at Tharwa Sandwash, according to Waterwatcher Deb.

Ash and silt from the fires had been deposited on the steps at Tharwa Sandwash (CMM450), February 2020.

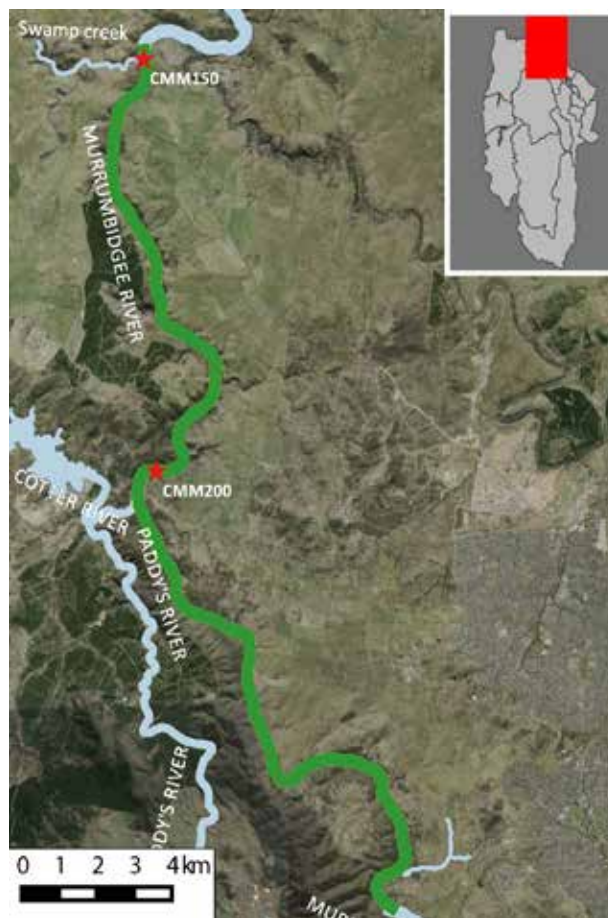
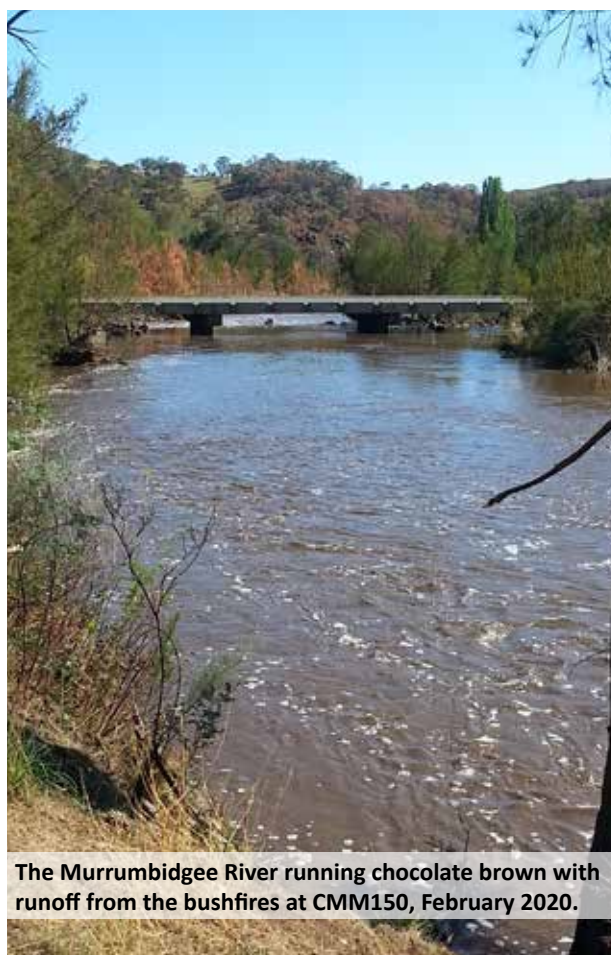
Thick deposits of ash sat two metres up the bank at Casuarina Sands and further rains throughout the year resuspended nutrients and increased turbidity during periods of high flows. Ashen deposits and fine sediments could be seen on the river bed throughout the remainder of the year. This shows the downstream effects of bushfires impacting areas many kilometres away.

The Murrumbidgee River running chocolate brown with runoff from the bushfires at CMM150, February 2020.

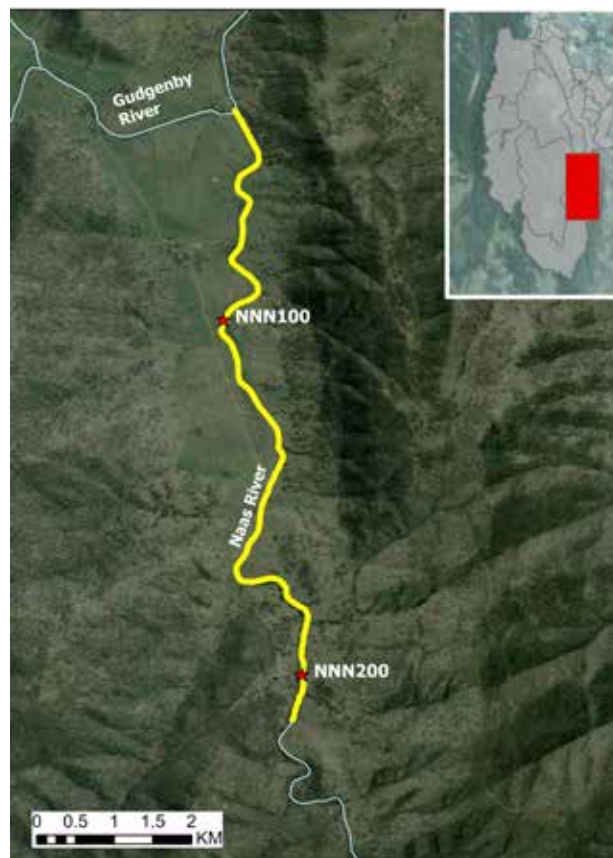
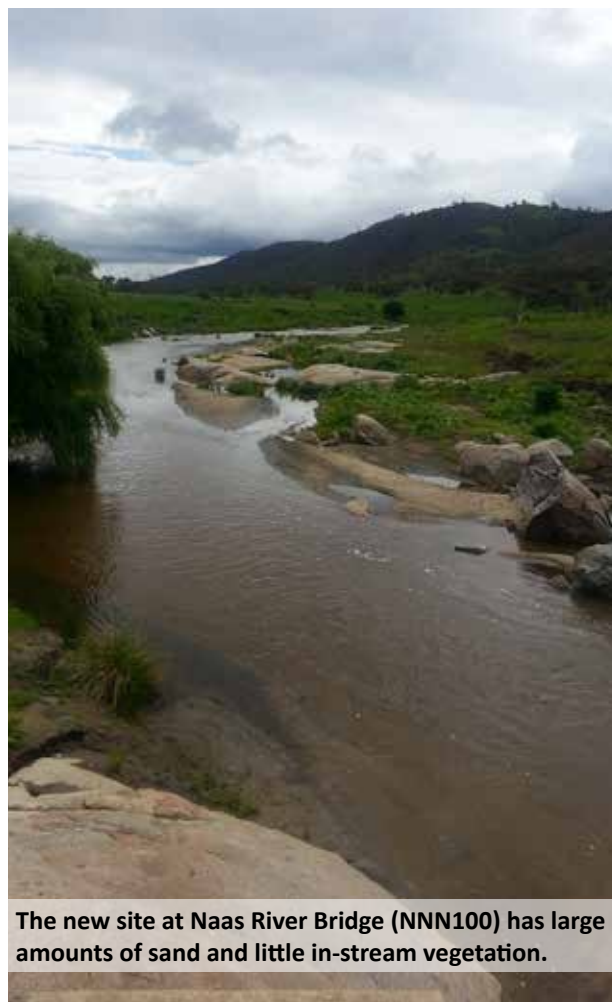
The riparian condition assessment of *fair* reflects a combination of the Naas Valley Bridge site (NNN100) with its complete lack of trees and very few native plants, and Caloola Farm (NNN200) that has a native canopy but with a mostly weedy understorey and ground cover plants.

The new site at Naas River Bridge (NNN100) has large amounts of sand and little in-stream vegetation.

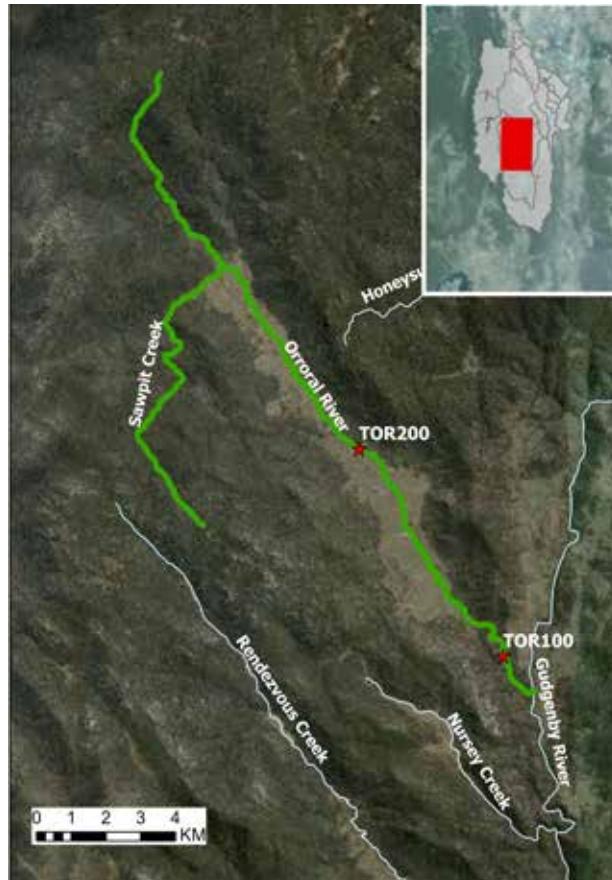
The area near the tracking station was the point where the Orroral Valley Fire began in January 2020, subsequently burning 80% of the surrounding National Park. Large plumes of sand washed down from the fire-affected hills in the south west, covering parts of the adjacent road and on into the river. Ash and sediment were also washed into the upper stretches and much of the normally abundant Phragmites reedbeds were burnt.

Evidence of ash and sand deposited in the Orroral River channel after the summer bushfires.

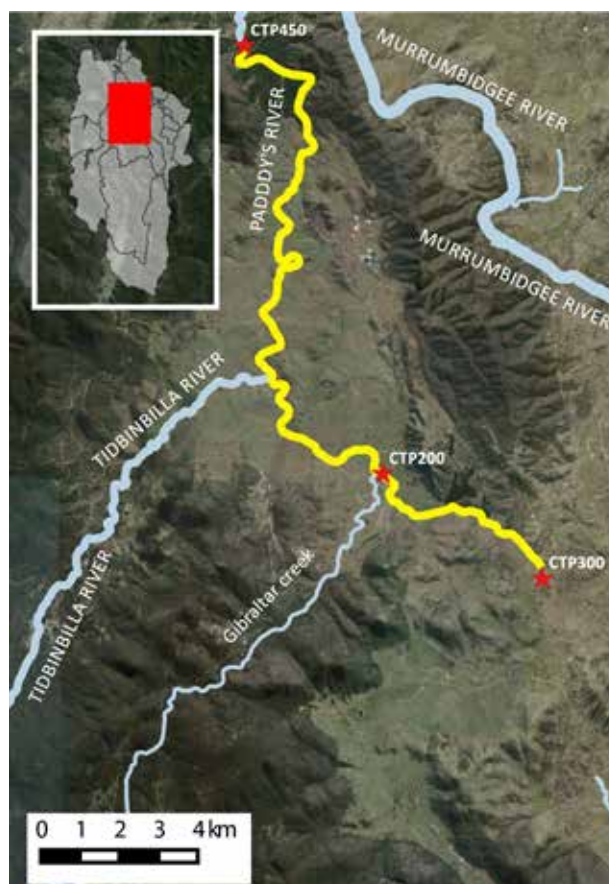
The 105mm of rainfall in February pushed large volumes of ash and sediment from the Orroral Valley bushfires down the Paddy's River. This left sticky ash deposits on the riverbank up to 20 metres wide at Murray's Corner (CTP150). Turbidity was over 400NTU and phosphorus over 0.2mg/L and similar results were detected upstream at Tidbinbilla Road Bridge (CTP300). This ash continued to be detected in the reach throughout the year as it was remobilised every time water levels rose, increasing turbidity and phosphorous levels.

Motorbike tracks on the ash-laden bank of the Paddy's River (CTP150), February 2020.

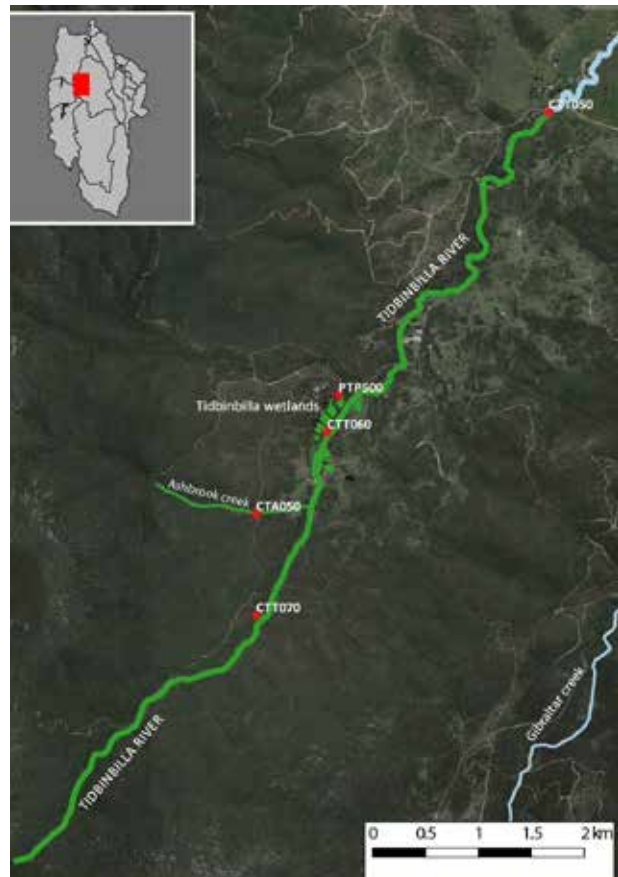
While the summer bushfires didn't directly burn much of the Tidbinbilla River, it did burn areas of the upper catchment. This was followed by intense flooding in February which flushed large amounts of sand and ash downstream into unburnt areas. Waterwatcher Fiona noted phosphorus levels at the upper site (CTT070) as high as her kit would measure (0.25mg/L) as well as electrical conductivity four times higher than what is usually detected at that site (430 μ S/cm).

Animal tracks in the ash-laden sediment at CTT070, washed down from the fire grounds (Photo: F. Spier).

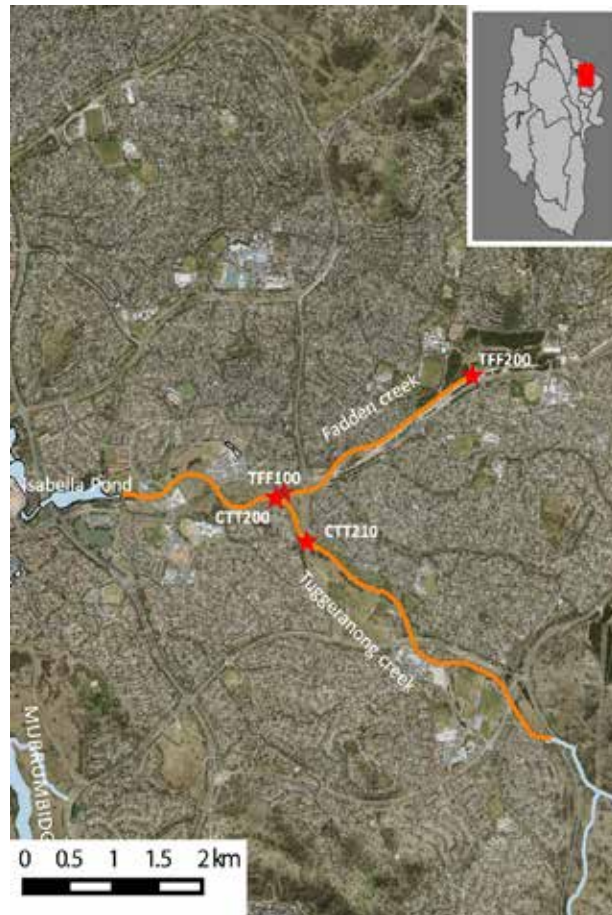
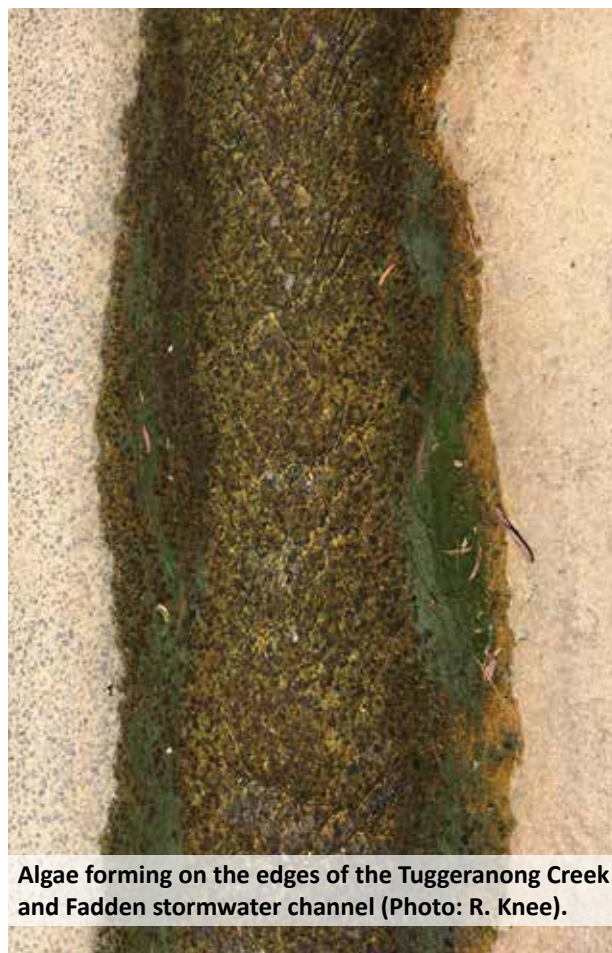
For most of the year there was a steady, low flow through the system. Most of the data collected was from May onwards, when volunteers could return after COVID-19 lockdowns. For much of the remaining year, three out of the four sites in this reach experienced super-saturated dissolved oxygen levels, that is, in excess of 100%. This is most likely a result of the continuous flows maintaining an array of algae in the channel which spend their daylight hours photo-synthesising. A by-product of this process is oxygen which can be detrimental when it occurs at such extreme levels as this. Interestingly, another effect of photo-synthesis is that it can drive up pH levels and, again, these sites had pH readings above 8.5 on ten occasions in 2020.

Algae forming on the edges of the Tuggeranong Creek and Fadden stormwater channel (Photo: R. Knee).

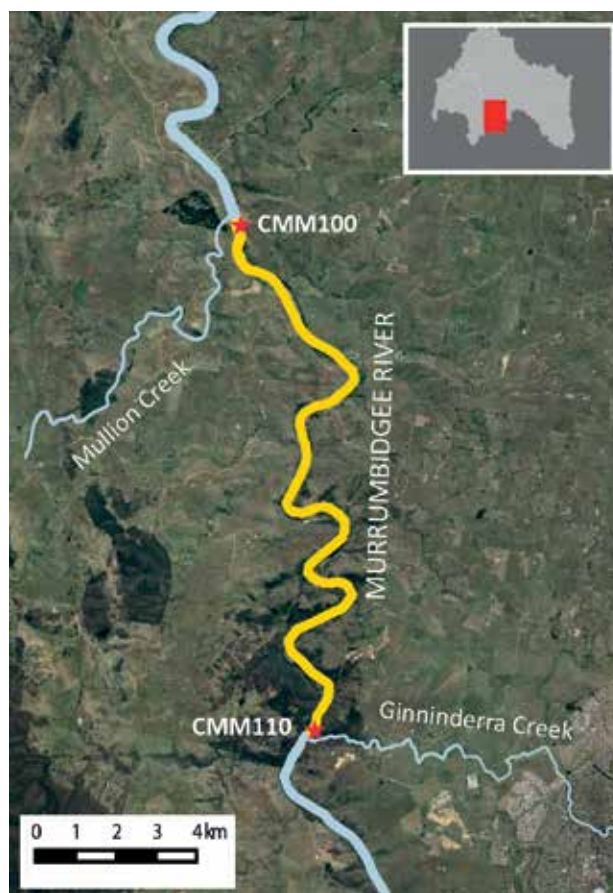
Evidence of the summer bushfires were felt even this far down the Murrumbidgee River. Ash was observed suspended in the water and lying thick on the banks throughout 2020. After the early rains in February, the amount of ash was so high that phosphorus concentrations were 0.25mg/L and turbidity levels were in excess of 400NTU – both as high as the Waterwatch equipment can measure. Waterwatcher Fiona took photos at her downstream site at Wallaroo (CMM110) where the river looked like a chocolate milkshake.

The Murrumbidgee River looked like a chocolate milkshake at CMM110, February 2020 (Photo: F. Hamer).

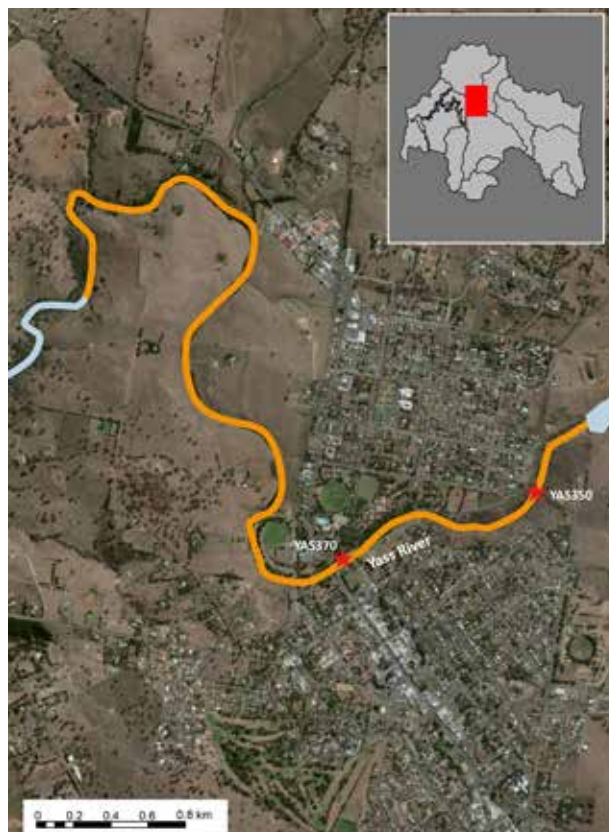
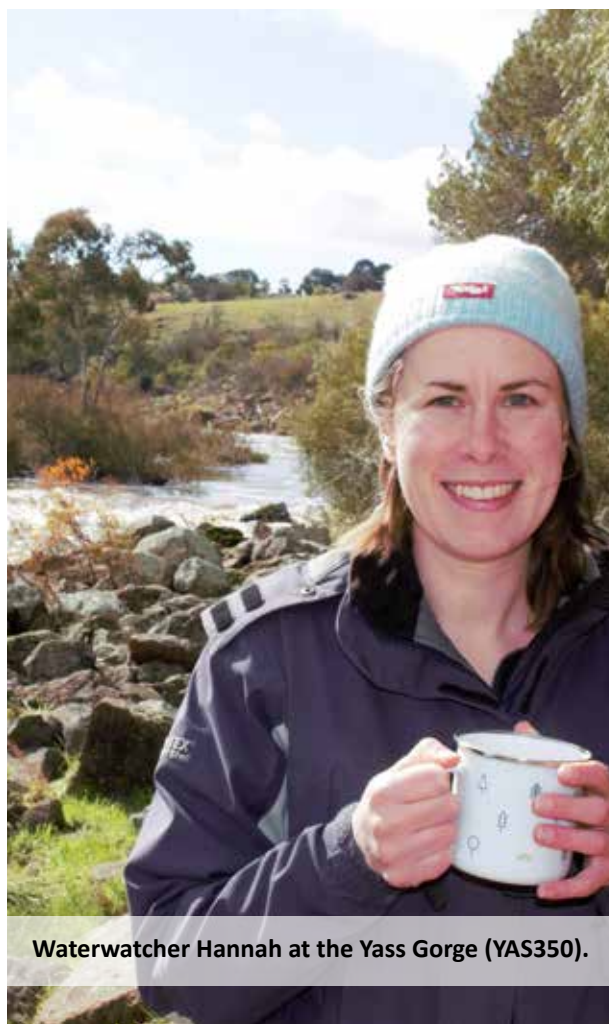
Waterwatcher Hannah at the Yass Gorge (YAS350).

In 2020, Waterwatcher Rebecca noticed signs of erosion at YAS370, as well as an increase in weeds such as hemlock, prickly lettuce, soldier thistle, poplars and blackberry. Waterwatcher Hannah also noticed the presence of exotic weeds close to her sampling site in YAS350. The increased weed growth this year is most likely related to the extra rainfall following the years of dry conditions

Nitrate, presumably from urban inputs, continues to be a problem in this reach.

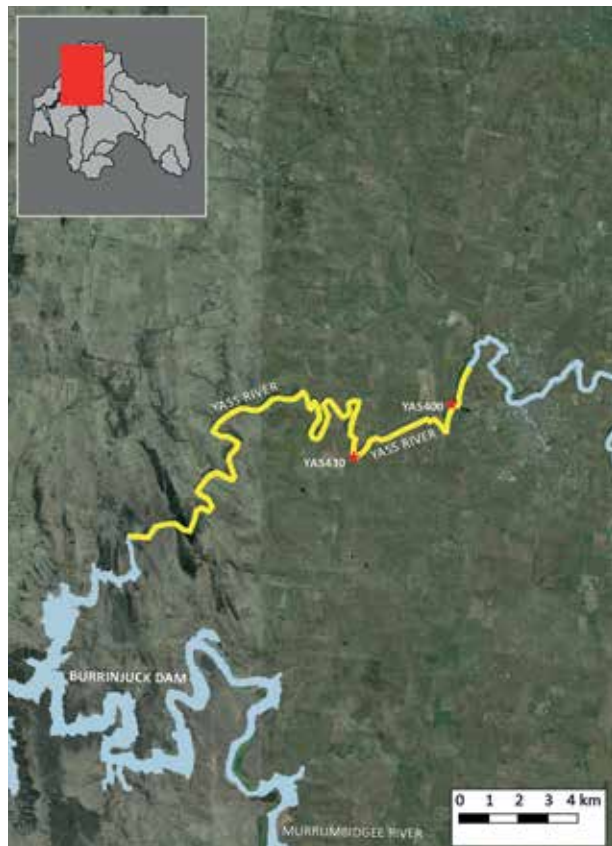
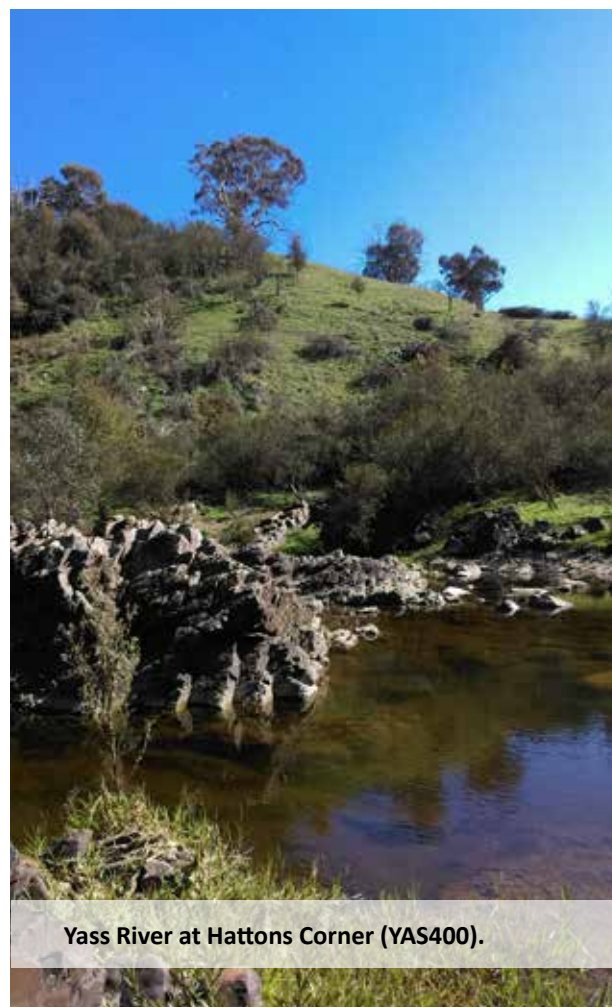
Yass River at Hattons Corner (YAS400).

In 2020, the effect of high flows has been felt in this reach with more water moving along the system, bringing sediments, silt and organic materials. As a consequence, there were a few spikes in phosphorus (0.05-0.08mg/L), and turbidity (30-35NTU), where clear water is measured at <9NTU. Nitrate were also high and this is possibly a result of an increase in urban run-off from the Yass township (see also reach YAS3)

During the November sampling, Waterwatcher Rebecca noted 'bank shape has totally changed due to flooding. Large gravel deposition area and shrubs washed away'. She also observed a very thick growth of weeds on the riverbank, such as blackberry, wild radish, black oats and dock.

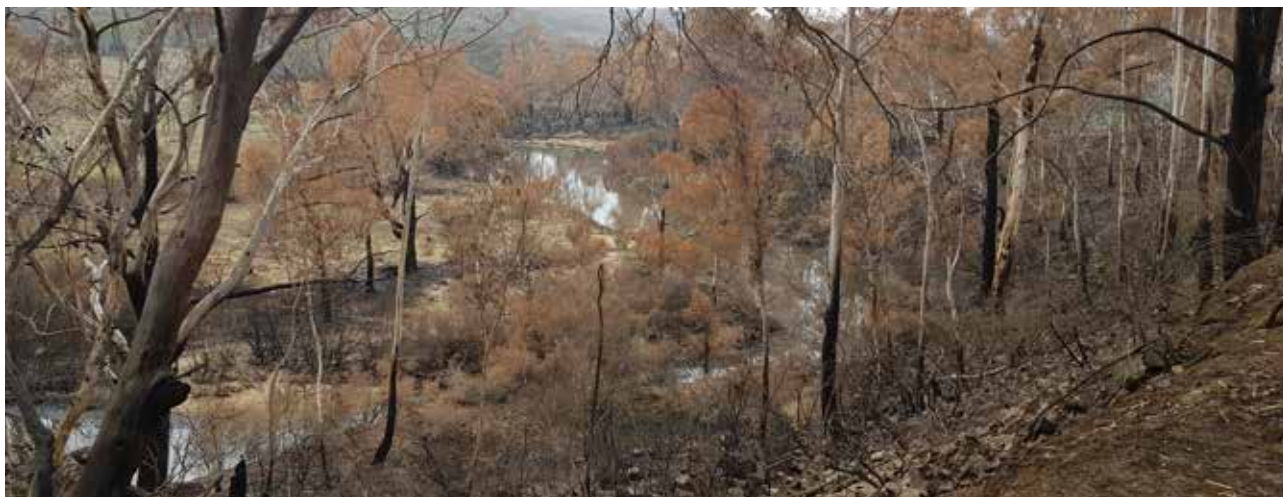
The upper Badja River catchment was nearly entirely burnt in the fires (Photo: A. Brademann).

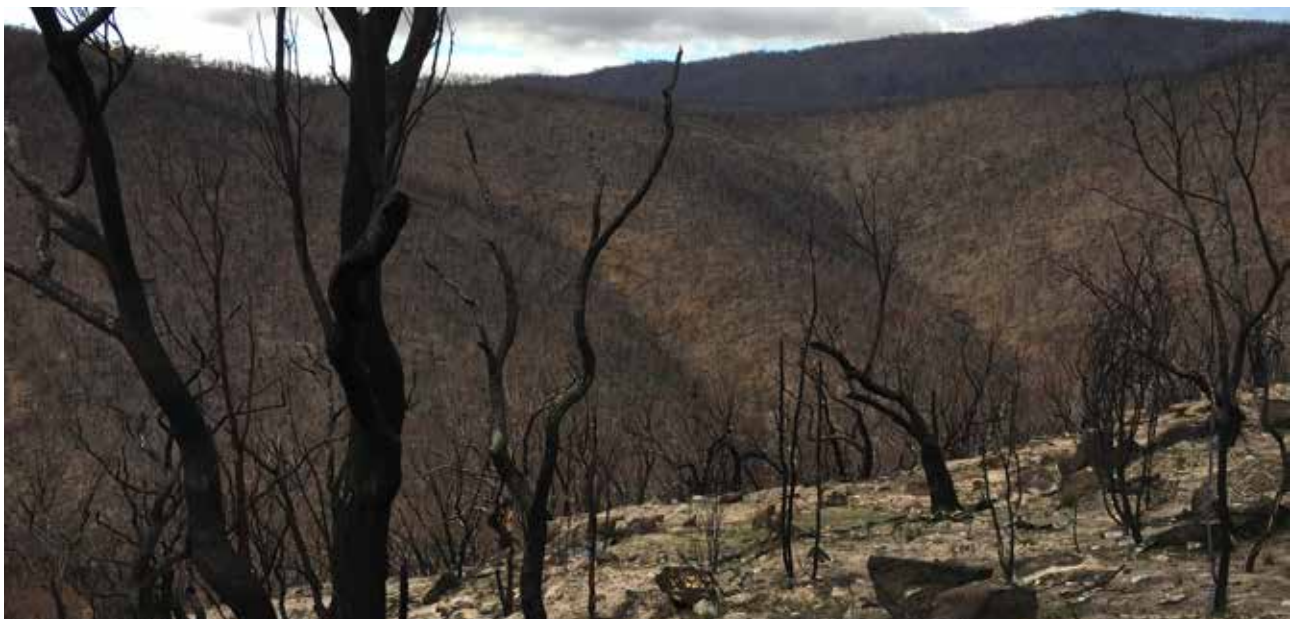
Parts of the Gudgenby River catchment were still devoid of vegetation six months after the fires (Photo: W. O'Reilly).

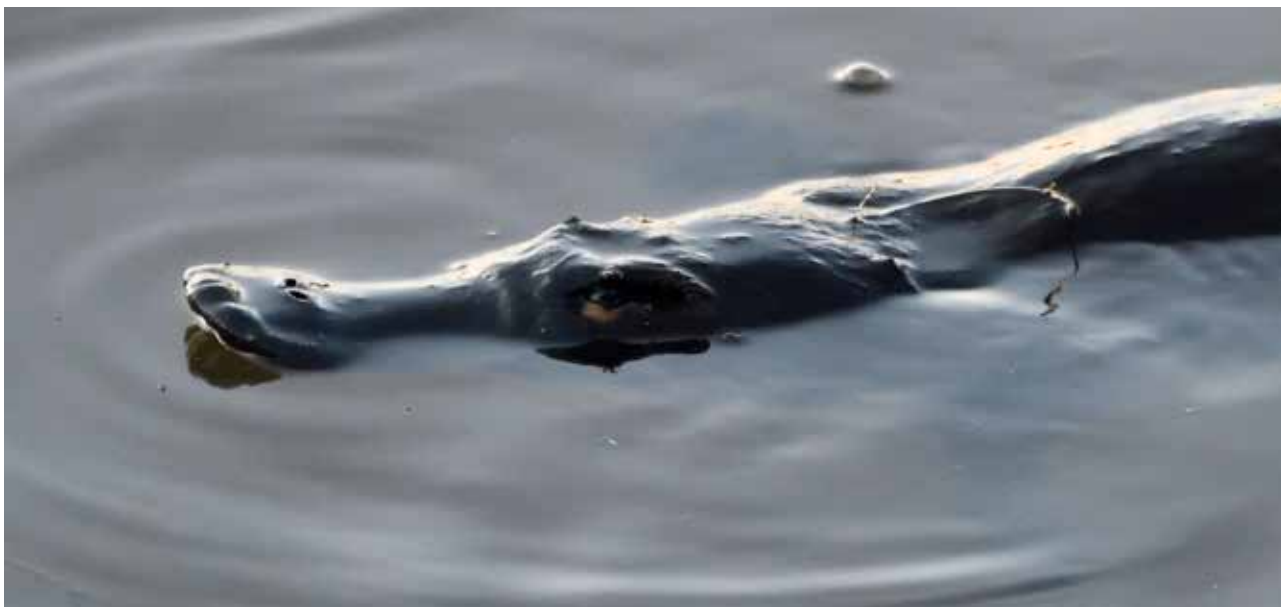
ABOVE: Platypus at Jerrabomberra Creek with a fishhook in its back. Photo: David Cunningham.

One thing that we can all do to help Platypus right now, is to **pick up litter**. There are too many examples of hair ties or plastic milk bottle rings getting caught around Platypus which can rub through their fur and compromise their ability to maintain body temperature. This often leads to death. Another common scenario is Platypus getting caught in discarded fishing line or fishhooks and drowning. In fact, two volunteers captured images of Platypus entangled in litter during Platypus Month (see next page).
