# Catchment Health Indicator Program

2014–15

Written and produced by the Upper Murrumbidgee Waterwatch team:

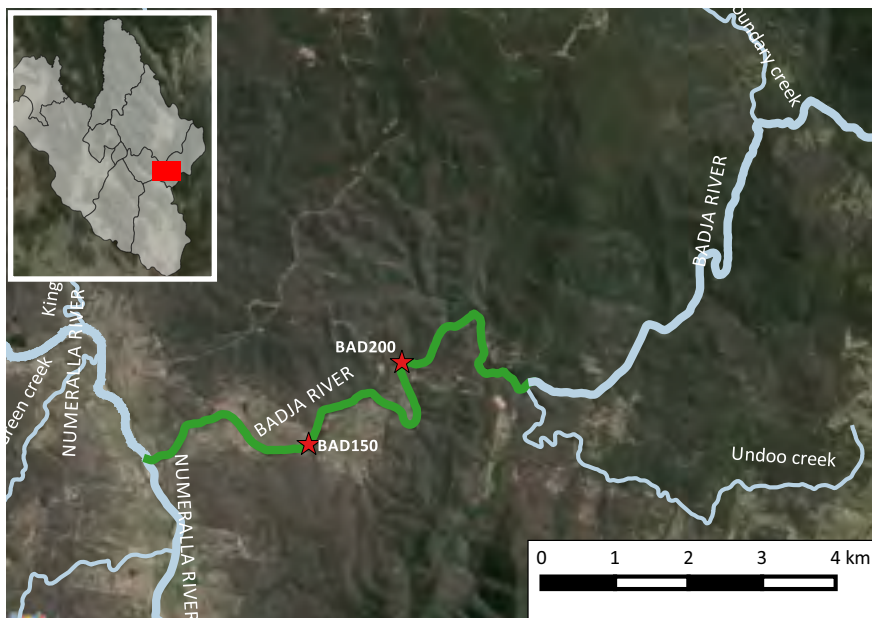
Water bug surveys indicated 'good' stream condition. The overall riparian survey result was 'fair', with native canopy and understorey vegetation present. Habitat features such as River Tussock, debris and hollow bearing trees were limited. Willows and Blackberry occur, which are the focus of a current Landcare project.

Badja River looking upstream from the Peakview Road bridge

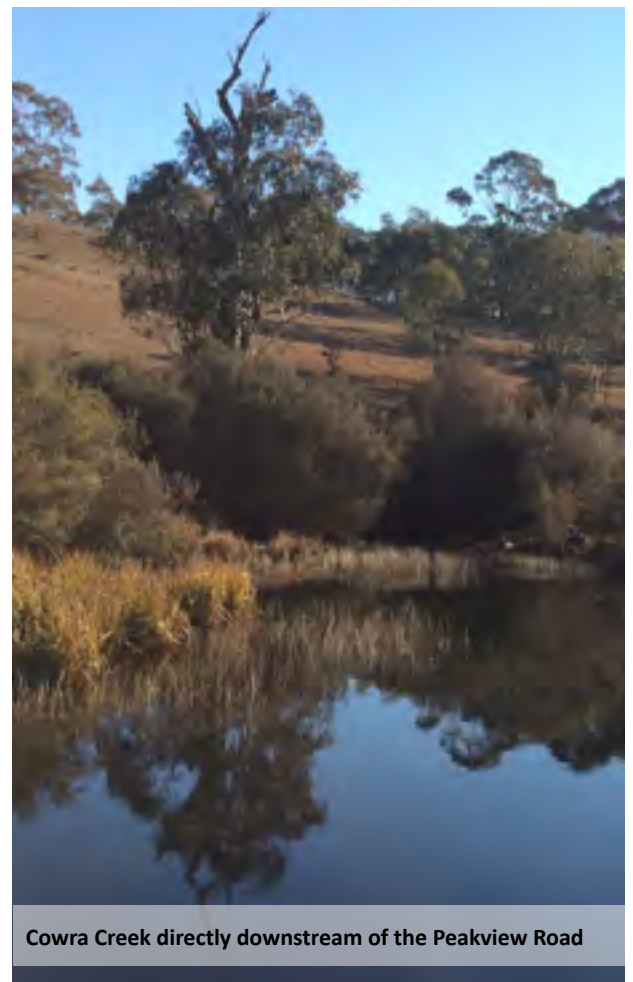
The water bug score indicated stream health was 'excellent'. Riparian condition was found to be 'fair', due to lack of under storey (possibly due to grazing pressures) and limited presence of habitat features such as logs and hollow bearing trees. River Tussocks (which provide excellent habitat and filtering qualities) and other native vegetation was present in all riparian zones.

Cowra Creek directly downstream of the Peakview Road

Regular monitoring is required to improve confidence in this CHIP score. Further sites at the top of the Bredbo River are desirable.

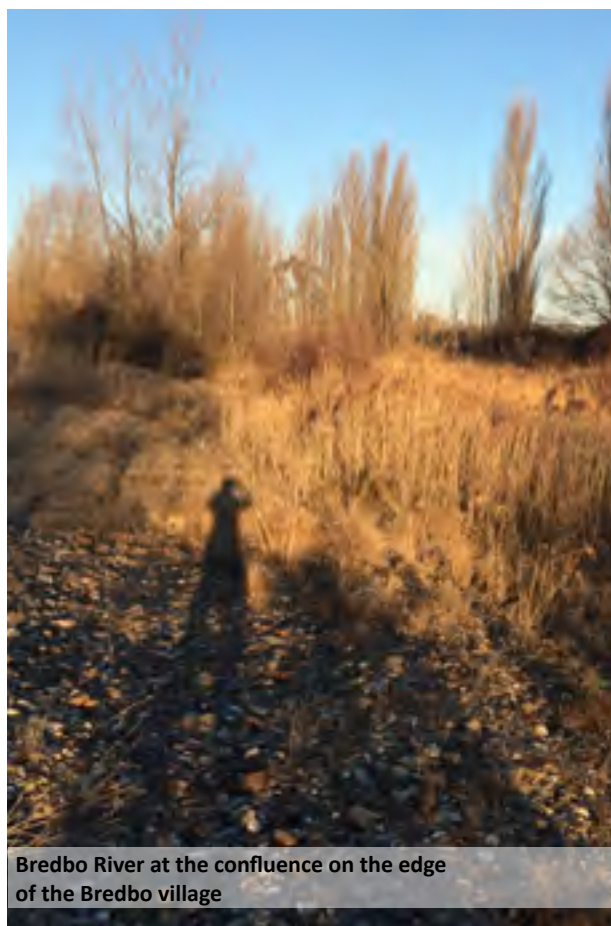
Water bug surveys indicated stream health was 'good'. Riparian condition rated as 'poor' due to high levels of exotic canopy and understorey cover (Poplars and Blackberry) and lack of habitat features including River Tussock and debris.

Bredbo River at the confluence on the edge of the Bredbo village

Regular monitoring is required to improve confidence in this CHIP score. Further sites at the upstream end of the reach are desirable.

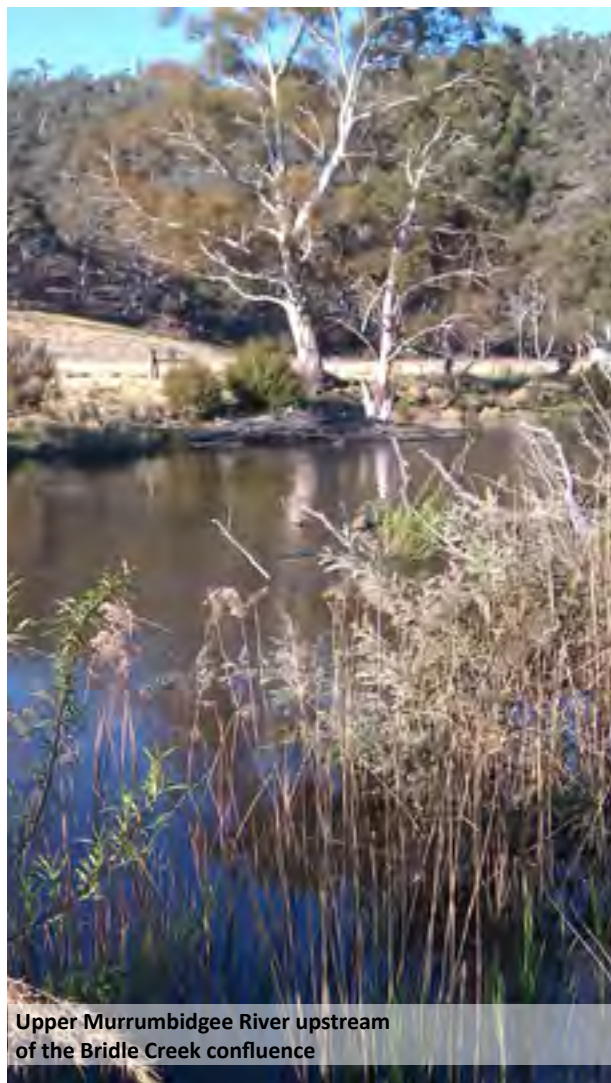
Water bug surveys indicate 'good' stream health. Macroinvertebrates were sampled from both riffle and macrophyte (reeds and rushes) habitat. Riparian condition was 'fair' comprising of a 'poor' riparian survey result at the bottom of the reach and a 'good' condition score at the top of the reach. The latter was one of the few sites in the Cooma Region where hollow bearing trees were recorded in riparian surveys.

Upper Murrumbidgee River upstream of the Bridle Creek confluence

Regular water quality monitoring will increase confidence in this score.

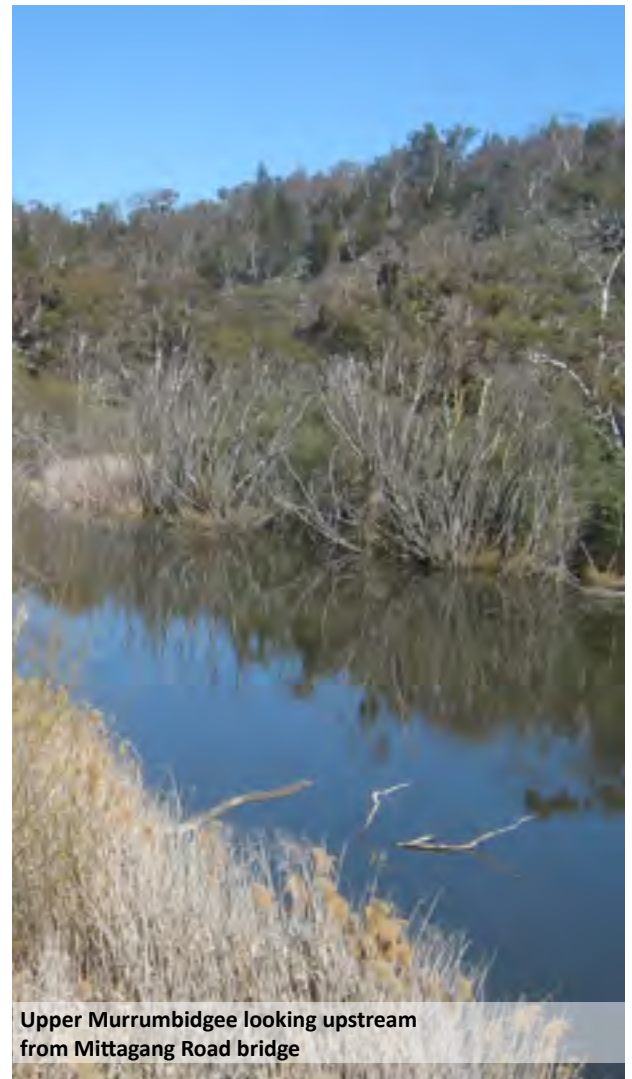
Water bug surveys for this reach indicated that stream health is in 'fair' condition. Riparian condition assessments resulted in an overall 'poor' condition score which was influenced by high levels of exotic canopy (Willows) cover, limited understorey and a lack of habitat features such as River Tussock at the downstream end of the reach. Surveys were carried out at sites which are at sites dominated by rural landuse.

Upper Murrumbidgee looking upstream from Mittagang Road bridge

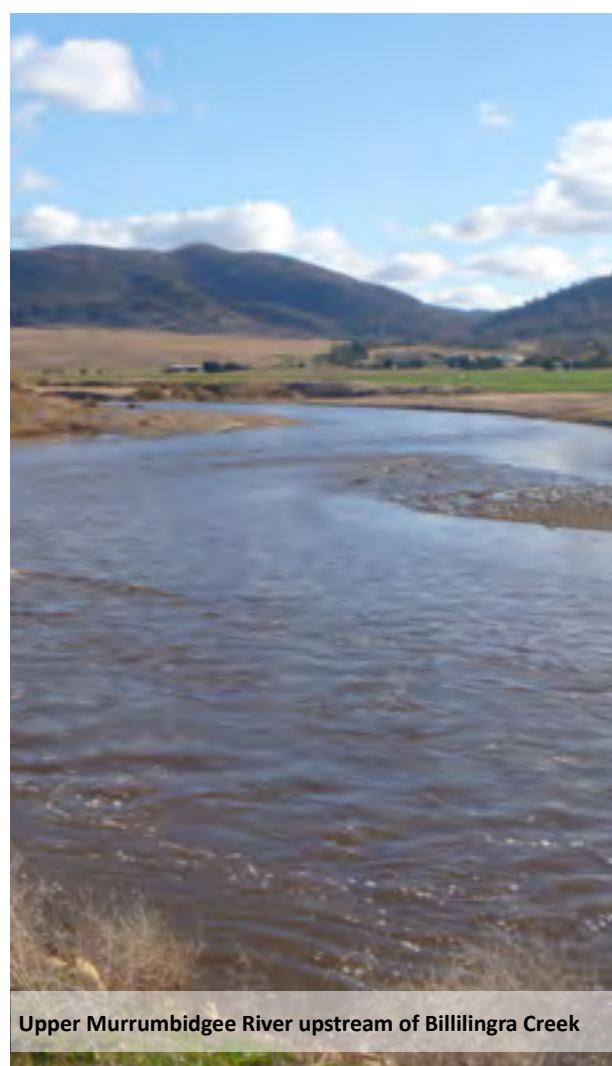
Water bug survey results indicated 'poor' stream condition due to water quality and reduced instream habitat. The overall riparian condition score was 'degraded', due to the presence of medium to dense willow infestation, limited understorey, lack of native groundcover and habitat features such as River Tussock and debris. Instream gross sediment deposition has simplified aquatic and riparian habitat in this reach.

Upper Murrumbidgee River upstream of Billilngra Creek

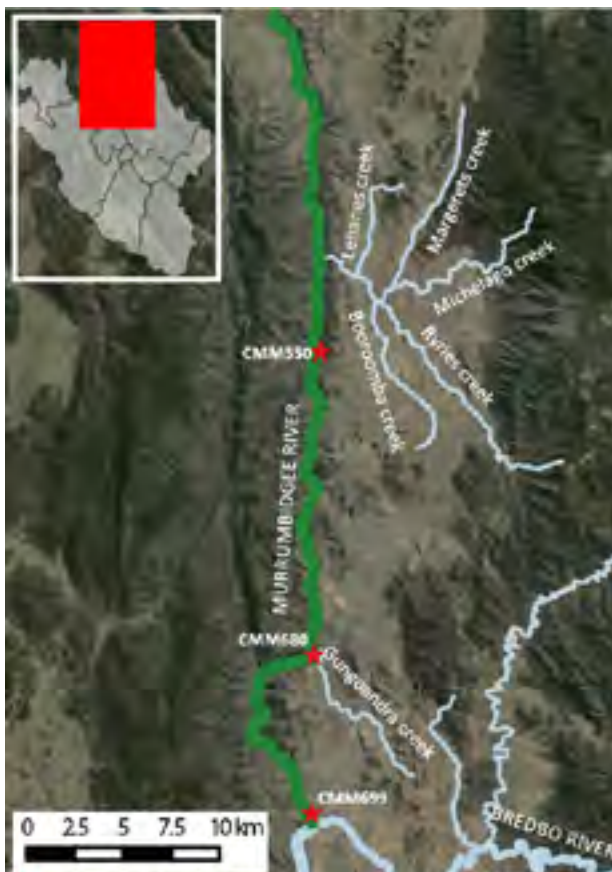
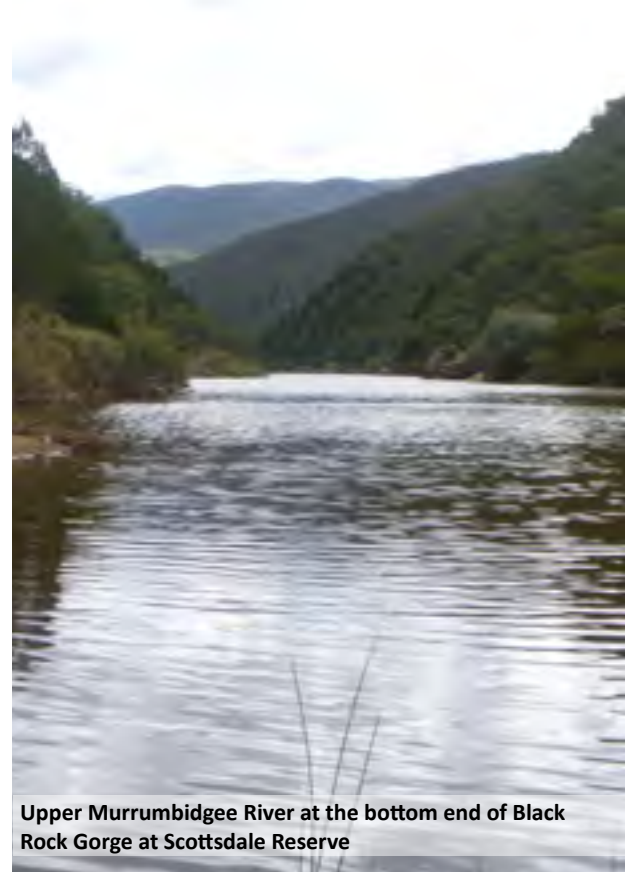
Riparian condition scored as 'poor', due to limited native canopy and understorey cover, exotic groundcover (African Lovegrass) and lack of habitat features such as River Tussock and debris. Riparian condition was sampled in the middle section of the reach at sites historically utilised for rural landuse.

Upper Murrumbidgee River at the bottom end of Black Rock Gorge at Scottsdale Reserve

Water bug surveys are desirable to increase confidence in this rating.

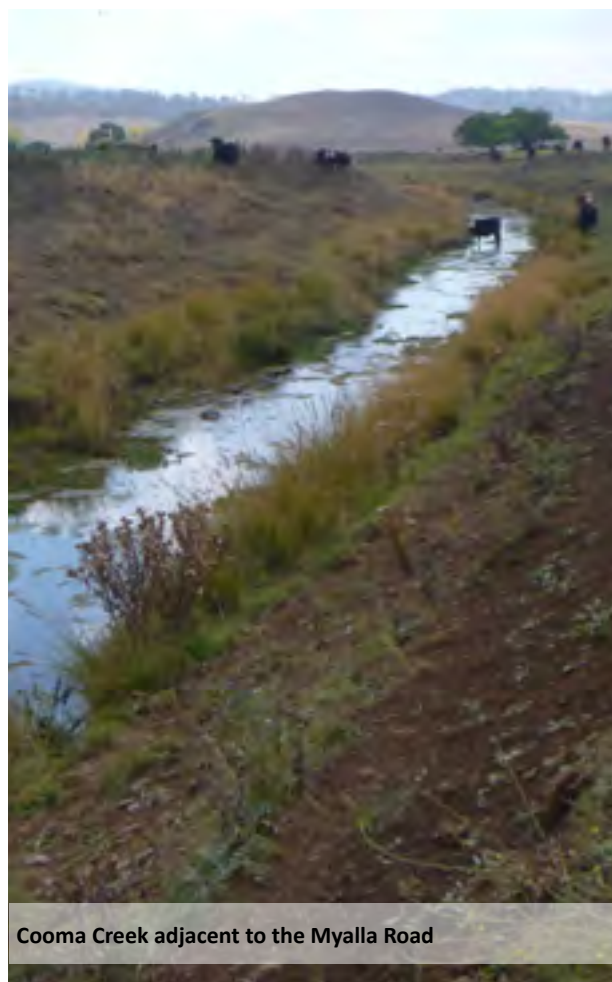
Waterbug sampling indicated that the stream condition was 'good'. Riparian condition was rated as poor due to a lack of native species overall, scarcity of general understorey and habitat features such as River Tussock and debris and large numbers of exotic trees (Willows). Riparian fencing would greatly improve condition along this reach.

Cooma Creek adjacent to the Myalla Road

An additional site upstream on this reach would increase confidence in the CHIP result

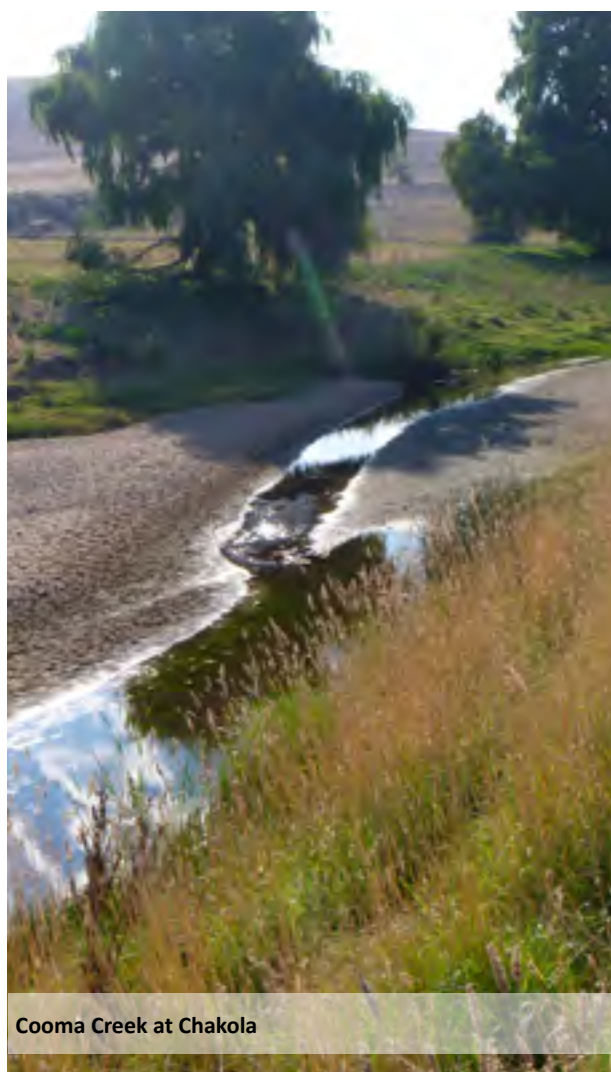
Electrical conductivity rated as 'degraded' which may be partly due to geological influences in the catchment. Turbidity can be very elevated during high discharge events associated with streambank and gully erosion.

Water bug surveys indicate 'good' stream condition. Riparian condition scored as 'poor' and was surveyed at sites dominated by rural landuse. The score was influenced by the lack of native vegetation, scarcity of understorey and habitat features such as River Tussock and debris.

Cooma Creek at Chakola

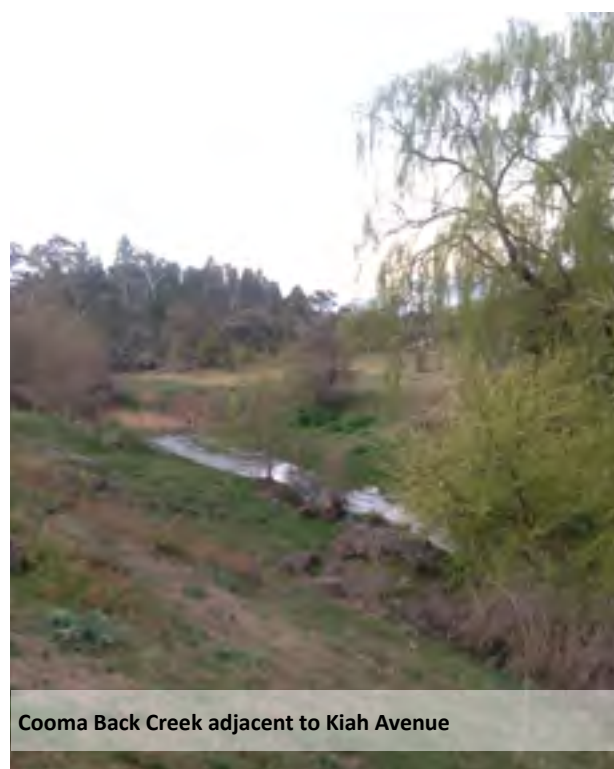
Aquatic surveys show macro-invertebrates indicate that the condition of the stream is good.

Lambie Gorge is a site of Indigenous and European cultural significance and retains native vegetation and aquatic habitat which is being managed for conservation purposes in the Cooma township. Reeds (*Phragmites* sp.- a native ) are spreading in the creek channel in the heart of Cooma. This is advantageous for filtering and stabilisation purposes.

Cooma Back Creek adjacent to Kiah Avenue

The inclusion of water quality sampling data will increase confidence in the CHIP score. A further site towards the top of the reach is desirable.

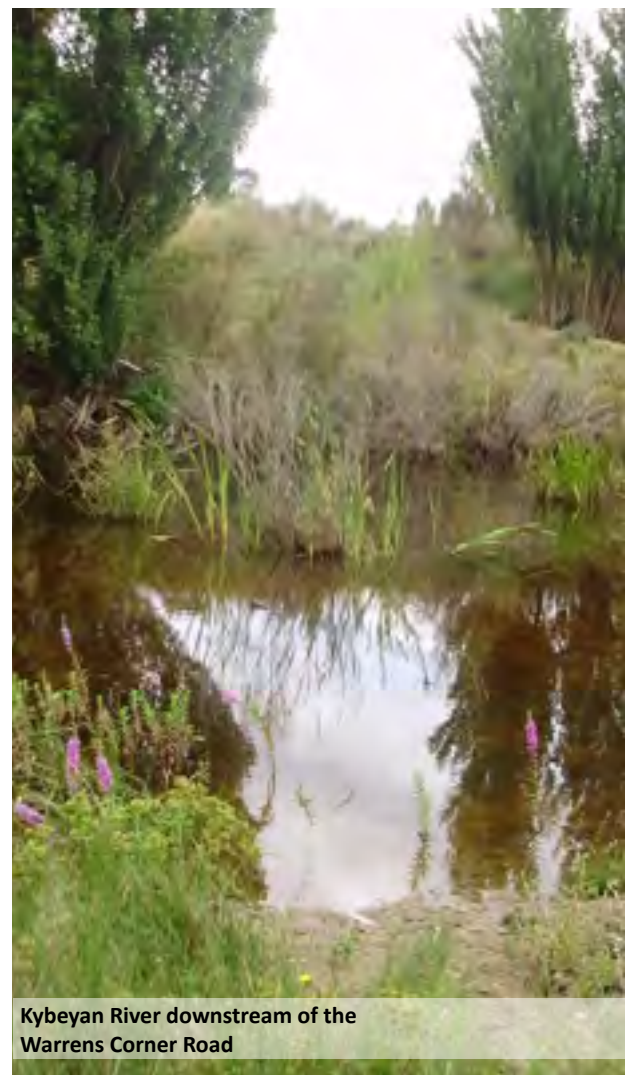
Water quality sampling shows that most parameters were classed as 'excellent'. Turbidity may be slightly elevated due to rural influences at the downstream end of the reach, while the upper section maintains good catchment cover.

Riparian condition scores were 'fair' due to marginal quantities of understorey vegetation and presence of exotic canopy and groundcover. Riparian condition was surveyed in the lower reaches where rural landuse adjoins the river corridor.

Kybeyan River downstream of the Warrens Corner Road

The inclusion of water quality sampling data will increase confidence in the CHIP score. More sites upstream are desirable.

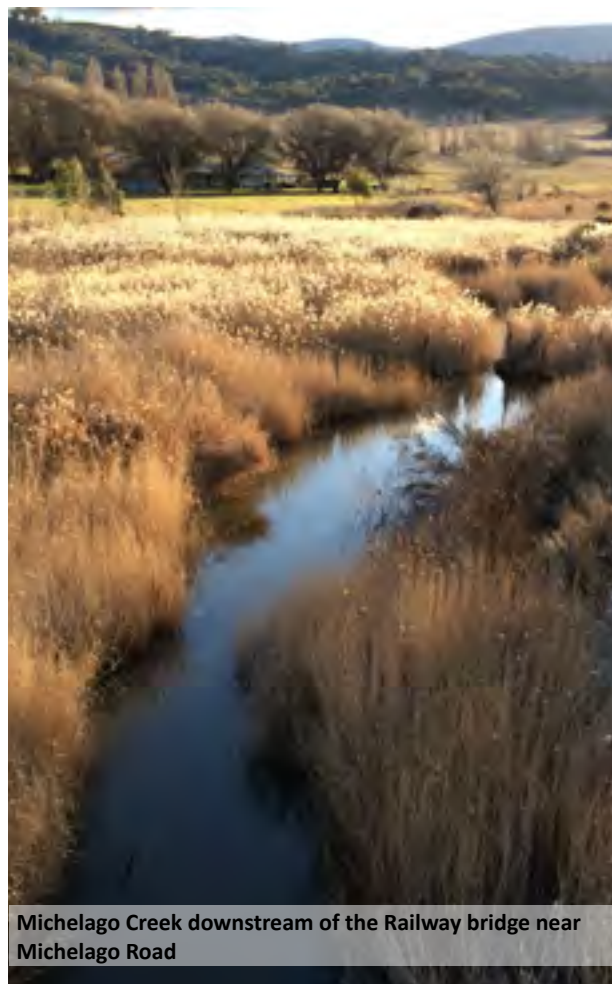
Riparian surveys showed a 'poor' result, due to the lack of native canopy cover, limited understorey and general lack of habitat features such as River Tussock and debris. This is characteristic of the riparian zones in rural (and floodplain dominated) parts of this reach.

Michelago Creek downstream of the Railway bridge near Michelago Road

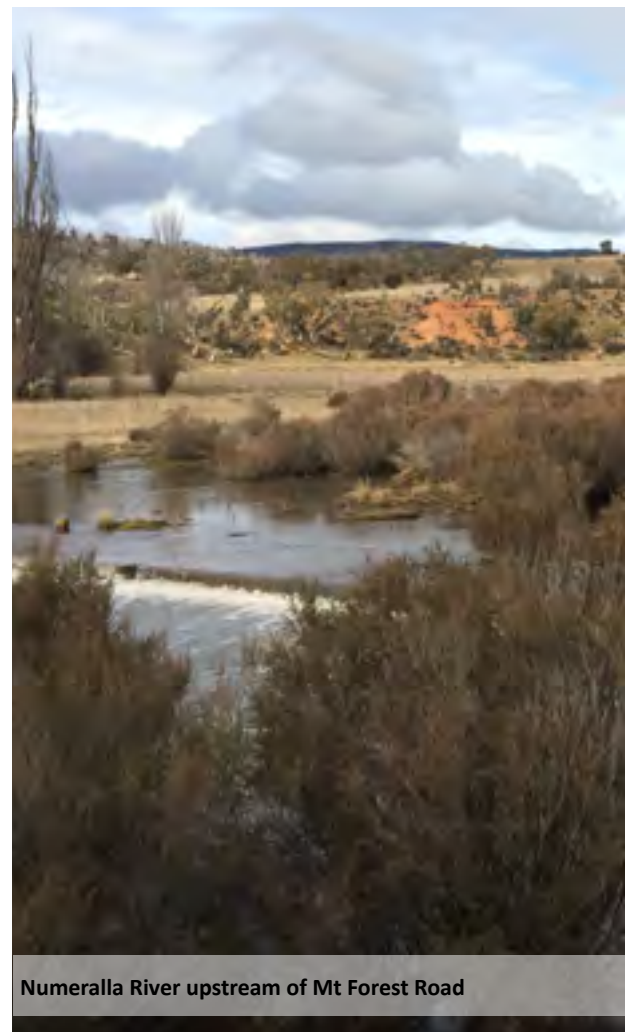
Water quality was rated as 'excellent' overall. Turbidity can be elevated especially in association with high rainfall and runoff events indicating streambank and gully erosion.

Water bug surveys indicated that stream condition was 'poor'. Riparian condition was rated as poor, due to lack of canopy cover and habitat features. It was sampled in the lower section of the reach at a site dominated by rural landuse.

Numeralla River upstream of Mt Forest Road

This reach is included in a high priority ACWA catchment. Actions which stabilise streambanks, gully floors and encourage groundcover throughout the catchment are desirable. Carp sightings are reported up to the middle of this reach.

Further sites upstream are desirable.

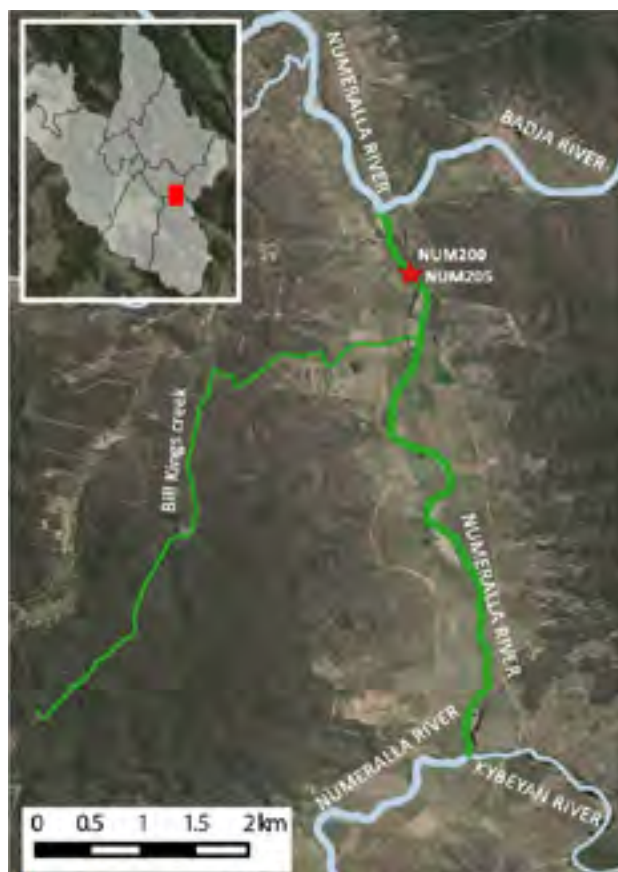
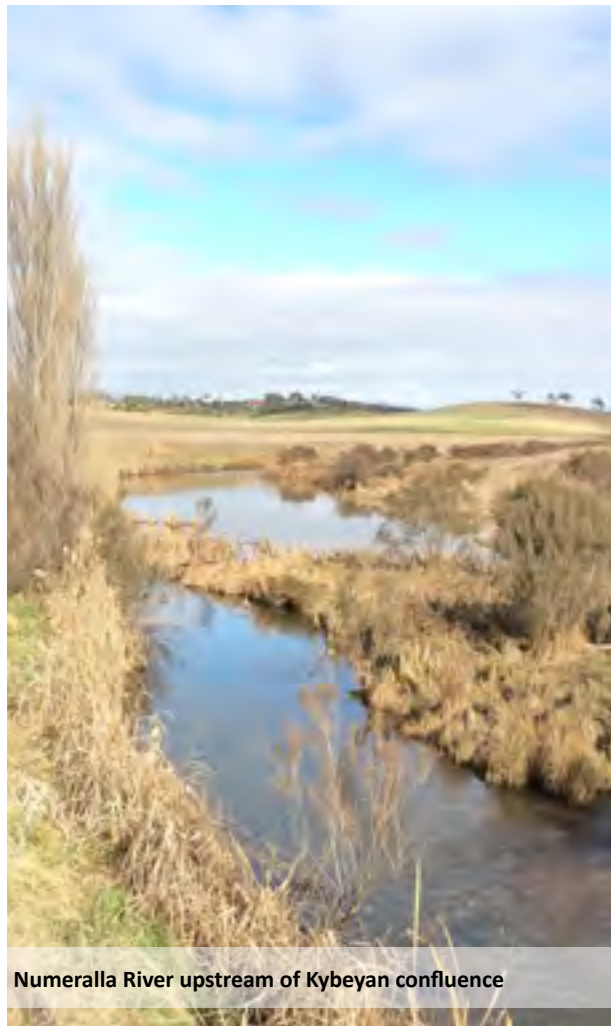
Water bug surveys indicated 'excellent' stream health. Riparian condition was rated as 'fair' due to the exotic canopy cover and only limited abundance of understorey and habitat features such as River Tussocks and debris.

Numeralla River upstream of Kybeyan confluence

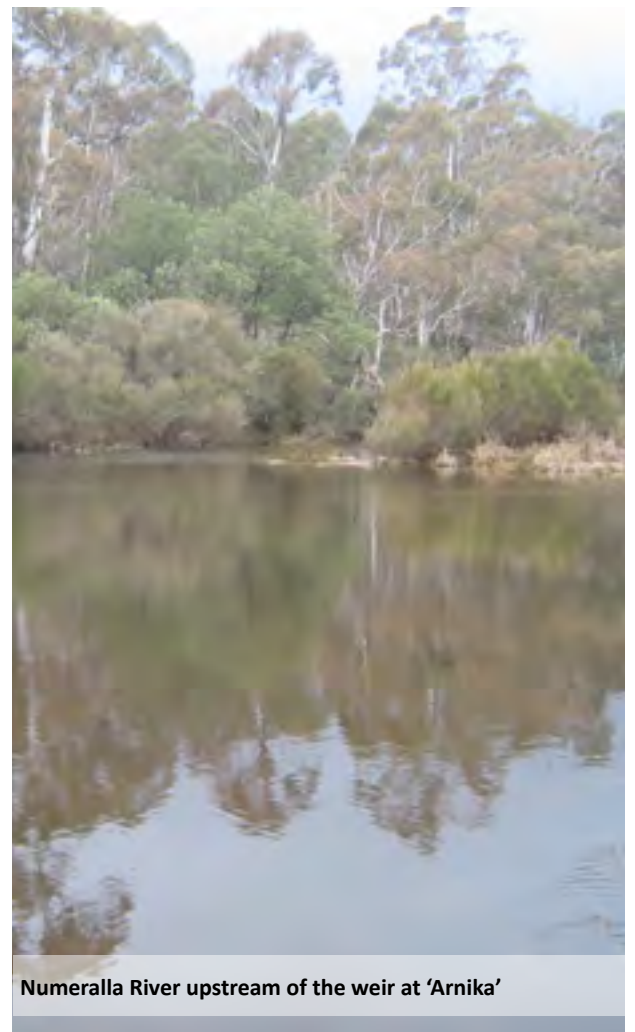
Water quality was rated as 'good' overall reflecting upstream influences. The Badja River is a source of 'excellent' water quality. Turbidity can be elevated associated with high discharge events which indicate streambank and gully erosion in the catchment.

Riparian condition scores were 'fair' overall. Downstream sites were grazed and lacked native vegetation, understorey and habitat features such as River Tussock and debris.

Numeralla River upstream of the weir at 'Arnika'

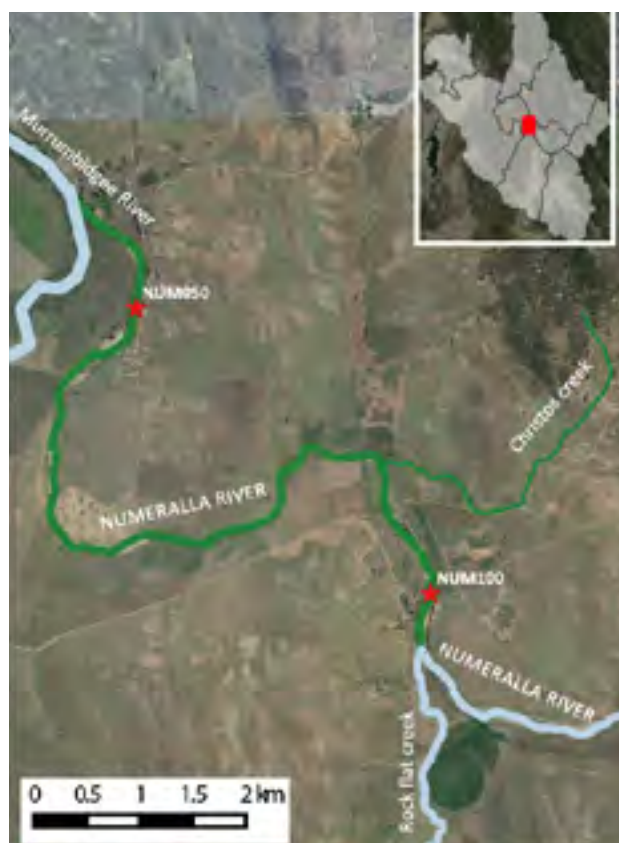
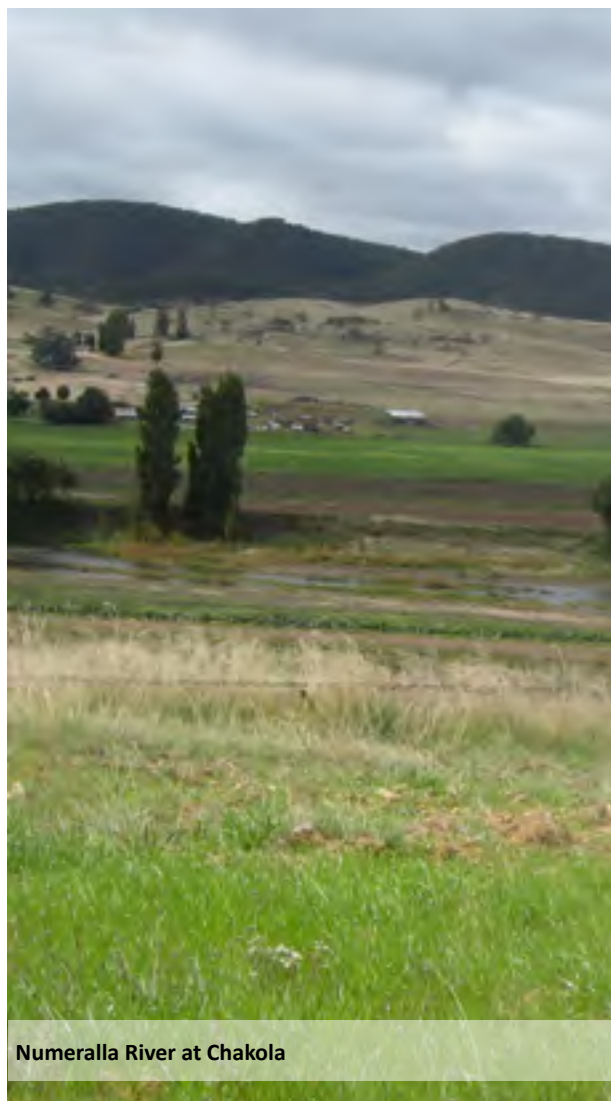
Water bug surveys indicated stream health was 'excellent' and reflects good instream habitat at survey sites. In contrast, riparian condition was found to be 'degraded' due to lack of native vegetation, understorey and habitat features. Riparian condition was sampled at sites dominated by rural landuse which is characteristic of riparian zones along the reach.

Numeralla River at Chakola

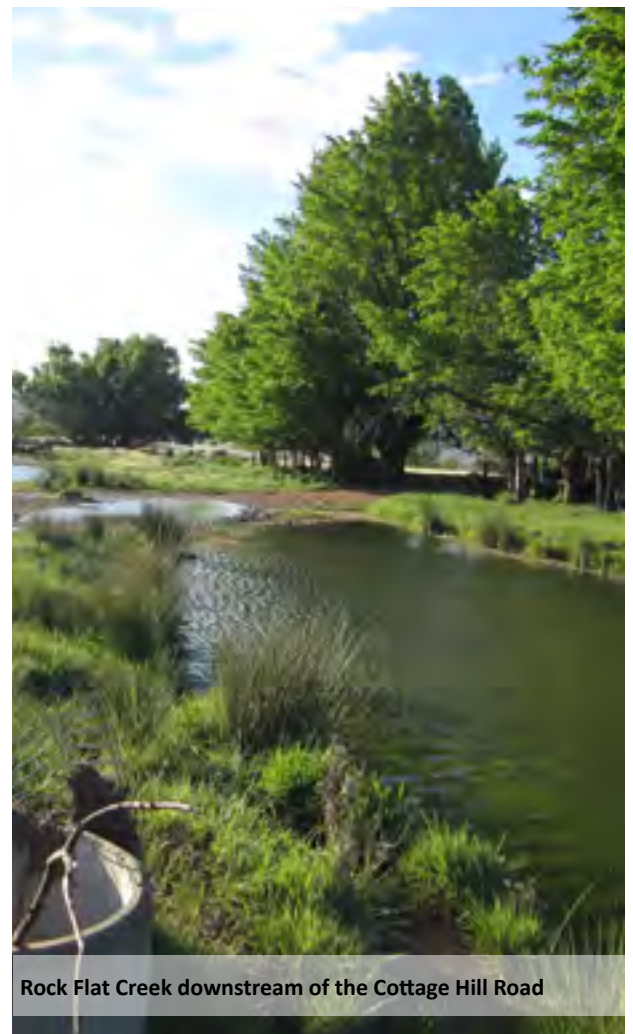
Electrical conductivity is consistently high and is most likely due to geological influences. Turbidity levels can be high in conjunction with high discharge events indicating the presence of streambank and gully erosion in the reach.

Water bug surveys indicated 'good' stream condition reflecting presence of instream habitat. Riparian condition was 'degraded' due to the lack of canopy and understorey cover, heavy grazing at some sites and lack of habitat features such as River Tussock and debris.

Rock Flat Creek downstream of the Cottage Hill Road

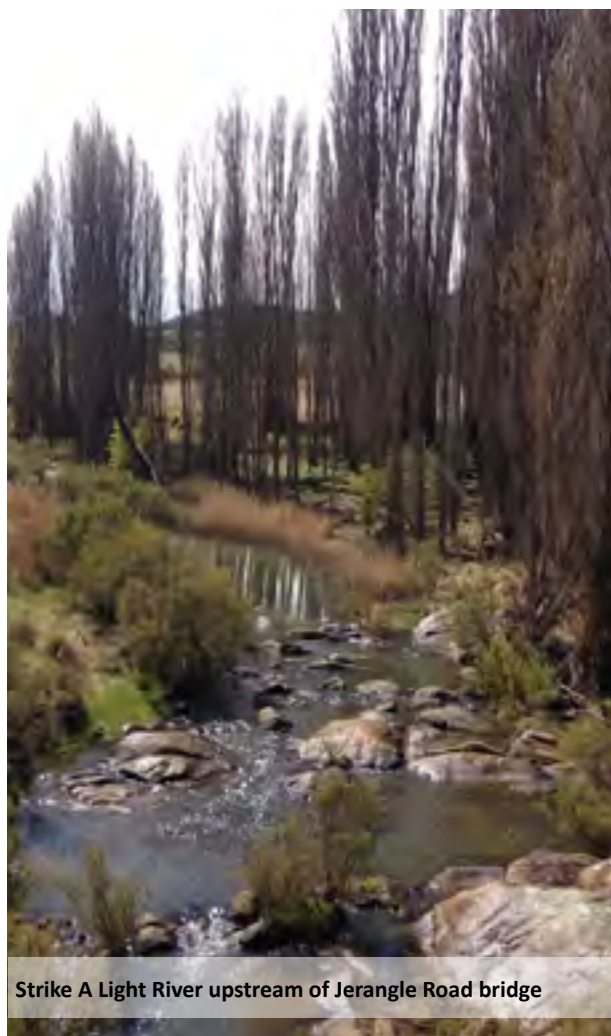
Water quality parameters were 'excellent'. Water bug surveys, taken at upstream sites, indicated 'excellent' stream health also reflect the integrity of instream and riparian habitat along the upper parts of the reach.

Riparian condition was 'fair', especially in rural sites due to lack of native canopy and limited understorey and lack of habitat features such as River Tussock and debris. Sites in the upper catchment are swampy type meadows which also lack canopy and understorey, but this is natural.

Strike A Light River upstream of Jerangle Road bridge

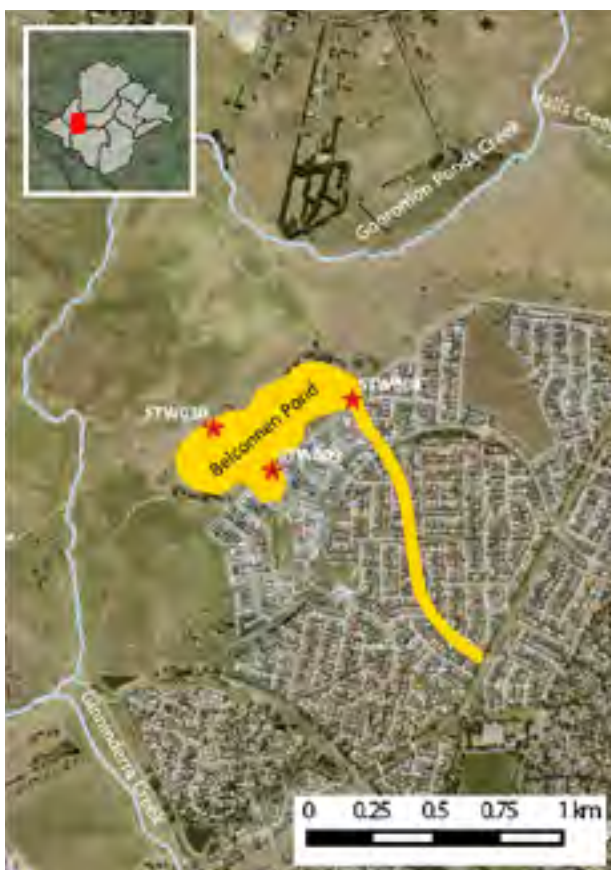
Despite insufficient water quality data across three Waterwatch sites in this wetland, riparian condition and water bug surveys indicate that this wetland is in fair condition. A poor riparian condition score was obtained due to very limited canopy cover and midstorey, however groundcover is good. Water bug scores were good, which is commendable for a still-water pond with considerable urban inflows.

Total phosphorus can vary between 'excellent' and 'poor', while nitrates are generally good. Dissolved oxygen levels can vary greatly, with oxygen saturation consistently below 100% (range: 69-89%). Further planting of riparian vegetation is required to improve the riparian condition score for this site.

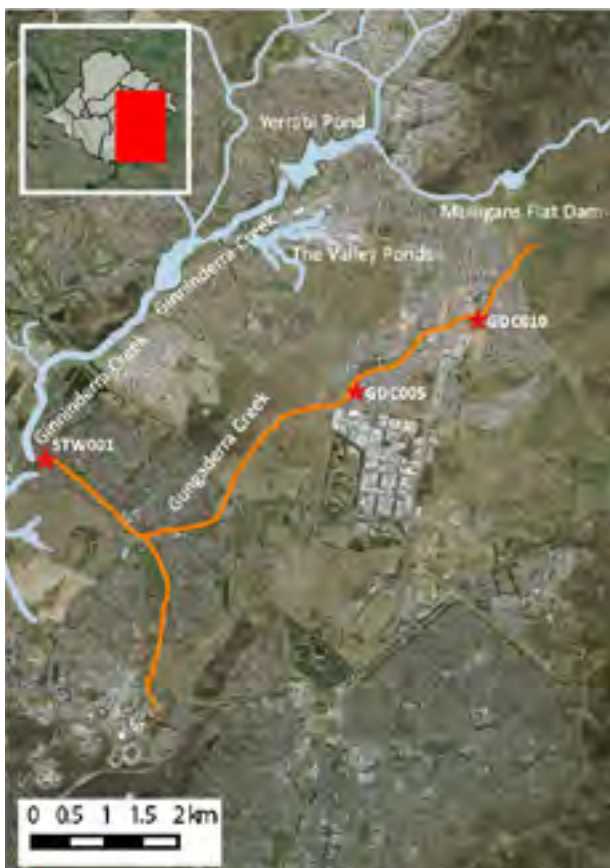
Whilst water quality data did not meet the data density cut off, results that were recorded suggest 'fair' condition. Results varied greatly as a result of the ephemeral nature of this reach.

Large sections of wholly exotic riparian vegetation and sections of concrete stormwater drains have resulted in a 'poor' riparian scores.

The combination of poor riparian habitat and variable flows also resulted in 'poor' macro-invertebrate (water bug) scores. At some sites only 6 different types of water bug were recorded with most in the tolerant category.

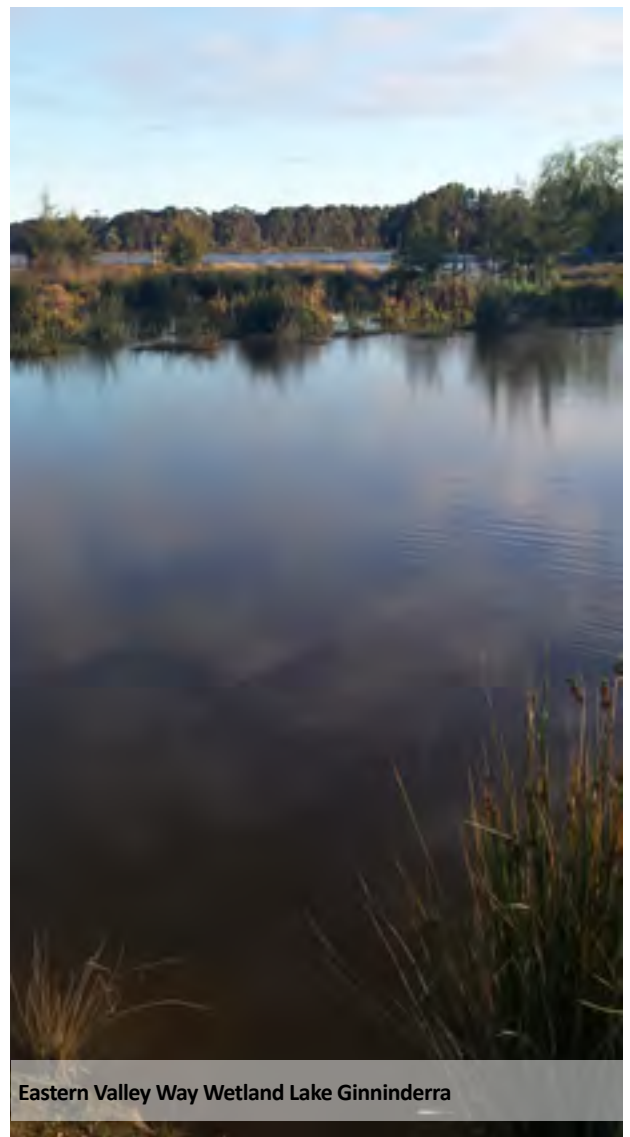
Eastern Valley Way Wetland Lake Ginninderra

While overall the water quality score was 'good', 'degraded' dissolved oxygen results for the reach mainly came from very low results in the new Eastern Valley Way wetland which is not performing as expected. Dissolved oxygen records for the remaining sites were consistent with previous years.

Riparian vegetation scores were 'poor' as expected in a parkland environment scoring very low in habitat features such as leaf litter, logs and native vegetation. This reach includes Lake Ginninderra which has large areas of manicured parkland and does not score well in riparian vegetation assessments.

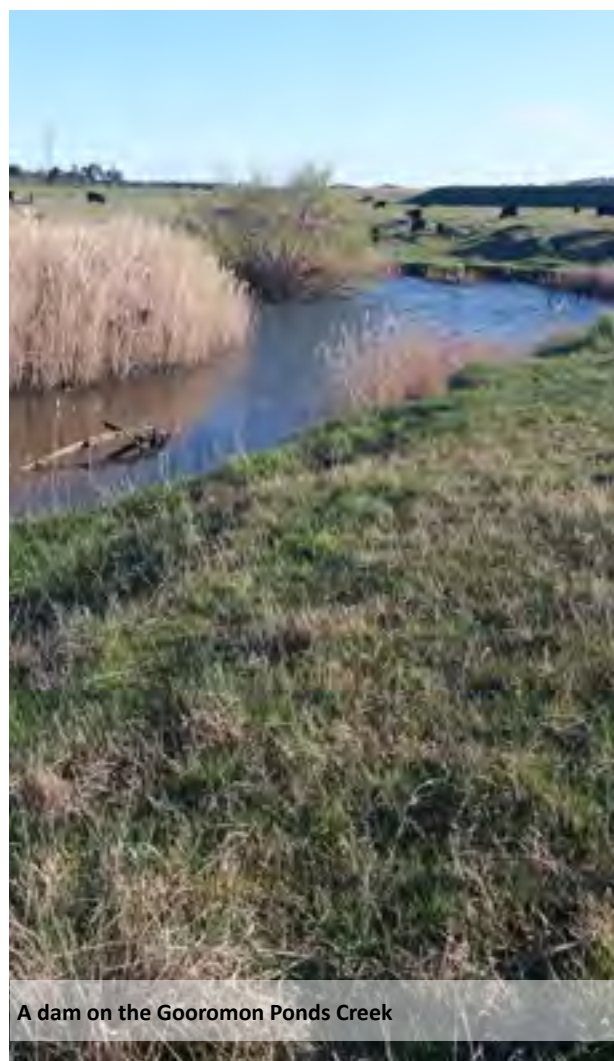
A dam on the Gooromon Ponds Creek

Water level rises quickly during rain events and returns to low levels just as quick. Water bugs scored 'poor' as a result of low flow, high algal growth and limited instream habitat.

Riparian habitat is almost non existent through this reach with only exotic ground cover in many sections. Fast flowing water and a lack of vegetation has resulted in significant gully erosion in this reach. Ginninderra Catchment Group is working with the newly formed Landcare group in the area to improve habitat and address gully erosion.

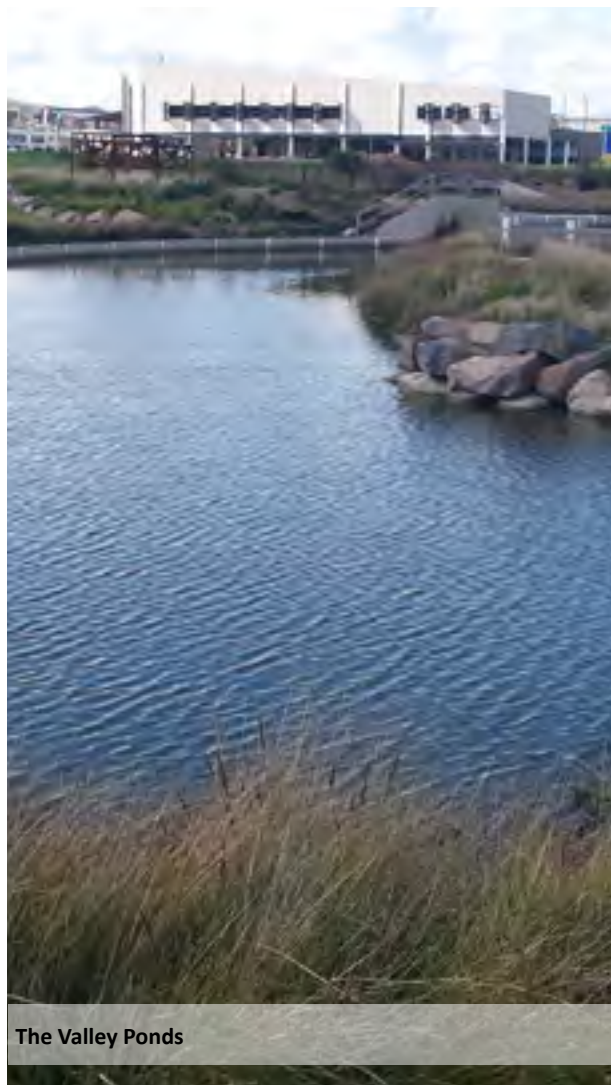
The Valley Ponds

Water quality results were mostly 'excellent' except for electrical conductivity which is possibly due to the fact that this reach is in a highly urbanised catchment with ongoing construction. Dissolved oxygen was 'poor' which is surprising given the amount of newly planted macrophytes. As a new wetland this indicates a settling period may be required for optimum functionality.

The macro-invertebrate (water bug) results were 'good' with a wide range of species including a few sensitive ones. The good macrophyte layer provides a diverse habitat for water bugs.

Riparian vegetation was 'poor' as this is a new wetland and lacks both the canopy and midstorey layers. A diverse habitat has been planted here and it is anticipated that the riparian score will improve. The wetland has good tussock grasses and reeds providing excellent frog habitat.

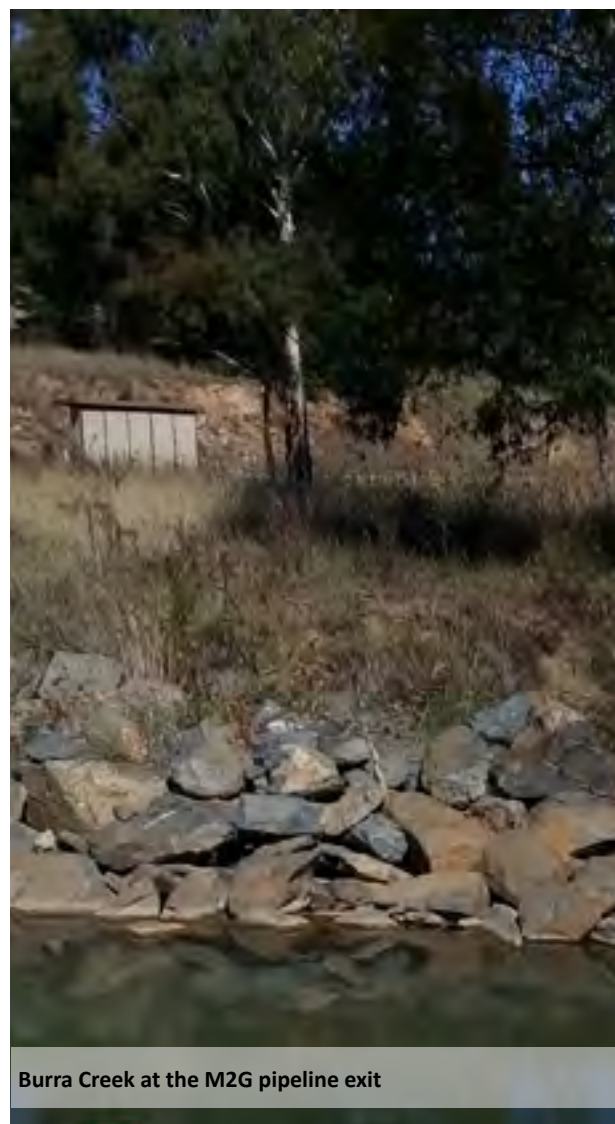
Burra Creek at the M2G pipeline exit

The macro-invertebrate (water bug) score was 'good', but the riparian assessment indicated poor habitat given that much of the reach is cleared. Water at some sites on this reach may include water from the Murrumbidgee to Googong pipeline. We now have a Waterwatch site above the pipeline which will improve our knowledge of any potential effects if the pipeline becomes operational in future.

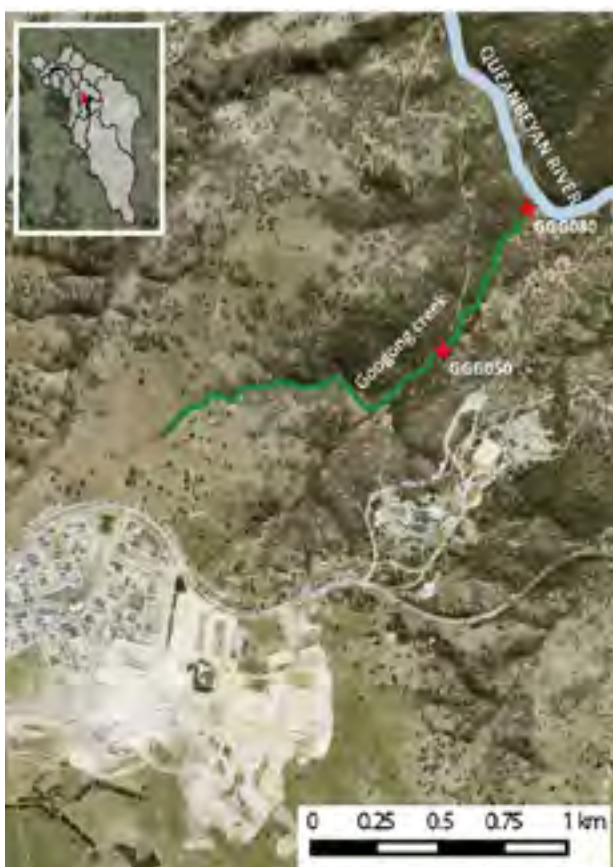
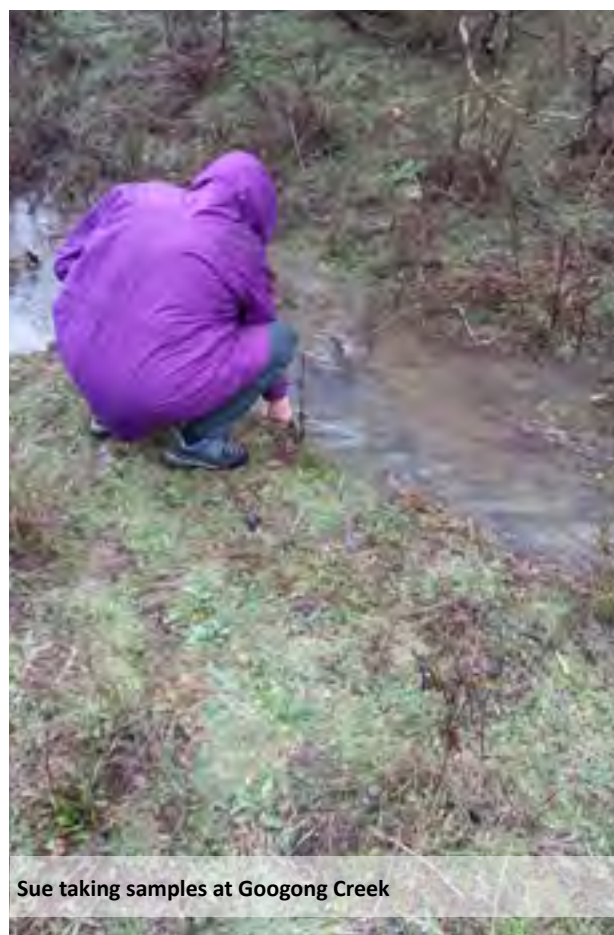
Googong Creek had 'excellent' and 'good' water quality results for all parameters, except electrical conductivity which indicated a 'degraded' system (310-690  $\mu$ S). High electrical conductivity readings, however, can often be associated with ephemeral creeks.

Sue taking samples at Googong Creek

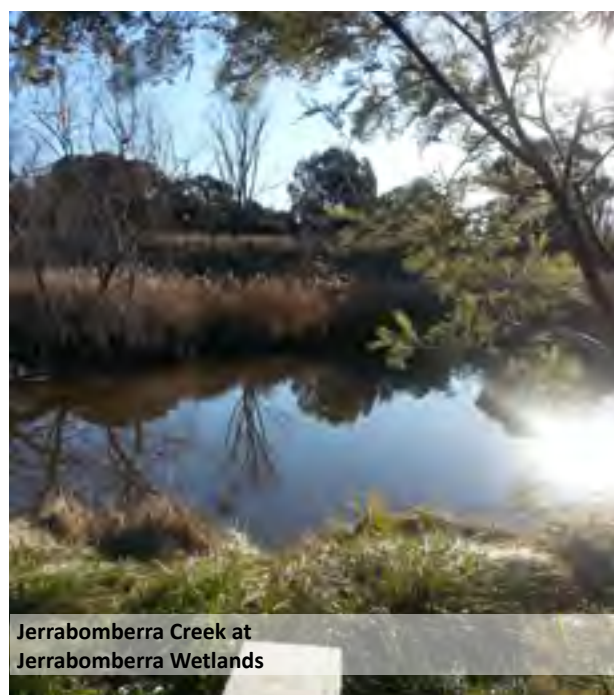
Water quality surveys showed that turbidity was 'fair', pH was 'poor', and electrical conductivity (160-1770  $\mu$ S), total phosphorus (TP) (0-1.8 mg/L), and dissolved oxygen (40-109%) were 'degraded'.

The water bug survey was done in the Creek with a 'good' result. The riparian vegetation assessments indicated 'poor' condition. There is some riparian revegetation work in the Narrabundah section immediately before Jerrabomberra Wetlands as well as along the Creek in the reserve. These may help improve the riparian score over time.

Jerrabomberra Creek at Jerrabomberra Wetlands

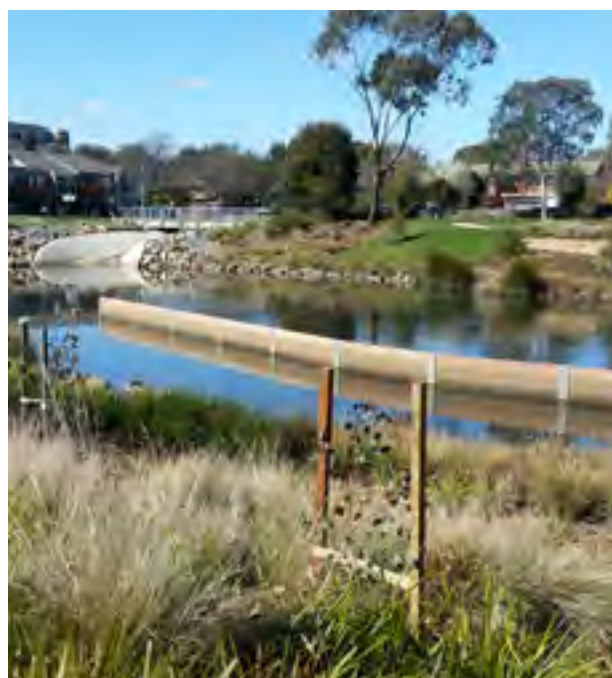
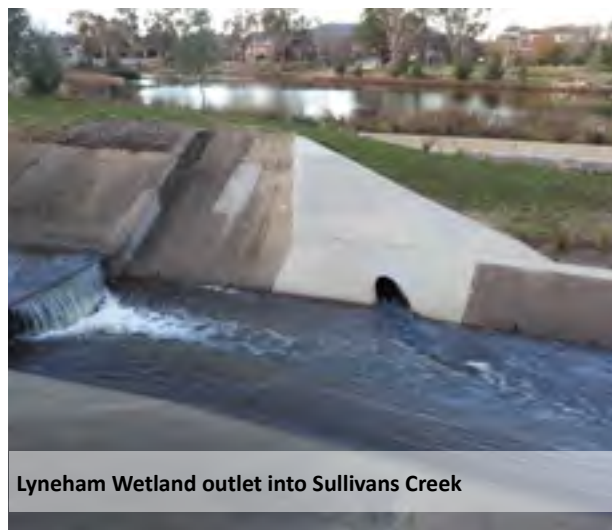
Water bugs, however, indicated ‘good’ water quality/habitat, but the riparian vegetation assessment indicated ‘fair’ riparian condition. This may be a result of the young nature of this wetland that lacks the complexity of mature plants and multiple vegetation storeys. It would be expected that this score will improve as the wetland develops.

Lyneham Wetland outlet into Sullivan's Creek
