# Catchment Health Indicator Program

2014–15

Written and produced by the Upper Murrumbidgee Waterwatch team:

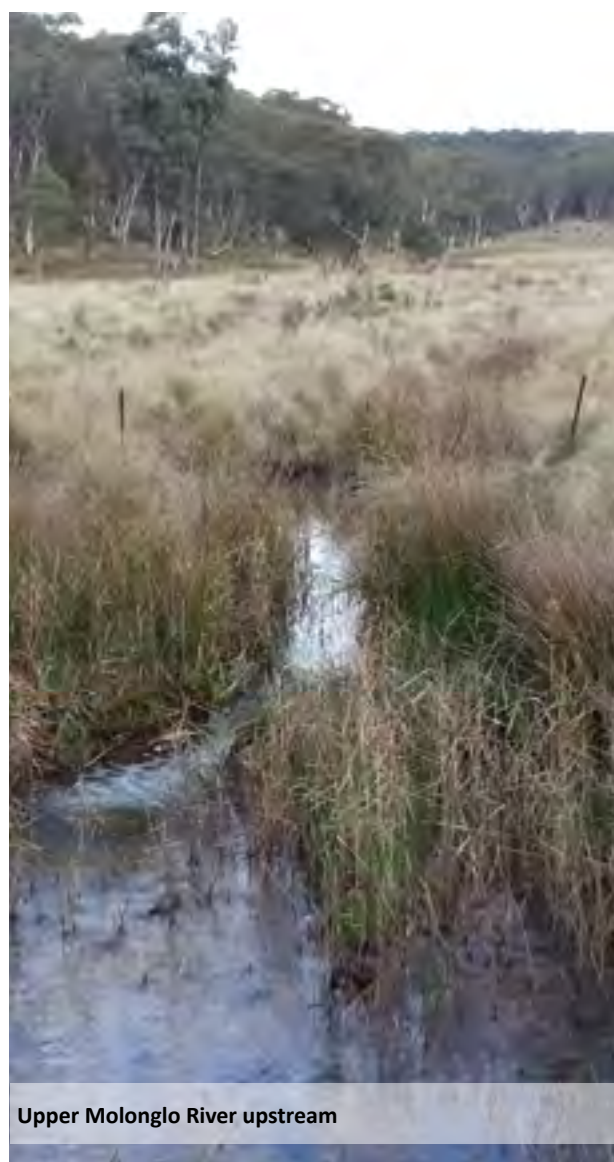
Though there was no water quality data to assess this year, water bug data indicated only 'fair' water quality/habitat, with pollution sensitive water bugs present but only limited diversity. The riparian assessment indicated 'poor' riparian condition, reflecting the highly cleared rural land. Stock also have ready access to the river in this reach. A second site on this reach would increase confidence in the results.

Upper Molonglo River upstream

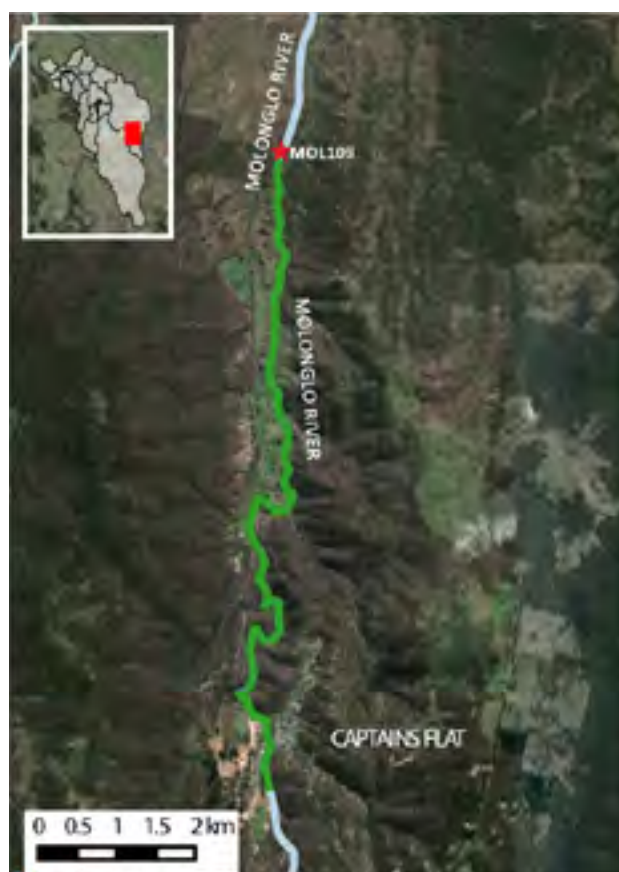
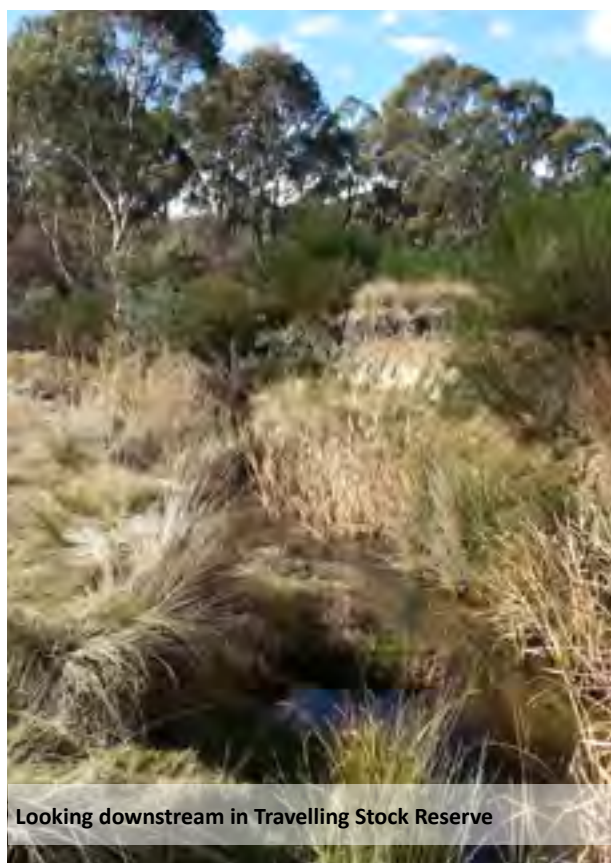
The water bug surveys were 'poor' with little diversity being detected. This is likely to be caused by historical mine leachate impacts. The riparian vegetation assessment in the TSR rated as 'good', however riparian vegetation in this reach varies considerably, with the TSR representing the best condition on the reach.

Looking downstream in Travelling Stock Reserve

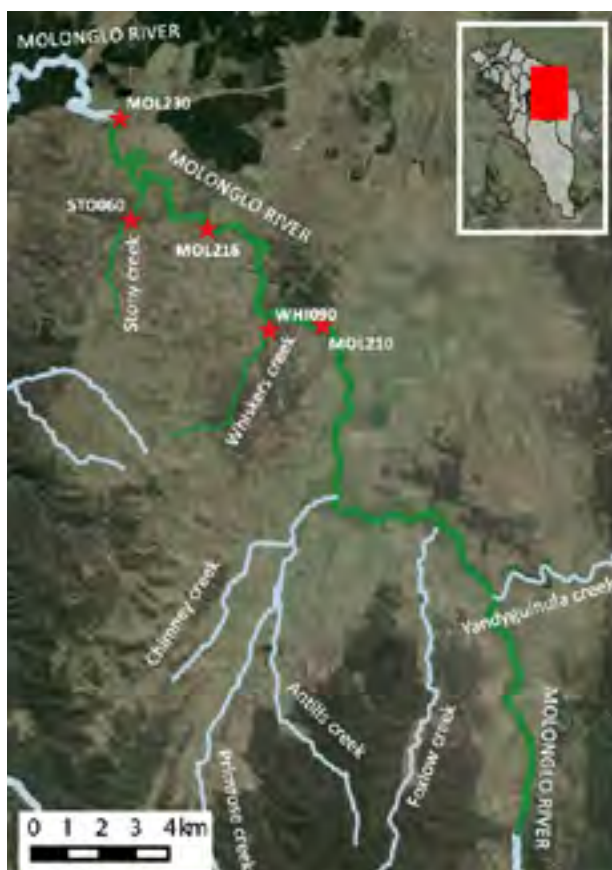
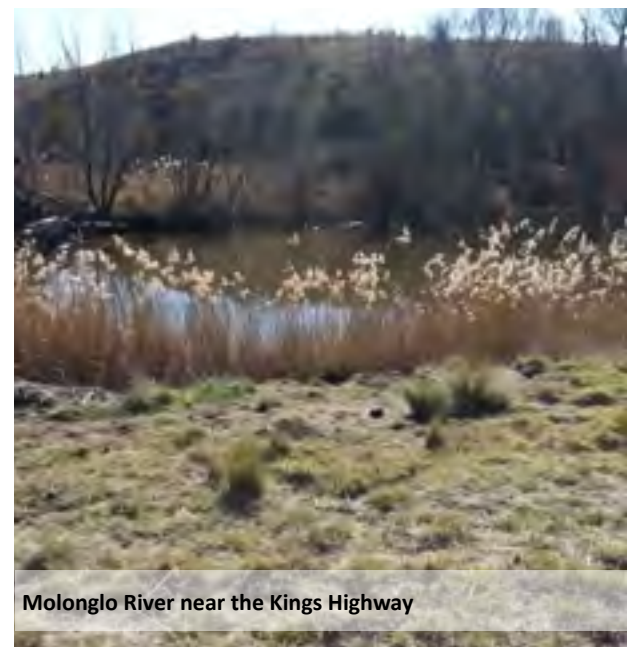
While most water quality parameters in this reach were 'excellent' or 'good', electrical conductivity (EC 150–1320  $\mu\text{S}$ ) was 'poor' and dissolved oxygen (22–92%) indicated a 'degraded' system.

Stony Creek particularly, but also Whiskers Creek, were the main contributors to the 'degraded' electrical conductivity readings, due most likely to their underlying geology. There was a pollution event reported to the EPA by landholders, which affected this section of the Molonglo River. This pollution event coincided with some of the very low Waterwatch dissolved oxygen readings but no cause could be drawn from the EPA investigation.

Molonglo River near the Kings Highway

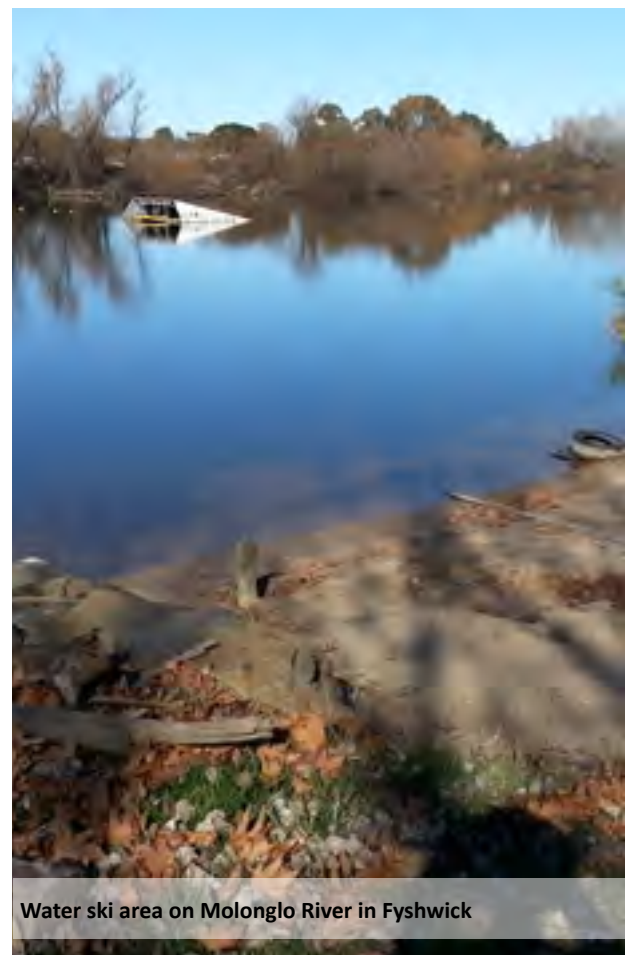
This is a highly altered environment, impacting the water bug and riparian assessment scores. However, Platypus and Water Rats have often been observed in this section of the Molonglo River.

Water ski area on Molonglo River in Fyshwick

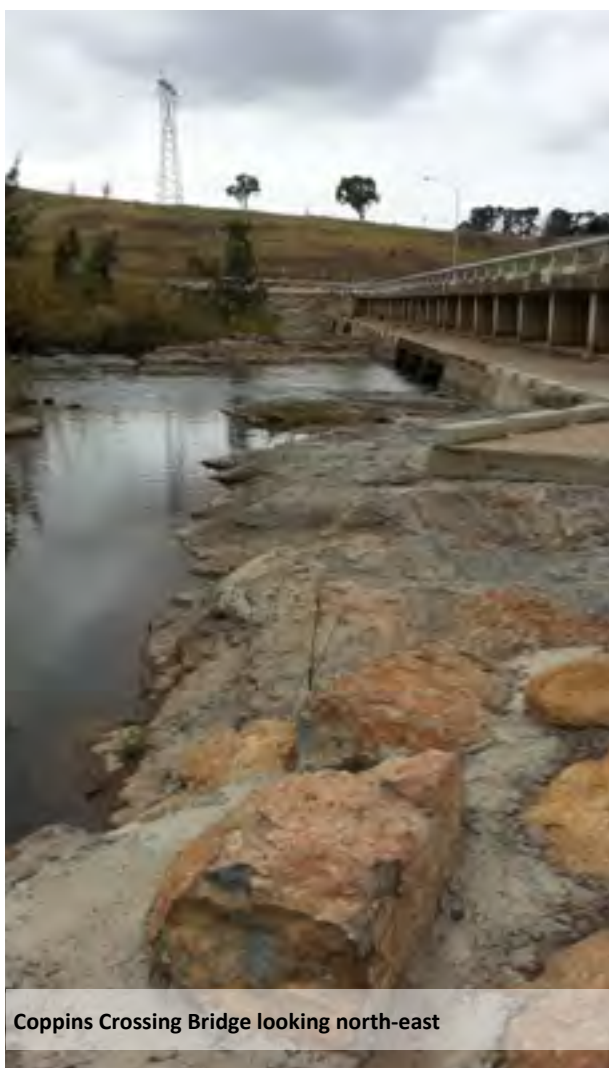
The water bug score gave a 'good' result, however the riparian vegetation assessment reflected the largely cleared areas on most of the reach, with willows and other introduced species being the dominant vegetation type.

Coppins Crossing Bridge looking north-east

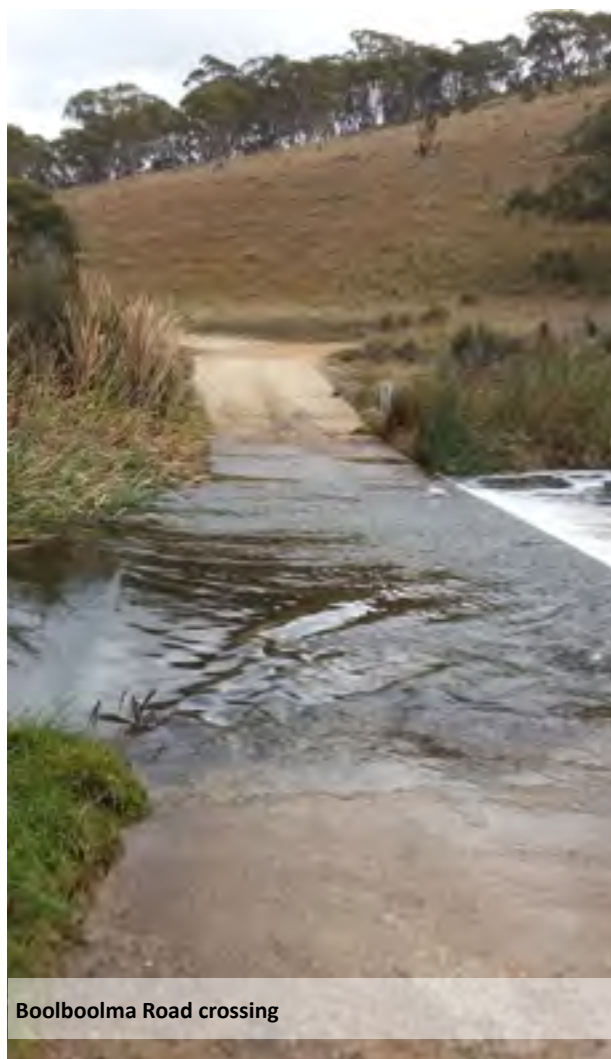
Dissolved oxygen (DO) (56-97%) however indicated a 'degraded' system.

Boolboolma Road crossing

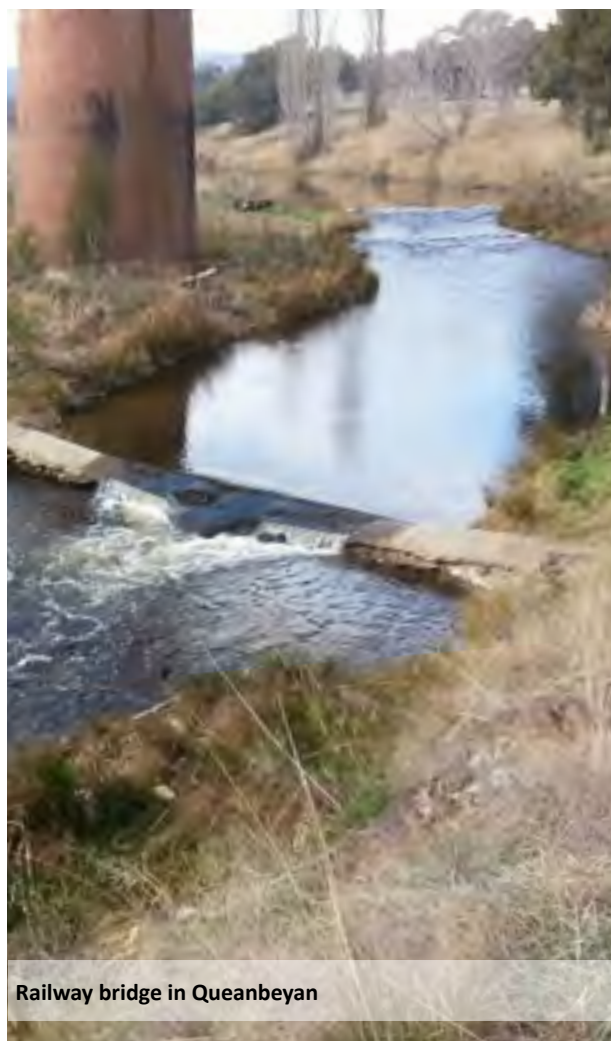
Railway bridge in Queanbeyan

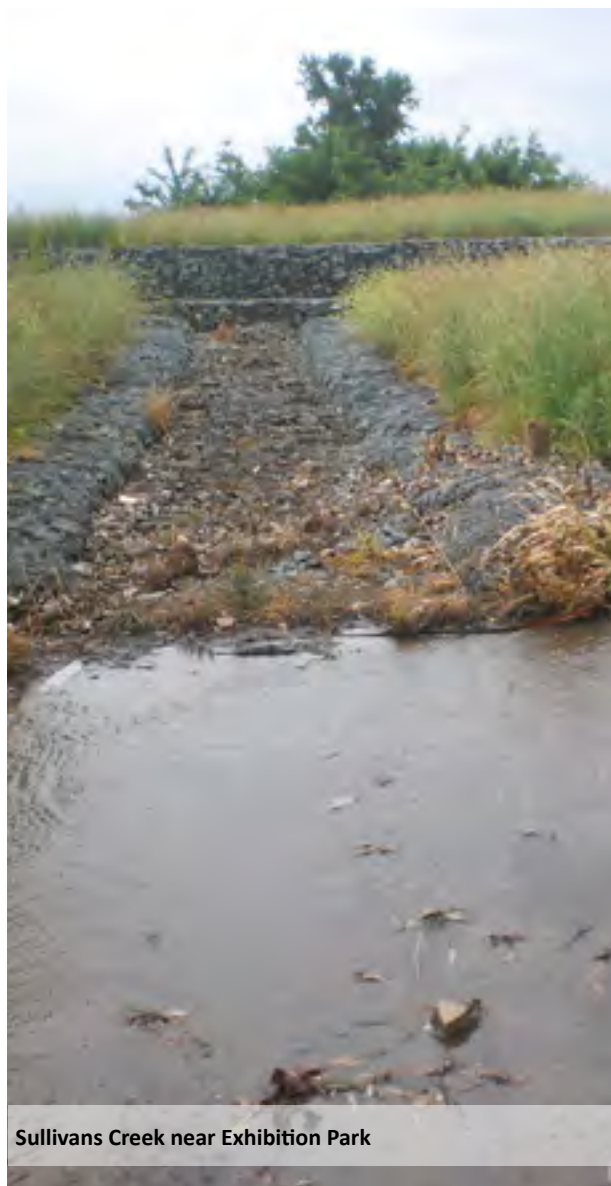
Sullivans Creek near Exhibition Park

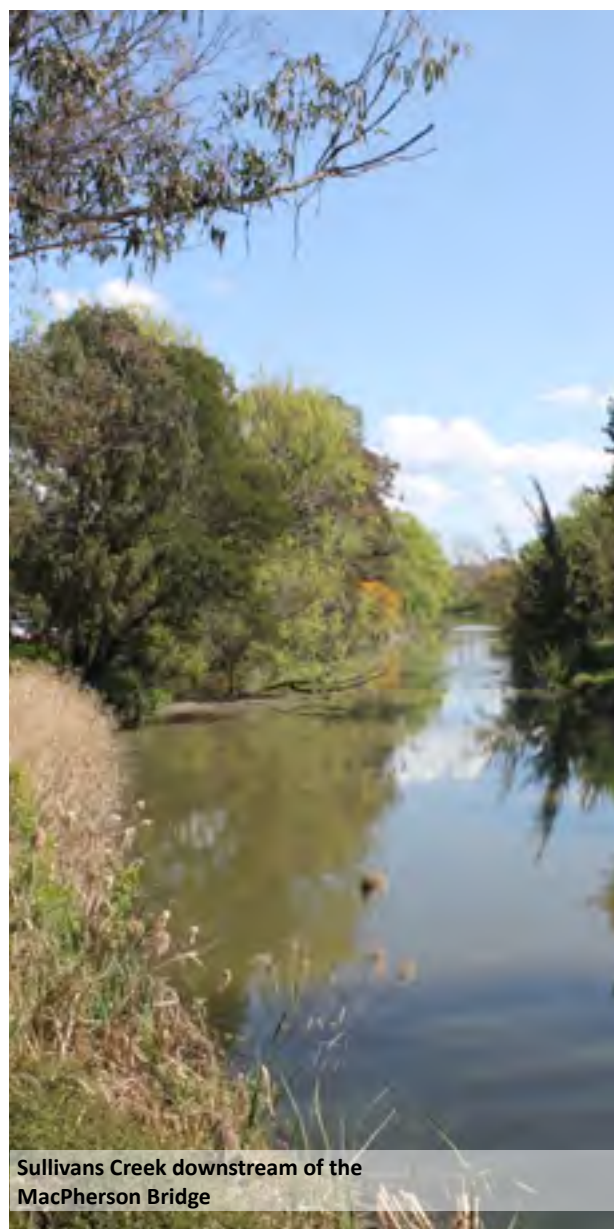
Sullivans Creek downstream of the MacPherson Bridge

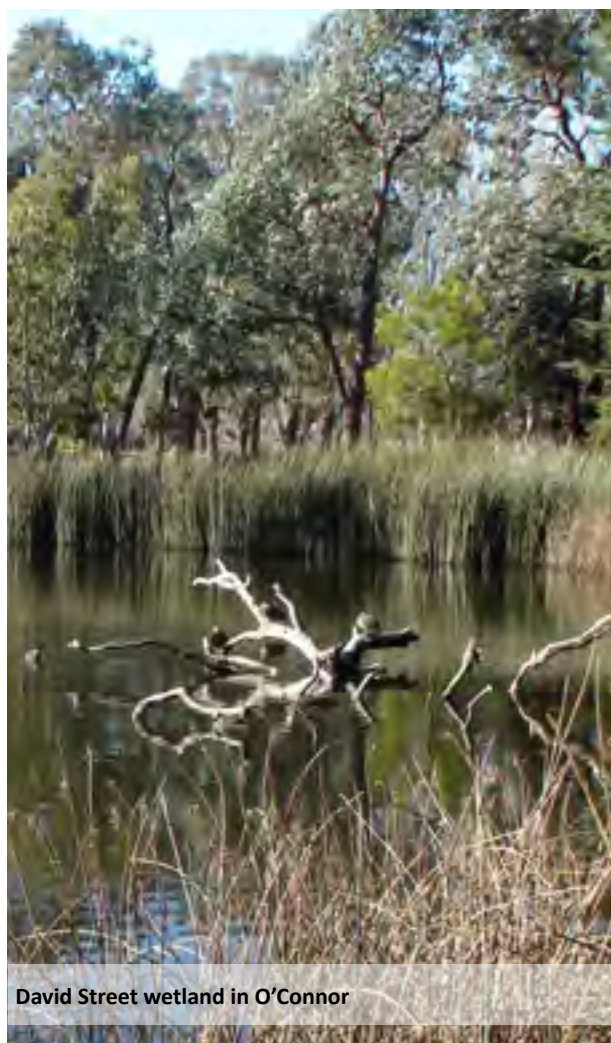
David Street wetland in O'Connor

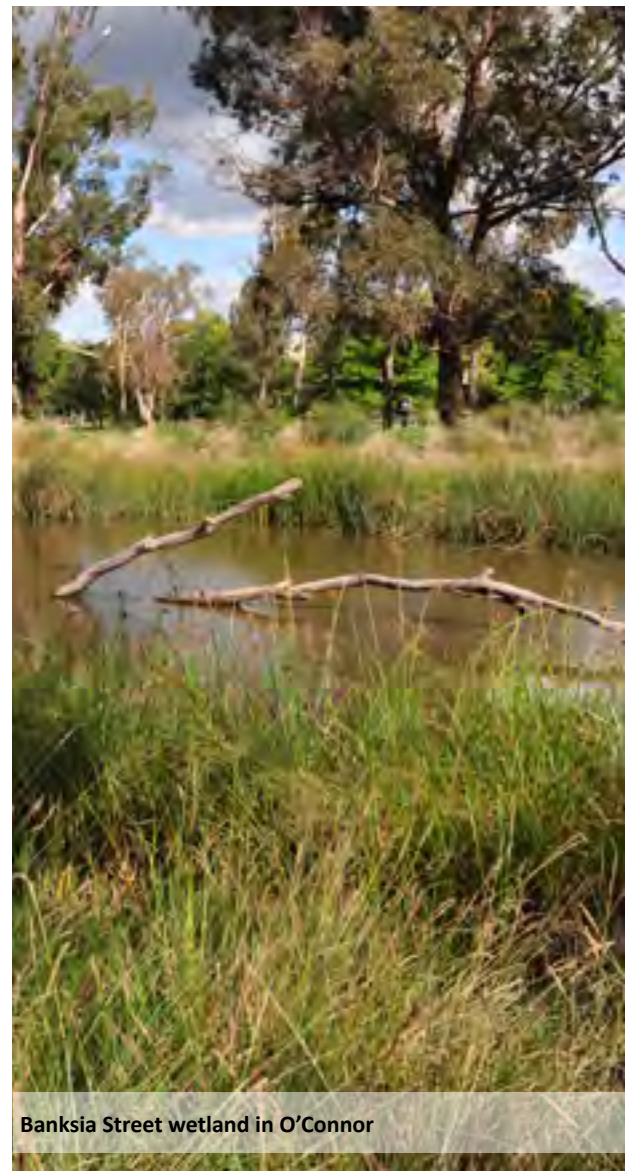
Banksia Street wetland in O'Connor

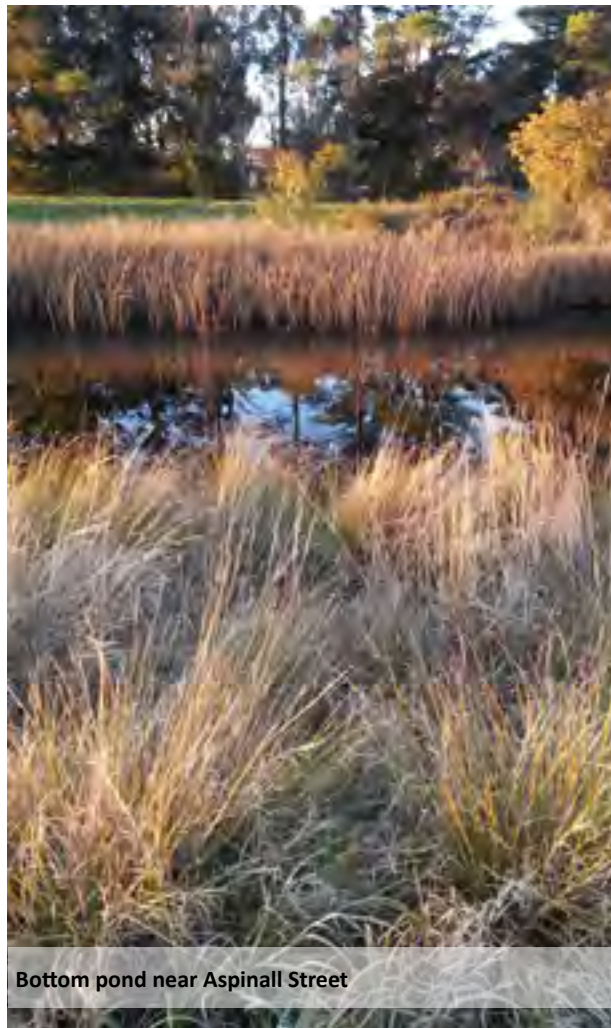
Bottom pond near Aspinall Street

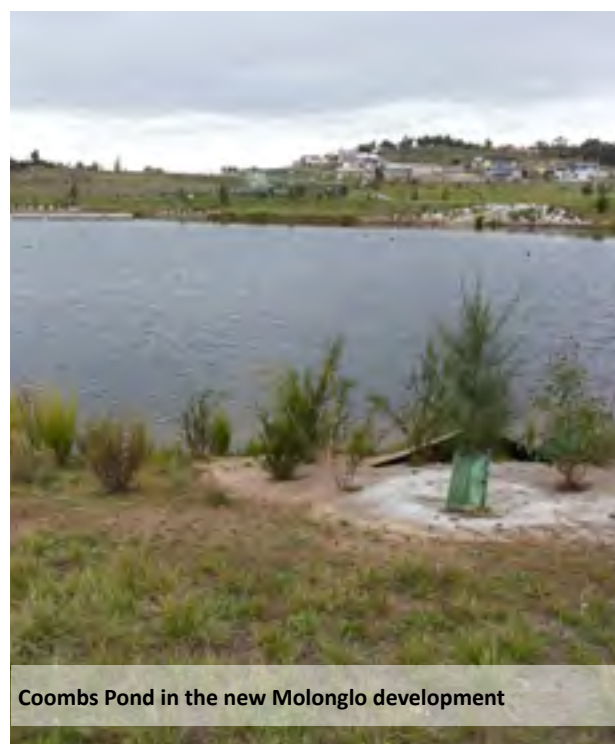
Water in this reach comes almost entirely from urban runoff. Flows are often very low, and the water flows in concrete channels with very limited riparian vegetation, before entering Coombs sediment ponds. The ponds have recently been sparsely planted with emergent and riparian species, however much of the riparian area is still bare. Below Coombs pond, the concrete channel becomes a grassy channel with large rock armoured sections before joining the main Weston Creek concrete channel flowing from underground. The final section of the creek has a mix of native and exotic riparian vegetation above the Molonglo River confluence. This reach had the worst riparian assessment score in the catchment.

Coombs Pond in the new Molonglo development

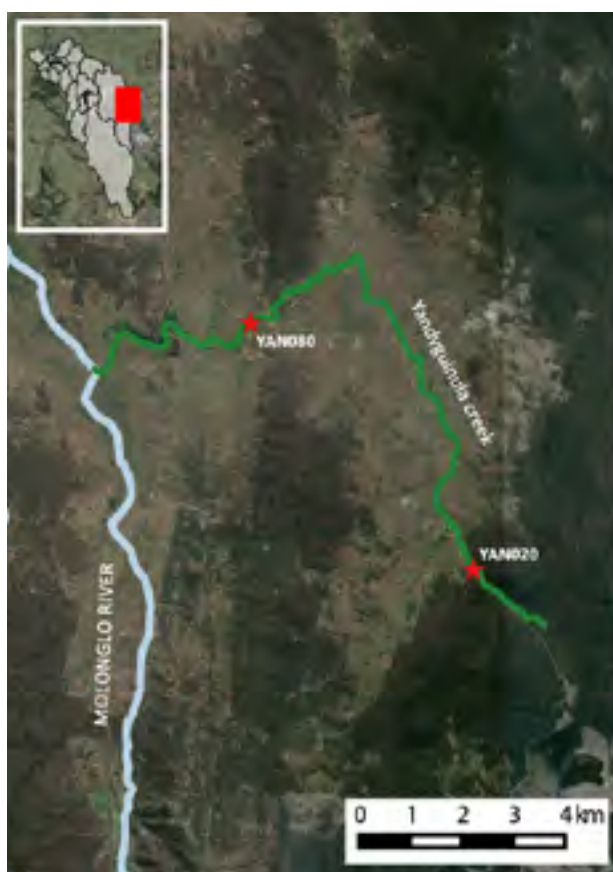
Yandyguinula Creek near the Tallaganda National Park

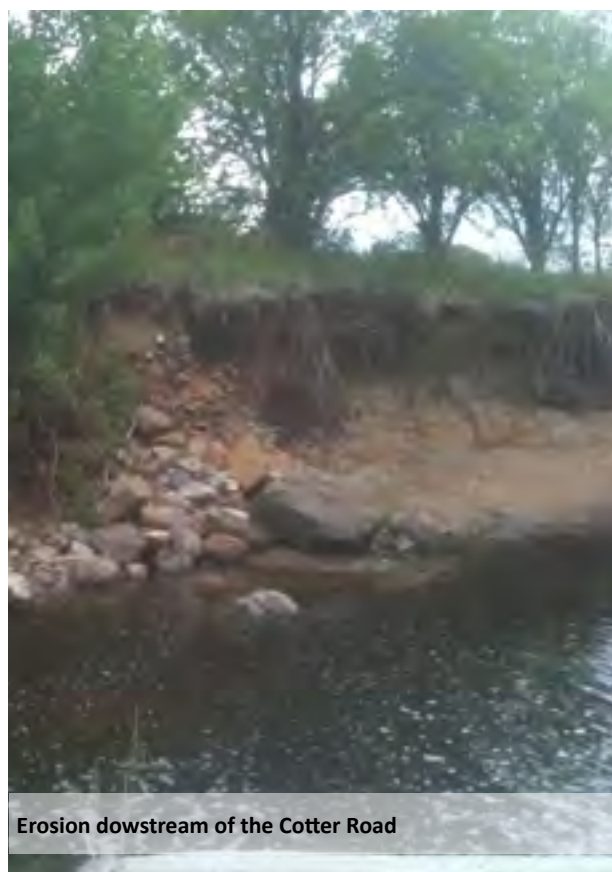
Erosion downstream of the Cotter Road

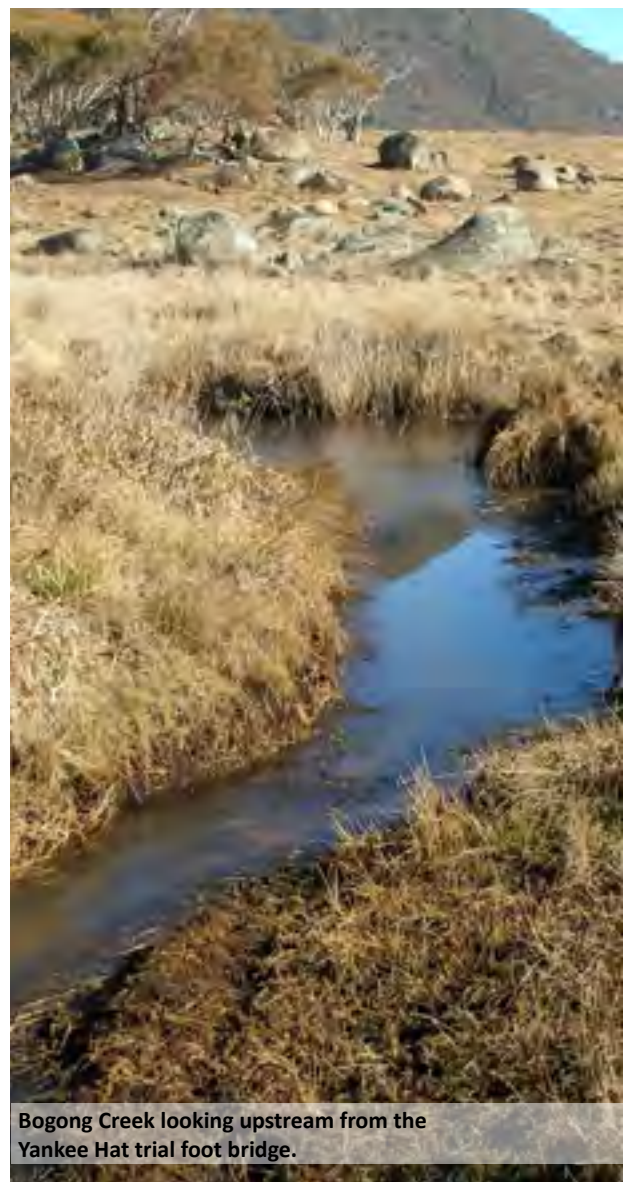
Bogong Creek looking upstream from the Yankee Hat trial foot bridge.

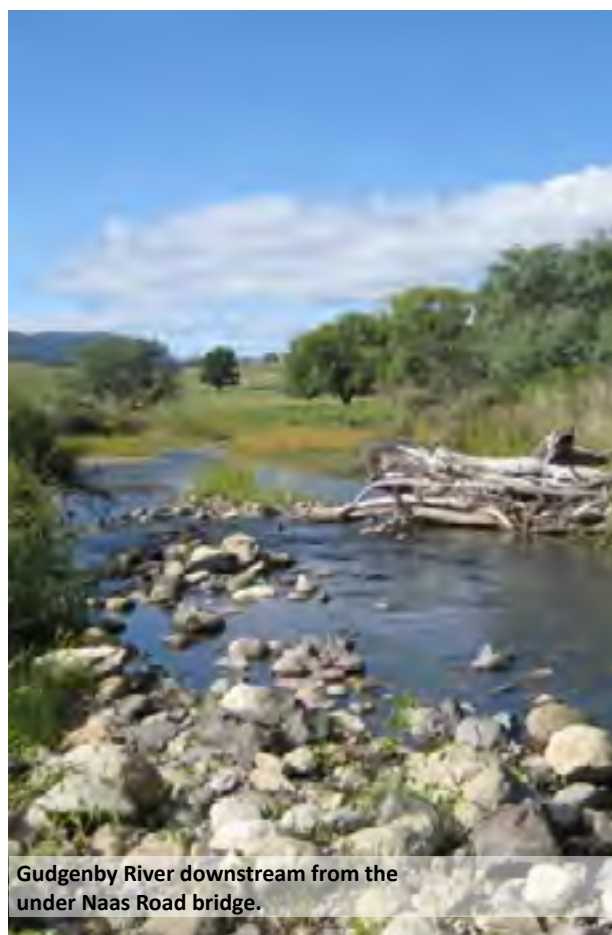
The water quality in this system is one of the best in the southern region but the catchment as whole scores badly on both the macro-invertebrate (water bug) and riparian vegetation (RARC) scores. The 3 main arms of this reach do have different characteristics that influence the overall assessment. The Orroral Valley naturally gets a low RARC score as it is mostly bog and the dominant vegetation are macrophytes (large aquatic plants). Honey Suckle Creek has good riparian vegetation along most of its length but the water bug survey showed few sensitive species. The same is seen at the sites on the Gudgenby river itself. Low dissolved oxygen and possible land use factors drive down the water bug score on the Gudgenby and RARC results are also moderate due to the dominance of exotic plant species.

Gudgenby River downstream from the under Naas Road bridge.

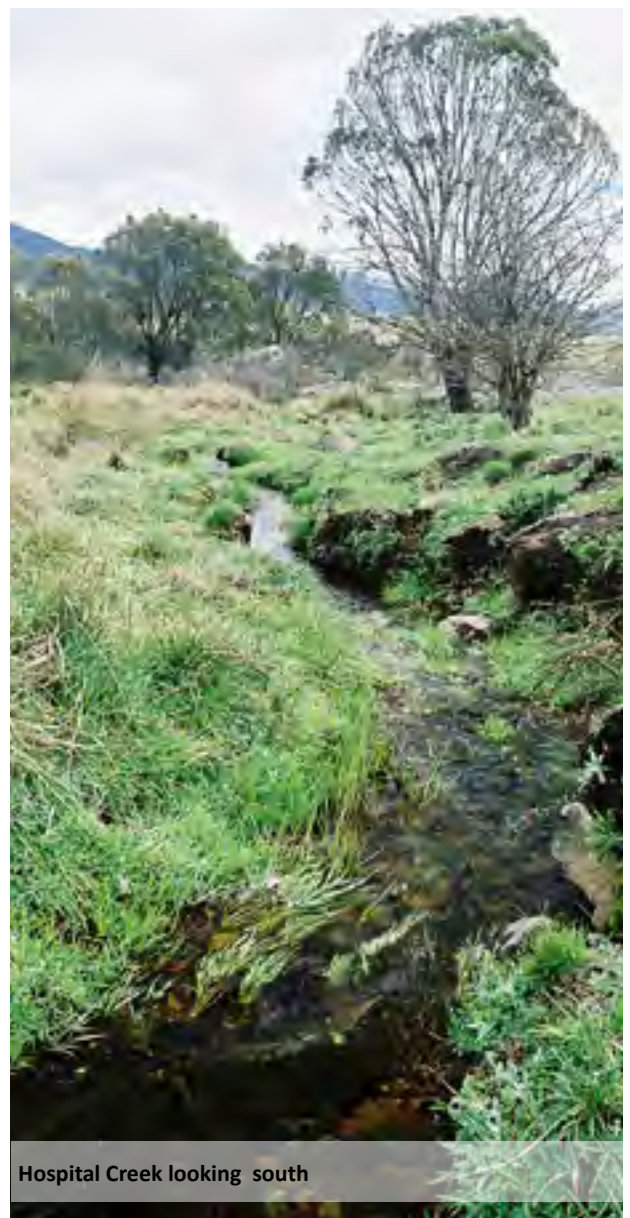
This reach scored the healthiest overall result for the Southern ACT in 2014–15. A excellent water bug score, highlighting the abundance of highly sensitive water bugs, was a reflection of how good the water quality was in this upland reach. A healthy score was also recorded for the riparian survey revealing good vegetation condition. A concern can be low dissolved oxygen levels in the boggy section of the creek. This is possibly a natural effect of low flows as the water spreads out. The Little Dry Creek arm of the reach had water flowing for most of this period which is a good indicator of how much rain Namadji has experienced.

Hospital Creek looking south

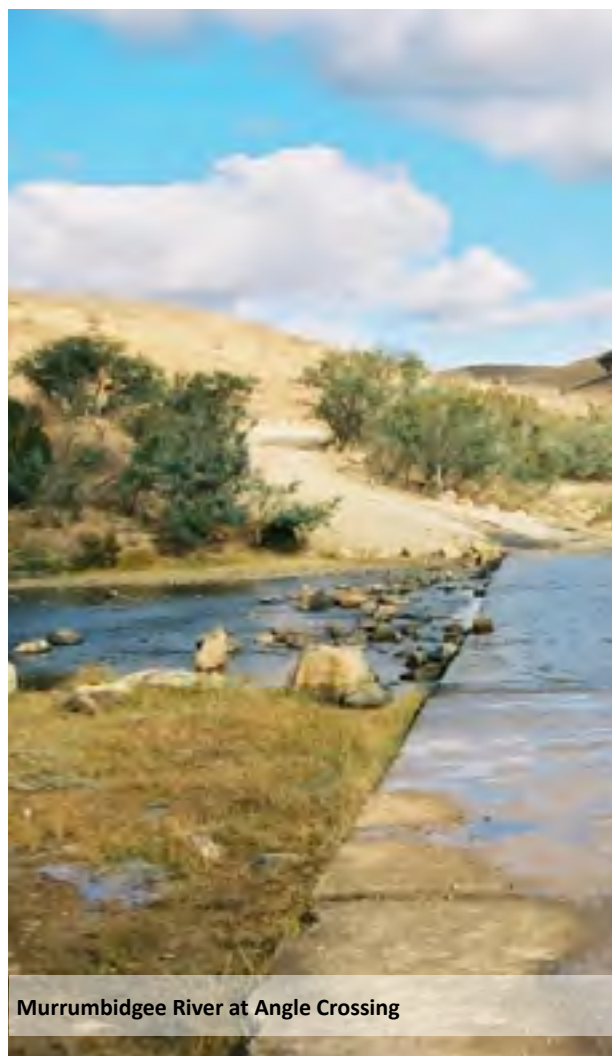
The Murrumbidgee at the top and bottom of the ACT is a river that is not in great shape. The water often has 'degraded' electrical conductivity and only 'fair' dissolved oxygen levels. Water bug surveys reveal a depressing paucity in diversity and an absence of pollution sensitive species. The riparian vegetation is in fair condition at best.

Murrumbidgee River at Angle Crossing

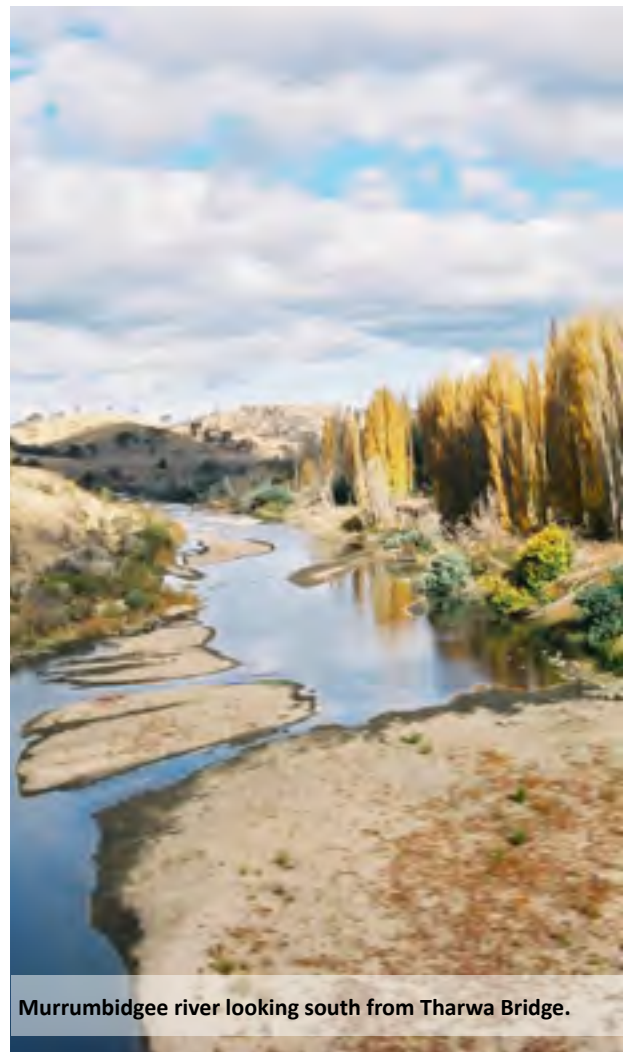
The riparian vegetation in this reach is extremely poor with very little mature canopy species. The shallow gradient of this section of river also compounds the problem of sediment build up, which reduces in-stream habitat. The Tharwa logjam project continues to be monitored with interest for its effectiveness at scouring out the substrate sediments and improving fish passage. Other projects have begun in the last year to revegetate the riparian zone on the Castle Hill Homestead bank of this reach. An extension of this much needed work is planned for the coming year.

Murrumbidgee river looking south from Tharwa Bridge.

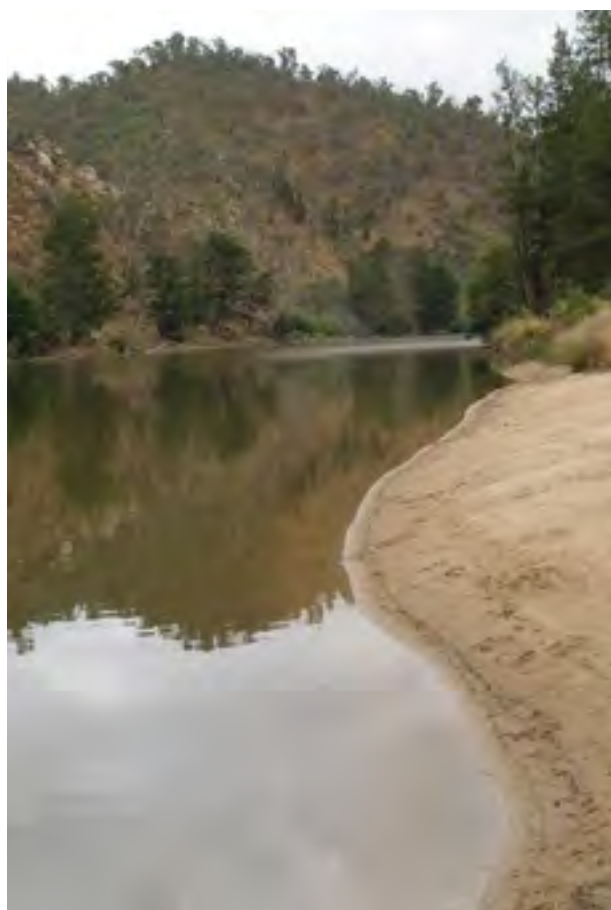
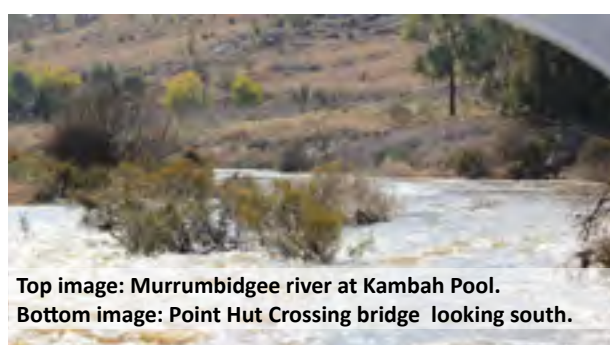
This stretch of the Murrumbidgee is unique in the ACT in that it had no stand out catchment health concerns over this period. Dissolved oxygen was 'fair' but all other water quality parameters were 'good' or 'excellent'. The clarity of the water, measured by turbidity, was excellent this year. The surveys for water bugs showed a 'fair' level of species diversity and sensitivity and the riparian vegetation surveys conducted at either end of the reach also recorded 'fair' habitat health.

Top image: Murrumbidgee river at Kambah Pool.  
Bottom image: Point Hut Crossing bridge looking south.

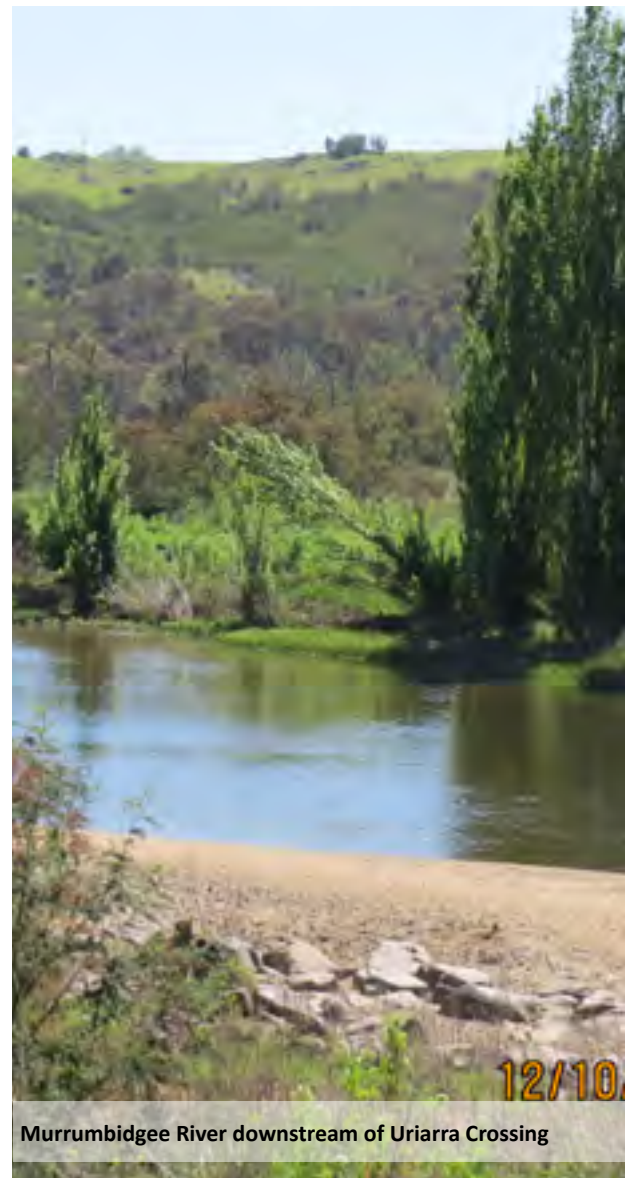
Water bugs do have a hard time in this stretch of the Murrumbidgee though and this is probably an indicator of the sandy river bed and lack of water plants present at either Waterwatch site. The riparian vegetation surveys also give testament to a stretch of river lacking mature native trees.

Murrumbidgee River downstream of Uriarra Crossing

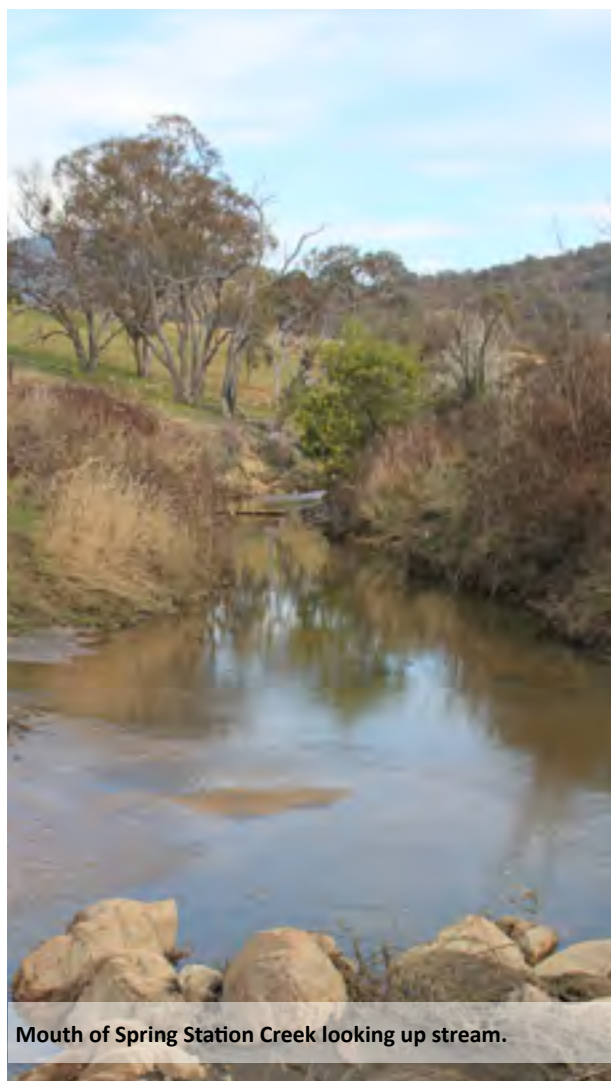
The pH, turbidity and nitrate levels recorded were 'excellent' on average. Electrical conductivity had a high 'degraded' level which is typical of many small, rural creeks in the Southern ACT catchment. The water quality overall however, was 'good' and actually the best of similar rural creeks in the region. Riparian vegetation assessments and water bug surveys conducted on this reach scored poorly. The 'poor' water bugs result suggests poorer water quality than currently assessed.

Mouth of Spring Station Creek looking up stream.

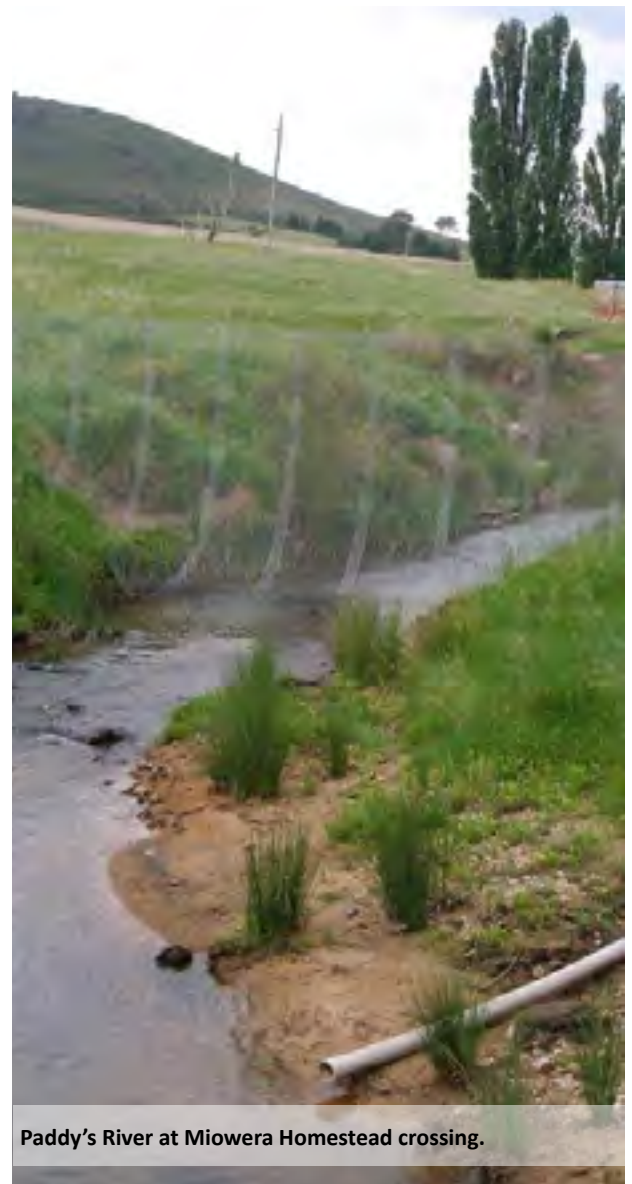
While water quality was 'excellent', the overall CHIP score was reduced as a result of the water bug (Signal 2) and riparian vegetation evaluations which scored 'fair'. Much of the riparian zone along Paddy's River lacks significant native vegetation. The water bug surveys revealed the absence of many highly sensitive bugs which raises questions about the instream habitat.

Paddy's River at Miowera Homestead crossing.

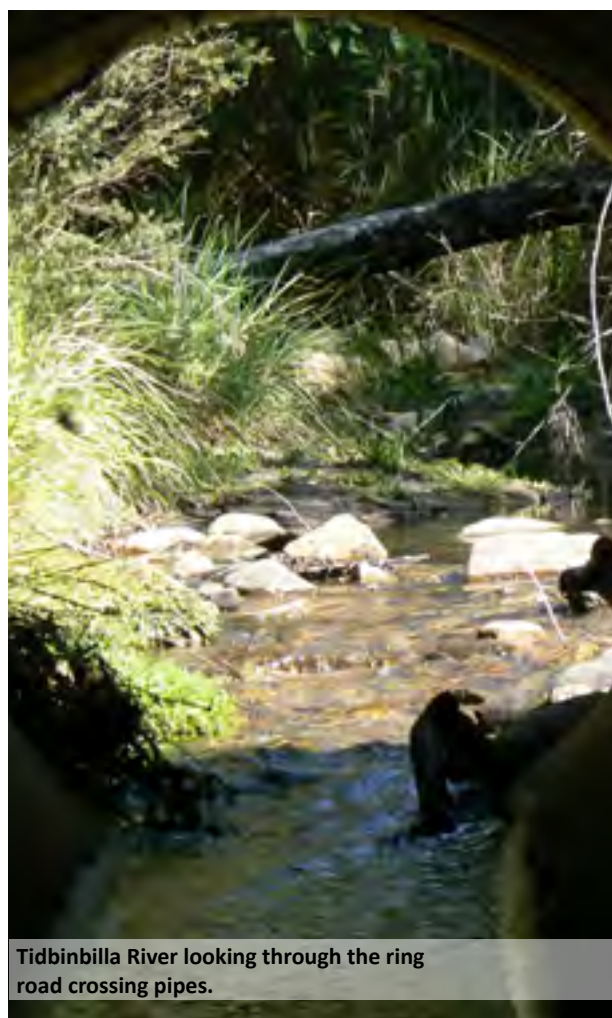
Tidbinbilla Nature Reserve maintained a good level of health in this 12 month period. Tidbinbilla River is very small and suffers dramatically when there is little rain and has been known to dry up completely at the downstream end. Fortunately this has not been the case this year thanks to a mild summer and some good rains throughout the year. As a result the water quality remained close to pristine. The riparian condition along most of this reach is what one would expect from a well managed nature reserve, rich and diverse. The artificial wetlands of the Sanctuary can suffer from depleted dissolved oxygen levels and 'poor' water bug scores. This can have a negative affect on the overall assessment of the catchment condition.

Tidbinbilla River looking through the ring road crossing pipes.

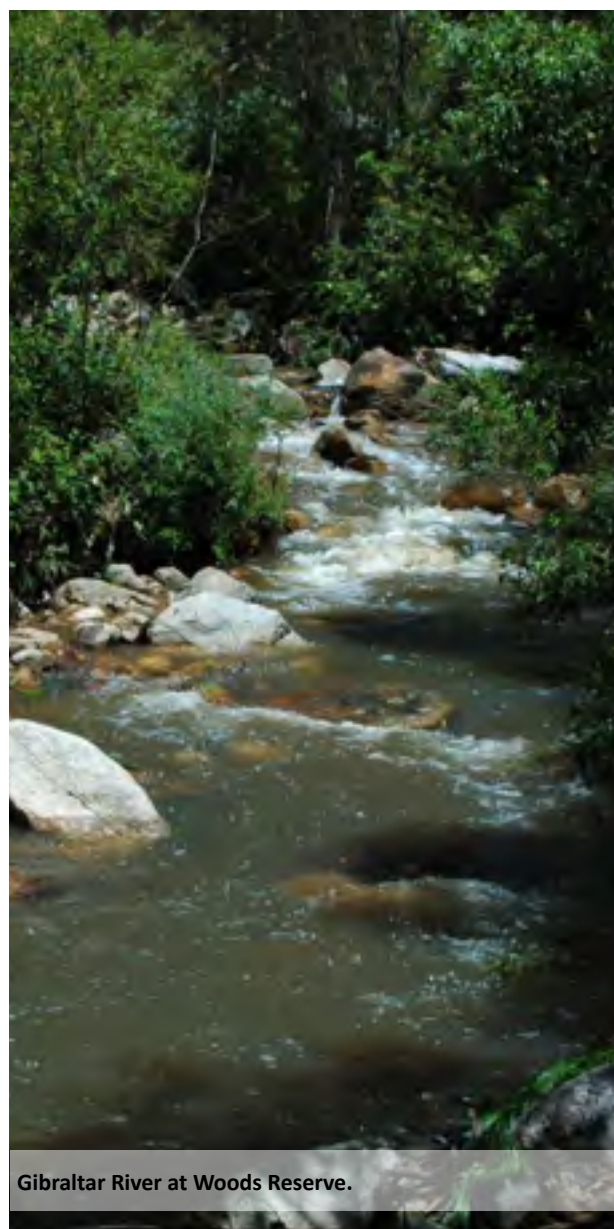
Gibraltar Creek has the highest value riparian condition of all the Southern ACT Reaches. The water quality in this little creek is also invariably pristine. The extensive recreational use of the surrounding Corin Forest seems to have had little impact on Gibraltar Creek's health. It's high altitude and fast flows keep the water well oxygenated and free from any build up of sediment or nutrients. Surprisingly the water bug scores are 'fair'. The absence of water plants in the monitored sections of the creek mean that aquatic invertebrates dependant of these are absent reducing the water bug (Signal 2) assessment. This may be different if one examined much higher in the reach where upland bog conditions occur.

Gibraltar River at Woods Reserve.

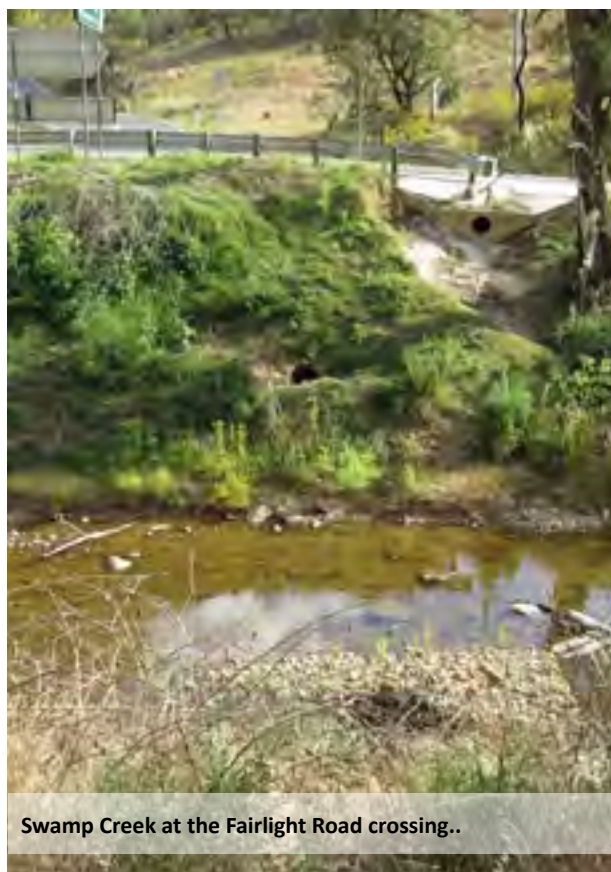
Macro-invertebrate (water bugs) surveys revealed a healthy variety were present at the bottom of this small creek. The riparian survey assessed this section of the creek just missed out on a 'good' rating and scored 'fair'. This was partly due to poor native ground cover.

Swamp Creek at the Fairlight Road crossing..

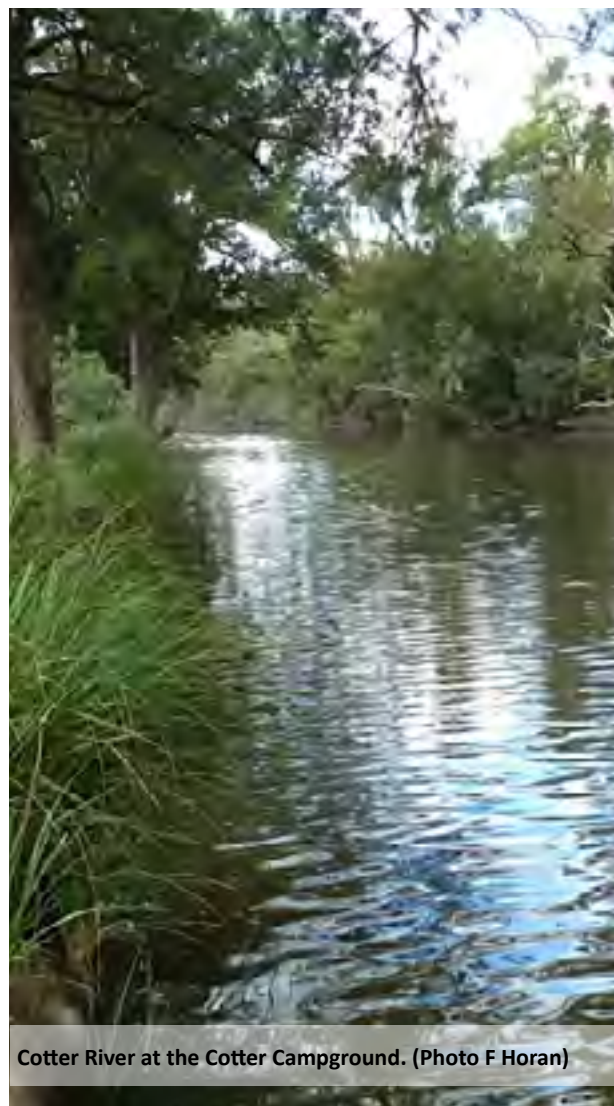
An ongoing issue are the poor macro- invertebrate (water bug) results. Extensive diatom sludge on the rocks and sand in the river may explain this. Diatoms, a microscopic plant, form a fine silt in high numbers making it almost impossible for invertebrates to live in and around the rock bed. If the level of silt becomes high enough a symptom known as 'armouring' occurs where all available spaces in the creek substrate become clogged. Constant flow with little variation enable the formation of algal communities that drives down bug condition. This is symptomatic of waterways immediately downstream of dams.

Cotter River at the Cotter Campground. (Photo F Horan)

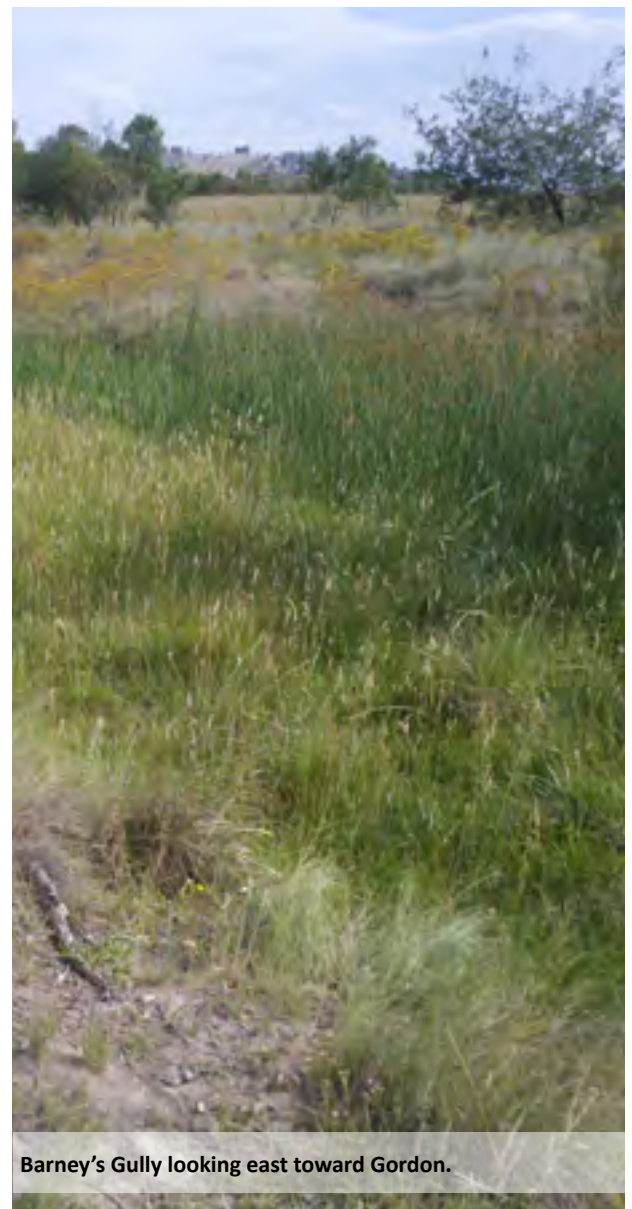
This the first time Barney's Gully gets its own report card. As a small creek close to the suburbs in Tuggeranong, Barney's Gully is showing the positive effects of years of hard work by the 'Park Carers of the Southern Murrumbidgee' Parkcare group. The macro-invertebrate (water bug) survey had one of the highest scores in our catchment with a 'good' rating. The water quality had problems with salinity (electrical conductivity) and dissolved oxygen levels but all other water quality parameters were 'good' or 'excellent'. Salinity has been a recorded problem in this creek as far back as the 1990s when Calwell High School conducted Waterwatch here. This is common issue with small creeks in our region that have a rural heritage. A riparian assessment is yet to be conducted.

Barney's Gully looking east toward Gordon.
