# Catchment Health Indicator Program

2014–15

Written and produced by the Upper Murrumbidgee Waterwatch team:

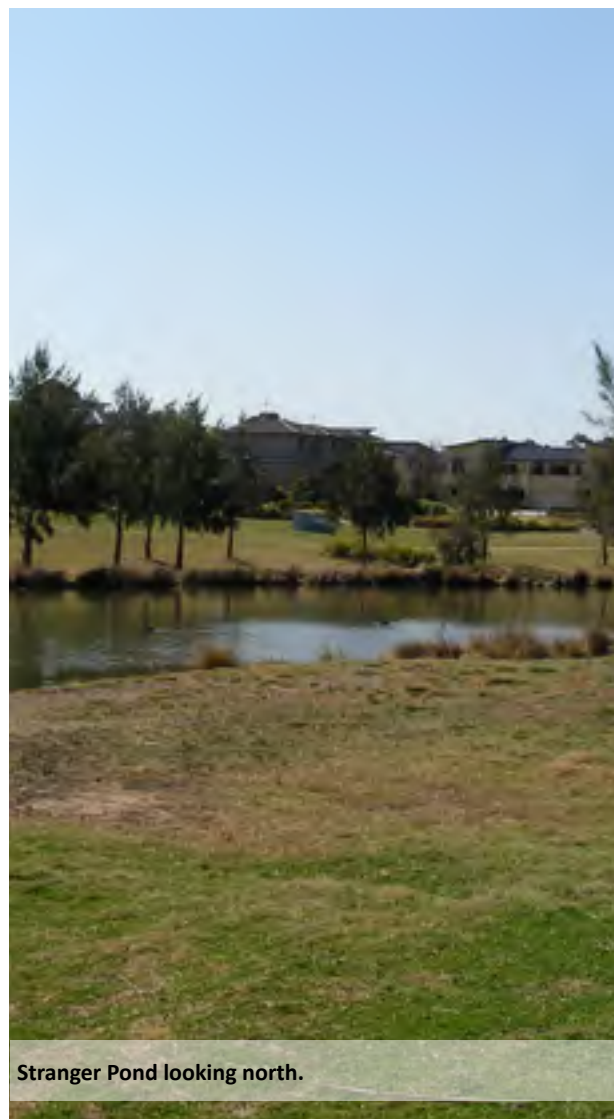
The results show a the pond is under considerable strain. The water tests we did receive showed pH levels and electrical conductivity that were 'degraded', total phosphorus levels that were 'poor' and only 'fair' levels of dissolved oxygen. Macro-invertebrate (water bug) surveys conducted by both Erindale College and the Green Army told a similar story to other still water reaches with a 'poor' assessment overall.

Stranger Pond looking north.

A riparian survey is yet to be connected for this site. More monitoring on this pond is necessary to gain a complete picture of its ongoing health.

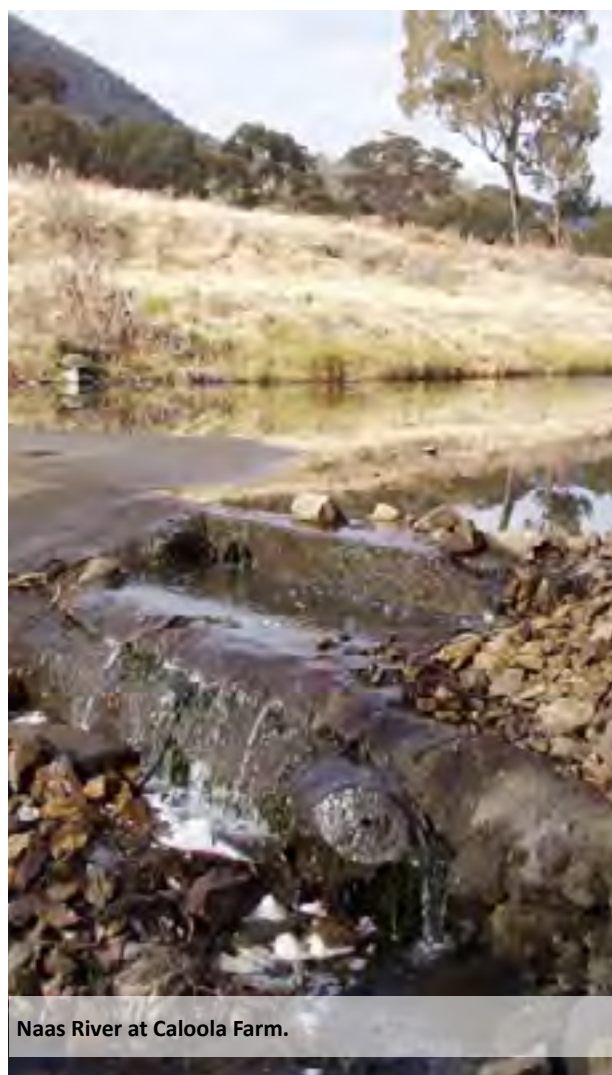
This reach missed out on a CHIP evaluation last year due to data deficiency. The successful completion of water quality, macro-invertebrates (water bugs) and riparian vegetation (RARC) assessments this year reveal a catchment network in better health than anticipated. Turbidity is possibly an issue according to our results and this supports concerns raised in the regional Actions for Clean Water (ACWA) Plan released in 2012 that highlighted the Naas as an erosion hotspot. The 'good' RARC score is most likely due to a significant stretch of the Naas River running through national park.

Water bugs results were not as positive, as on average the surveys scored poorly. Two of the surveyed sites are in rural sections and these appear to have caused issues for highly sensitive water bugs even though water quality tests failed to detect results of concern.

Naas River at Caloola Farm.

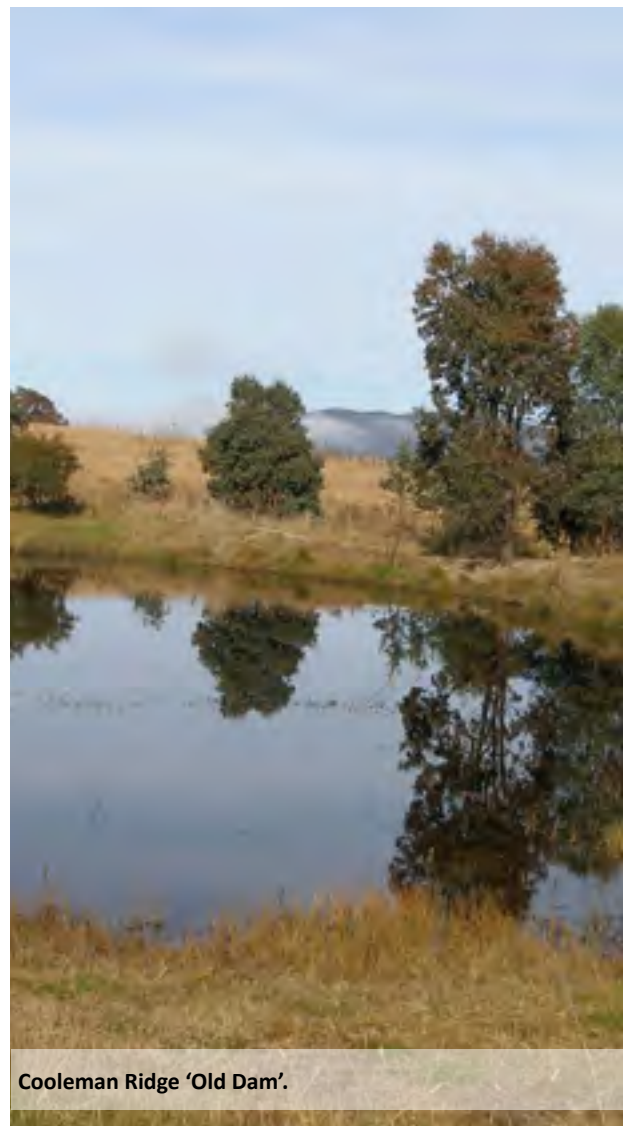
The Coolleman Ridge dams continue to exhibit the same water quality issues as last time. Extreme total phosphorus (TP) readings are common at these sites. The source of the TP, as well as the high electrical conductivity readings, are not conclusively known. A possible reason is the extensive use of pasture improvement chemicals in the rural history of the ridge having a lasting impact by leaching chemicals into the dams. The 'old dam' is still regularly accessed by cattle and this would definitely exacerbate nutrient and turbidity levels. But this alone does not explain the high total phosphorus in the Kathner Street dam where no stock are present.

Water bugs surveys had the expected 'poor' results for the above reasons and the 'poor' riparian vegetation assessment would have also contributed to this.

Coolleman Ridge 'Old Dam'.

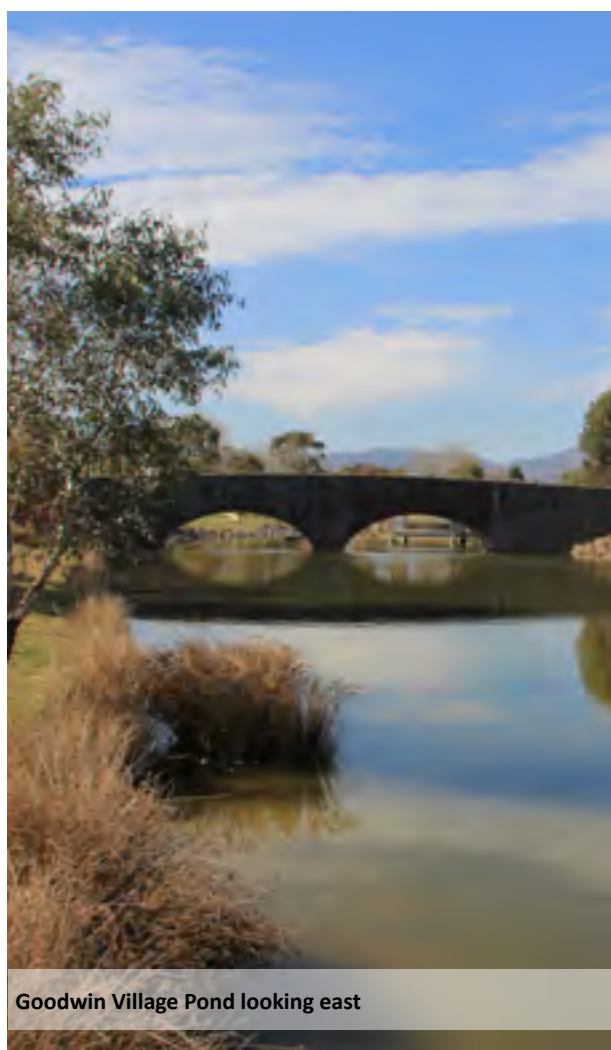
Water quality was the best for of any of our urban ponds. It's young age is arguably a key factor. Water bug survey scores were 'poor' for this still-water reach.

Goodwin Village Pond looking east

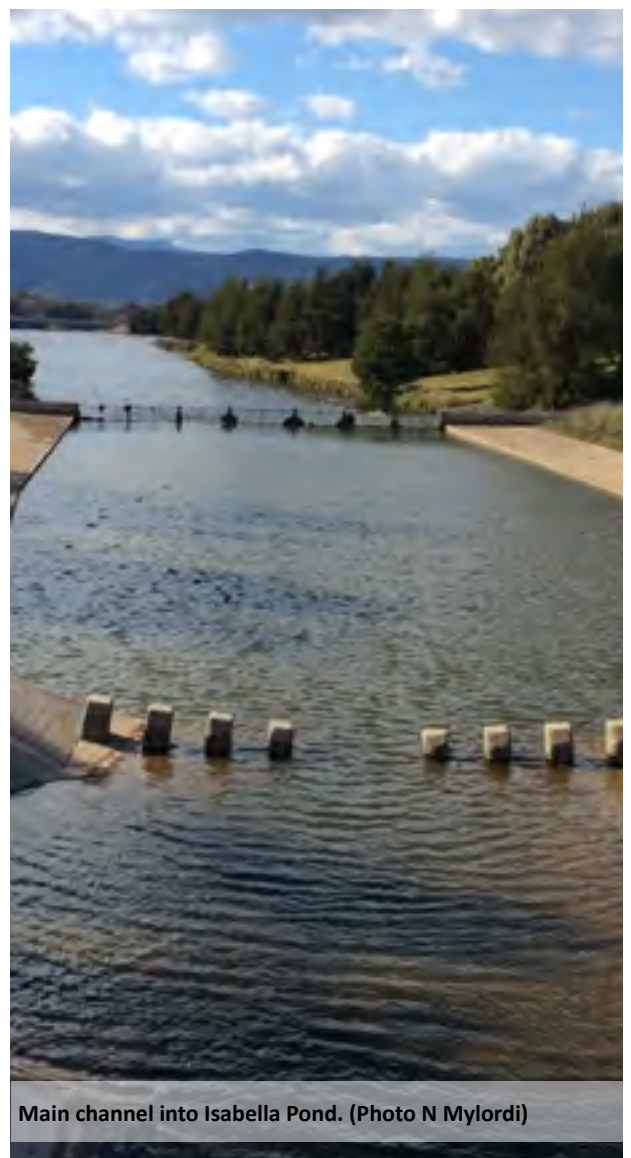
There was an unfortunate hiatus in water quality monitoring at Isabella Pond in the last 12 months. This has now been resolved but unfortunately not in time for this report. One monitoring location used in the previous CHIP report was inside the northern gross pollution trap. This has been cancelled and a new site established to better reflect the ponds in situ water condition. To assess the reach for this period 2 macro-invertebrate (water bug) surveys and a riparian vegetation (RARC) survey along the southern bank were used to calculate the CHIP score.

The water bug surveys yielded unsurprisingly poor results, as did the RARC survey as there is little significant vegetation around this still-water reach. The return of water quality data for next year may lift the assessment for this reach.

Main channel into Isabella Pond. (Photo N Mylordi)

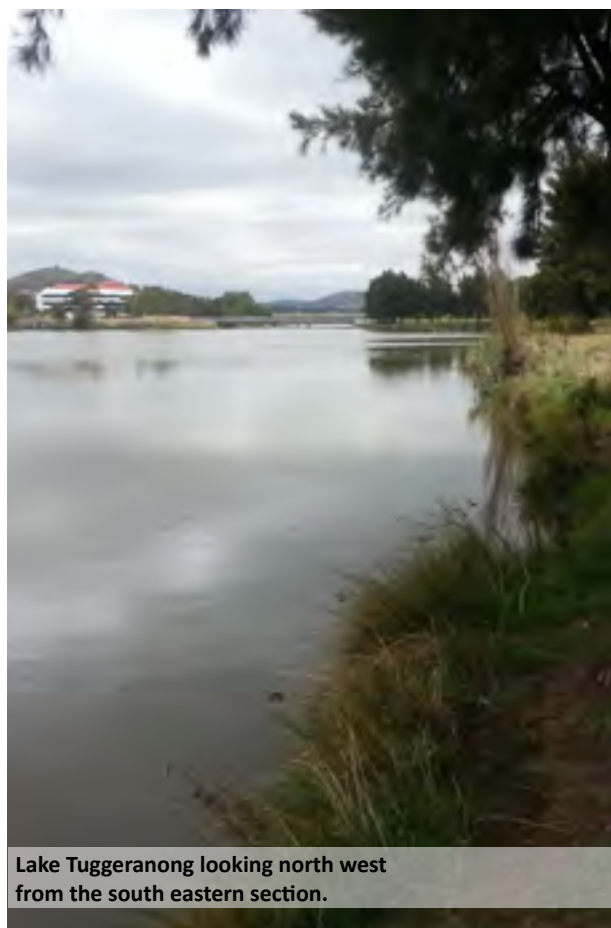
In the last 12 months the southern stretch of Lake Tuggeranong has been host to a major development on its western side. The 'South Quay Development' project included the building of a promenade into the bank of a section of the Lake. To achieve this, the reach needed to be drained of most of its water. The water level variation and habitat disturbance out seems to have had no positive effect on the reach's subsequent water quality. The only acceptable reading for this period was pH. Turbidity was 'fair', total phosphorus levels were poor and all other measures categorised as 'degraded'.

The overlays of macro-invertebrate (water bug) and riparian vegetation surveys give little improvement to the overall picture. There is a healthy stand of Casuarinas on either bank of this stretch of the lake. All but the toughest of water bugs were absent.

Lake Tuggeranong looking north west from the south eastern section.

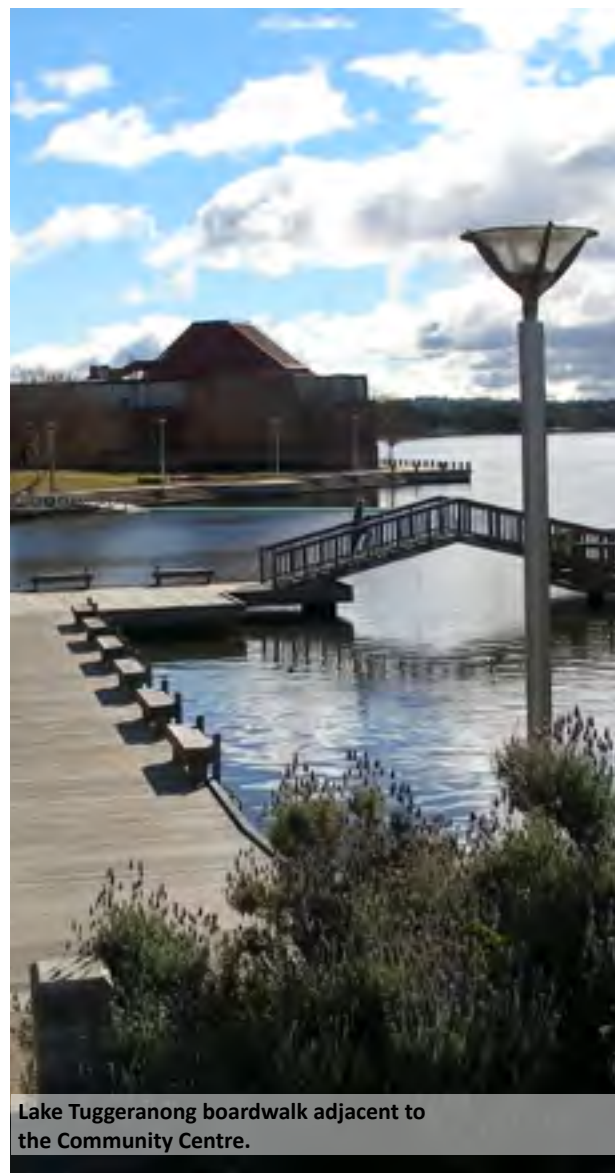
The water quality improved marginally in the body of the lake compared to its southern tail (the 'Wetlands'). Nutrient levels improved to a 'good' level, turbidity remained 'fair' and dissolved oxygen was still far too low and rated as 'degraded'. Water bug surveys were conducted extensively around all the Waterwatch sites on the lake in spring and autumn. That the lake is a still-water body will always have some bearing on the outcomes of monitoring water bugs. The very sensitive ones are only found in fresh running water, so no matter how good the lake water quality becomes the water bug score will be affected. Similarly the riparian vegetation scores are affected by the highly managed nature of the surrounding landscape. This is where these report cards are important to provide context on these highly modified landscapes.

Lake Tuggeranong boardwalk adjacent to the Community Centre.

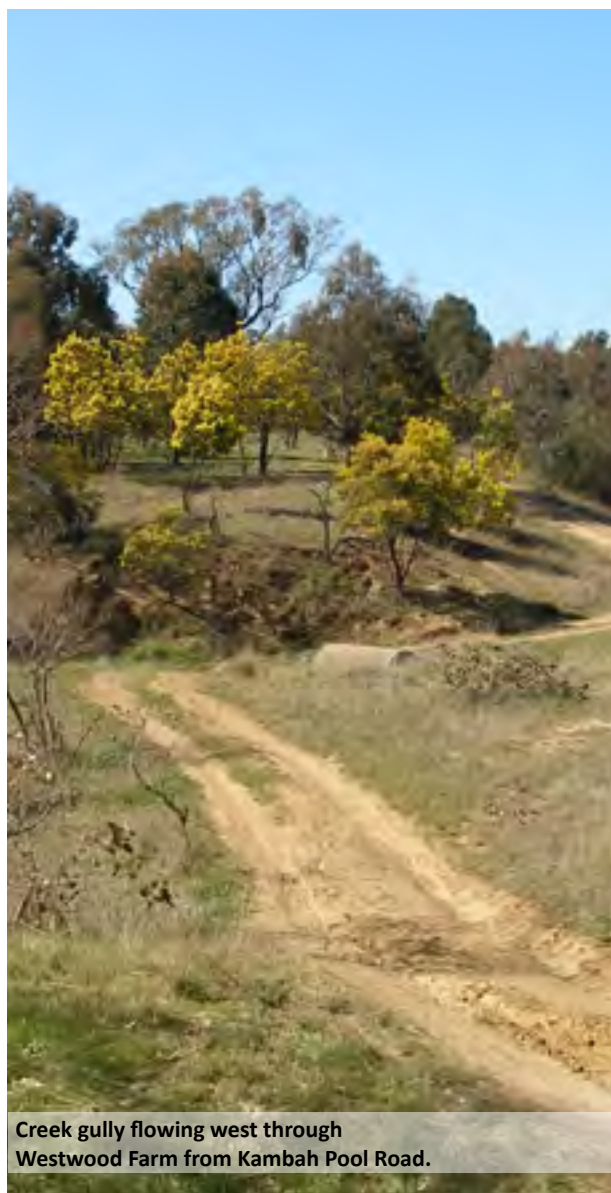
This reach was monitored for this period by the regional 'Green Army' team (an Australian government program for 17-24 year olds to train and work in the environment). Surprisingly, for a rural creek and dam system, the nutrient levels recorded were extremely low and therefore rated as 'excellent'. Salinity (electrical conductivity) is still an issue and this was mainly recorded in the creek line running from the golf club. The overall assessment of the water quality, however, was 'excellent'.

The water bug surveys conducted at the dam and in the creek gave a 'fair' score as a result of a good bug diversity but a lack of many sensitive species. The riparian condition overall was recorded as 'poor'. Like many small, rural creeks it lacks a significant mature native canopy cover.

Creek gully flowing west through Westwood Farm from Kambah Pool Road.

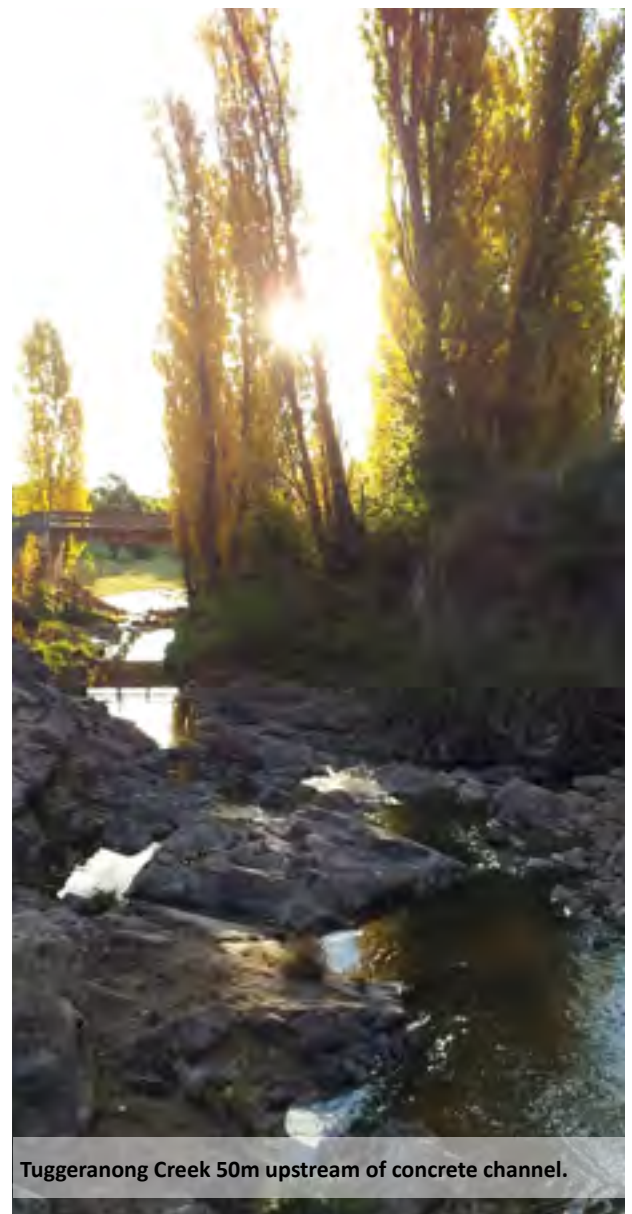
This creek on the very eastern edge of the Southern ACT catchment had an extreme mix of excellent and terrible scores. Most of the water quality parameters such as pH and nutrients were at 'excellent' levels. However the water's dissolved oxygen and salt (electrical conductivity) levels were considered 'degraded'. A good population of water bugs (even with the dreadful oxygen records and saltiness) were found by Calwell High School students, (including the largest leeches ever seen!) but the riparian vegetation comprised mostly weed species. The canopy is almost exclusively old poplars with many of their wilding saplings as the understory. Further monitoring upstream is planned for the next CHIP report. This will add invaluable reference data that is currently missing on this reach.

Tuggeranong Creek 50m upstream of concrete channel.

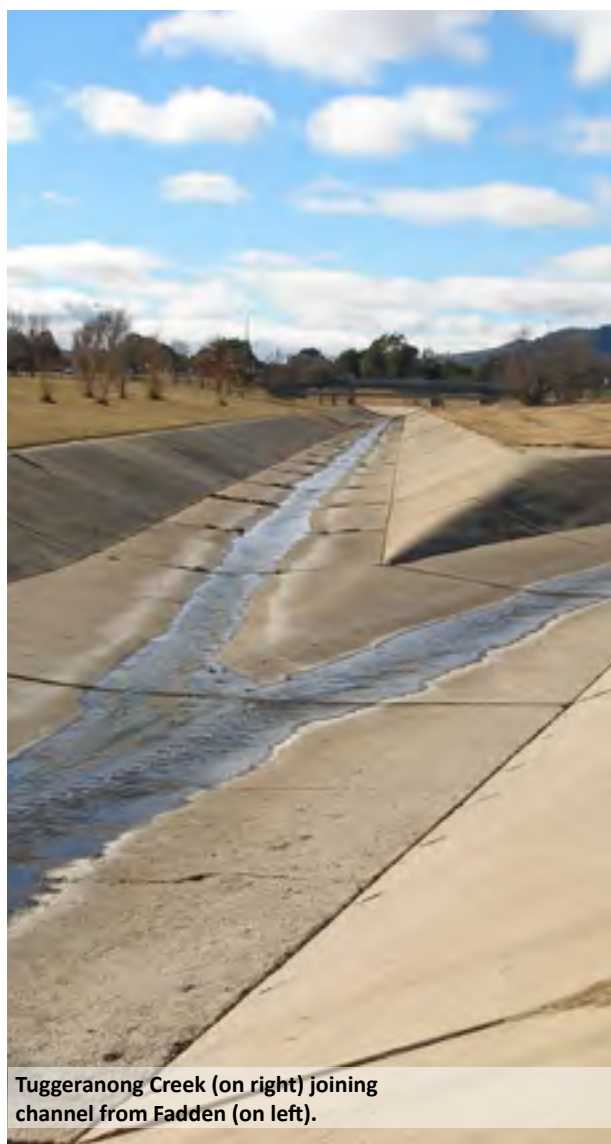
This reach earns the dubious title of worst in the Southern ACT catchment. That it consists entirely of concrete means it could not get a positive score for riparian vegetation condition, as it has none (other than algal filaments).

Similarly water bugs survey that were conducted in the channels at 3 sites revealed nothing other than a few hardy water snails and the odd blood worm. Many thanks are owed to the intrepid students of Chisholm High School who undertook these surveys in good spirits despite the dismal outcomes and uncomfortable conditions. They also kept an eye on the water quality of these drains, getting on hands and knees to extract water for testing with syringes. Turbidity and total phosphorus levels were 'excellent' in the channel, while all other parameters were 'degraded'.

Tuggeranong Creek (on right) joining channel from Fadden (on left).

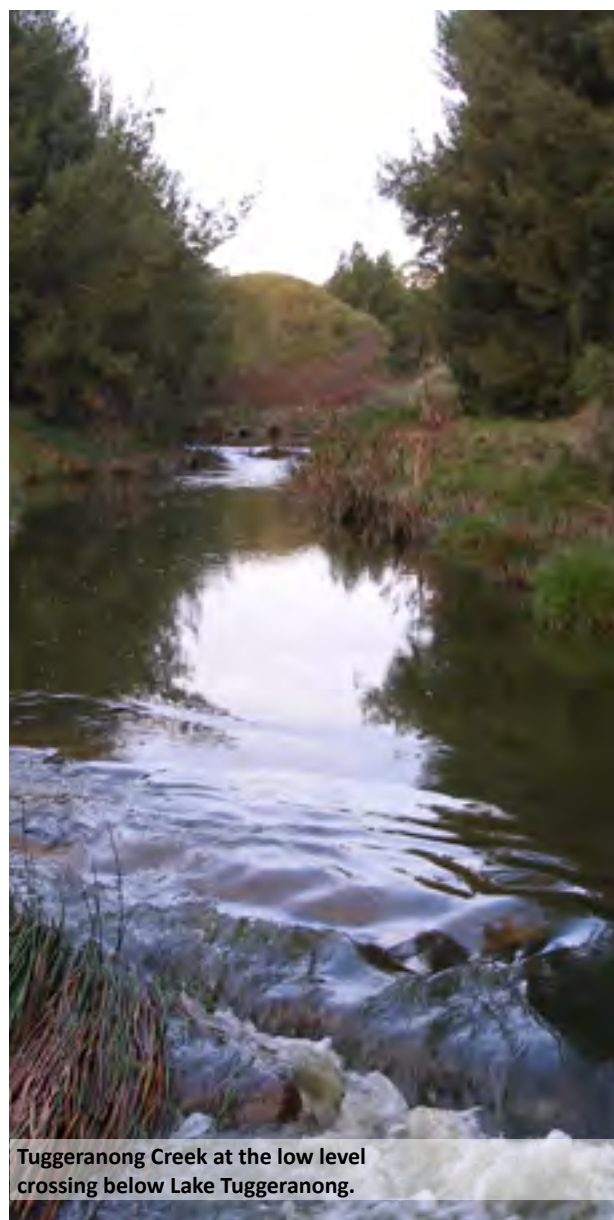
Although well lined with Casuarinas, most of the understory vegetation along this creek consists of weeds. The Creek itself is heavily overgrown with algae for most of the year. This is no doubt driven by the high levels of nutrients (nitrates and total phosphorus) overflowing from Lake Tuggeranong. The water also showed 'degraded' levels of electrical conductivity and dissolved oxygen for this period. One parameter that can attest to the effectiveness of the Lake as a sediment trap is turbidity. Turbidity levels were extremely low compared to those recorded in the Lake. That the water quality was only marginally better than that entering the Lake at the southern end fuels concerns that the Lake is now struggling to protect the Murrumbidgee River from this urbanised catchment.

Tuggeranong Creek at the low level crossing below Lake Tuggeranong.

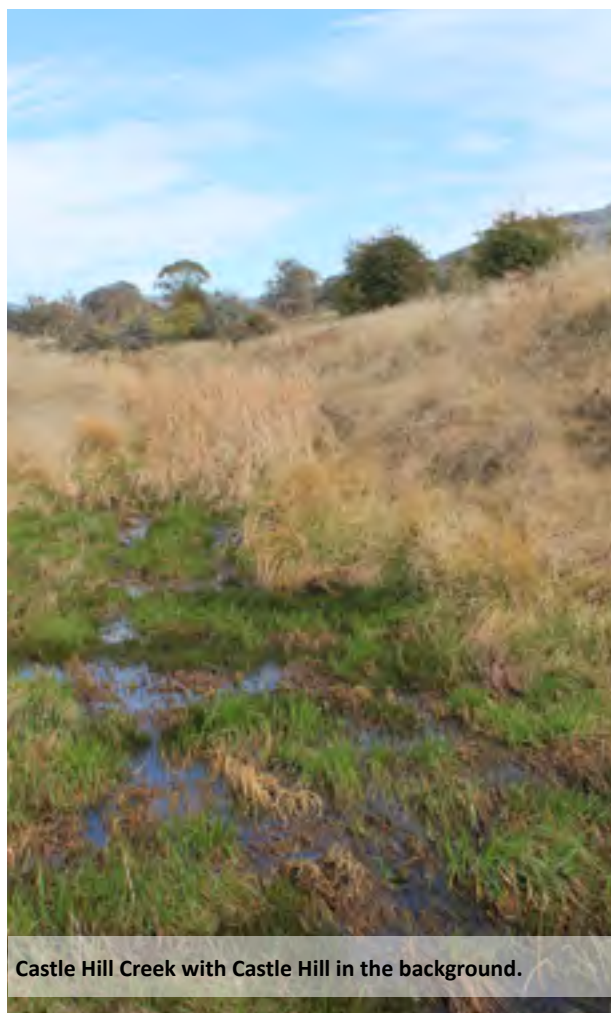
Waterwatch monitoring on this reach was conducted by the land managers at Castle Hill Homestead who have an interest in the health of this creek. The water quality results for this period do show high nutrient levels in this creek compared to other creeks with similar attributes. On average, however the results still fell within the 'good' range. Turbidity was worse than other similar creeks, reflecting the unstable steep nature of its banks. Dissolved oxygen levels were 'poor' and salinity levels (electrical conductivity) were 'degraded'. Both of these parameters were the same as a similar tributary named Barney's Gully and were most likely a consequence of the waterway spending most of the time as isolated pools with no flow. Macro-invertebrate (water bug) and riparian vegetation surveys gave poor results. This should improve over time as the planted trees mature.

Castle Hill Creek with Castle Hill in the background.
