**WATERWATCH**

**Upper Murrumbidgee**

# Catchment Health Indicator Program

2015–16

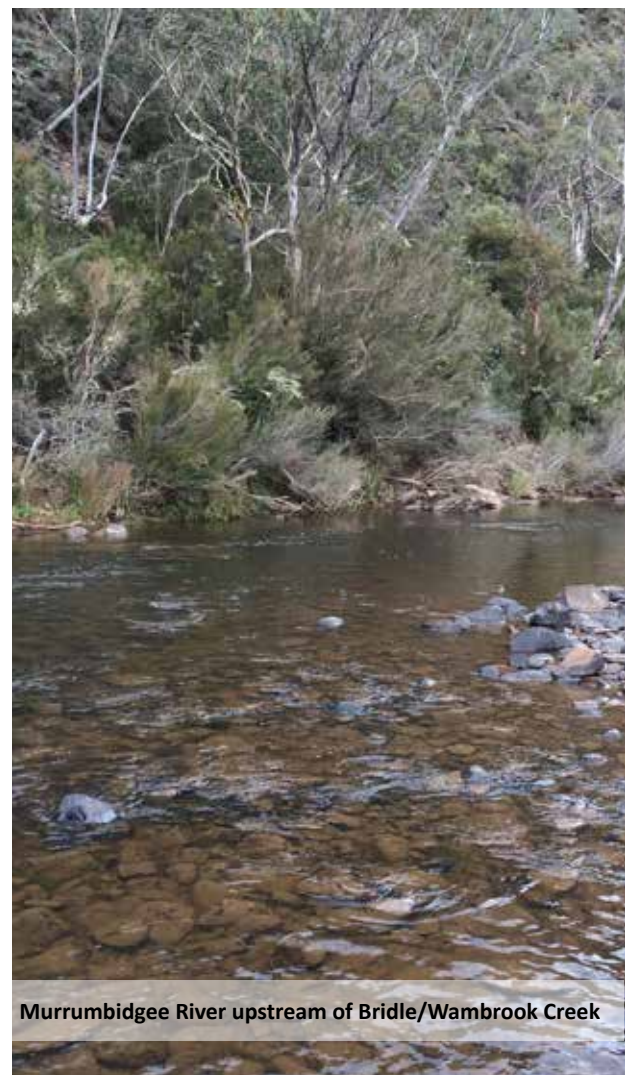
Murrumbidgee River upstream of Bridle/Wambo Creek

Water quality in this reach is influenced by inflow from upstream catchments including (naturally) high electrical conductivity found in Wambrook/Bridle creek. Turbidity and nutrient levels can be elevated during high flow events due to gully erosion in tributaries and cultivation of floodplain areas.

Riparian condition score is 'poor', due to thick exotic (Willow) canopy cover, limited native understorey and a lack of habitat features such as native tussocks and fallen logs. Restoring healthy riparian vegetation zones as filter strips is desirable in this reach especially where floodplain cultivation takes place.

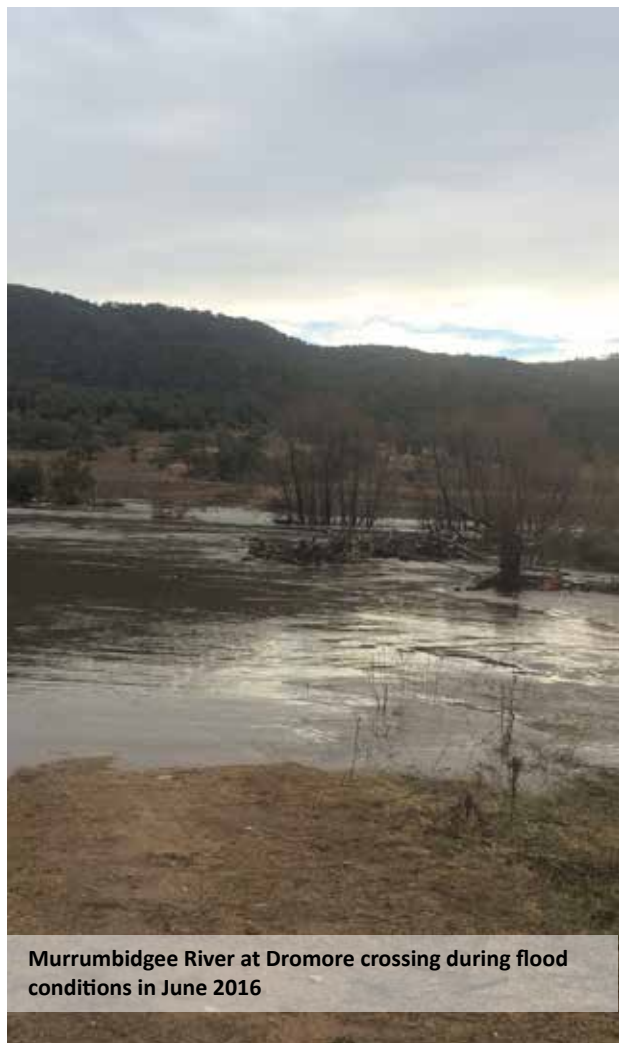
Murrumbidgee River at Dromore crossing during flood conditions in June 2016

Water quality in this reach is influenced by inflow from upstream catchments including the Numeralla River, which can result in elevated turbidity levels during high flow events. High flood conditions in June 2016 resulted in stream bank slumping along this reach.

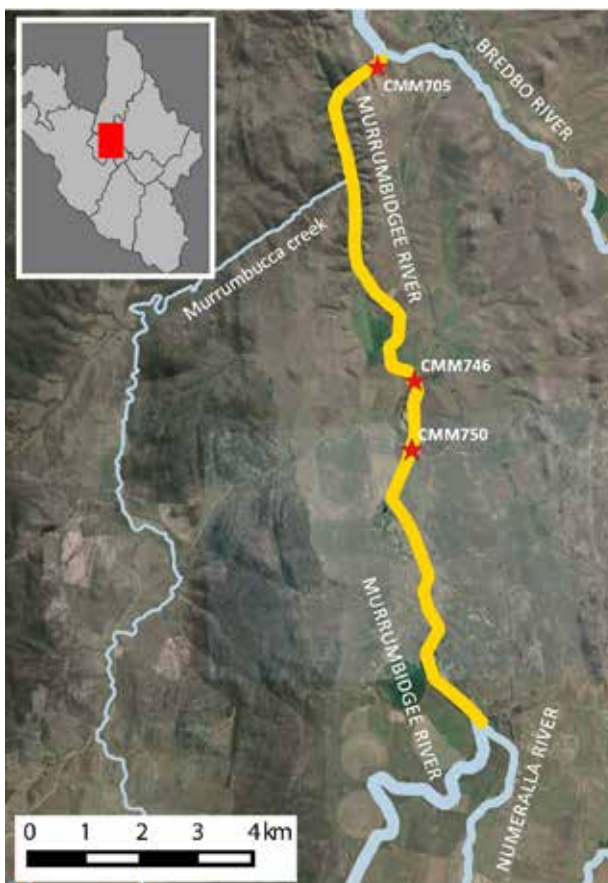
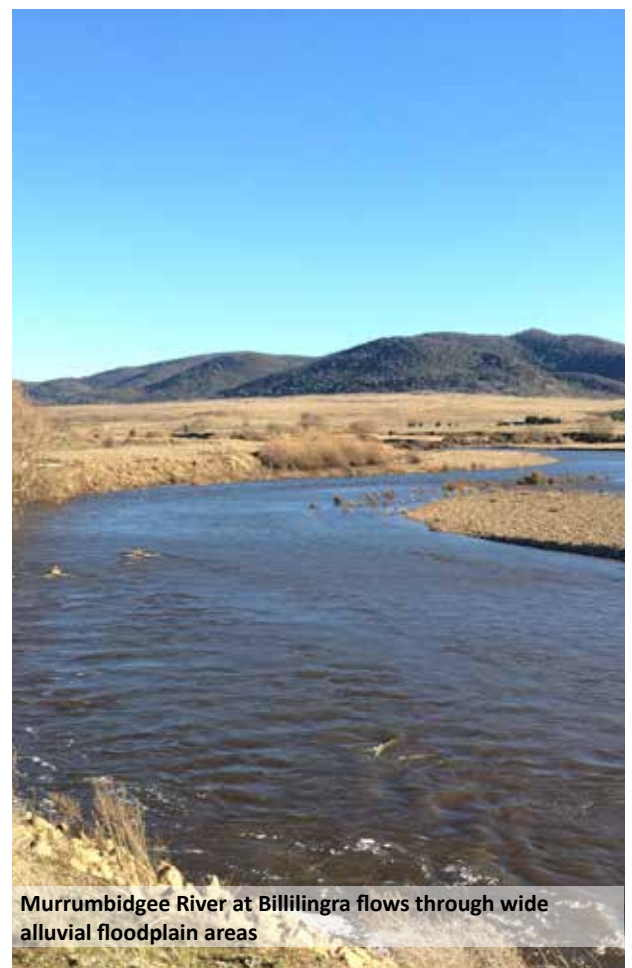
Murrumbidgee River at Billilingra flows through wide alluvial floodplain areas

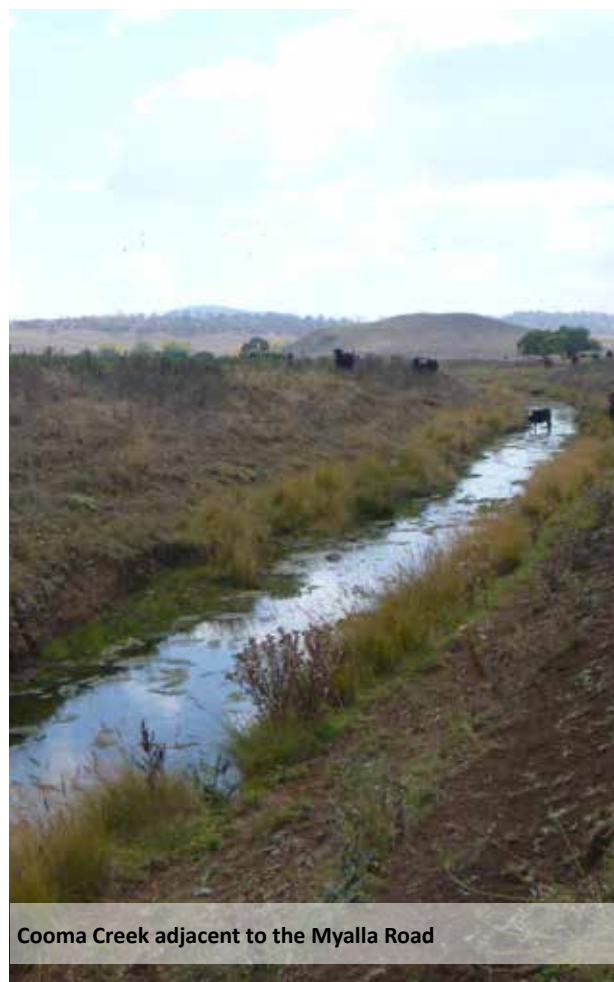
Cooma Creek adjacent to the Myalla Road

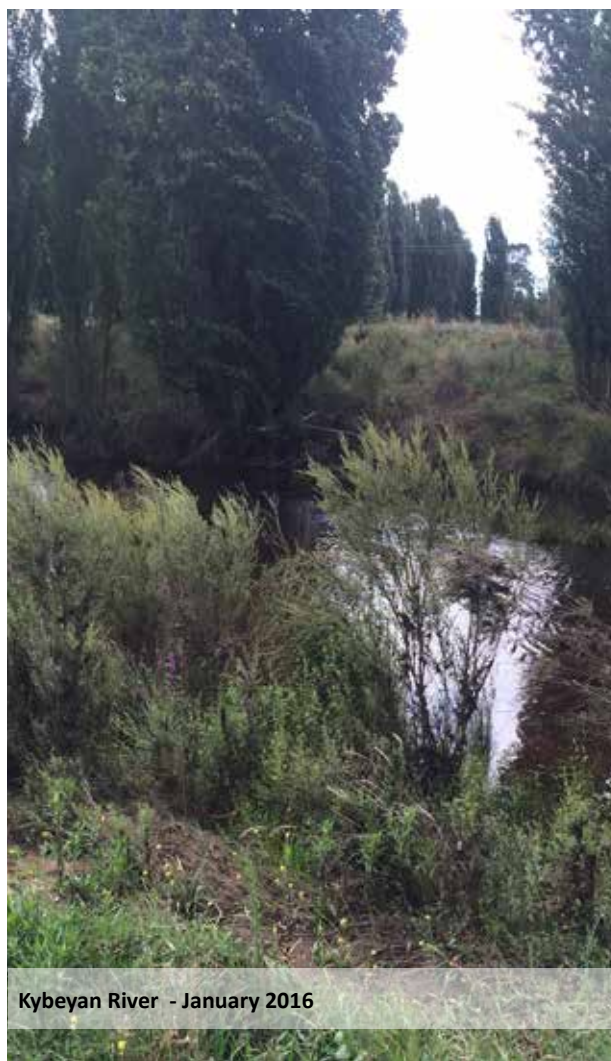
Kybeyan River - January 2016

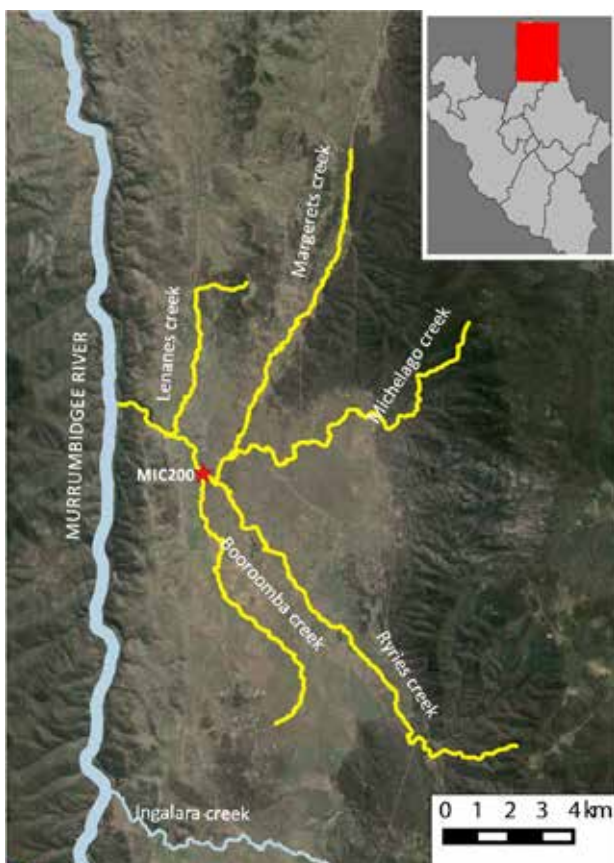
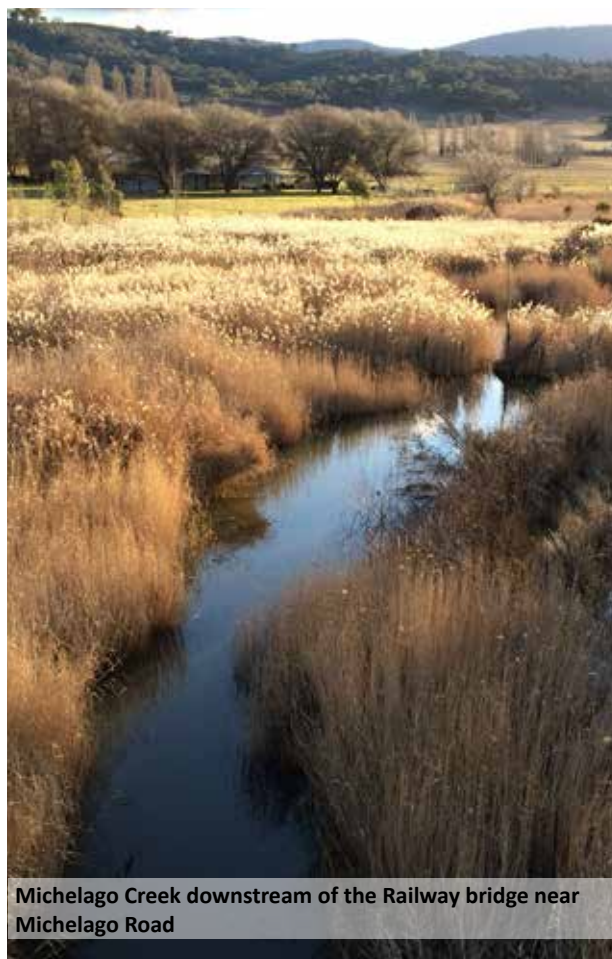
Michelago Creek downstream of the Railway bridge near Michelago Road

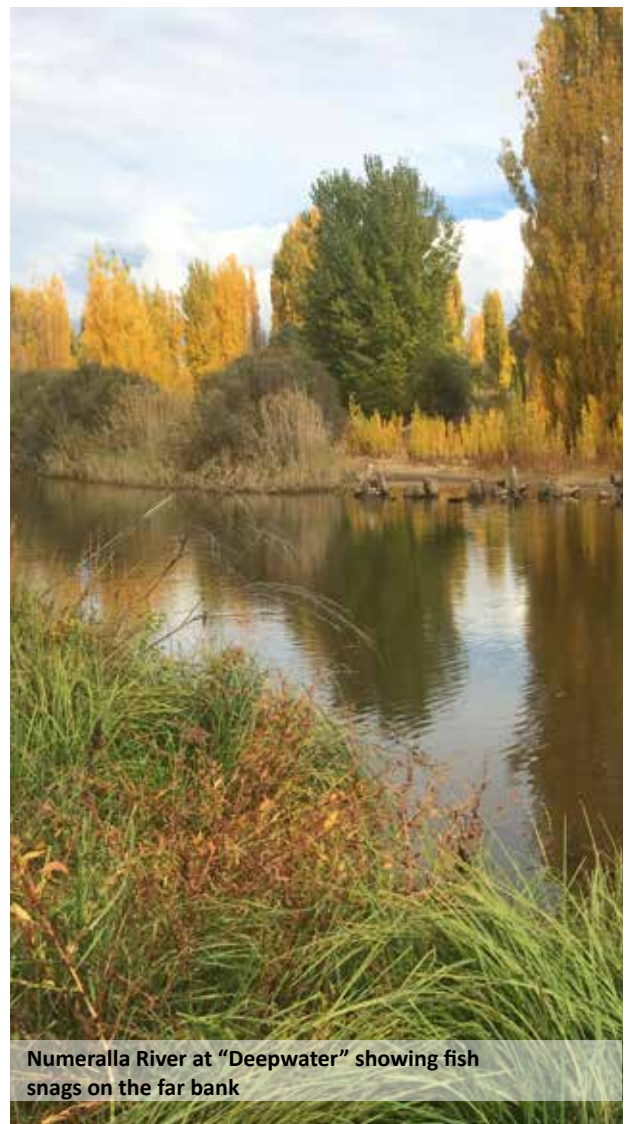
Numeralla River at "Deepwater" showing fish snags on the far bank

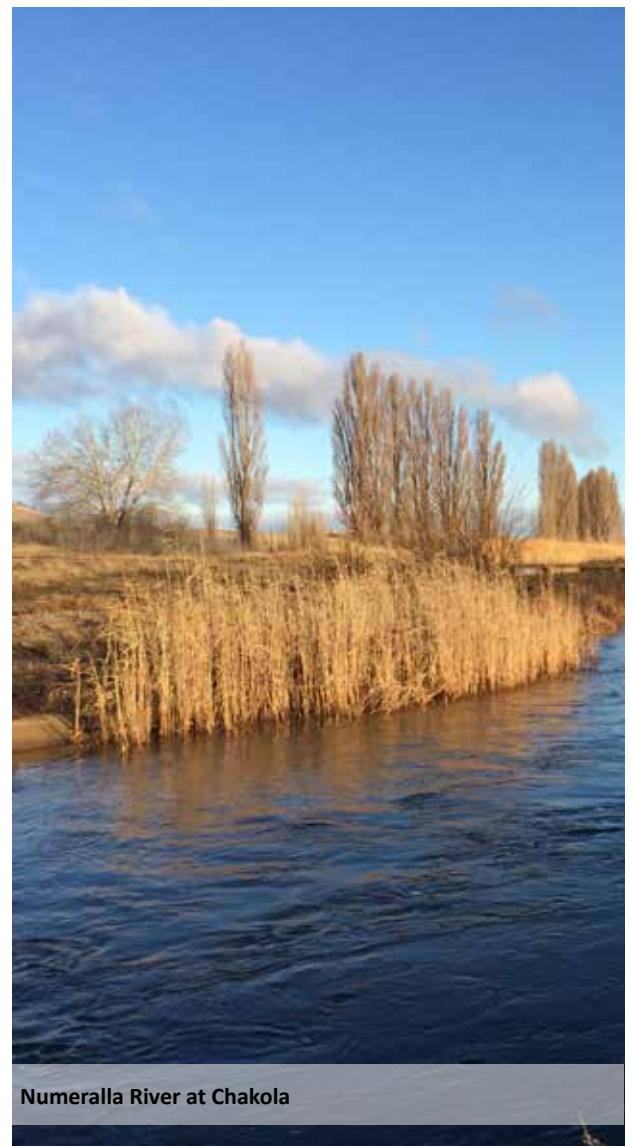
Numeralla River at Chakola

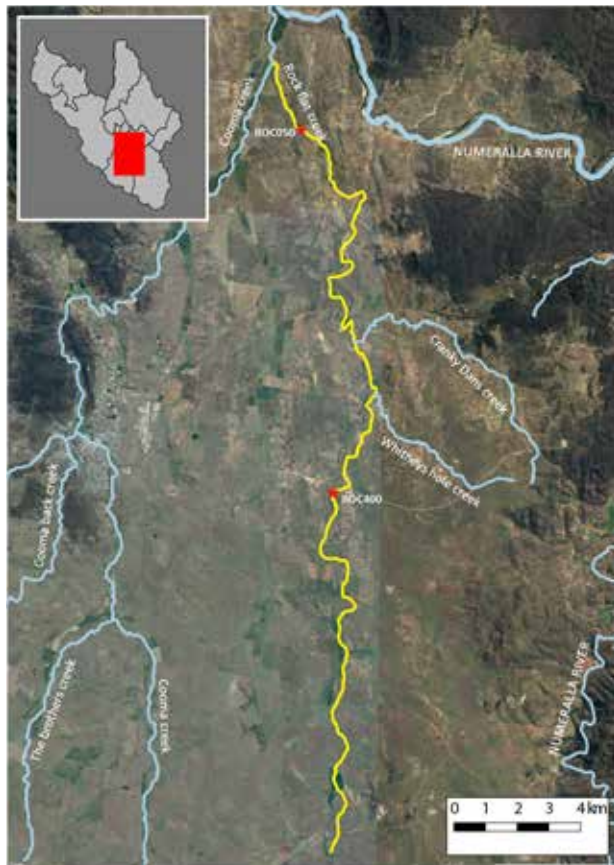
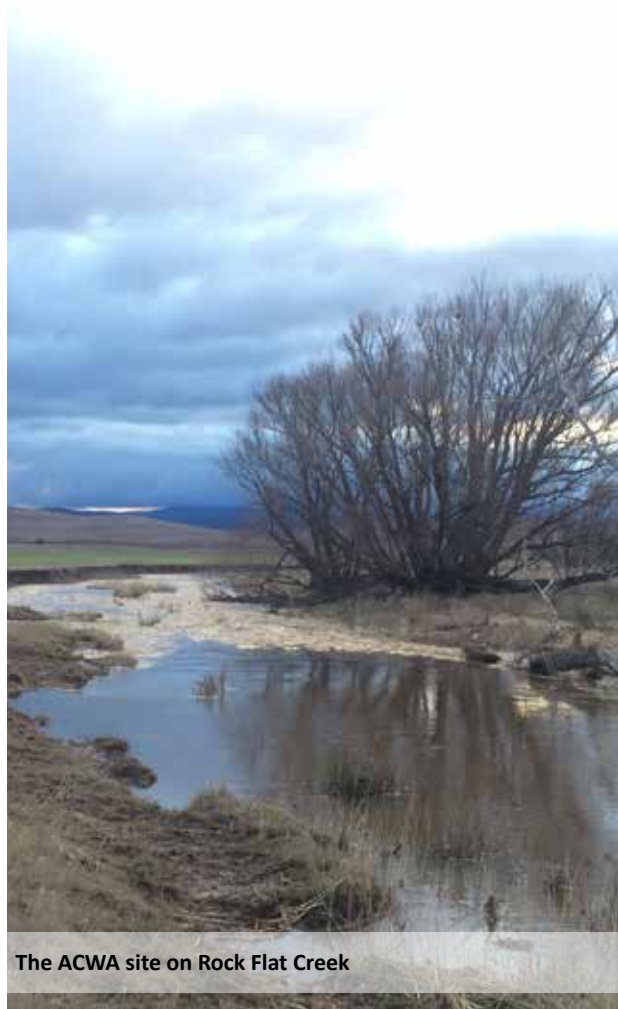
Riparian vegetation is rated as 'poor' and reflects a lack of native species, habitat features and native tussocks in riparian zones. Native tussocks and regeneration of riparian species is limited where stock have access to the creek and riparian fencing is desirable in these areas.

The ACWA site on Rock Flat Creek

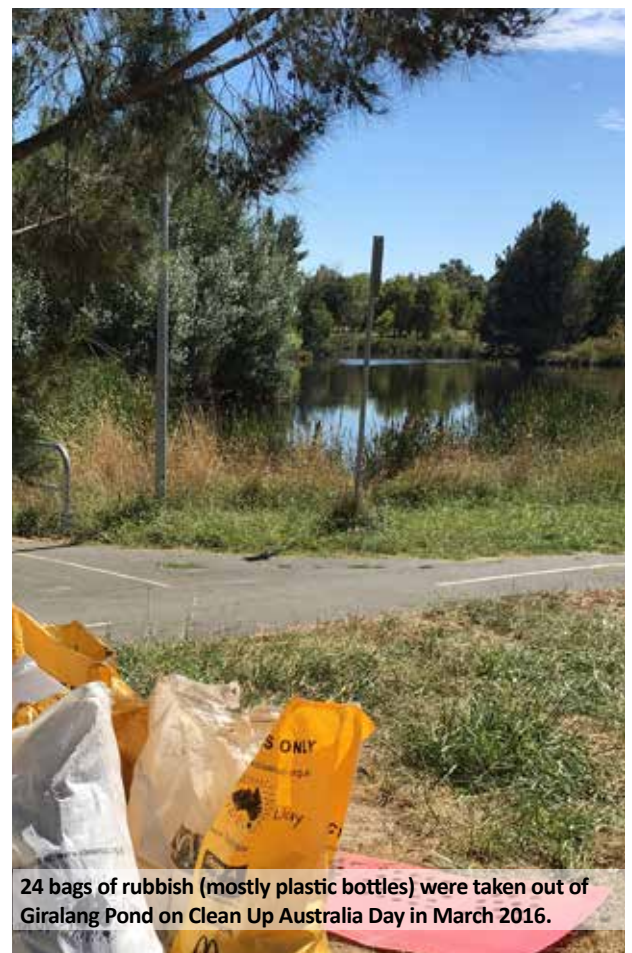
24 bags of rubbish (mostly plastic bottles) were taken out of Giralang Pond on Clean Up Australia Day in March 2016.

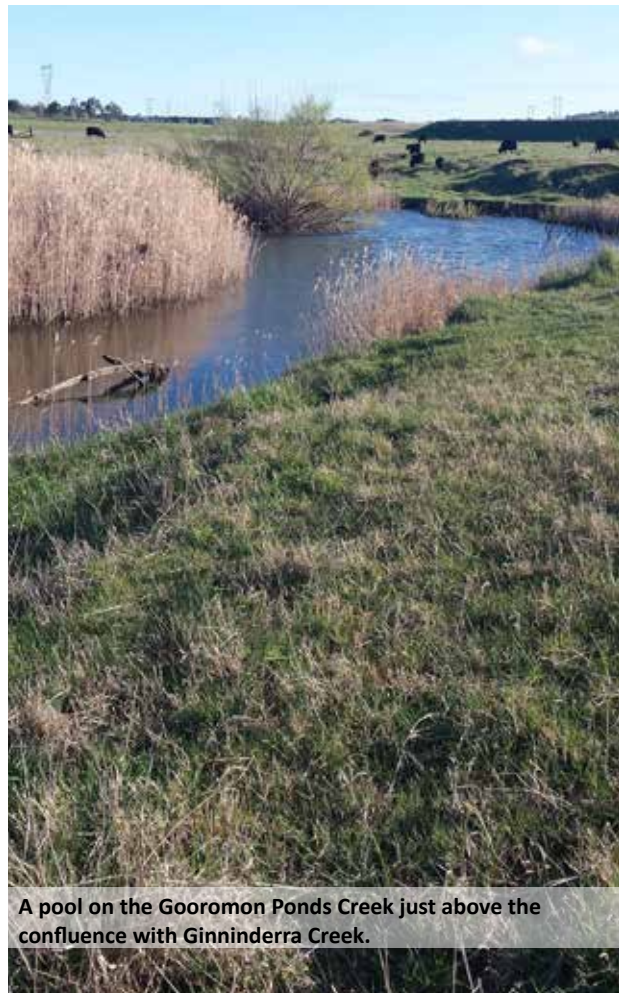
A pool on the Gooromon Ponds Creek just above the confluence with Ginninderra Creek.

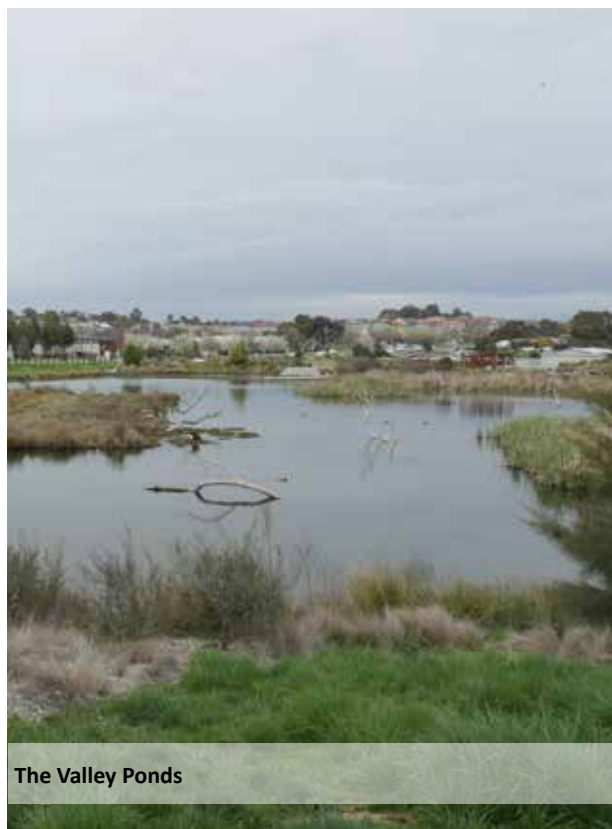
The Valley Ponds

The CHIP score declined due to poorer water quality results which were likely due to the neighbouring construction site that has contributed large amounts of rubbish and sediment. This was most apparent in elevated turbidity and nitrate levels with consistent poor results throughout the year. Reports of large amounts rubbish entering the wetland were forwarded to the ACT Government.

Water bug results also declined with only the 6 bug types recorded. The lack of instream habitat and in particular submergent macrophytes (plants living below the water surface) may also be impacting on bug diversity. As the wetland develops it is expected to improve in habitat value and in turn improve bug diversity. Plantings of submergent macrophytes to provide better instream habitat should improve bug diversity.

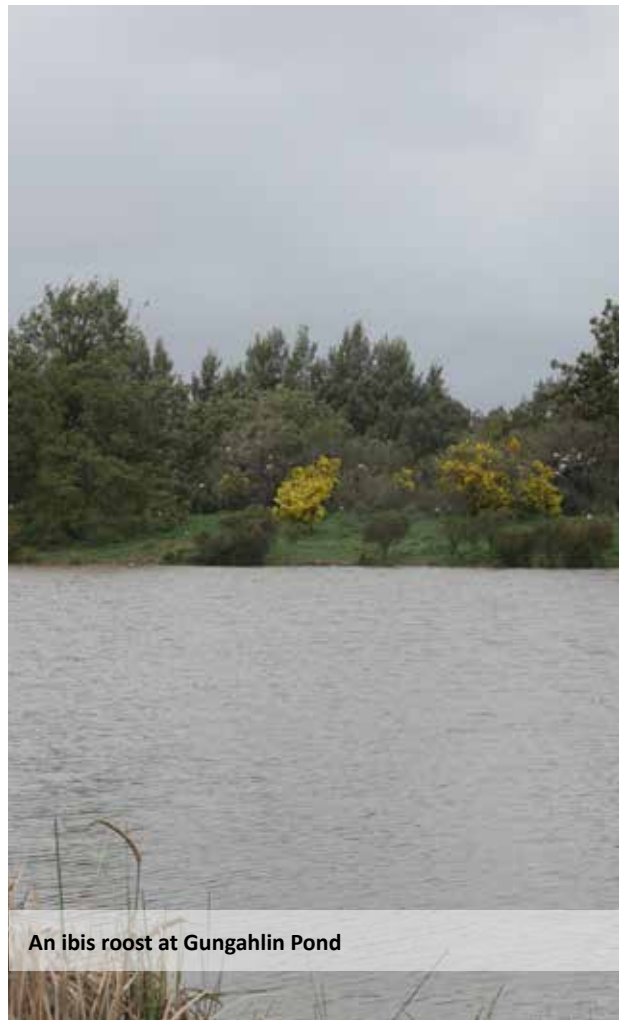
Limited sections of the riparian zone scored well for their habitat values, with some significant native canopy evident. Exotic species, however, with limited habitat values, dominate the edge of Gungahlin Ponds. Instream vegetation in the form of reeds are present throughout the reach, and abundant in some areas, providing good habitat value for frogs and water bugs.

An ibis roost at Gungahlin Pond

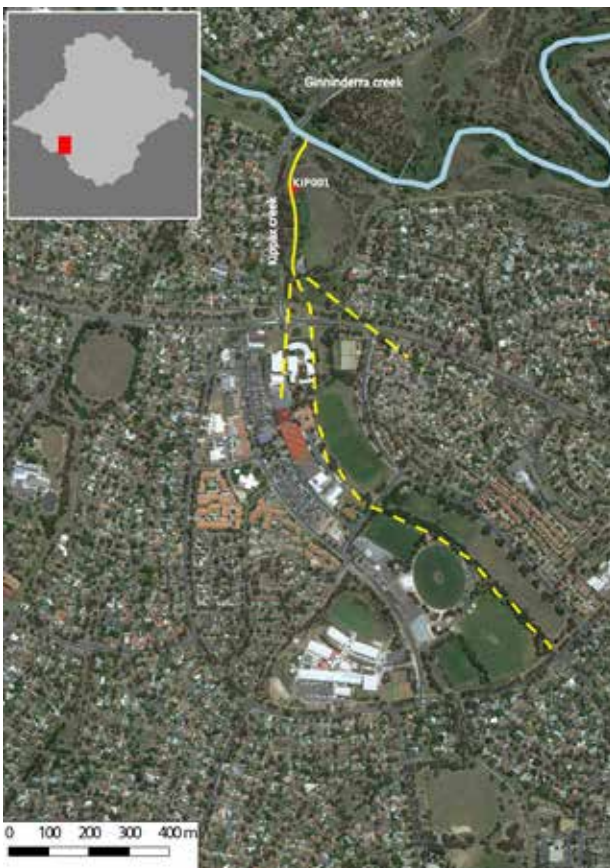
The lower section sits within an important native grassland at the Umbagog District Park. Significant erosion is evident towards the confluence.

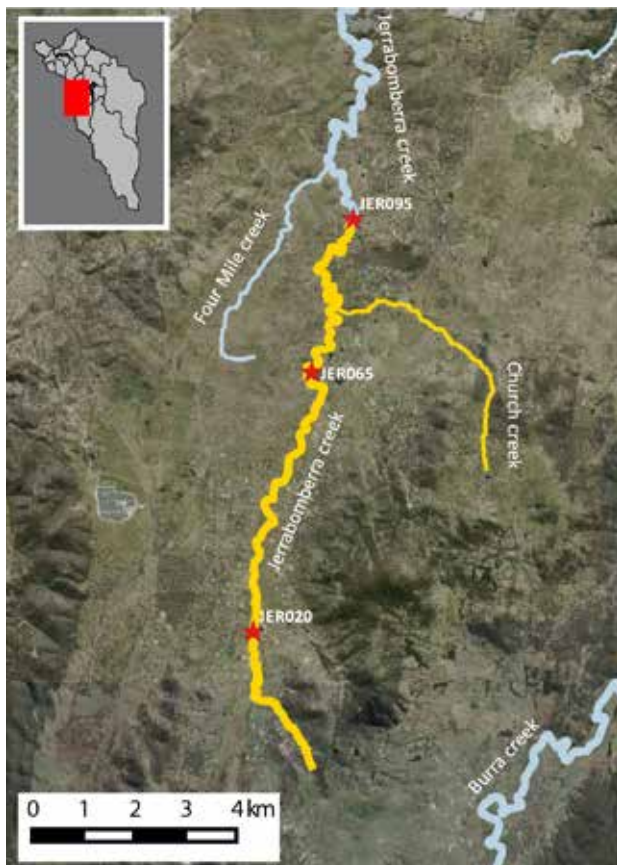
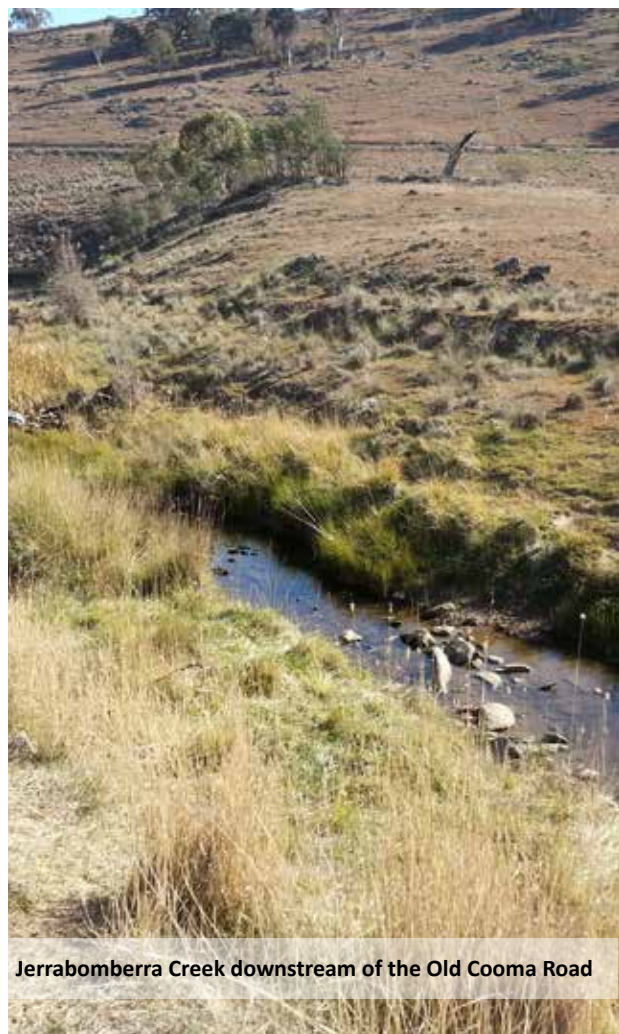
Electrical conductivity was concerning, but not surprising given the frequent low flows and extensive vegetation clearing on this mostly rural land. Both parent metamorphic rock and water logged discharge areas contribute to generally high electrical conductivity, and sodic soils make it subject to significant erosion.

Jerrabomberra Creek downstream of the Old Cooma Road

There are plantings along some of the creek, but the majority of this reach would benefit from increased planting and fencing off stock so erosion can be reduced.

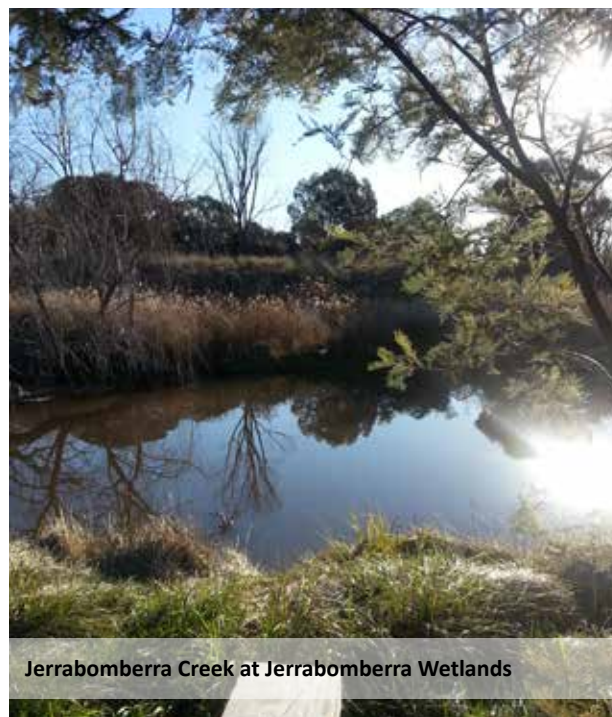
There is very little riparian vegetation along most of this reach which is reflected in its 'poor' riparian condition rating. There is work continuing in the Reserve on planting and removing woody weeds so this score should improve over time.

Jerrabomberra Creek at Jerrabomberra Wetlands

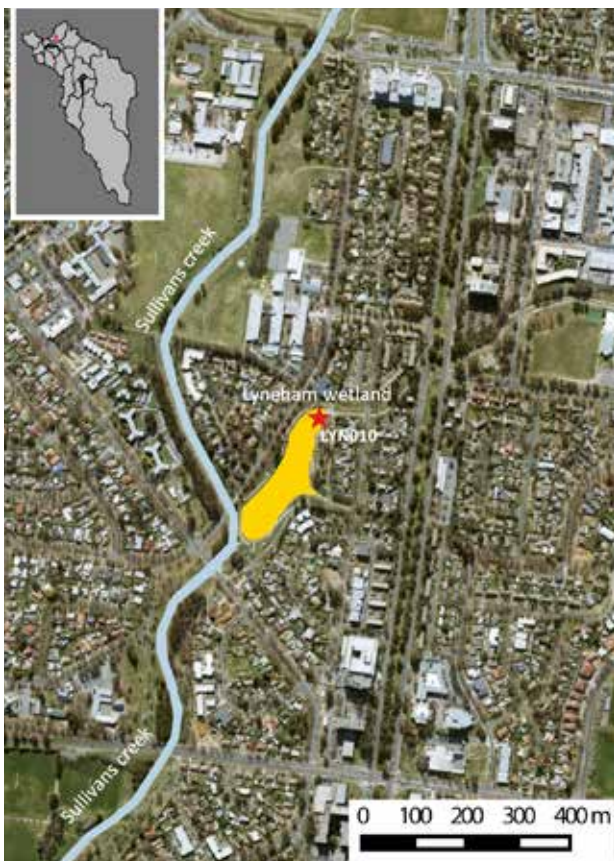
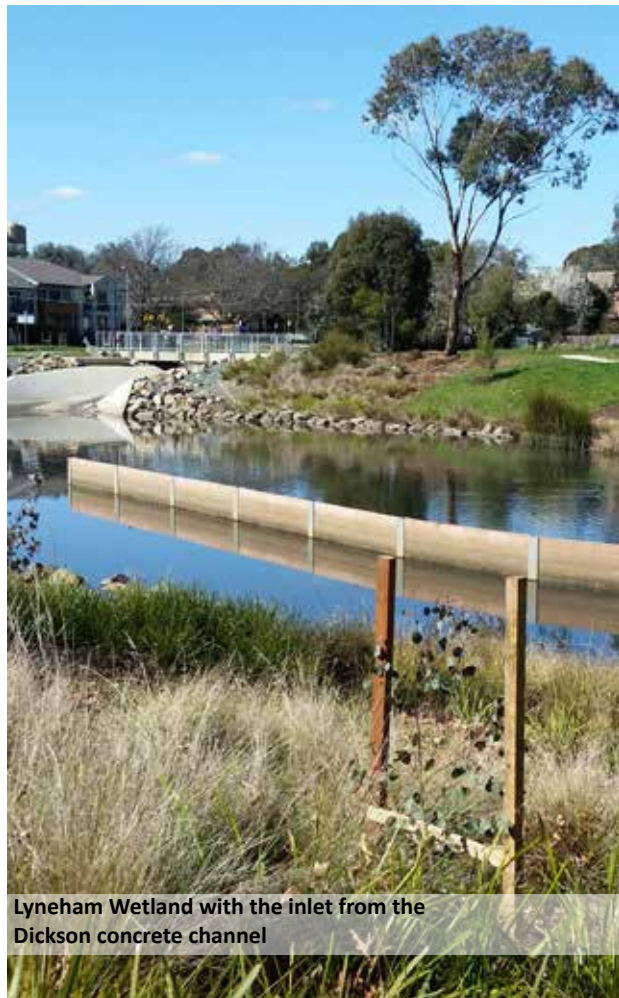
The water bug results at Lyneham Wetland were affected by a number of management actions during the past year. In Spring the Wetland was drained to address repairs and in Autumn, the water was pumped to Flemington Pond as part of the Inner North Reticulation Network to be used for irrigation. These events unfortunately coincided with the two bug surveys that found the usual water bug habitat of macrophytes were all above the water mark. This resulted in a greatly reduced water bug score with millions of large, orange daphnia being the main component of the Spring haul. Urban wetlands such as Lyneham were built with multiple uses in mind and getting the balance between water recycling, water quality treatment and biodiversity continues to be a challenge for managers.

Lyneham Wetland with the inlet from the Dickson concrete channel

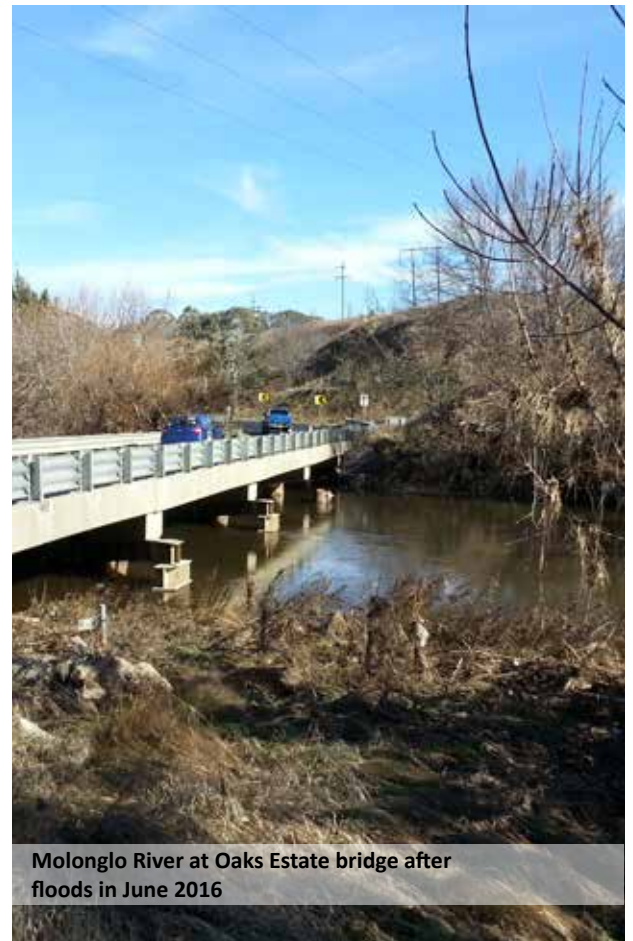
Water bugs were better than the previous year, but still rated as 'poor'. There were a dominant number of the tolerant true bugs (order: Hemiptera) observed such as water boatman that can take oxygen from the air and have the advantage of being able to fly to other waterways. The bug results reflect the generally poor riparian and instream vegetation and episodes of poorer water quality.

Molonglo River at Oaks Estate bridge after floods in June 2016

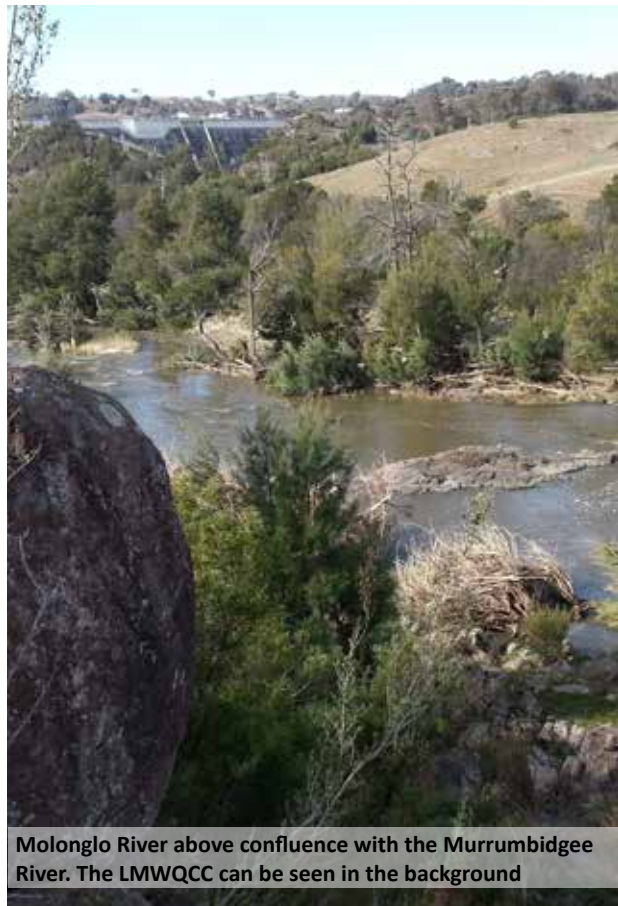
The extension of this reach has resulted in additional sites pushing the water quality score down and the riparian vegetation score up slightly. We had discontinuous data for all four sites, with the training of new volunteers. Dissolved oxygen may have been disproportionately affected by seasonal differences in the data collected, resulting in a 'degraded' score. The lowest site, below the LMWQCC, had very high nitrates (23 – 50 mg/L) when compared to the rest of the catchment. This is a management strategy to curb blue green algae growth. This site also contributed the highest electrical conductivity readings.

Molonglo River above confluence with the Murrumbidgee River. The LMWQCC can be seen in the background

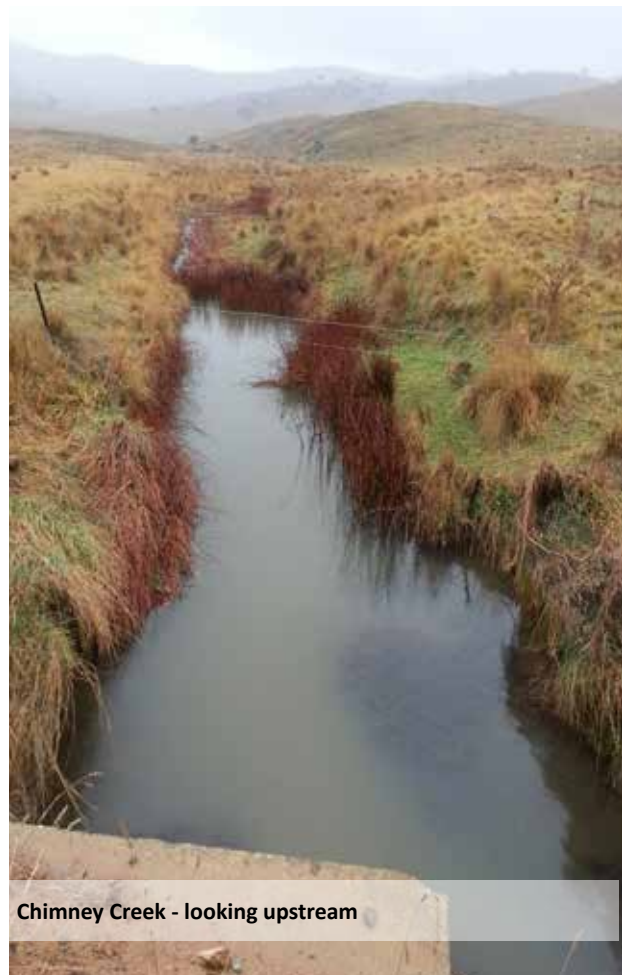
Chimney Creek - looking upstream

There was very little change between last year and this in water quality in this reach except dissolved oxygen, which moved from 'excellent' to 'good'. This is probably because flows were low for the majority of the testing. Electrical conductivity indicated a 'degraded' reach, however this too is likely linked to ongoing low flows, indicating that local geology and hydrology are playing a role here.

With its generally excellent water quality, this appears to be a small but important piece of biodiversity in the area, despite the very poor riparian vegetation throughout much of the reach.

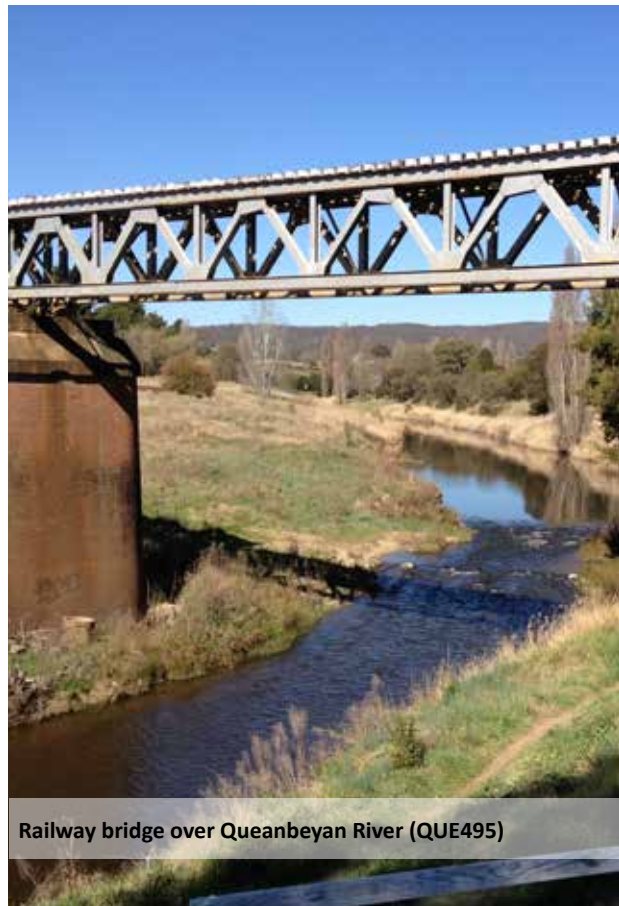
Railway bridge over Queanbeyan River (QUE495)

pH moved from 'fair' to 'excellent', probably resulting from a change in our testing method (from probes to strips) improving confidence in this data. Electrical conductivity rated as 'degraded' again this year, however all the highest readings are from Barracks Creek with possible causes being local geology and hydrogeology, as well as urban runoff. Likewise, the 'degraded' nitrates (N) is generally attributable to Barracks Creek, although N readings crept upwards on the Queanbeyan River which is something to watch as urbanisation upstream increases.

We plan to recruit a volunteer to sample water quality at the bottom of this reach (only water bug and riparian assessments were conducted at QUE495), so results next year should be less influenced by the small volume of water from Barracks Creek.

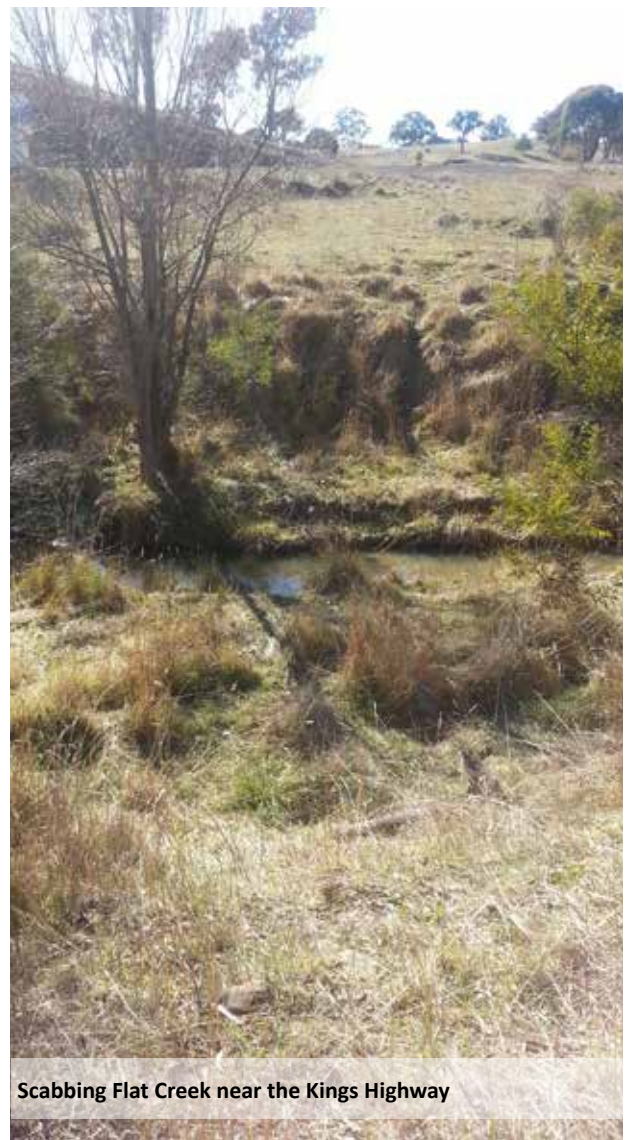
Riparian condition was assessed as 'fair', being at its worst close to the Kings Highway culvert, and rapidly improving upstream in Cuumbeun Nature Reserve.

Scabbing Flat Creek near the Kings Highway

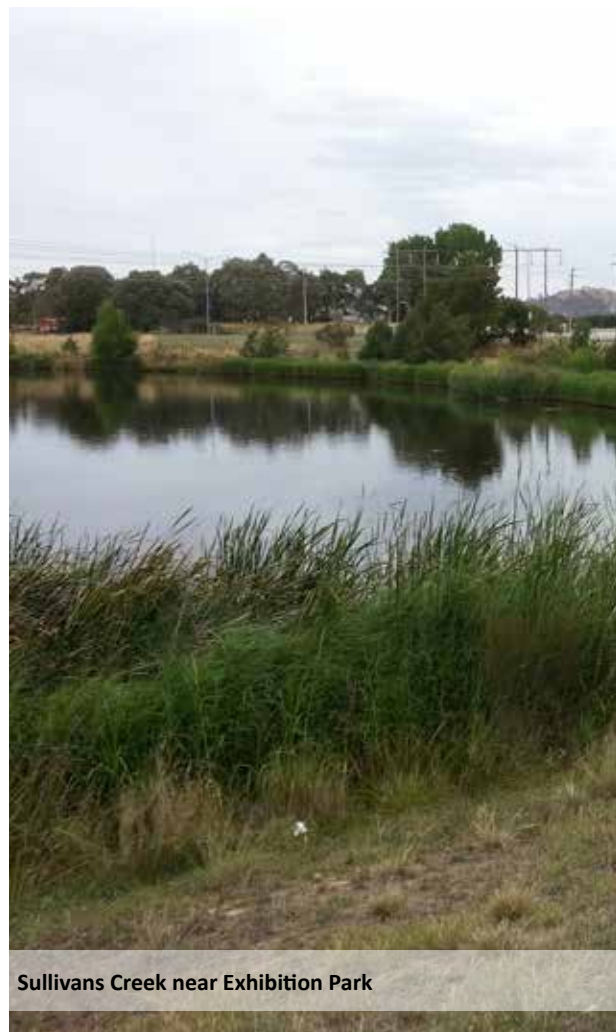
Sullivans Creek near Exhibition Park

Water quality was assessed as the worst in the catchment. While not all parameters were measured, with the low flows over much of the year at the two concrete drain sites, the 'poor' result is not surprising. The site at the constructed wetland generally had better water quality than the 'drain' sites with both high electrical conductivity ( $\leq 830 \mu\text{S/cm}$ ) and phosphorus ( $\leq 0.25 \text{ mg/L}$ ).

Sullivans Creek is an ephemeral creek collecting runoff from a large area, much of it degraded ex-rural land, new development and light industrial. Thus, adverse water quality impacts are to be expected. Extensive plantings planned for Gorooyaroo Nature Reserves (at the top of this catchment) as part of the 20 Million Trees program may play a role in improving this sub-catchment.

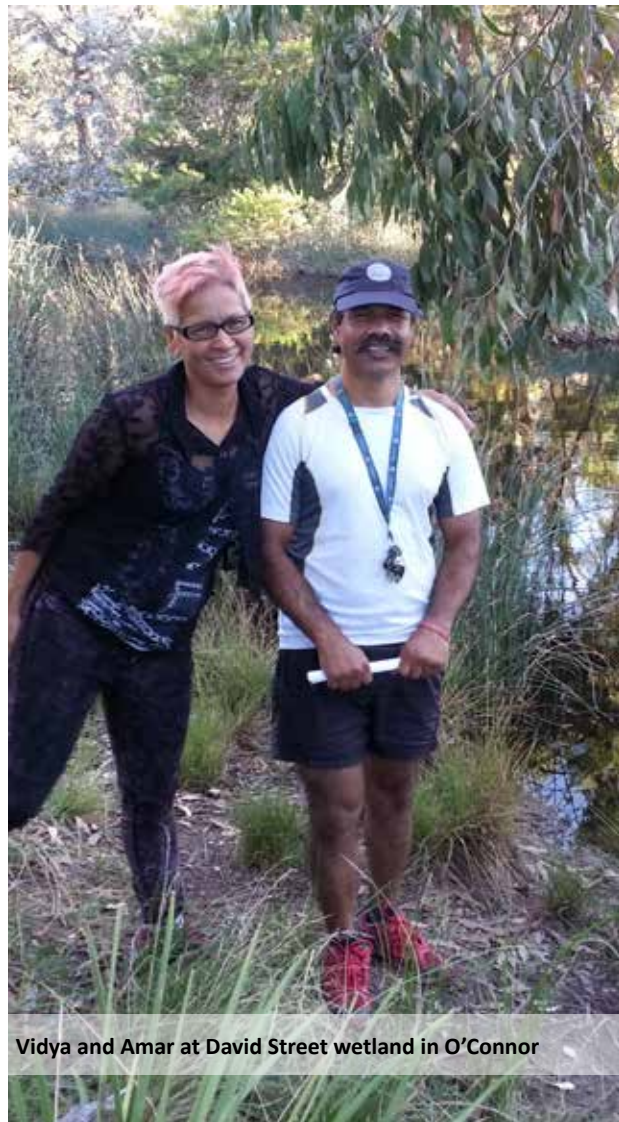
Very low flows over a hot Summer and dense algal growth made it extremely difficult to sample for water bugs, so the Autumn survey was not representative of the usual high diversity of water bugs at this wetland.

Water quality may sometimes be affected by the popularity of this wetland, with the volunteers Vidya and Amar observing that there was "a big dog swimming in the wetland" at the time of sampling.

Vidya and Amar at David Street wetland in O'Connor

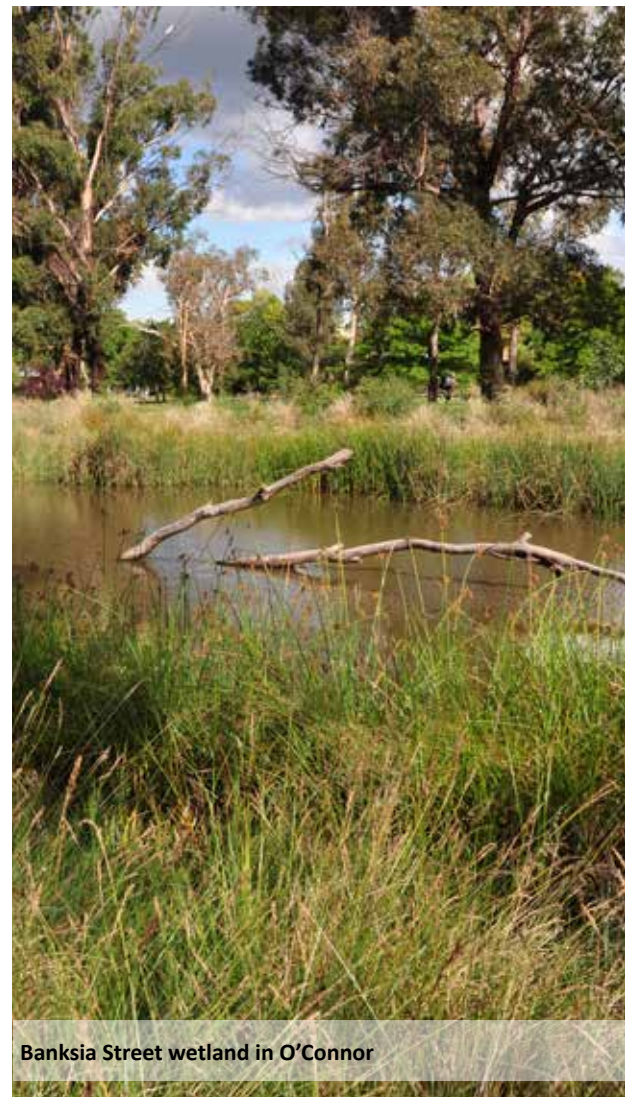
Banksia Street wetland in O'Connor

The single water bug survey, conducted in Spring 2015, indicated reasonable diversity of water bugs, with the majority being pollution tolerant. High algae growth was also noted.

Waterwatch is keen to recruit volunteers to sample water quality at this wetland, which has not been tested this year.

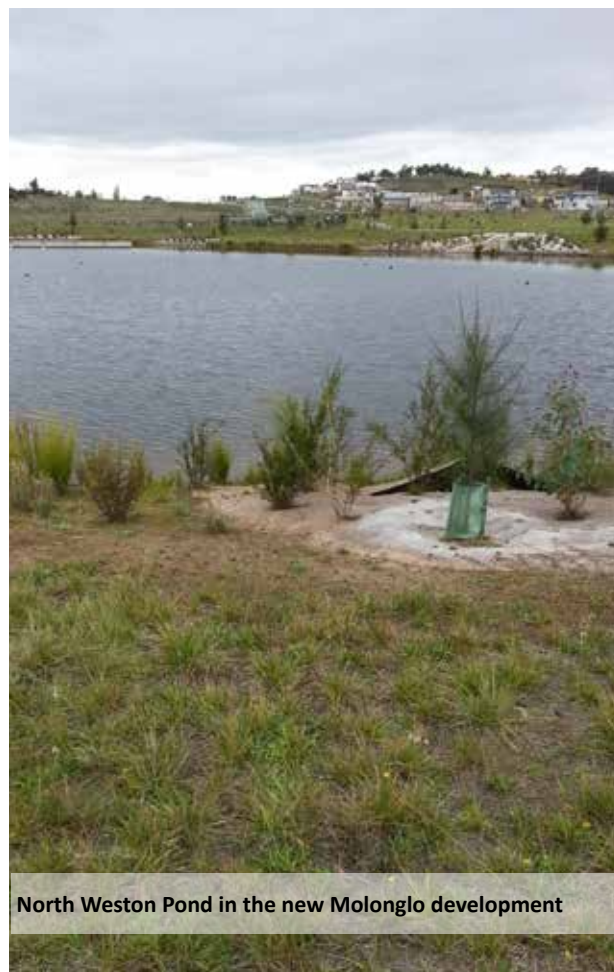
Water quality in this reach is extremely variable, particularly phosphorus and electrical conductivity. The North Weston Pond site has experienced eutrophication where you get a combination of high nutrient levels from urban runoff and warm temperatures lead to high levels of algae and bacteria (a 'bloom'). The 'bloom' then uses up all the nutrients, resulting in a mass die off of algae/bacteria. Their decomposition resulted in extremely low dissolved oxygen and high phosphorus at this site, and made the water noticeably smelly.

North Weston Pond in the new Molonglo development

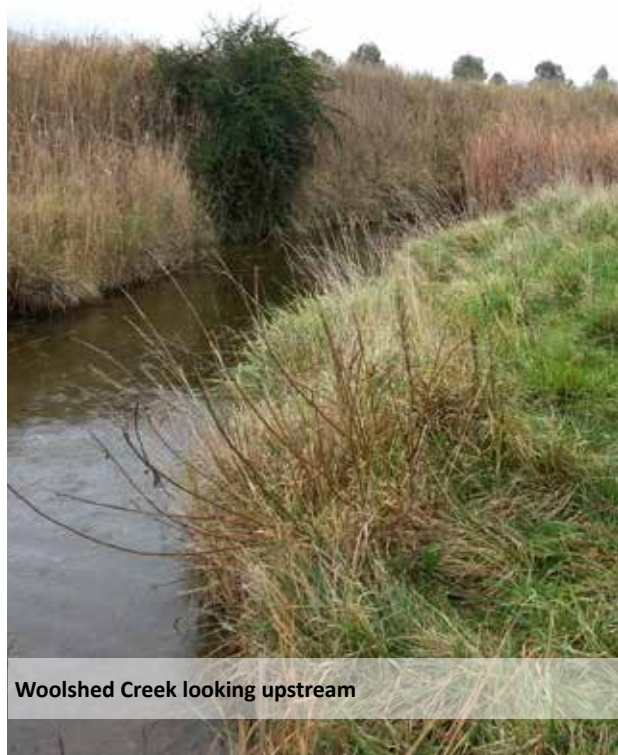
Water quality in the reach was very similar to last year, and electrical conductivity continues to be concerning, with minor seasonal saline outbreaks in land adjacent to the drainage line. This is an ephemeral creek, however, and low flows have a big impact on measured water quality and groundwater plays an important role. The waterholes along the creek provide important habitat, retaining water when the creek ceases to flow.

Woolshed Creek looking upstream

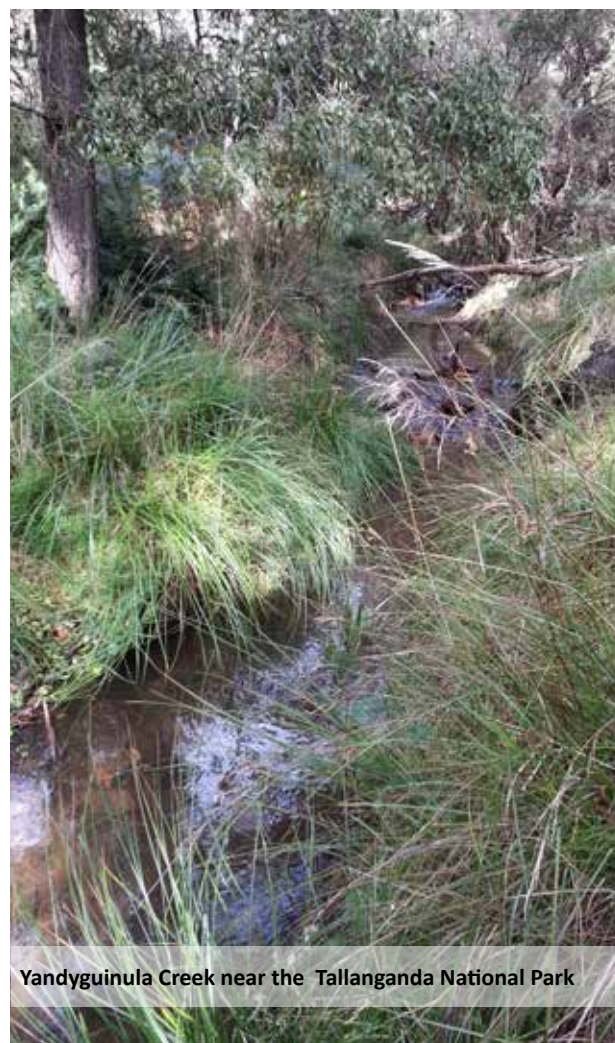
This creek has one pristine forest site upstream and one in rural land which is largely cleared of vegetation. The upper site had the highest riparian condition score in the Molonglo catchment, being a great example of intact wet Eucalypt forest.

Yandyguinula Creek near the Tallaganda National Park
