**WATERWATCH**

**Upper Murrumbidgee**

# Catchment Health Indicator Program

2015–16

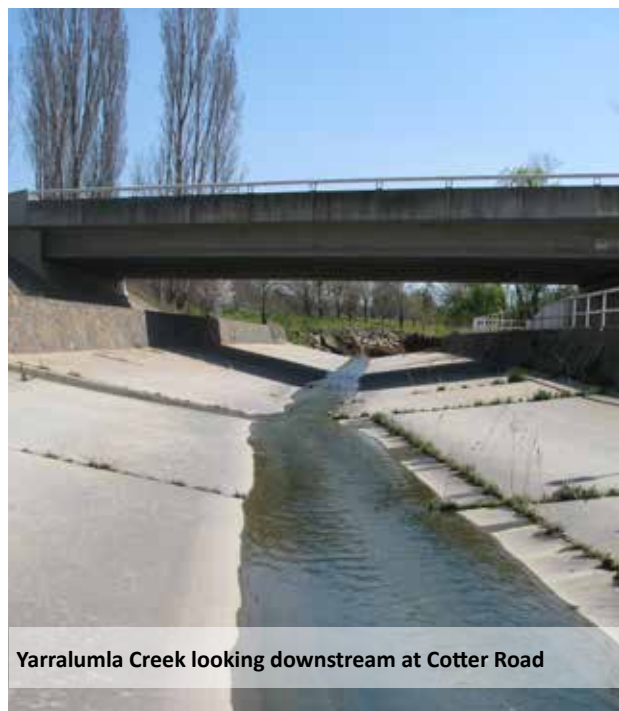
The gross pollution trap is just above the bottom site on this reach and it regularly overflows and washes rubbish downstream. This occurs with rapid changes in water flow which happens even after quite modest rainfall events. This is fairly typical of an urban catchment with many impervious surfaces. Erosion at the bottom of the reach continues to be a serious issue and improvements scheduled through Basin Project works will be welcomed.

Yarralumla Creek looking downstream at Cotter Road

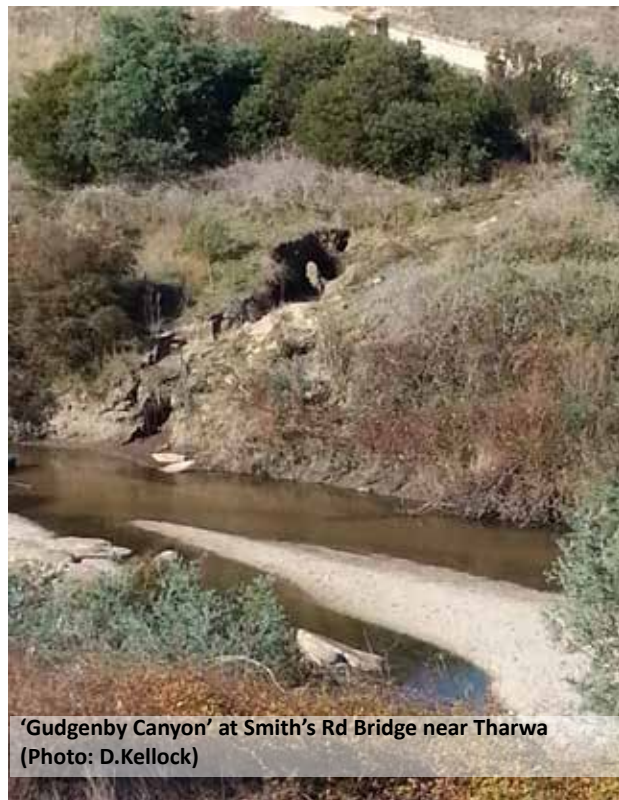
There was concern raised by volunteer Deb Kellock at CGG100 over increasing erosion occurring where the Smith's Road Bridge crosses the mouth of the Gudgenby River in Tharwa. This was resolved in February through reportings to the relevant ACT Government agencies.

'Gudgenby Canyon' at Smith's Rd Bridge near Tharwa  
(Photo: D.Kellock)

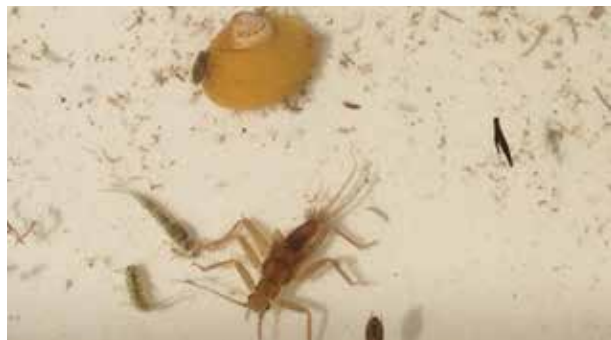
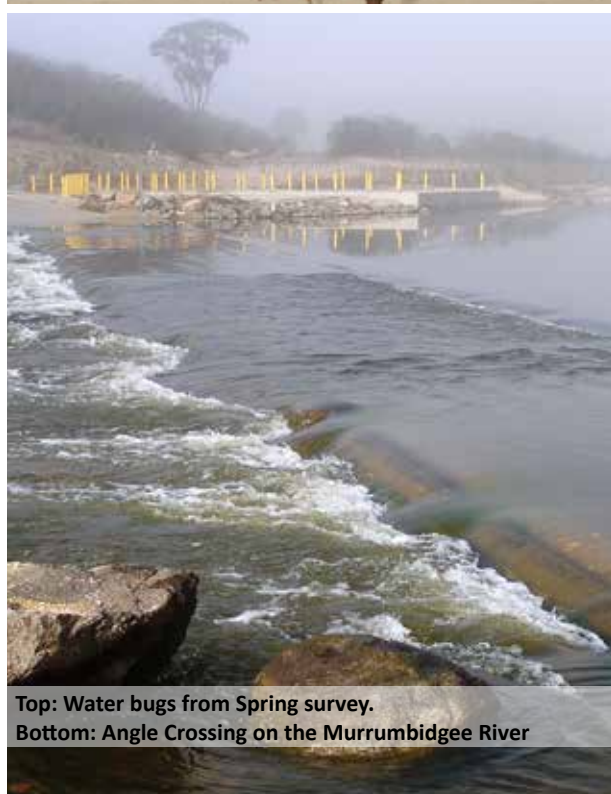
This section of the Murrumbidgee was looking good throughout Spring with a good flush from rain in the high country experienced a month before water bugs surveys were conducted. The Spring survey received an 'excellent' result with large number of sensitive stoneflies, caddisflies and mayflies as well as freshwater mussels which hadn't been recorded in the Murrumbidgee for some years. The Autumn water bug survey was also 'good' as the river picked up from a hot dry Summer.

Top: Water bugs from Spring survey.  
 Bottom: Angle Crossing on the Murrumbidgee River

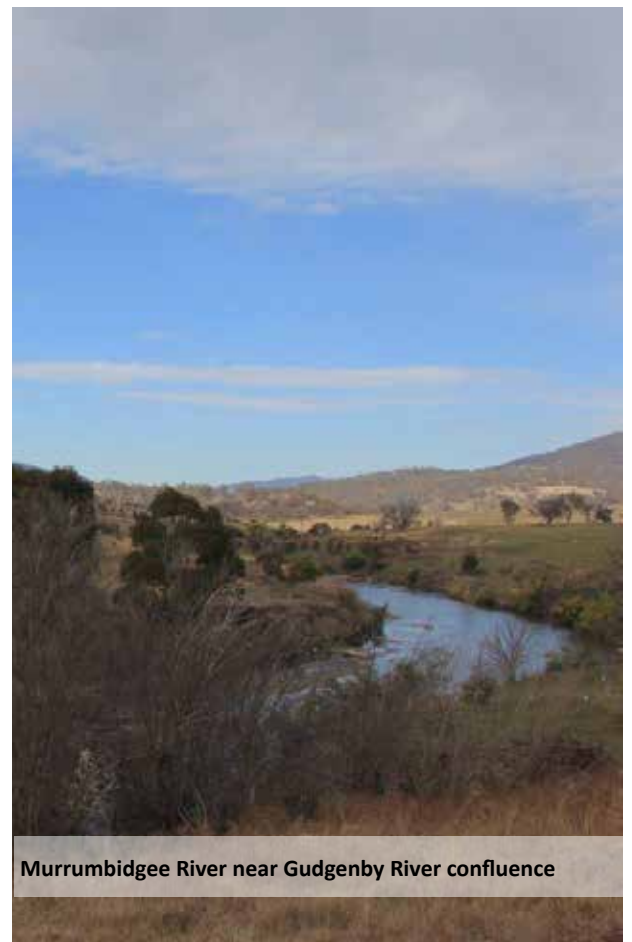
Murrumbidgee River near Gudgenby River confluence

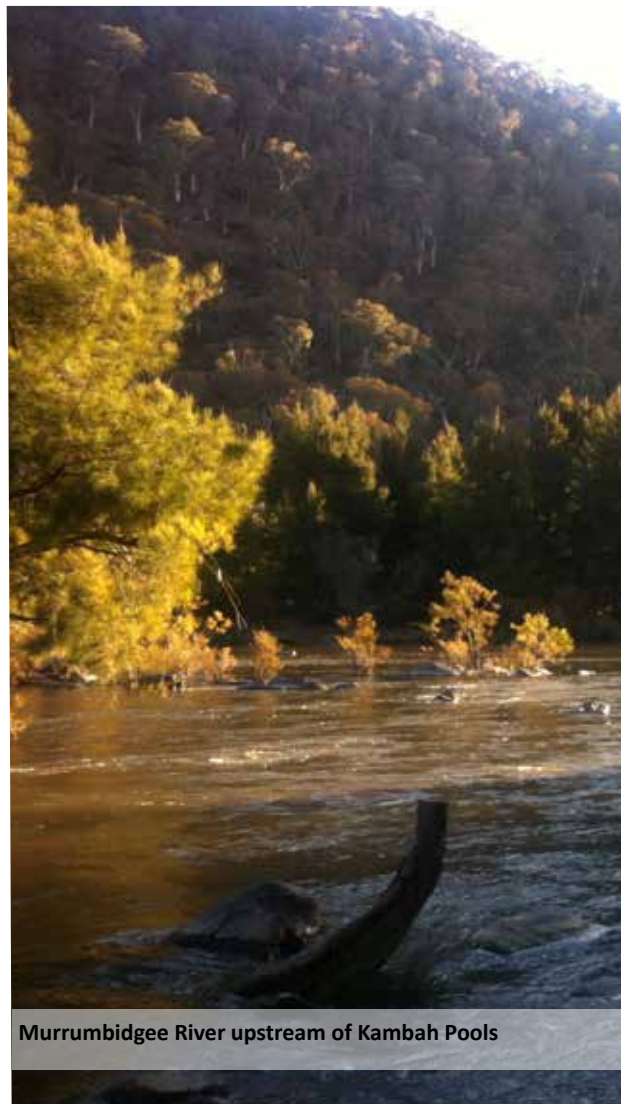
This section of the Murrumbidgee River in the ACT has the added influence of water from the Lake Tuggeranong and Point Hut Ponds catchments. In July 2015 Pine Island recorded turbidity of 50 NTU. By December, Kambah Pool was crystal clear, but experienced a turbidity spike (90 NTU) in early January. In June this year high rainfall experienced around the region drove the turbidity levels so high at Kambah Pool (400 NTU), the Green Army could not conduct the water tests that require colour comparisons. The turbidity recorded is a rare event only seen before in the Lake Tuggeranong catchment by this coordinator.

Murrumbidgee River upstream of Kambah Pools

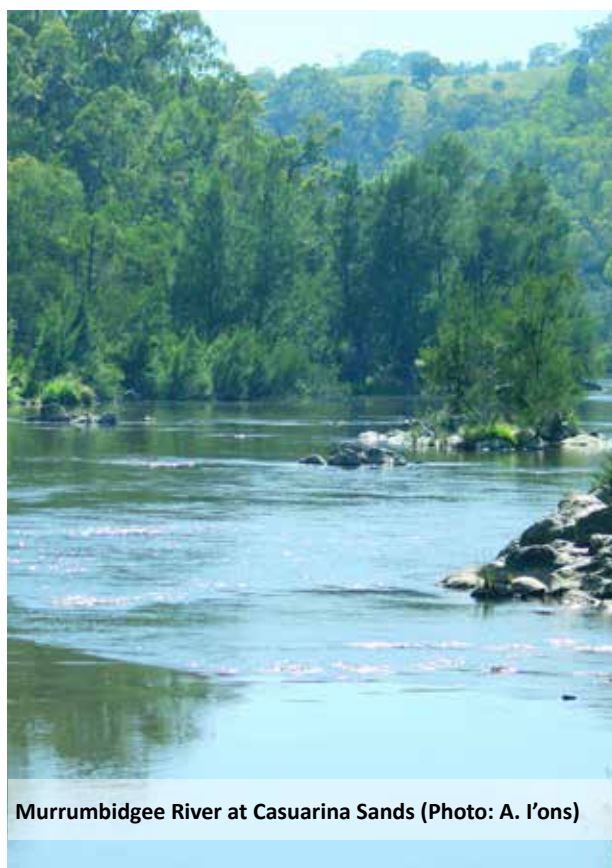
Wendy Rainbird of the 'Sands' group writes; "After good Winter rains, the Murrumbidgee is flowing fully. It is good to see!" Wendy also noted that some native trees had been chopped, and sand had been spread across the riparian zone, but a quick response from ACT Parks and Conservation Service' Shelley Swain provided a detailed picture of on-ground restoration works following the flood. This included smothering of lovegrass to control its spread, pruning of the Casuarinas to ensure good growth and longevity and planned replanting of the riparian zone this coming Spring.

Murrumbidgee River at Casuarina Sands (Photo: A. I'ons)

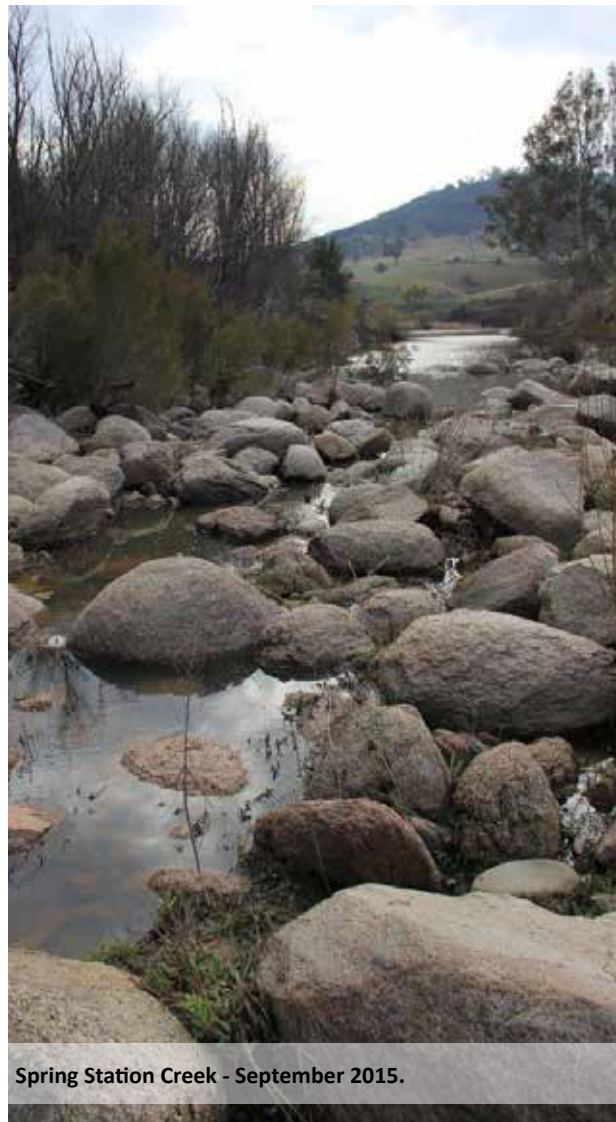
Spring Station Creek - September 2015.

The riparian condition in this reach is poor, with a narrow riparian zone with limited groundcover and canopy cover. This will remain so until significant revegetation occurs, through either natural regrowth or through planned plantings. This is not an isolated issue for a number of small, rural creeks in southern ACT.

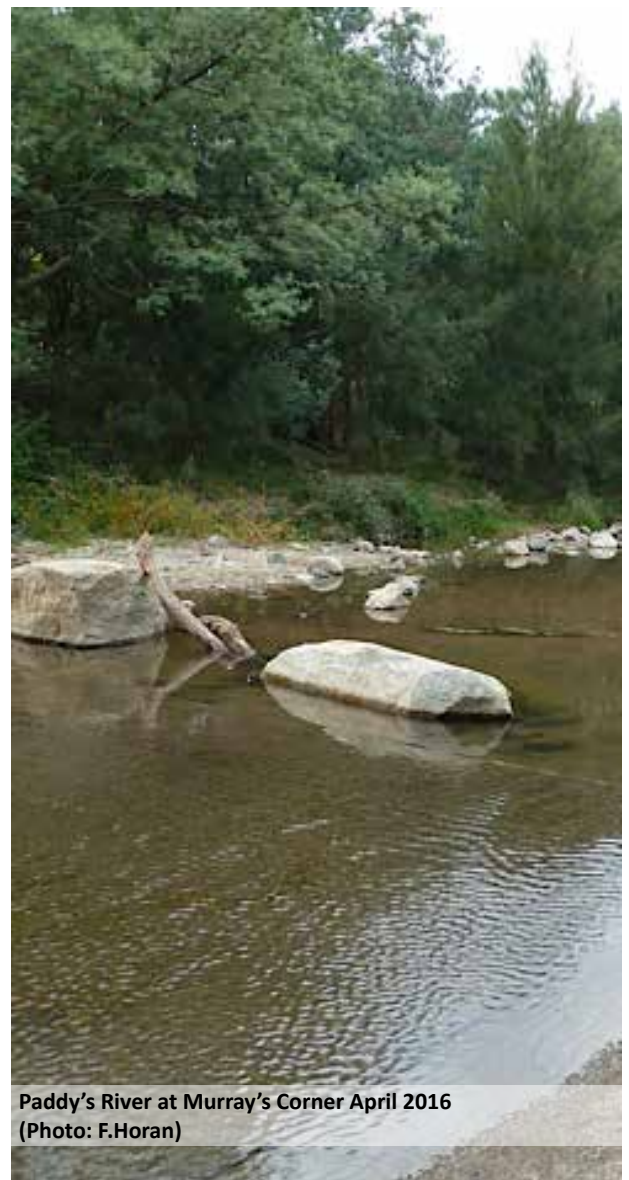
Paddy's River at Murray's Corner April 2016  
(Photo: F.Horan)

Paddy's River was clear with low flow volumes in early Summer. Heavy showers in later December moved a lot of sediment that was detected by PCS Ranger Bernie at Flint's Crossing in January (100 NTU). Fleur and Maree (Paddy's Waterwatch team) noted very little increase in water levels, just lots of gravel and weeds. Turbidity events from along much of the upper stretches of this River are a constant issue when there is decent rainfall. Steep unstable soils in the headwaters of the Booroomba Homestead region are a key contributor.

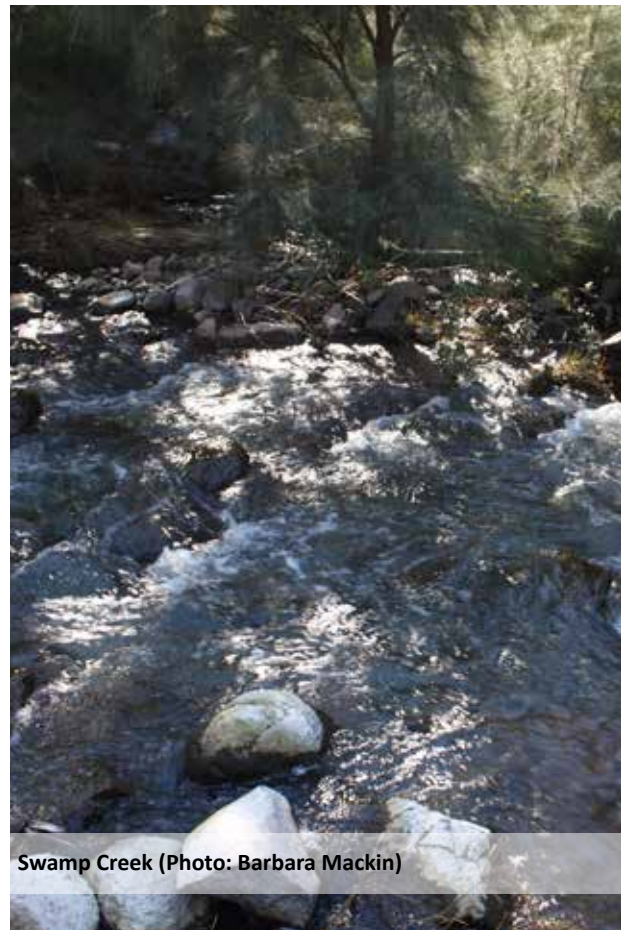
Swamp Creek (Photo: Barbara Mackin)

Barbara Mackin, from Uriarra Parkcare, found this little creek running crystal clear again this year, with the exception of a single survey of 20 NTU, which she described beautifully: "First time I hadn't seen the bottom of the turbidity tube".

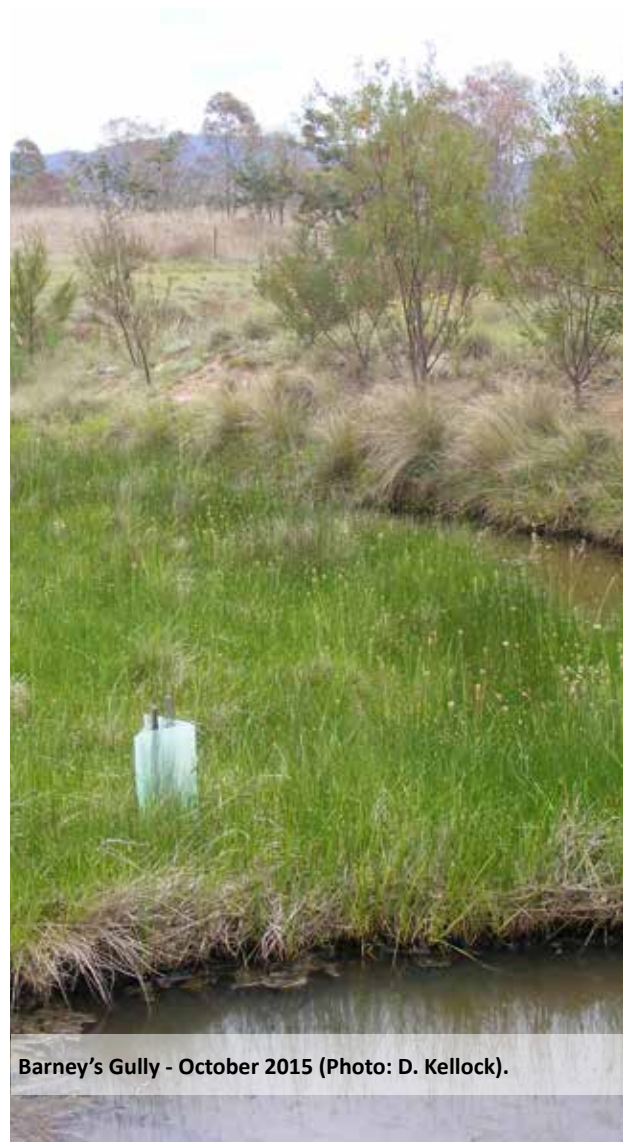
Barney's Gully - October 2015 (Photo: D. Kellock).

This natural creek line provides a good comparison to other 'creeks' in the suburban Tuggeranong region that have been engineered into stormwater channels that terminate in artificial ponds and lakes. Low flows and stagnant water conditions were reported which is typical for this ephemeral creek. Of concern was the reporting by volunteer Deb Kellock, from the Parkcarers of Southern Murrumbidgee (P.O.S.M) group, of an oily brown gunk on the water's surface, and milky brown water of 35 NTU of unknown origin.

Remedial work by P.O.S.M have had an enormous positive impact. High turbidity after heavy rain used to be an issue with the fragility and exposure of much of the surrounding soil but this is less the case now. Abundant reeds and groundcover support multiple species of frogs that are regularly reported calling in this reach.

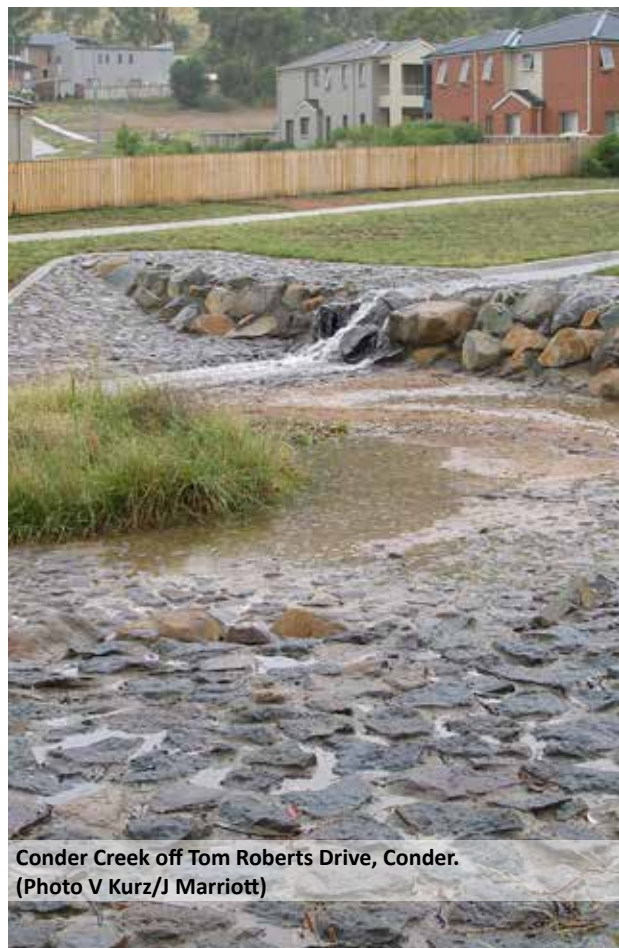
Conder Creek off Tom Roberts Drive, Conder.  
(Photo V Kurz/J Marriott)

Other issues identified over the last 12 months include strange smells in December, high phosphorus levels from January to March, clogged drains in January, and a stagnant gross pollutant trap (GPT). Steve from 'Carers of Point Hut Pond' Waterwatch noted the continued garnish of a submerged motorcycle at the southern end of the lake while Vera Kutz found the GPT under Box Hill Avenue very stagnant.

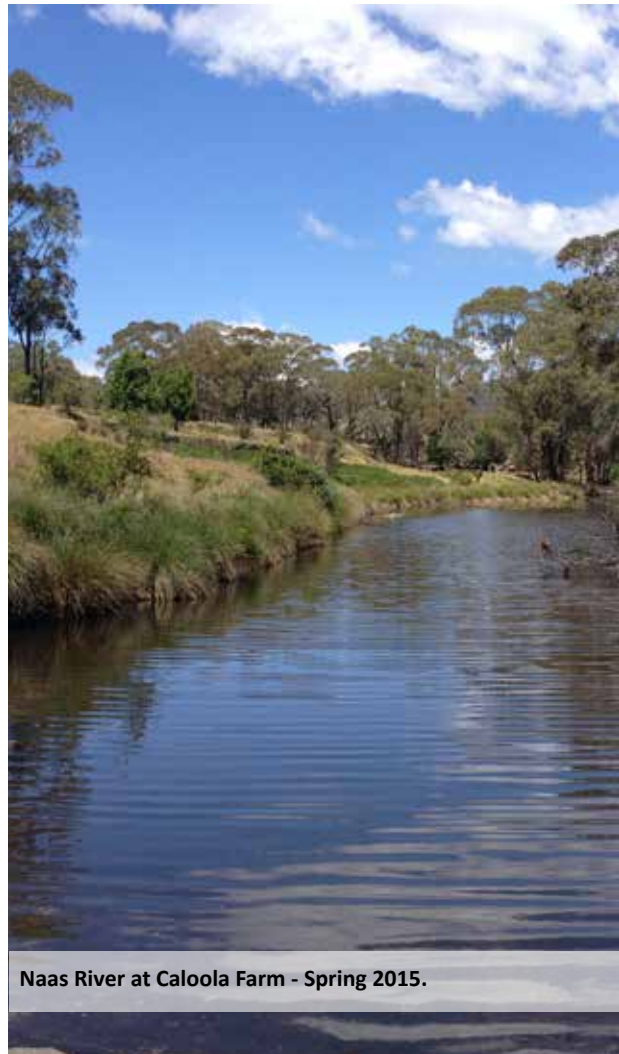
Naas River at Caloola Farm - Spring 2015.

Volunteers Danica Tagaza found the Naas River dry at Caloola Farm for most of Summer. Gudgenby Creek still had water, but it was salty (high electrical conductivity), high in phosphorus and full of cows.

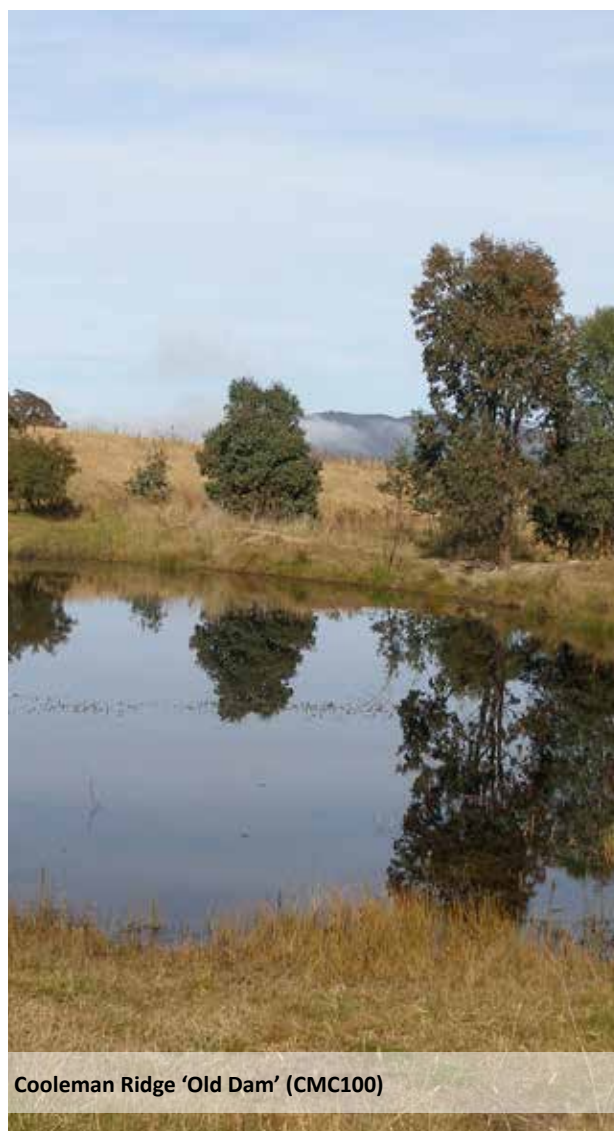
Coolleman Ridge 'Old Dam' (CMC100)

The Coolleman Ridge Parkcarers found the usual high phosphorus (0.1 – 0.2 mg/L) and turbidity (30 – 100 NTU) in both dams. Cattle have regular access to one of the dams but the persistently high phosphorus readings in the other is a continuing mystery. It's could possibly be blamed on historic use of super-phosphate on the ridge in its past, or potentially high use by waterbirds. Nitrates were not detected during any survey, while dissolved oxygen levels (3.8 – 10 mg/L) were respectable for these dams with their considerable water quality issues.

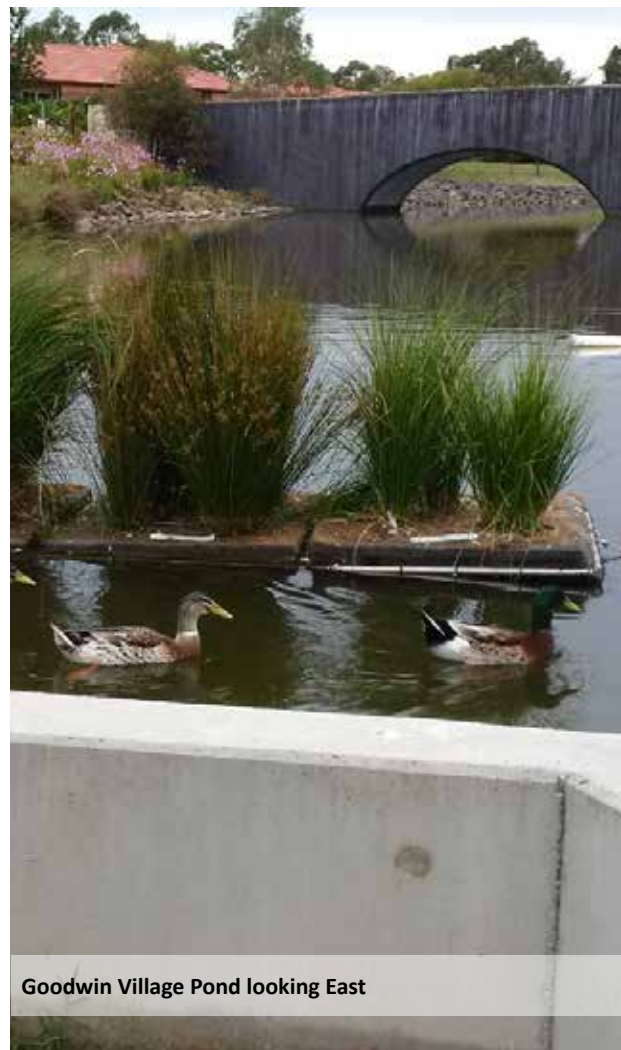
Goodwin Village Pond looking East

Dissolved oxygen levels (as low as 62% saturation) reflect the lack of flow and lack of any mature vegetation around the pond to provide any shade in hot months. The pond is fed mostly from run off from the surrounding village.

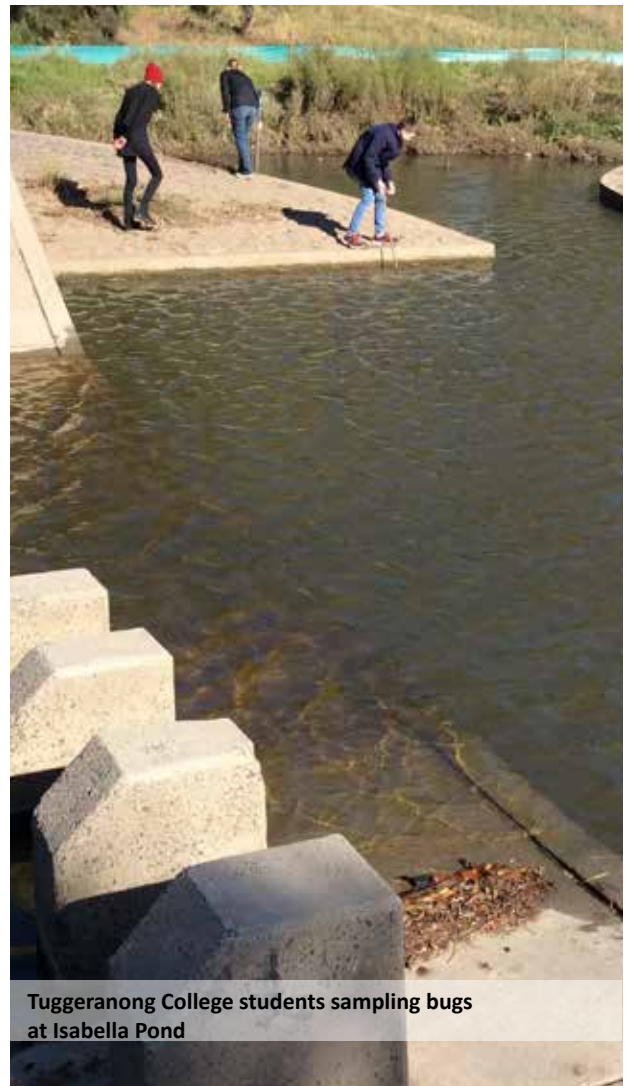
With increased rain in a concrete drain, however, come other problems. Volunteers Walt Daly, Eileen Becker and Stuart Young have been sharing Isabella Pond. The southern storm water entry experienced unusual rubbish (including a lawn mower), strange smells and extreme turbidity after heavy rain in February (82 NTU).

Tuggeranong College students sampling bugs at Isabella Pond

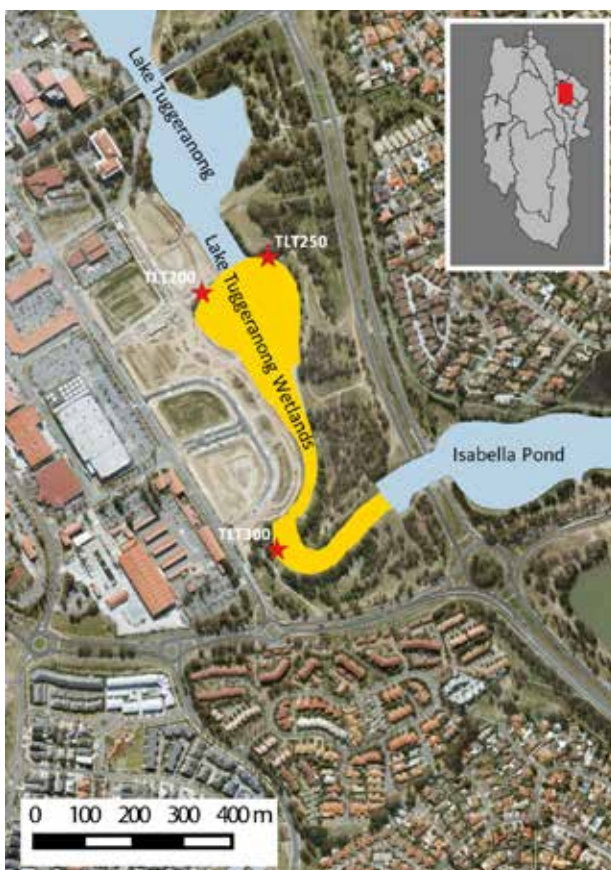
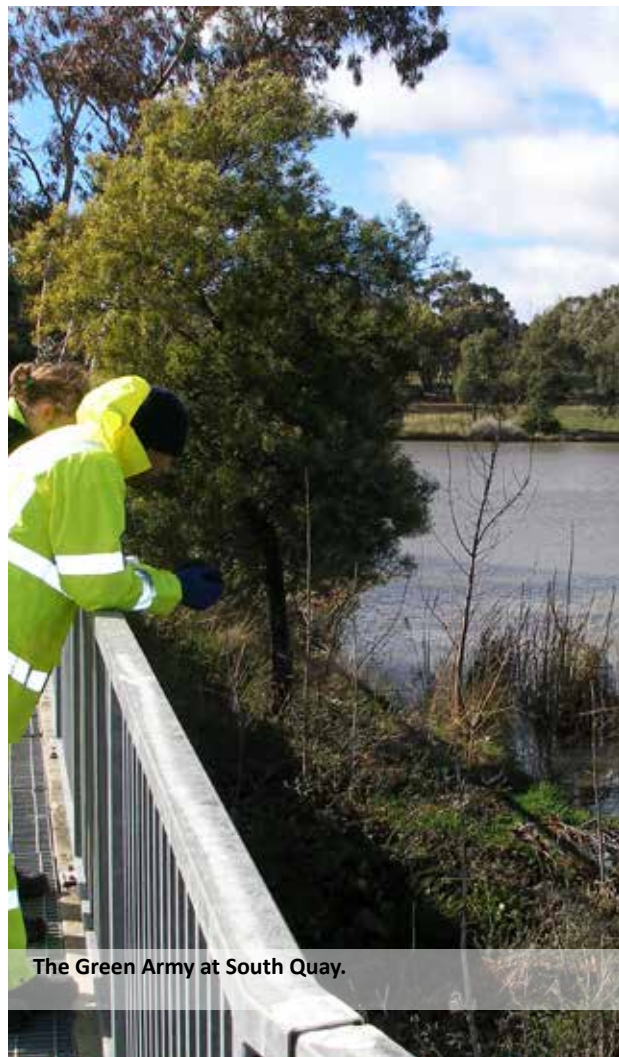
South Quay and the wetlands upstream recorded turbidity of 30 NTU in March after heavy rain and the wetlands had a low dissolved oxygen reading of 3.8 mg/L, possibly due to oxygen-deplete water from Isabella Pond being flushed over the Drakeford Drive wall.

The Green Army at South Quay.

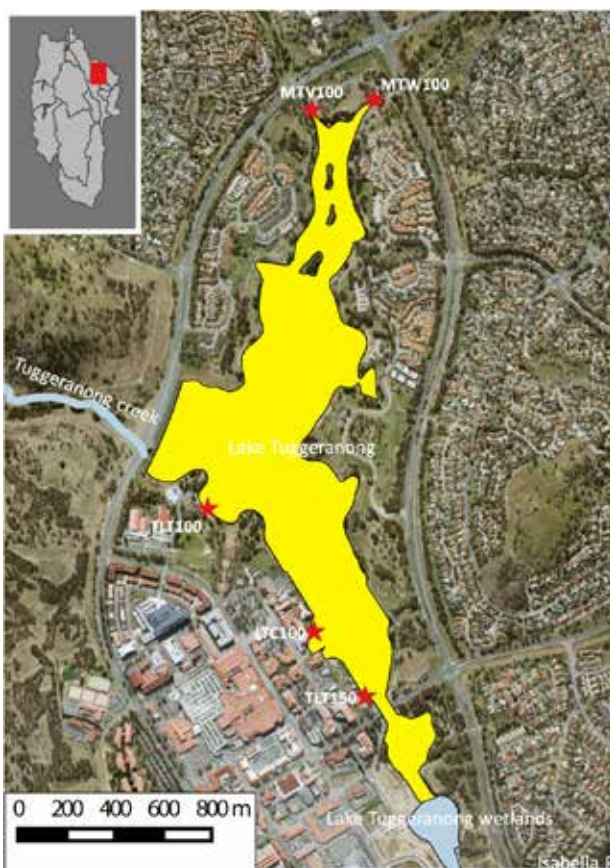
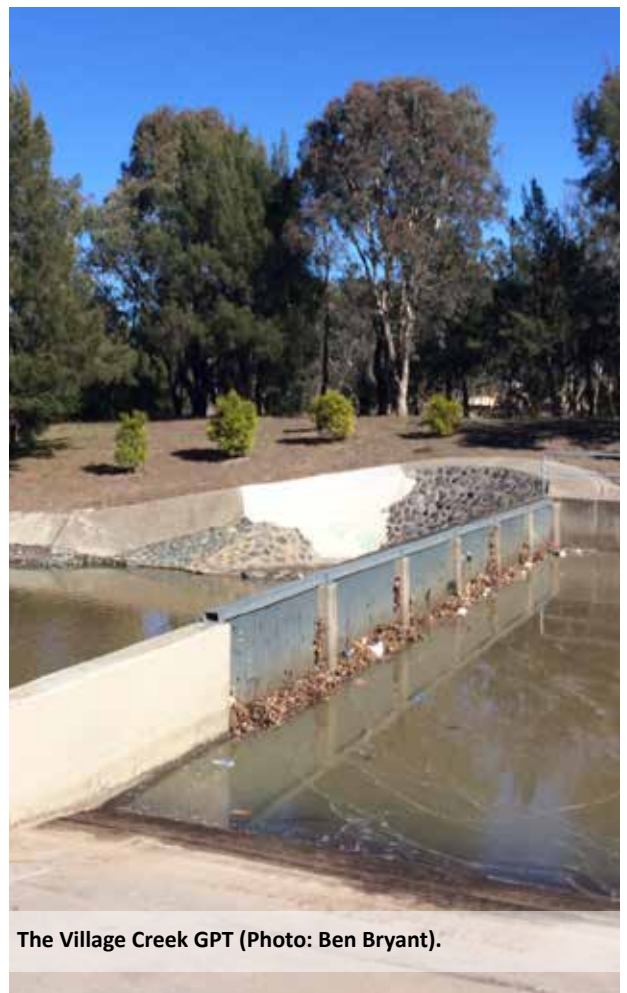
The Village Creek GPT (Photo: Ben Bryant).

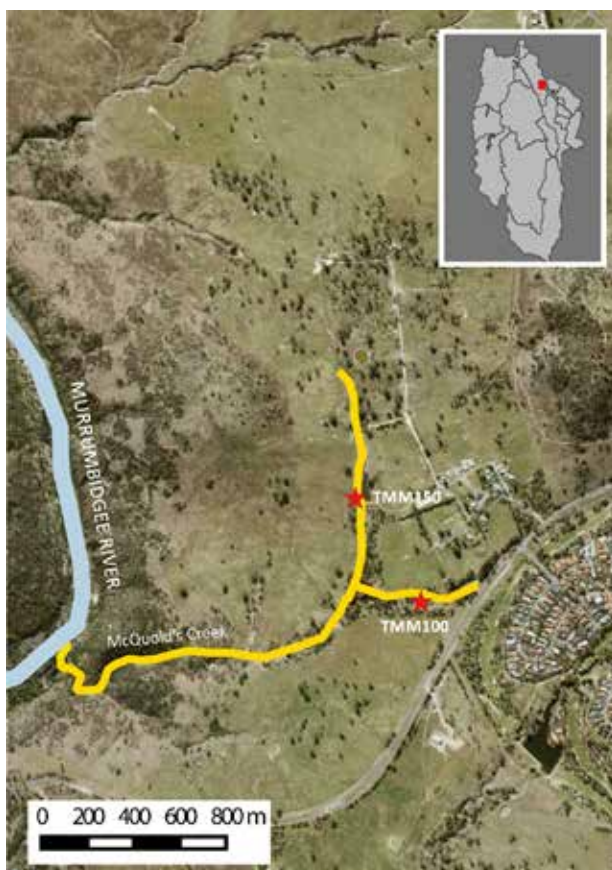
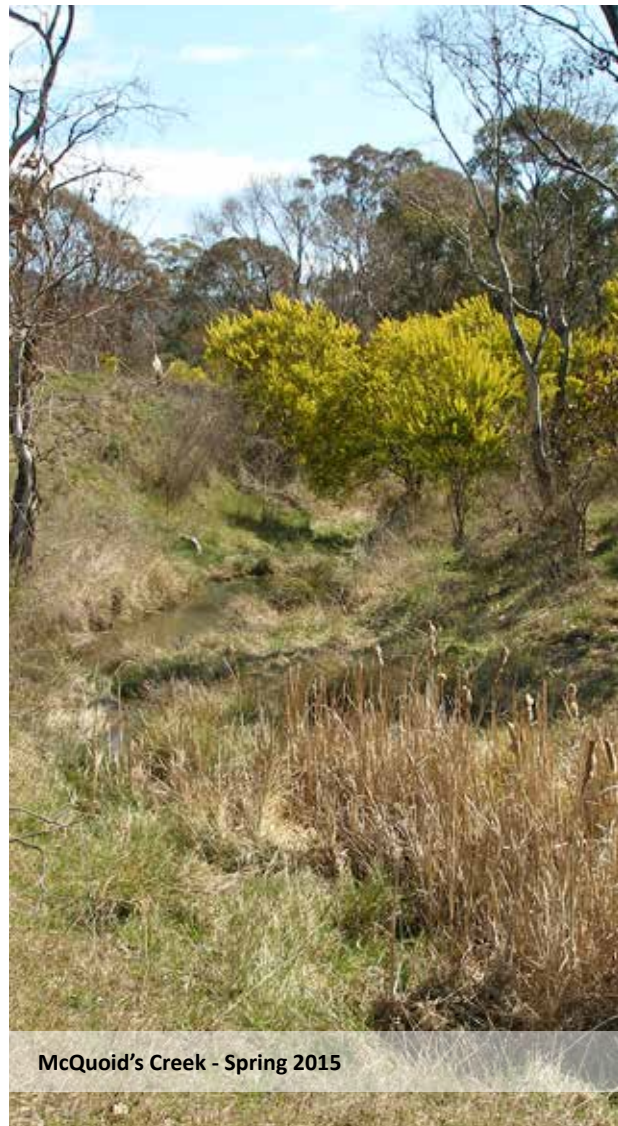
The riparian zone in this reach is generally low in understorey and canopy species, and very poor with regards to the lack of reeds, tussocks, dead trees and fallen logs that contribute greatly to the overall habitat and health of our waterways.

McQuoid's Creek - Spring 2015

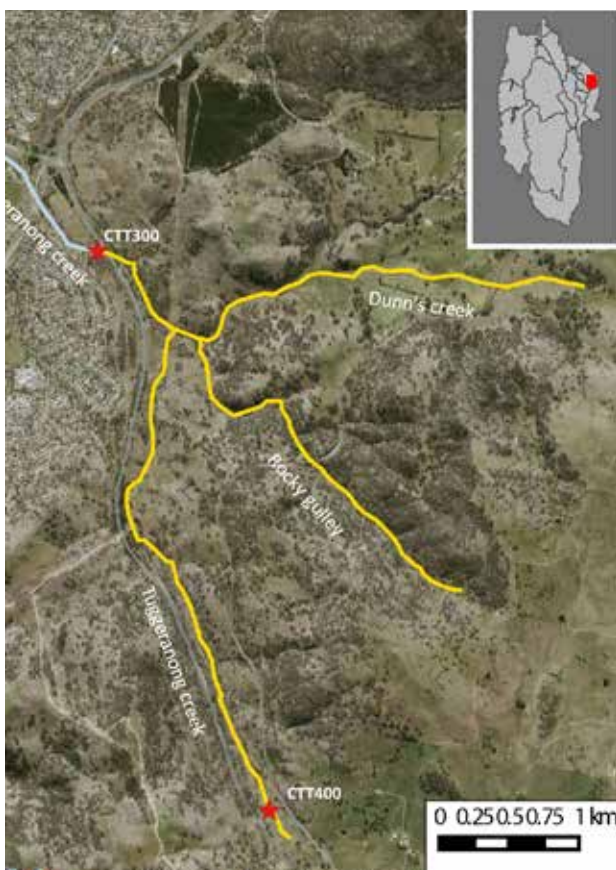
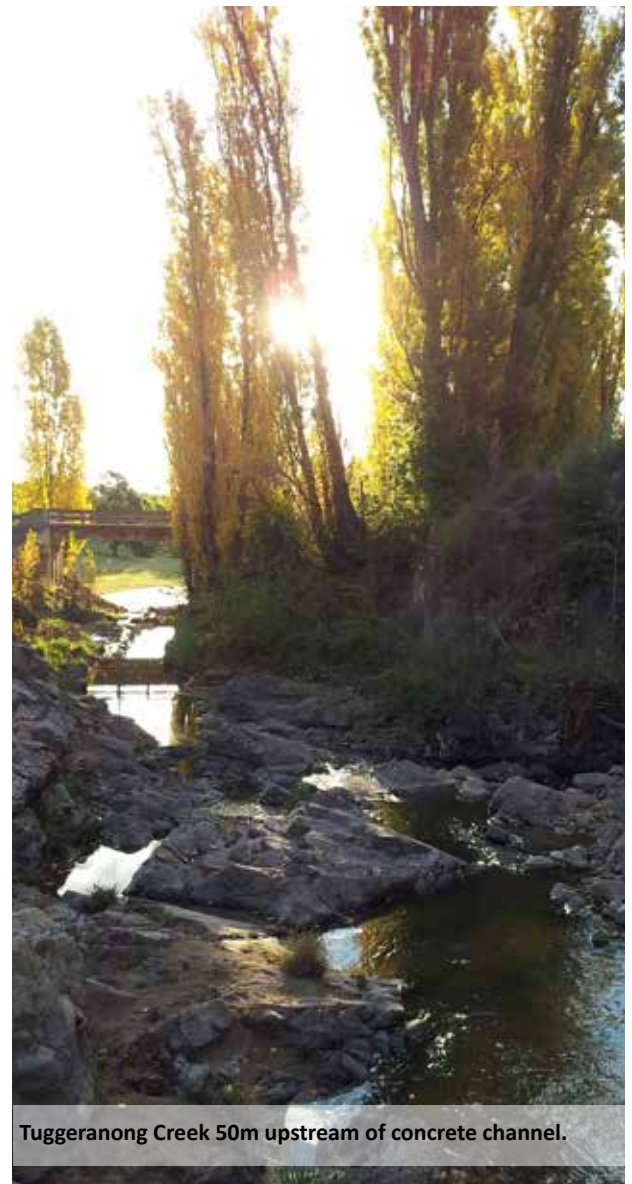
Volunteers Eileen Becker and Stuart Young found the top of Tuggeranong Creek with low water levels, high in turbidity ( $\leq 50$  NTU), high in electrical conductivity ( $\leq 418 \mu\text{S/cm}$ ) and full of rubbish in January. The Summer and school holidays are never kind to this little part of the creek.

Tuggeranong Creek 50m upstream of concrete channel.

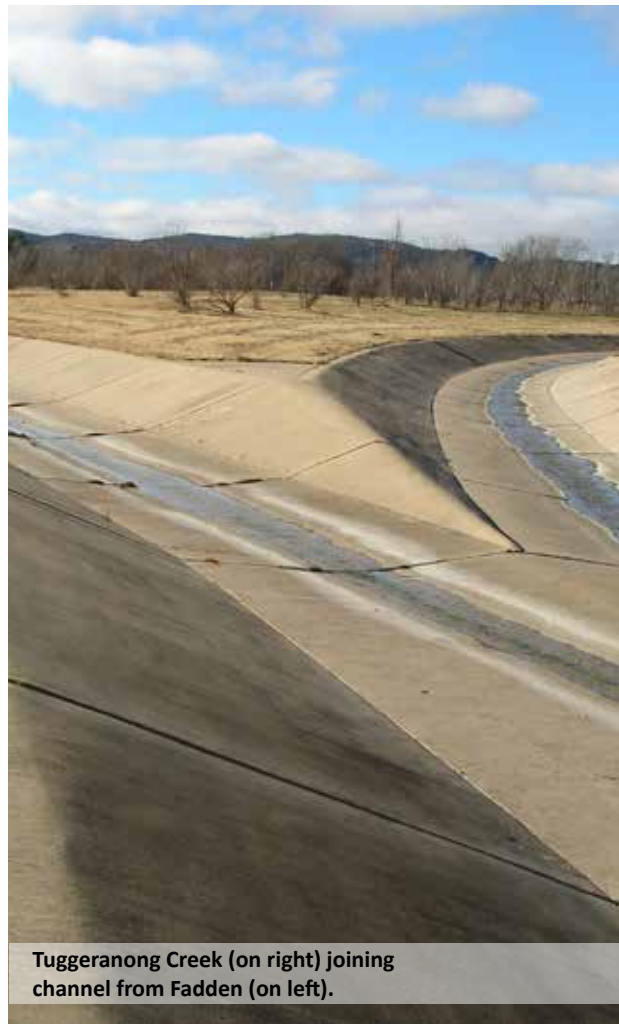
This concrete lined reach can only ever achieve reasonable CHIP values for water quality when rain sends fresh water flowing down the channel. Electrical conductivity is the highest in the southern ACT catchments (33 – 1030  $\mu\text{S}/\text{cm}$ ), while turbidity was generally low, reaching a peak of 43 NTU in July 2015. Both phosphorus (0 – 0.8mg/L) and nitrates (0 – 10 mg/L) intermittently reach very high levels. In Summer, unusually high pH levels (7 – 10) were recorded in the drain under Ashley Drive.

Water bugs and riparian vegetation are all but non-existent. Difficult bug surveys were again conducted by the terrific students from Caroline Chisholm School. To find any living animals in this concrete drain involves crawling along the concrete with a spoon or pipette, as it is insufficient water to run a net. Just a single lonely yabby was sampled in this section of Tuggeranong Creek.

Tuggeranong Creek (on right) joining channel from Fadden (on left).

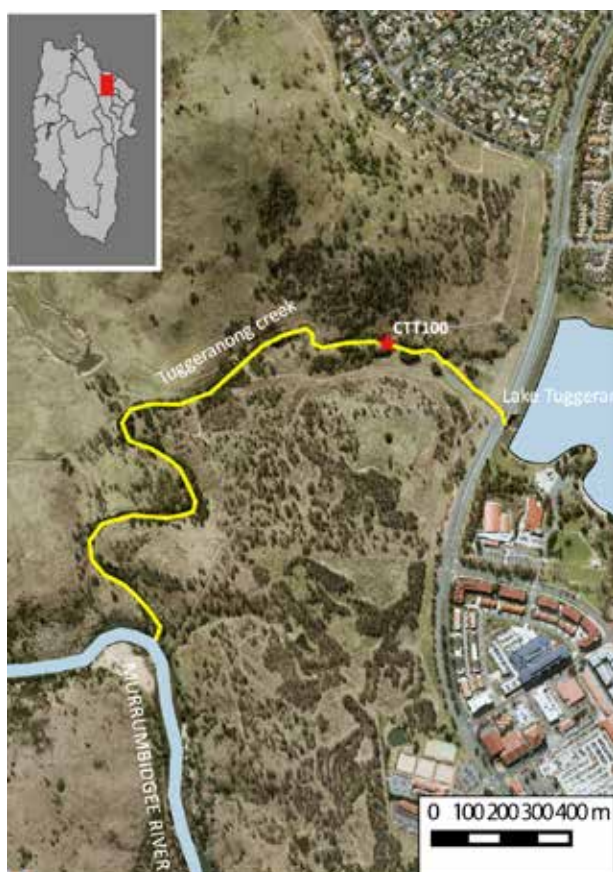
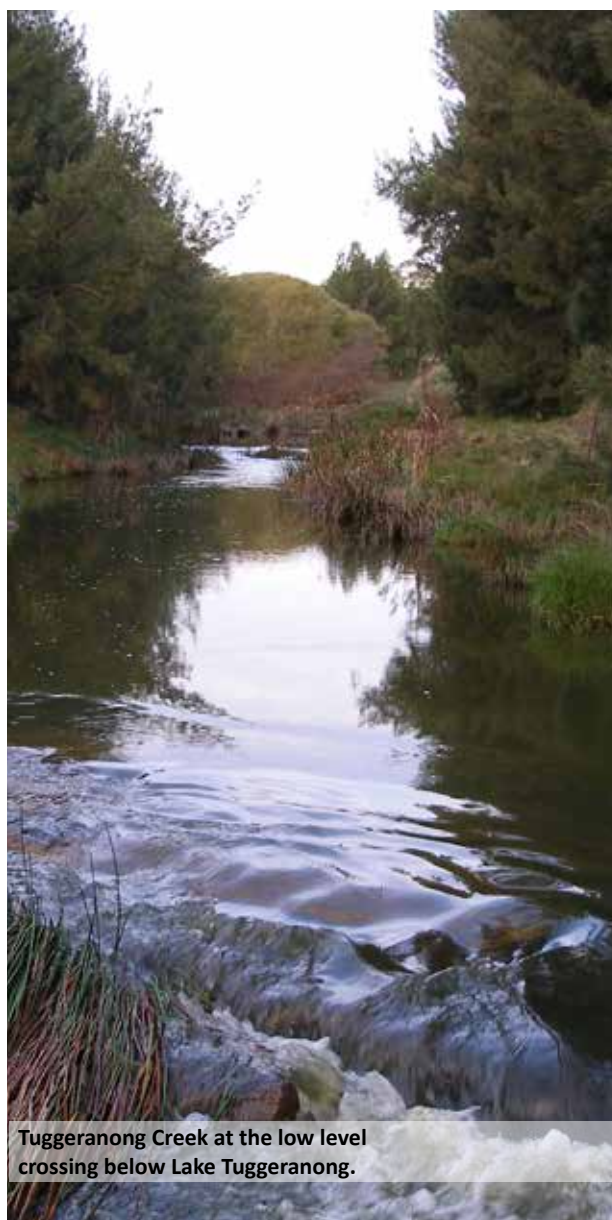
Below Lake Tuggeranong Dam, the Green Army reported high electrical conductivity (100 – 400  $\mu\text{S}/\text{cm}$ ), high nitrate levels (0 – 5 mg/L) and low flows in this little creek in early Summer. A water bug survey in Autumn contained 8 taxa including mayfly and caddisfly larvae in low numbers. This contrasts with the Spring survey which reported only 4 water bug taxa. This rapid reestablishment of sensitive species in this reach by Autumn is interesting to note.

Tuggeranong Creek at the low level crossing below Lake Tuggeranong.

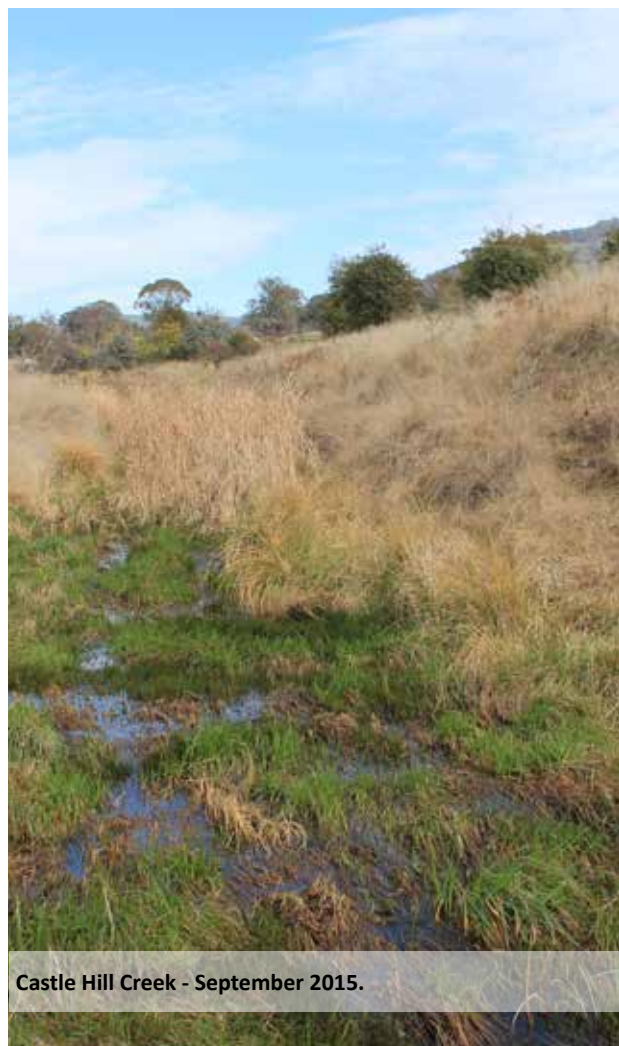
A riparian vegetation survey conducted last year showed a lack of canopy or understory, and no groundcover features such as fallen logs or leaf litter. This is a significant contributor to the 'fair' health assessment this creek has received.

Castle Hill Creek - September 2015.

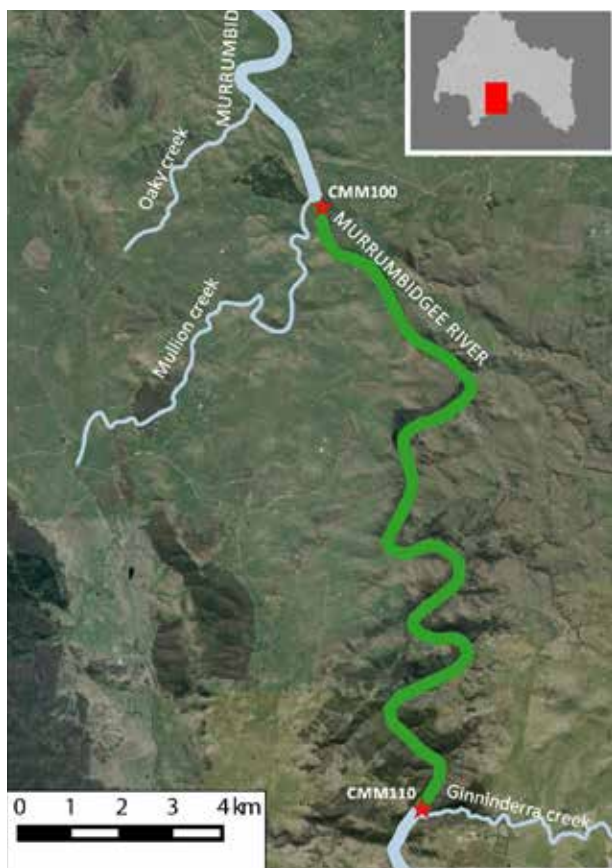
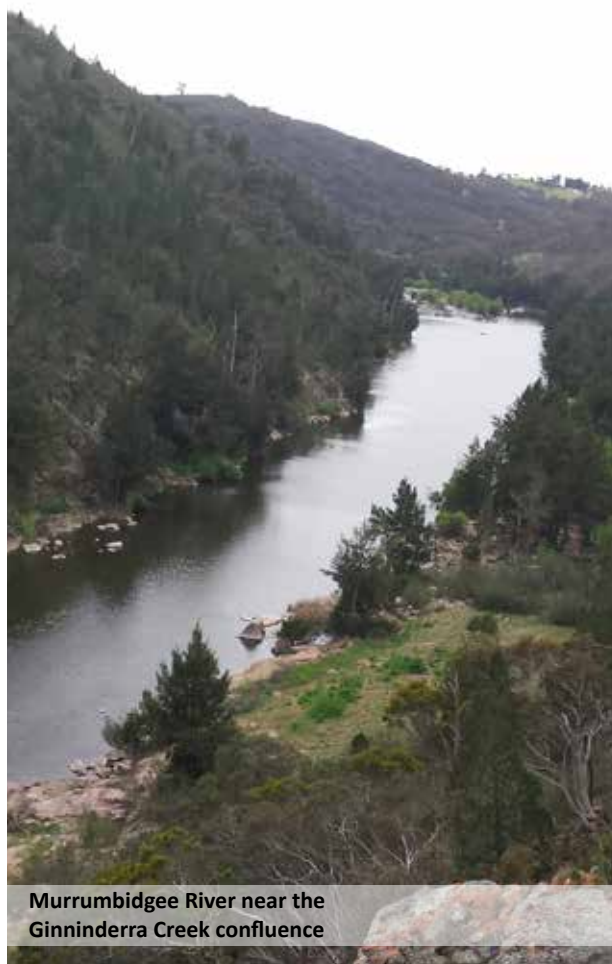
The riparian condition varies considerably through this reach. The upper section contains some of the most intact remnant patches in the area with steep rough terrain protecting the native species in the riparian zone. In contrast the lower section has many areas dominated by exotic weed species. The inaccessibility of the upper section means that this is a good place to see Platypus with kayakers reporting regular sightings.

Murrumbidgee River near the Ginninderra Creek confluence

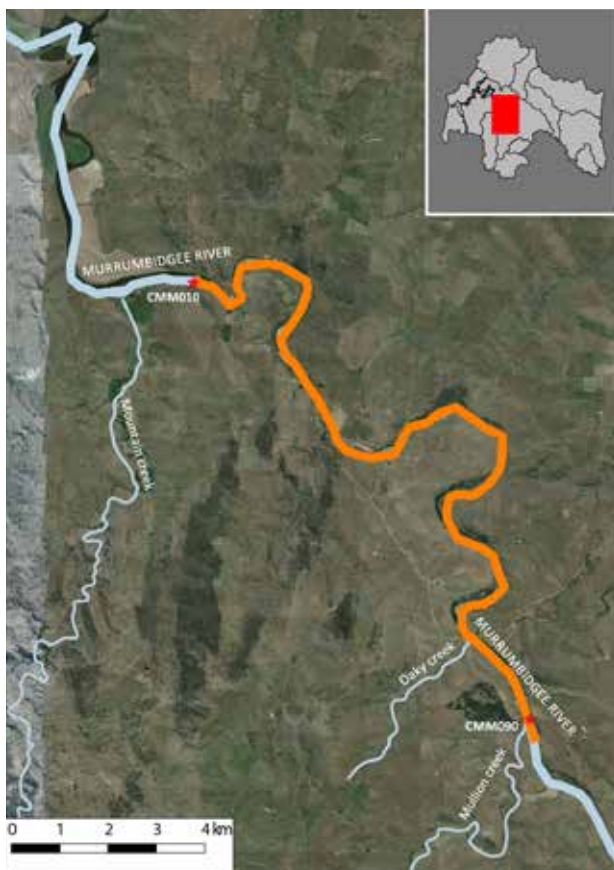
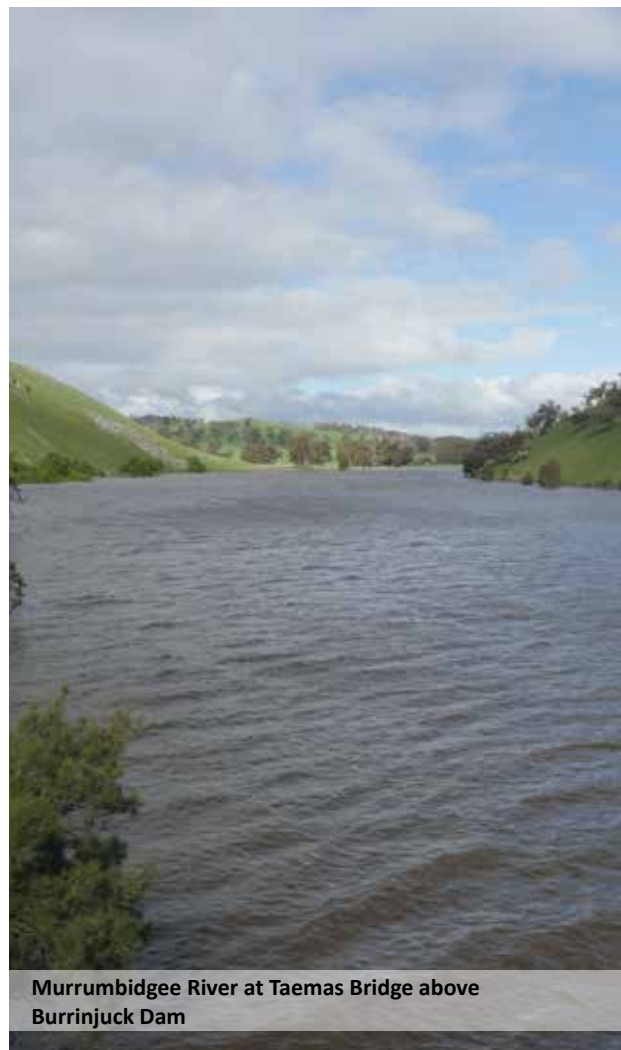
The water bug and riparian condition scores were poor, reflecting the very low habitat value through much of this reach. The lower section of the reach has large sand slugs resulting from damming of the river at the Burrinjuck dam. The natural river bed is swamped by the sand deposits creating wide shallow sections with little or no instream structure. The upper section of the reach does have some more natural pools and some riffle sections. The combination of poor riparian structure and almost no instream structure resulted in poor water bug scores. Only bugs that were well adapted to open water or the rocky banks were found in this reach. Large numbers of Carp have been sighted through this reach.

Murrumbidgee River at Taemus Bridge above Burrinjuck Dam
