**WATERWATCH**

**Upper Murrumbidgee**

# Catchment Health Indicator Program

2015–16

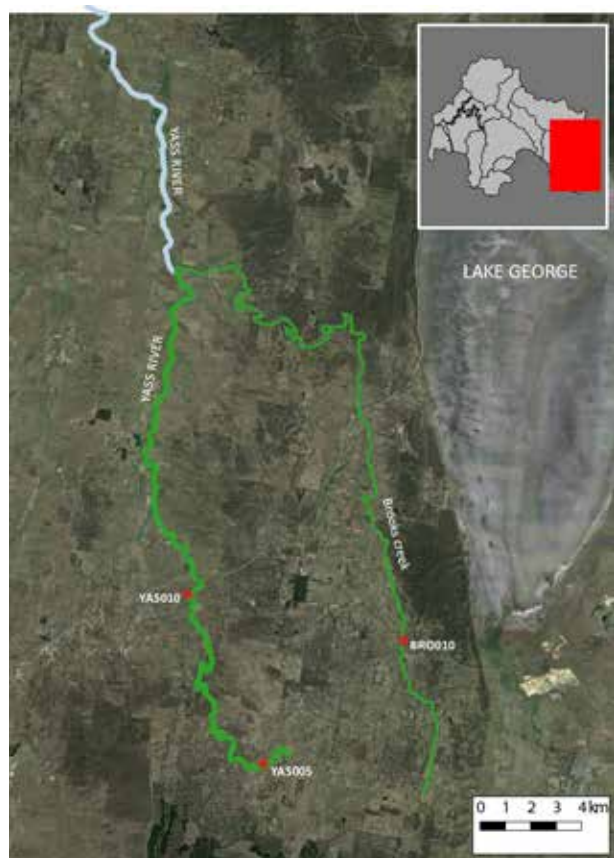
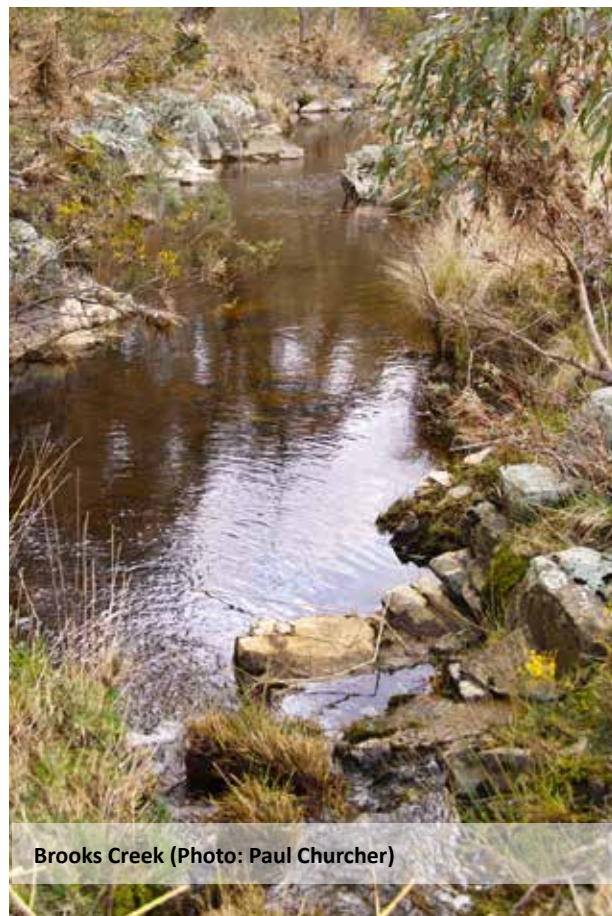
Brooks Creek (Photo: Paul Churcher)

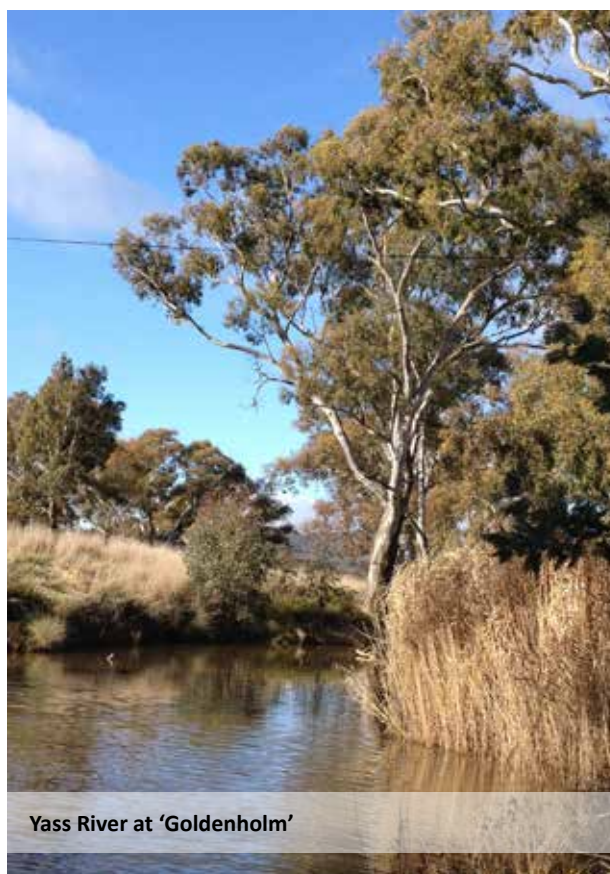
Riparian condition surveys portray contrasting results. Good riparian condition can be found at 'Goldenholm' with good native canopy cover, midstorey and groundcover, supporting a highly functional riparian zone. Conversely Booth's Crossing has minimal canopy cover and depauperate groundcover, which gives this reach its 'fair' rating.

Yass River at 'Goldenholm'

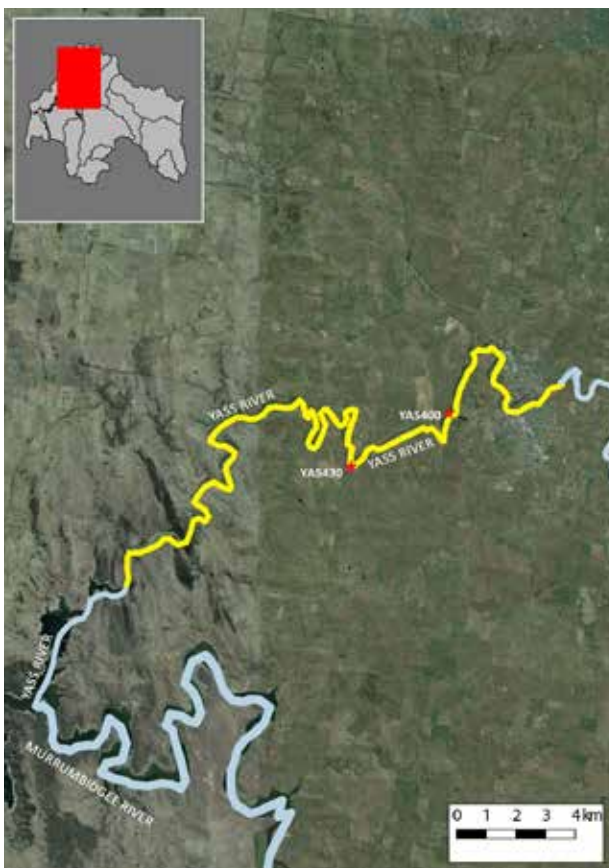
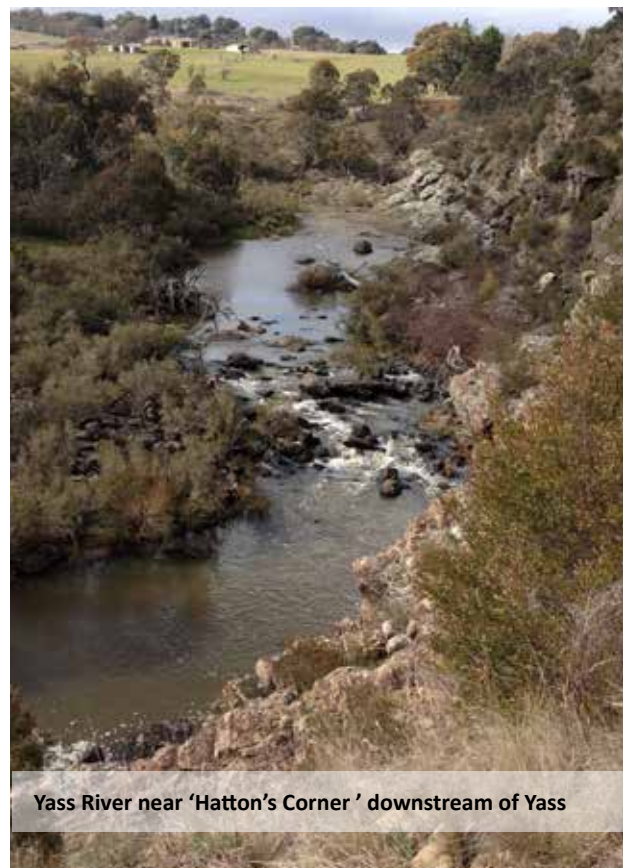
Water quality sampling was initiated in November 2015. High electrical conductivity was recorded for most of the year (680 – 920  $\mu\text{S}/\text{cm}$ ) which is expected as concentrations build up in the bottom end of this catchment. It then drops considerably in June (210  $\mu\text{S}/\text{cm}$ ) following a flood event. Turbidity was excellent during the low flow conditions however a spike of 75 NTU was observed on the back of a high flow event in June. Fallen trees were noted at this time, which will contribute to instream habitat for native fish in the future. Large flow events are likely to dispatch much of this large woody debris into Lake Burrinjuck.

Water bug scores were 'degraded' and are a likely combination of poorer water quality and reduced habitat value for instream and fringing vegetation with only scattered reeds and few native tussocks. Landowners below the township are undertaking habitat restoration projects so habitat values should improve in the coming years.

Yass River near 'Hatton's Corner' downstream of Yass
