# Catchment Health Indicator Program

2022

This document can be cited as: Upper Murrumbidgee Waterwatch (2022) Catchment Health Indicator Program: Report Card 2022. Canberra.

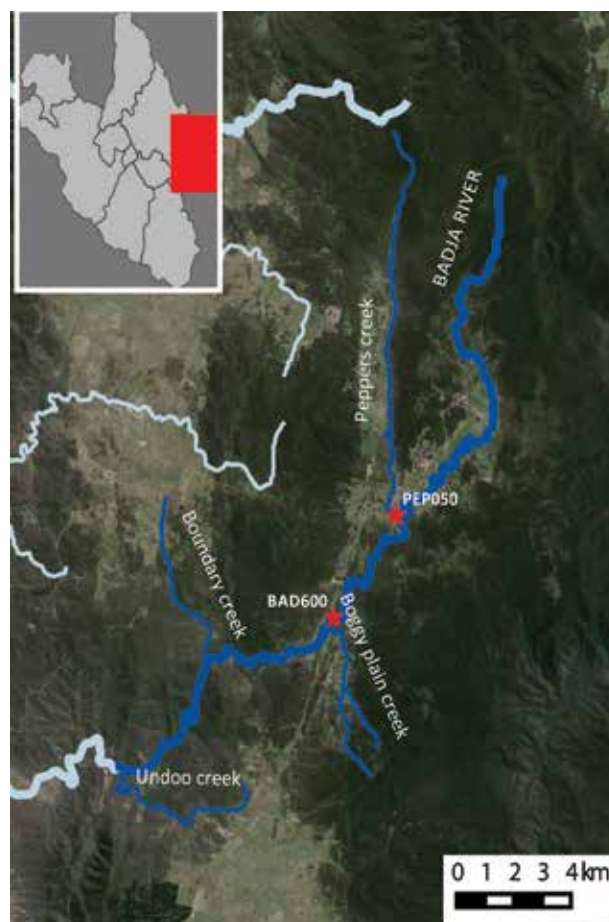
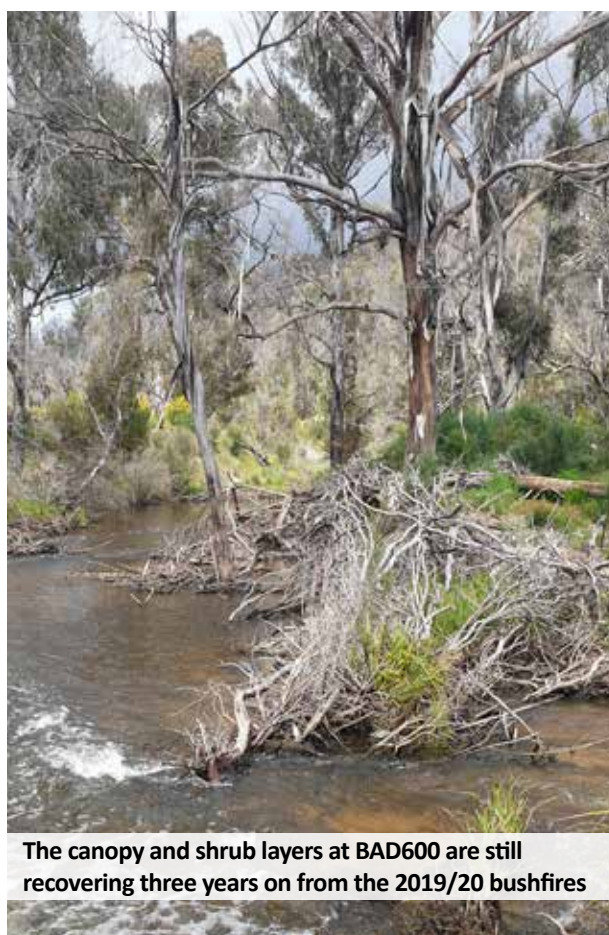
The 2019/20 bushfires greatly impacted this reach with fire burning out most of the catchment. Three years on, much of the riparian shrub and canopy layer vegetation has yet to recover properly. The higher than average rainfall over the last three years has been very favourable, resulting in replenished groundwater and good groundcover being established in this part of the catchment. Several larger flow events have flushed the heavy ash and sediment from in-stream habitats, which was washed into the river after the bushfires. This has contributed to improved waterbug survey results, which have been *excellent* for the last couple of years.

The canopy and shrub layers at BAD600 are still recovering three years on from the 2019/20 bushfires

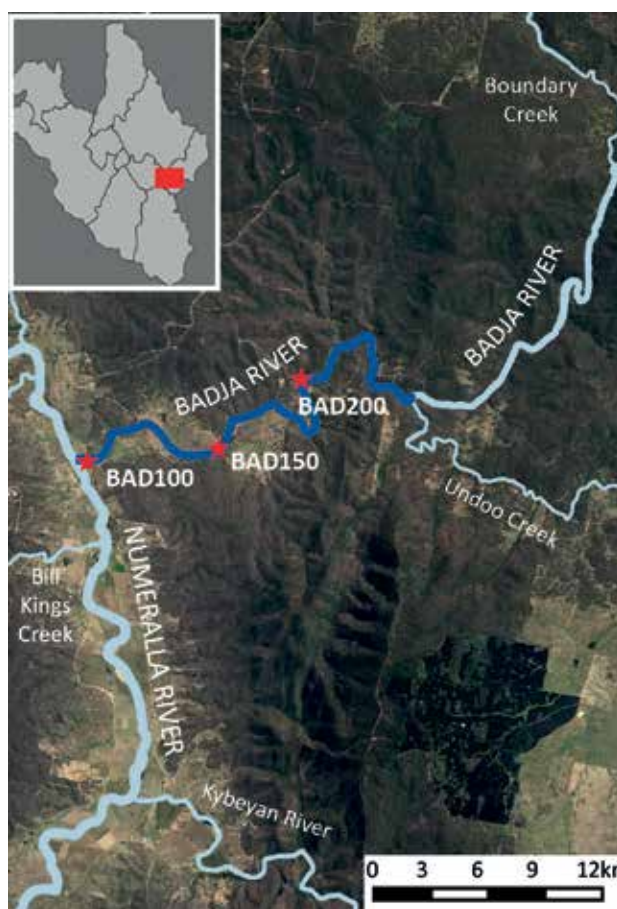
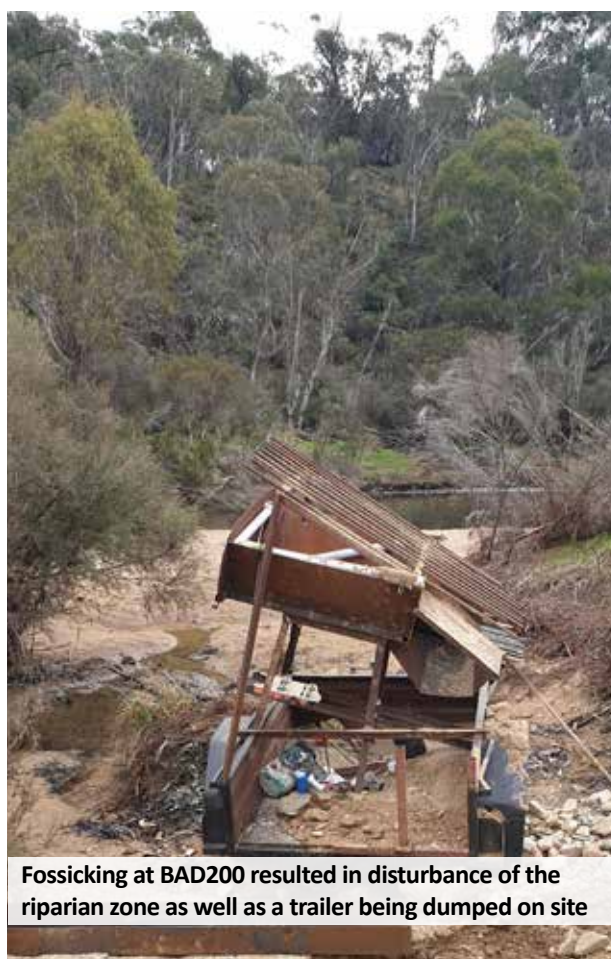
Fossicking at BAD200 resulted in disturbance of the riparian zone as well as a trailer being dumped on site

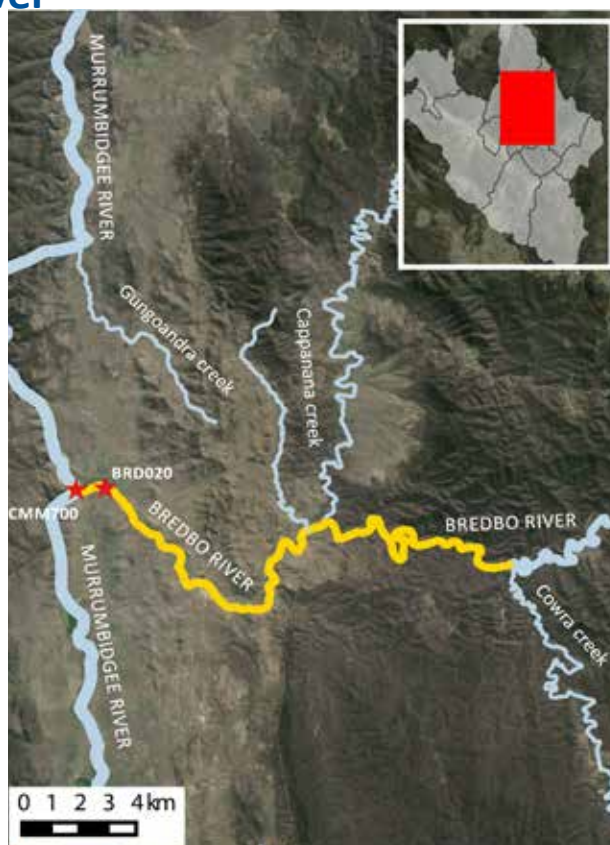
High flows continued throughout 2022 which saw ongoing streambank erosion along this reach, especially in areas where deep rooted native vegetation is limited. Successive flood events saw new deposits of sand and ash at the confluence, indicating the ongoing mobility of both fine and gross sediment in the system. This year's waterbug survey results reflected this with the majority of bugs found belonging to the Orders of Hemiptera (true bugs) and Diptera (fly larvae) which are tolerant of both poor habitat and water quality.

Streambank erosion is evident on the lower Bredbo River (BRD100) after several years of higher flows

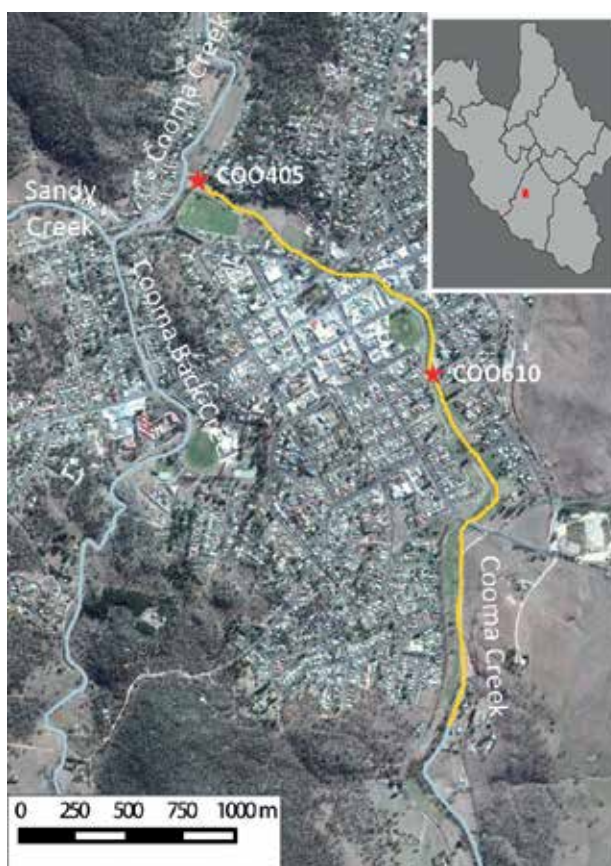
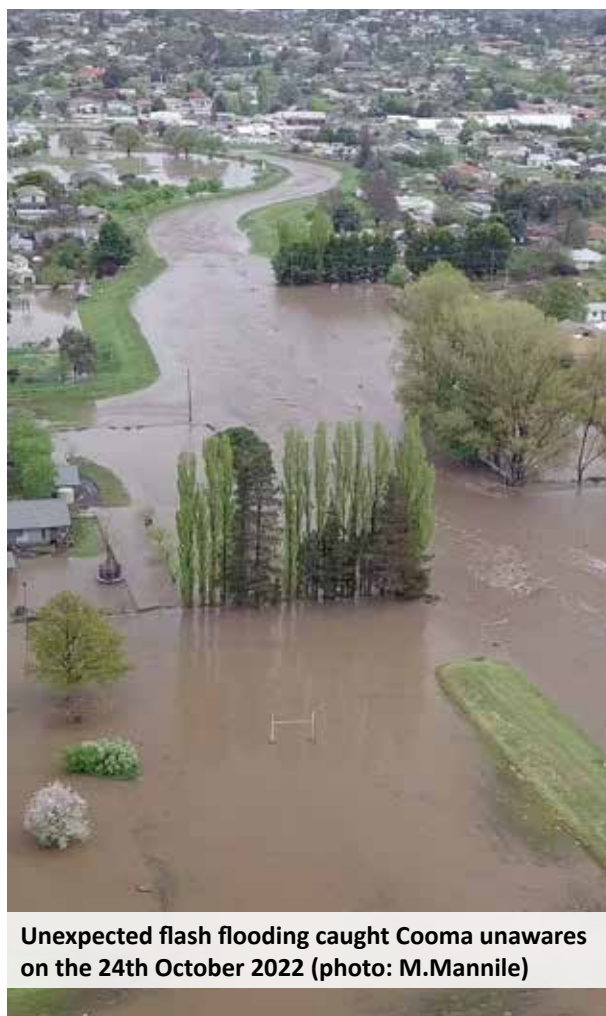
Medium to high flows have continued throughout 2022 including a flash flooding event in late October which outflanked the levee banks, flooding adjoining buildings. The flows have mobilised nutrients and dissolved salts and minerals, as well as increased turbidity. Such results were also seen upstream but it is exacerbated in this reach by pollution present in the urban stormwater inflows. Waterbug surveys reflect this trend and were dominated by waterbug types that are tolerant of increased nutrients and organic matter. These include freshwater snails, segmented worms and fly larvae.

Unexpected flash flooding caught Cooma unawares on the 24th October 2022 (photo: M.Mannile)

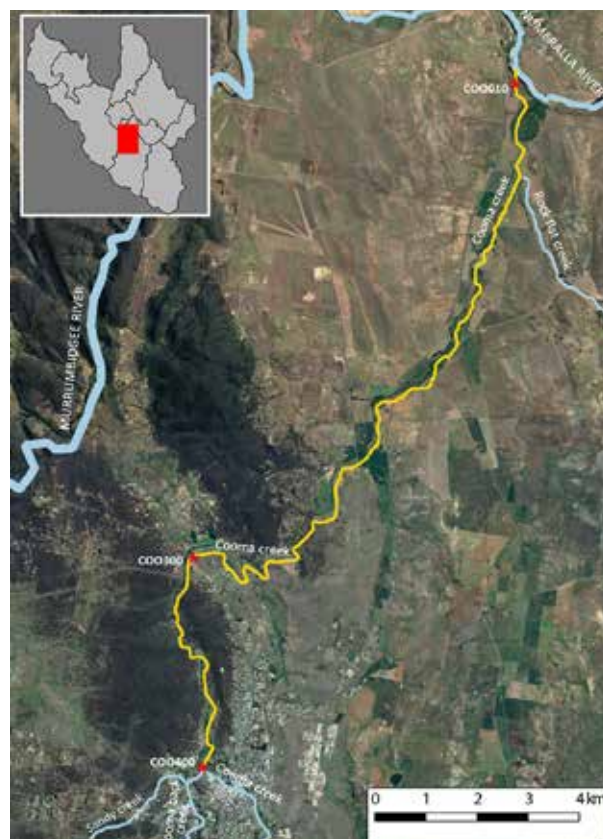
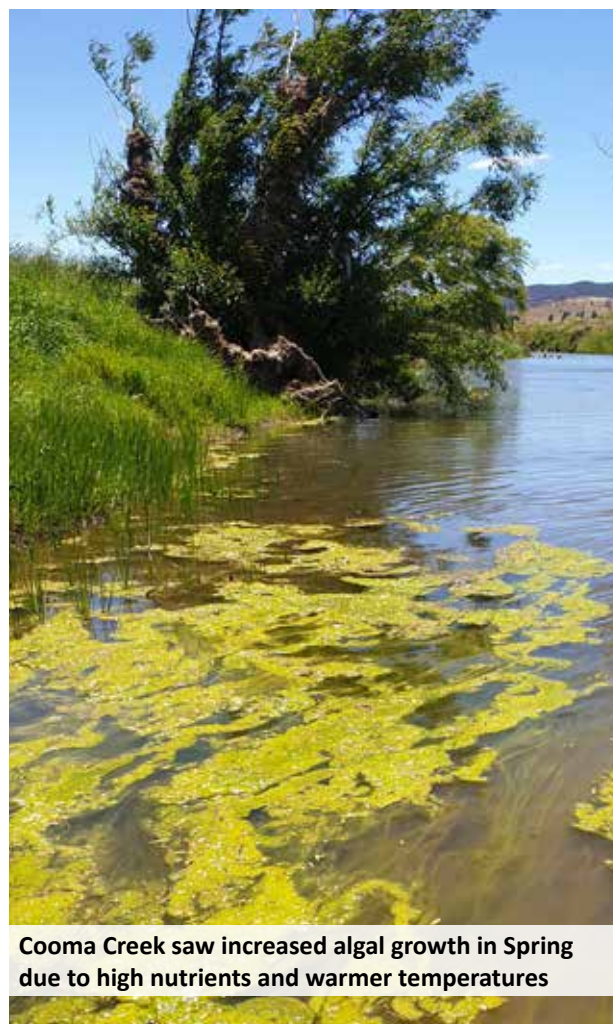
Cooma Creek saw increased algal growth in Spring due to high nutrients and warmer temperatures

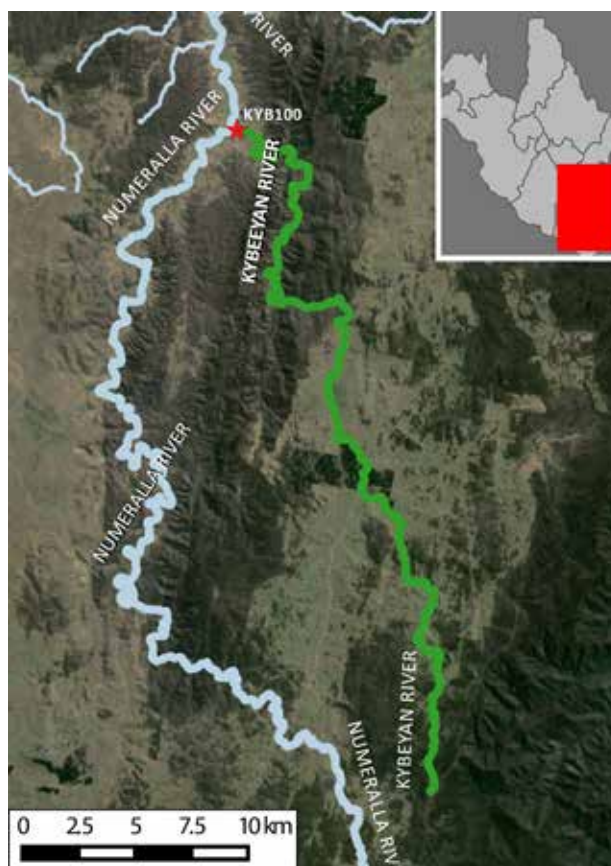
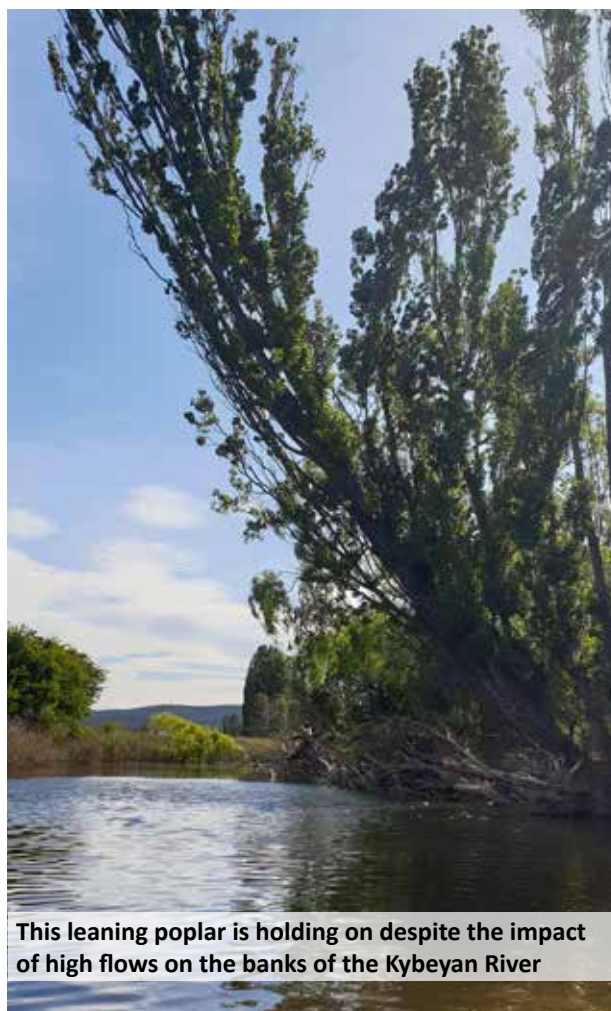
This leaning poplar is holding on despite the impact of high flows on the banks of the Kybeyan River

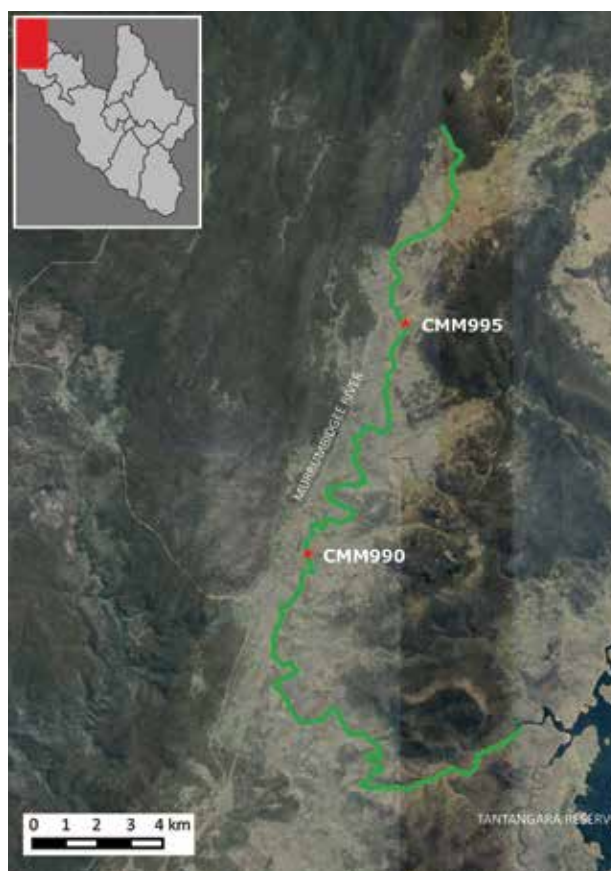
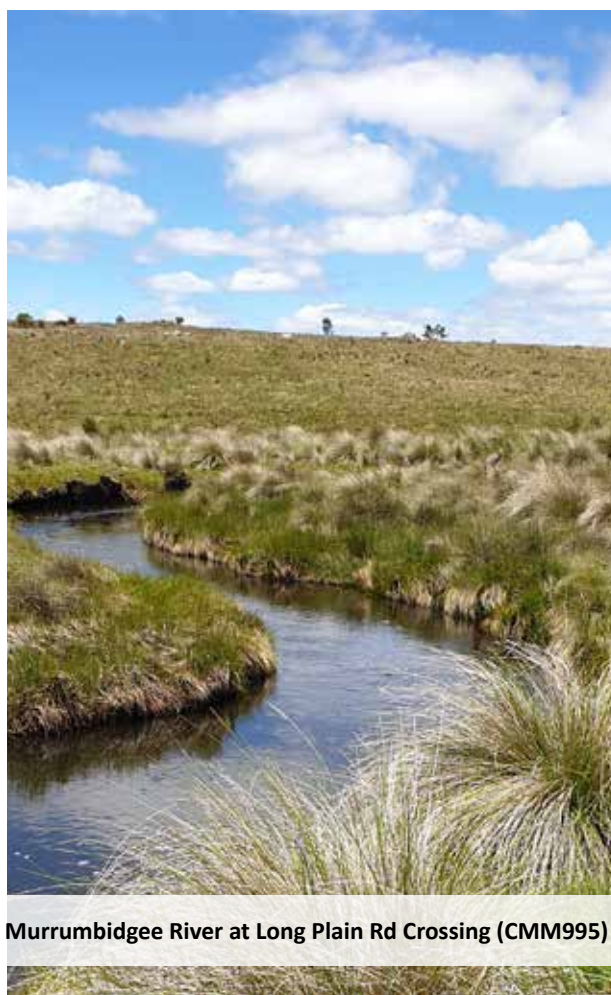
Murrumbidgee River at Long Plain Rd Crossing (CMM995)

Over the last years, however, we have been observing that the banks are increasingly pugged (destabilised by hard hooves of feral horses), the riverbanks heavily grazed and algal growth and sedimentation are increasing. While overall water quality and waterbugs scored *excellent* this year (as we would expect after several years of good flows), in drier years, some measurements are beginning to show a decline, such as increased nutrient readings. Overall, waterbug surveys are detecting less pollution-sensitive species with some highly sensitive bugs now missing altogether compared to earlier years.

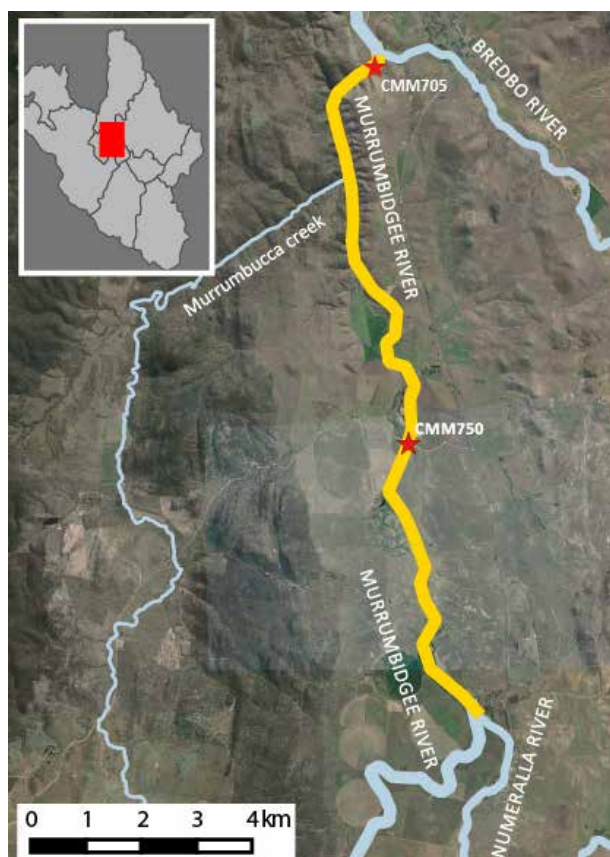
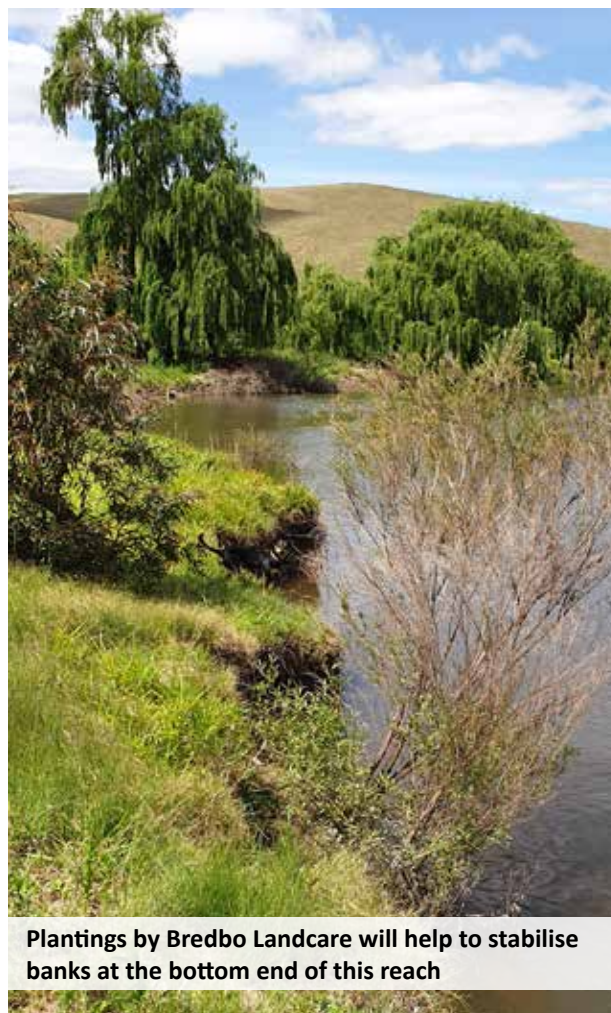
The consistently high water levels have reduced in-stream habitat by scouring out reeds stands, drowning ti-tree and reactivating streambank erosion in this reach. Flood conditions (which can flush waterbugs downstream) coupled with decline in a variety of quality habitat, may have contributed to the decline in the waterbug score from *poor* to *degraded*. The waterbug samples had low diversity of different Orders and high abundance of pollution-tolerant types such as those from the Family Hemiptera (true bugs) which breathe air and can fly away if conditions decline.

Plantings by Bredbo Landcare will help to stabilise banks at the bottom end of this reach

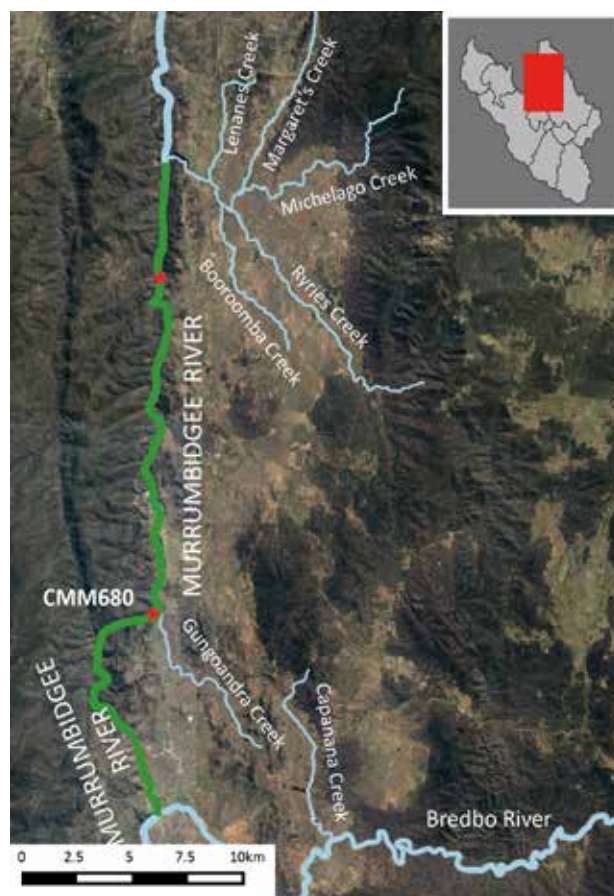
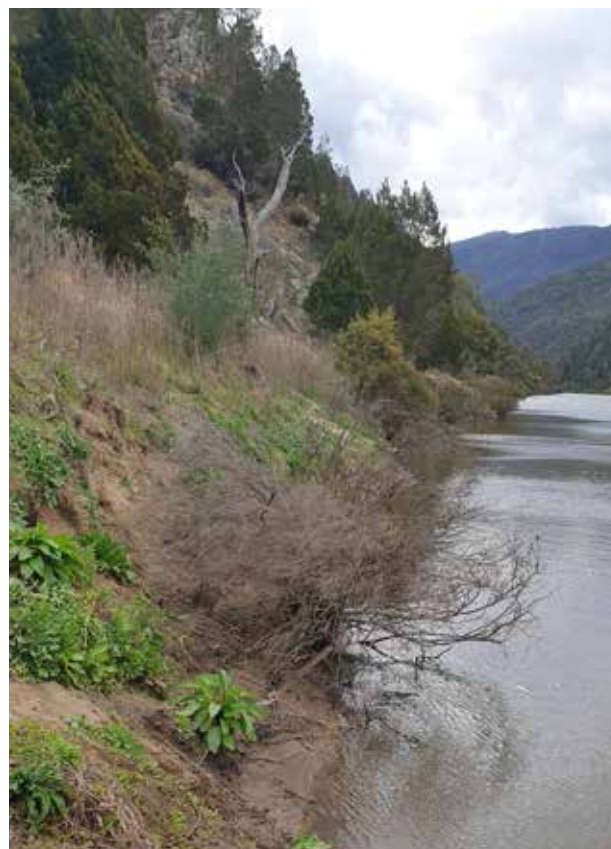
This reach was heavily impacted by bushfires in early 2020. Subsequent rains resulted in ash and sediment being washed into the river corridor, smothering in-stream habitat. While waterbugs showed signs of improvement this year, spikes of turbidity and nutrients after heavy rainfall are still being detected. Waterwatcher Alison noted local erosion during January sampling and measured turbidity of 210NTU in February when the river was in flood.

**High flows are reactivating bank erosion at Scottsdale Reserve (CMM680)**

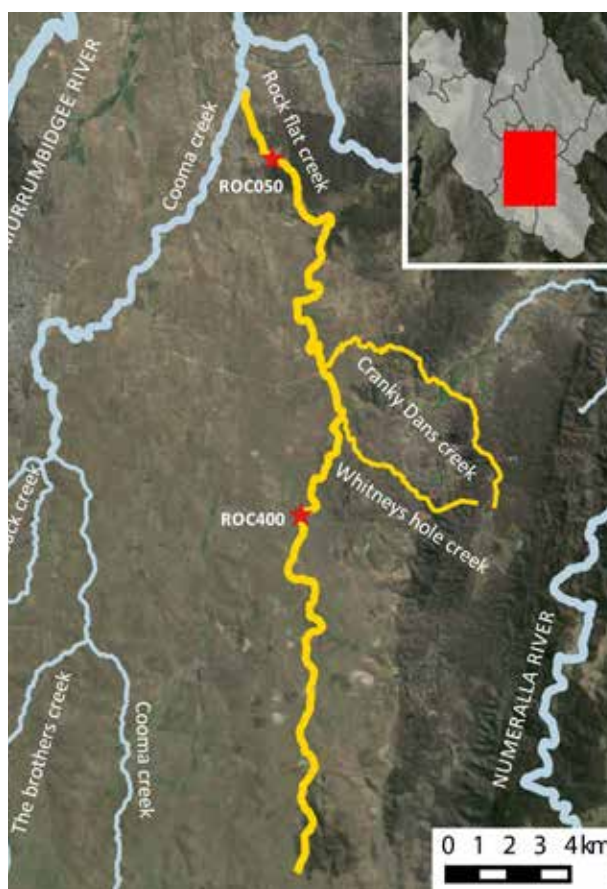
Increased nutrients have increased algal growth in the creek and were often noted by Mike, especially at ROC400. Waterbug survey results showed a decline this year compared to last year especially in the Spring survey which yielded a *poor* result due to low diversity. High numbers of mayflies, a pollution-sensitive waterbug, and the more tolerant fly larvae, dominated the sample.

Algal growth in Rock Flat Creek was most likely a result of extremely high phosphorous inputs

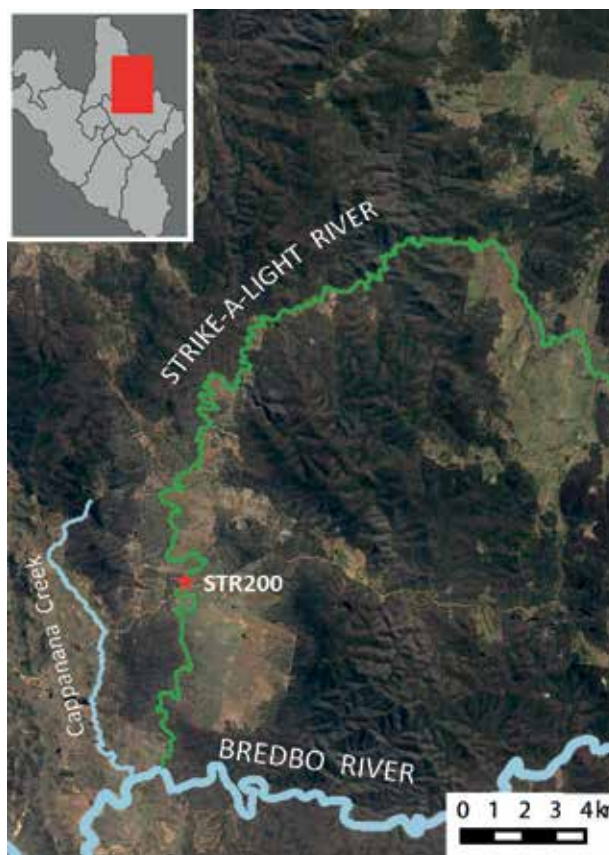
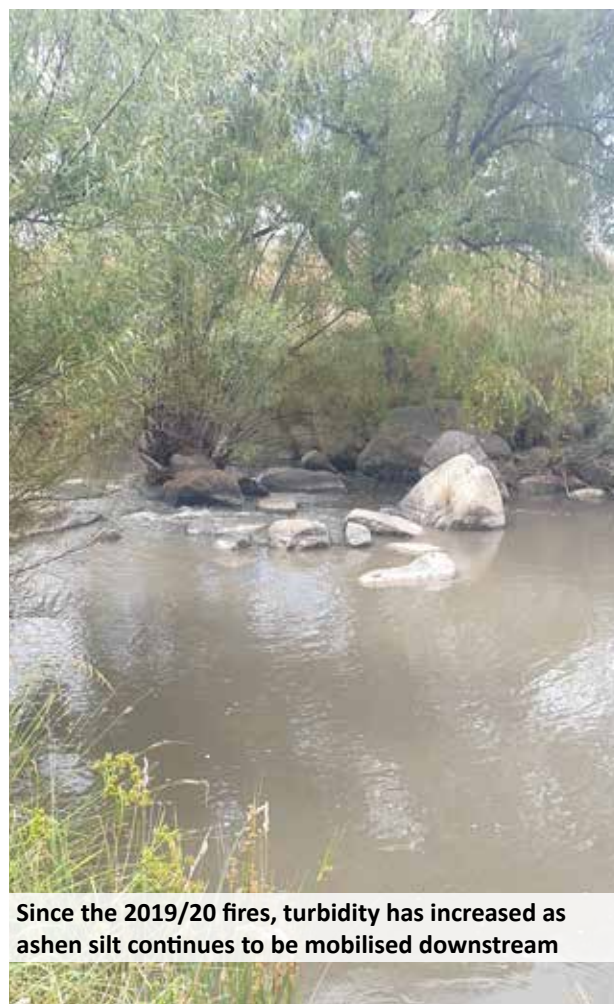
The top of the Strike-A-Light River catchment was impacted by the Calabash Fire in February 2020 followed by heavy rains which flushed large amounts of ash off the fireground. Three years on, ashen deposits remain in-stream, affecting phosphorous and turbidity levels, especially during times of higher flow. Turbidity spikes during higher flow events can also indicate the presence of streambank erosion.

Since the 2019/20 fires, turbidity has increased as ashen silt continues to be mobilised downstream

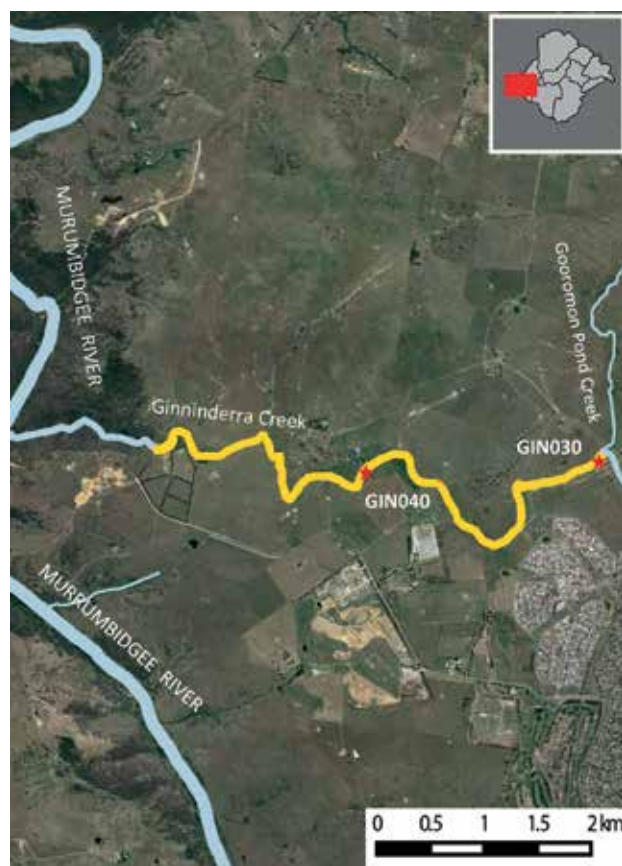
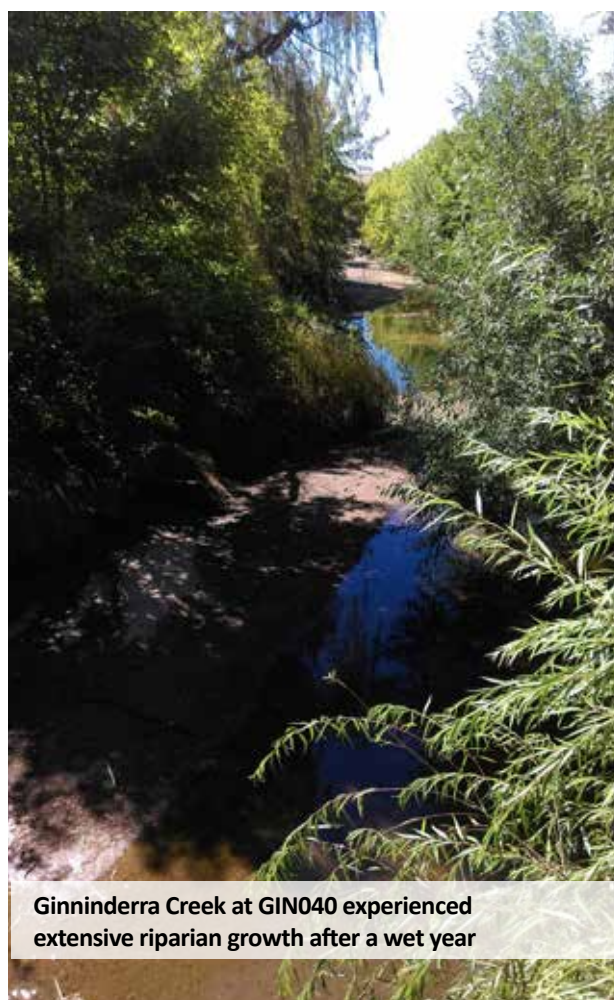
This year the riparian vegetation scores remained at *poor* and *degraded*, with many emerging willows observed growing along the river bank as well as evidence of continued bank erosion. Ginninderra Catchment Group, Greening Australia and the Riverview group have undertaken willow removal and native regeneration work in the midsection of the reach, which will eventually provide more habitat for small vertebrates such as frogs and lizards. Five Eastern water dragons were spotted at the Kilby Homestead (GIN040) during water sampling in November.

Ginninderra Creek at GIN040 experienced extensive riparian growth after a wet year

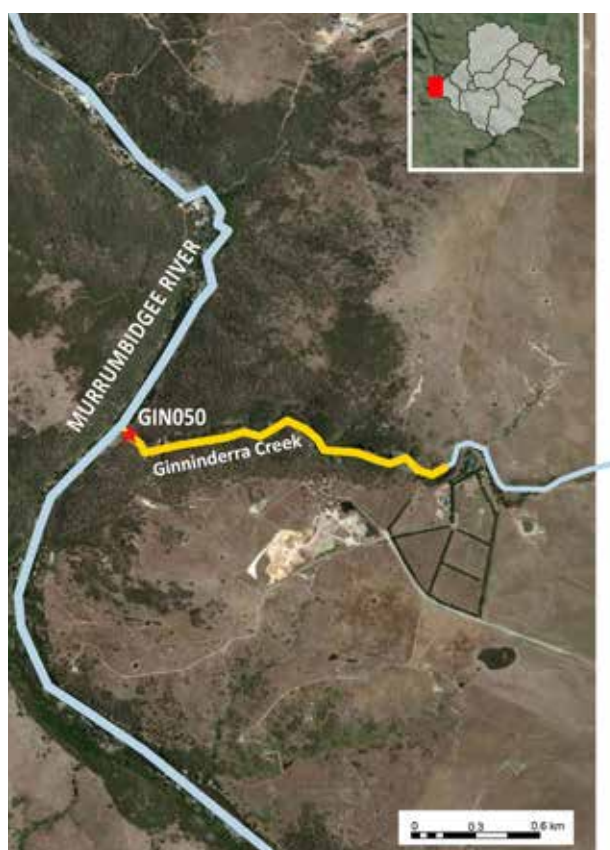
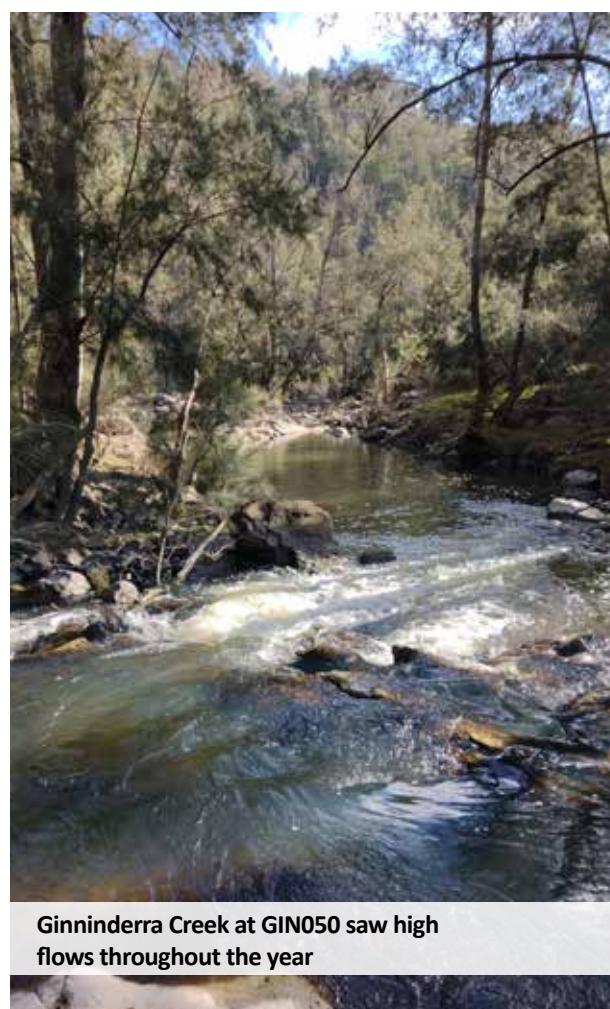
The frequent rainfall resulted in medium to high flows at GIN050 throughout 2022. The flows brought with them increased nutrient levels, with both nitrates and phosphorous higher than the previous year. Waterbug results were also poorer with low diversity being an issue, especially in Autumn when only three Orders were observed. There is limited riverbank vegetation for waterbugs and the creek bed in this section is mainly rocky with very little in-stream vegetation. The high flows can scour out Casuarina leaves and other potential habitat from the substrate and possibly contribute to the reduced diversity.

Ginninderra Creek at GIN050 saw high flows throughout the year

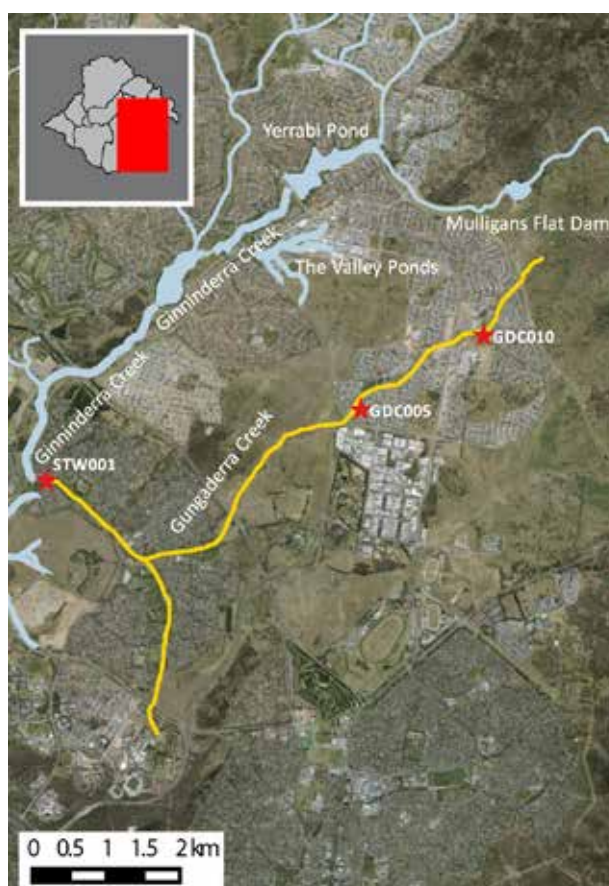
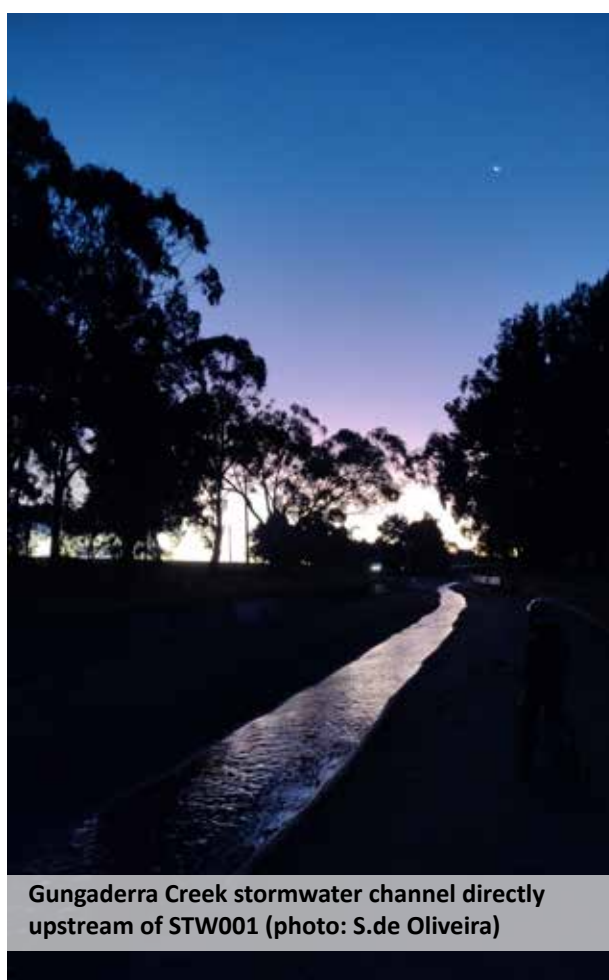
In addition to these concrete stormwater drains, the lack of native canopy and understorey plus a dominance of exotic vegetation in this reach, account for its *poor* riparian vegetation assessment score. Volunteers have planted trees and shrubs to improve the width of riparian habitat along Giralang Pond in collaboration with the Ginninderra Catchment Group and ACT Government.

Gungaderra Creek stormwater channel directly upstream of STW001 (photo: S.de Oliveira)

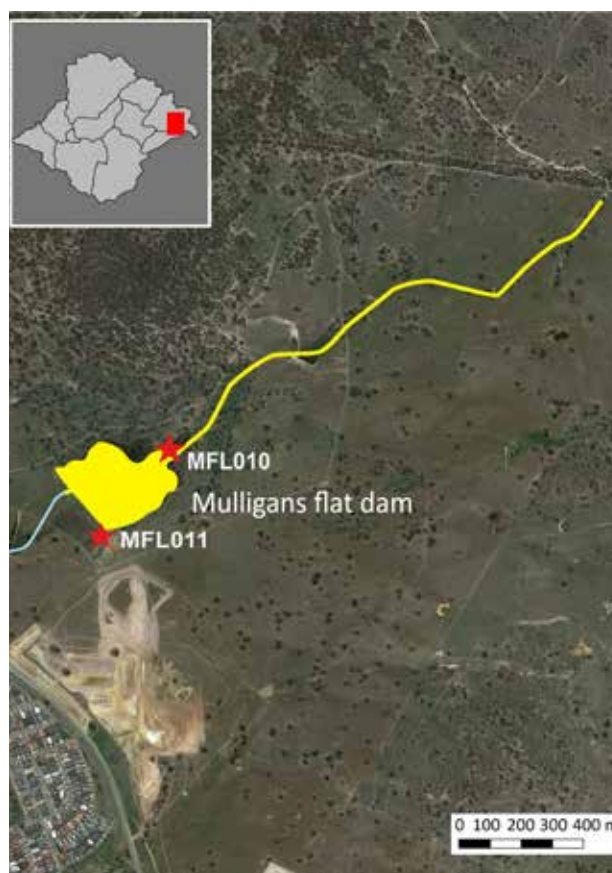
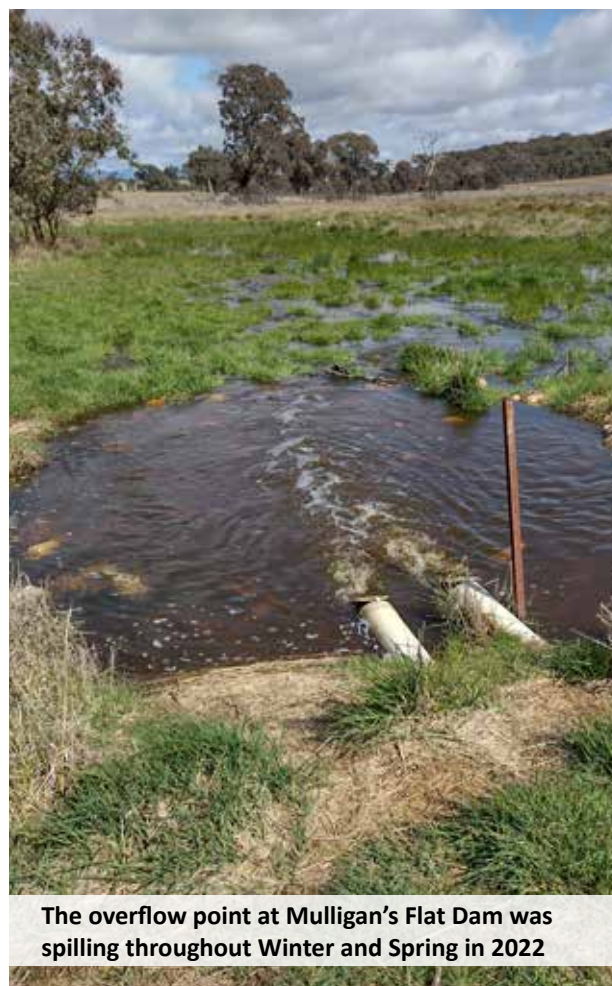
The dam remained full to overflowing throughout the wet Winter and Spring of 2022. Turbidity was elevated and waterbug diversity was lower than in previous years, driving down the overall CHIP score.

**The overflow point at Mulligan's Flat Dam was spilling throughout Winter and Spring in 2022**

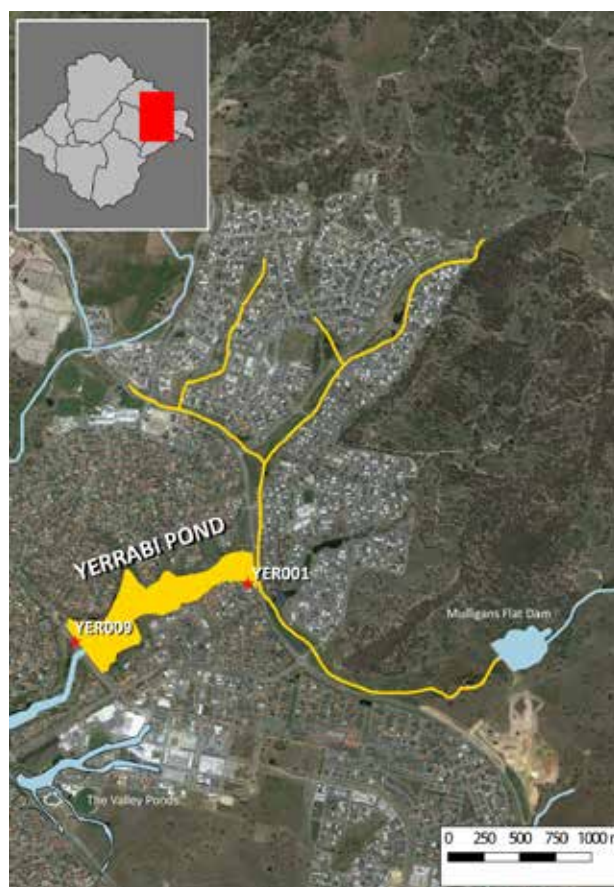
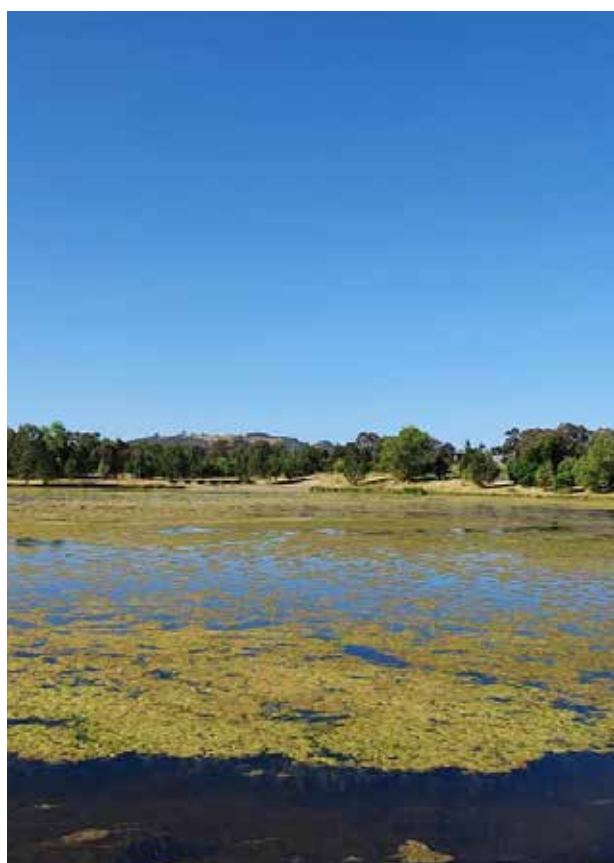
A large algal bloom across Yerrabi Pond in December was the likely driver of supersaturated levels of dissolved oxygen (157% saturation) along with strongly alkaline pH (9) near the southern inflow (YER001). Waterwatcher Connor Skeels conducted the dissolved oxygen test twice as he had never recorded an oxygen reading like that before. Phosphorus levels as high as 0.07mg/l were recorded in the months leading up to this event on the back of high inflows. It's possible that the increased amount of nutrients were in part responsible for the high growth of algae and this, in turn, produced high amounts of oxygen as a byproduct of photosynthesis.

**A large algal outbreak in December was affecting water quality at Yerrabi Pond (photo: C.Skeels)**

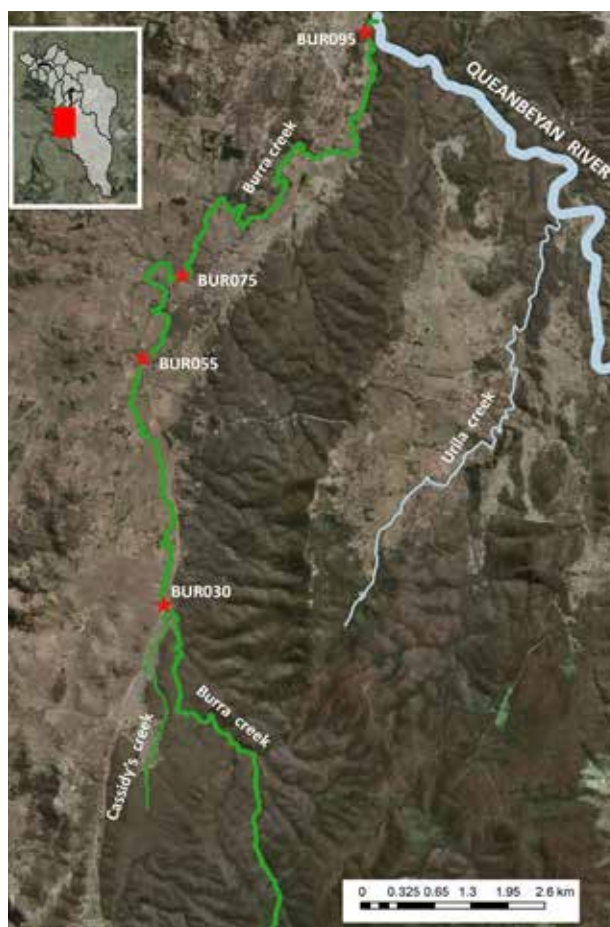
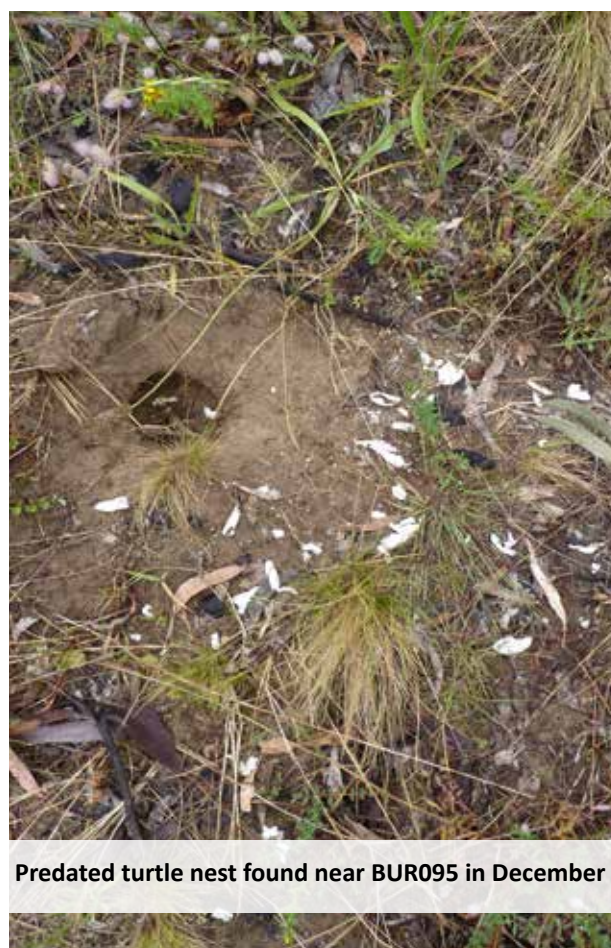
In December, a predated Eastern long-necked turtle nest was discovered on Burra Creek, just upstream of BUR095. Eastern long-necked turtles dig their nests in river and wetland banks and are easy pickings for keen-nosed foxes.

Predated turtle nest found near BUR095 in December

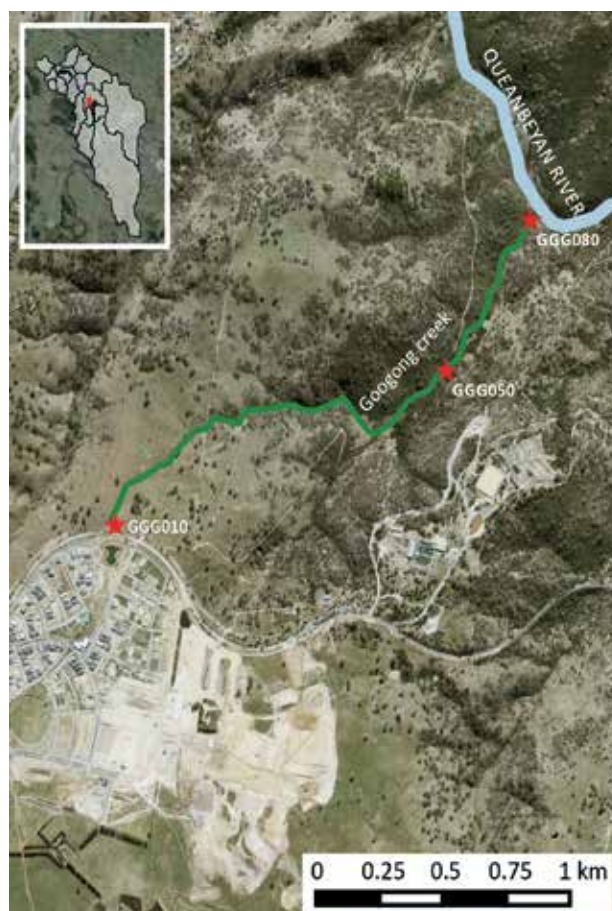
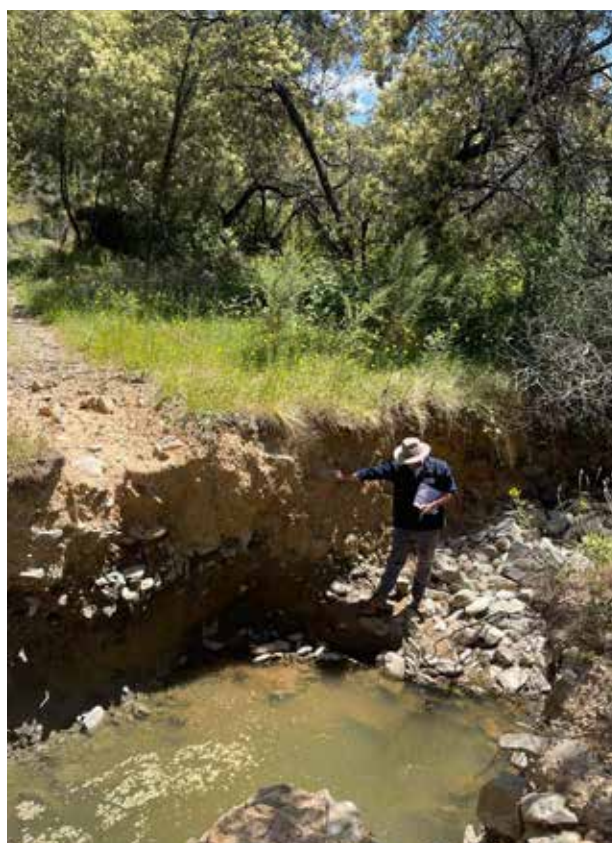
Even with healthy riparian vegetation and a high representation of native mid-story riparian species, extreme erosion was found on the dam at GGG050, which has cut the pipeline access track. Higher flows brought on by this year's increased rainfall have proven too much for the small overflow dam, spilling and eroding a deep gully down the dam wall and depositing sand back into the creek, smothering aquatic habitat.

**Extreme gully erosion on Googong Creek at GGG050 has cut the access trail**

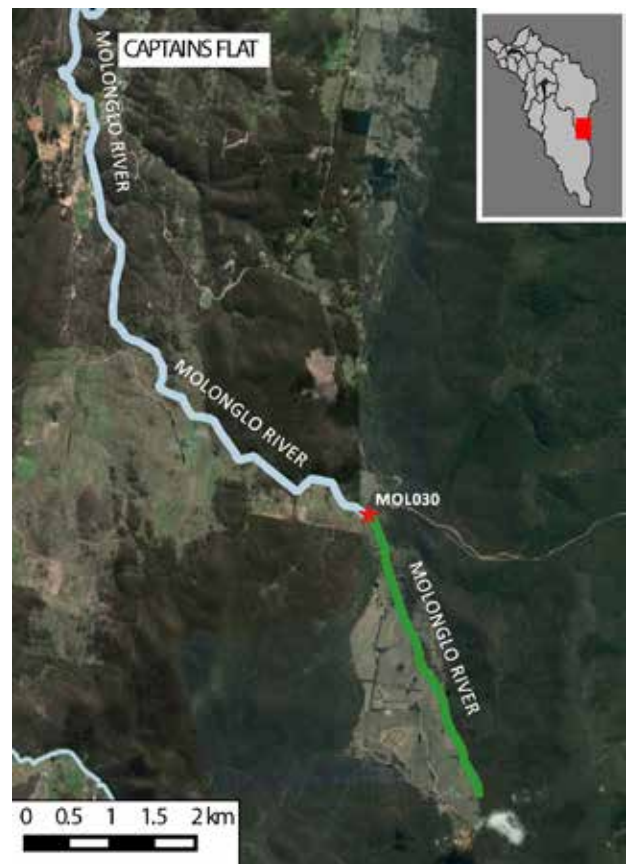
Grader works on Wild Cattle Flat Road in April pushed soil into the Molonglo at MOL030 and left much of the riverbank exposed. A grass fire in September has further reduced riparian coverage, burning *Carex* and large native tussock grasses growing in the riparian zone. Access to the river by nearby stock may result in a slower recovery of riparian vegetation and risk further erosion issues.

Evidence of a grass fire at MOL030 in September.
