# Catchment Health Indicator Program

2022

This document can be cited as: Upper Murrumbidgee Waterwatch (2022) Catchment Health Indicator Program: Report Card 2022. Canberra.

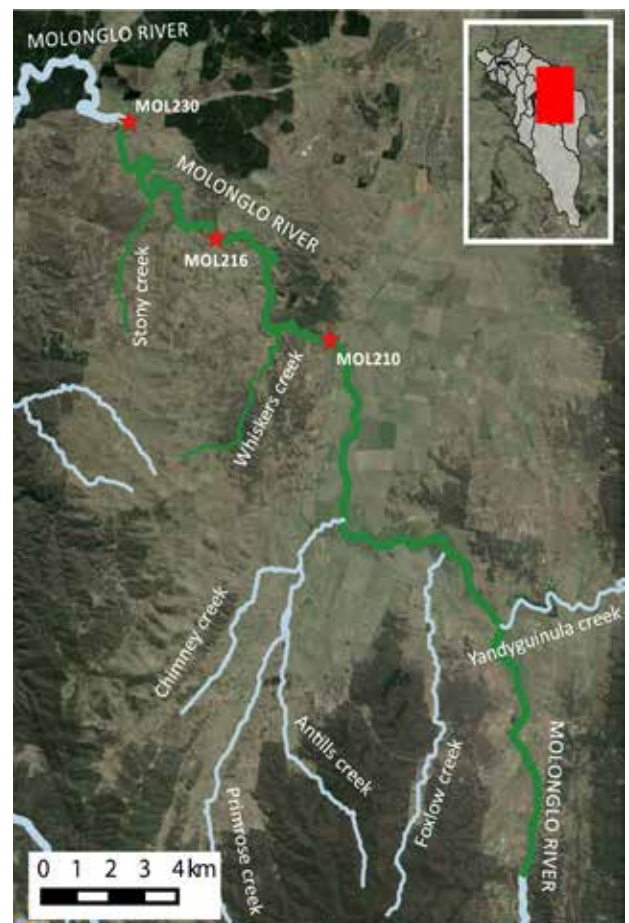
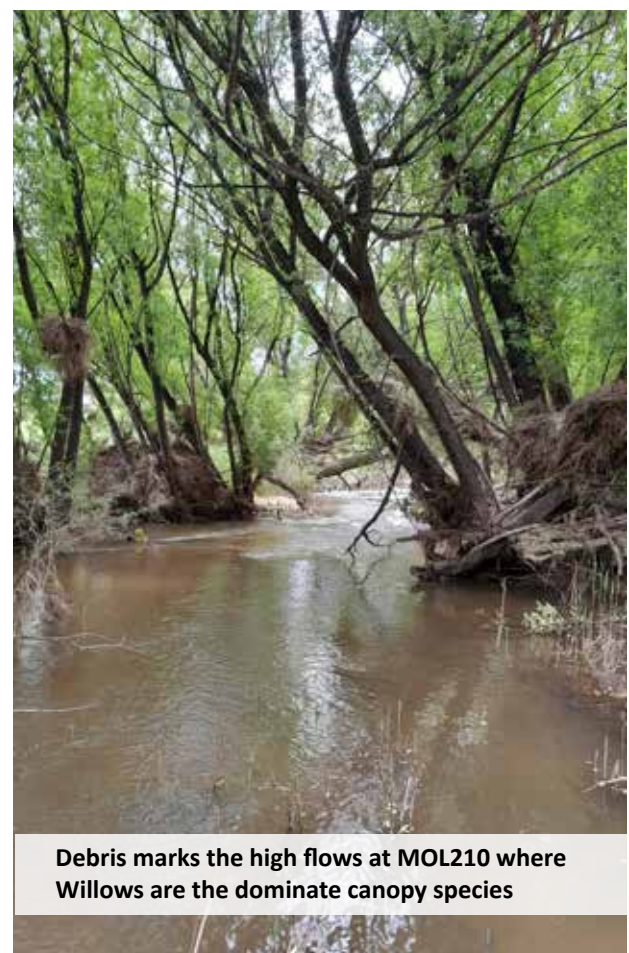
Riparian vegetation in this reach is largely exotic: willows dominate the canopy, and hawthorn and *Pyrocantha* have replaced most of the native mid-storey species. MOL216, located at the Molonglo River Park near Carwoola, has vast infestations of Chilean needle grass and African love grass, which has now taken over the native *Poa* tussock grasses that once dominated.

Debris marks the high flows at MOL210 where Willows are the dominate canopy species

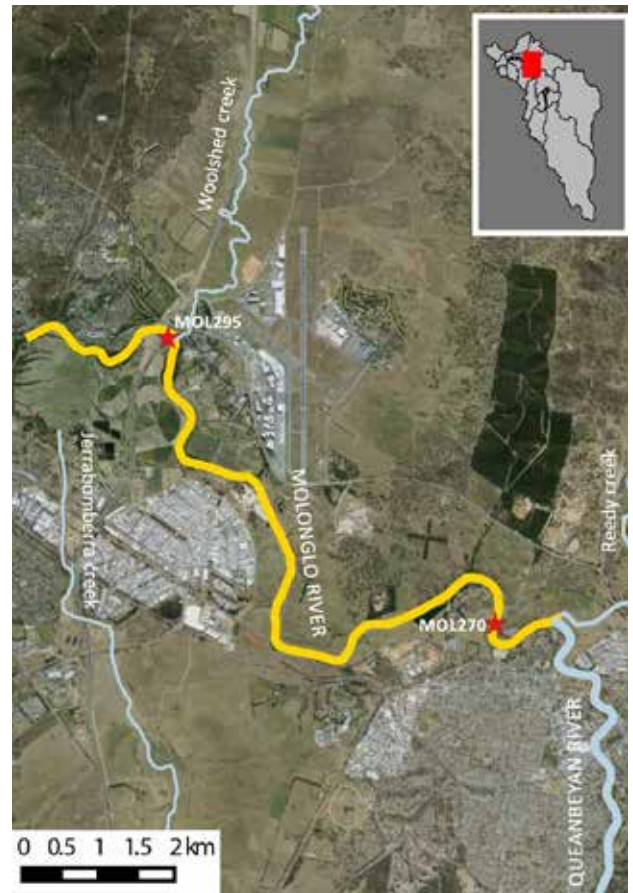
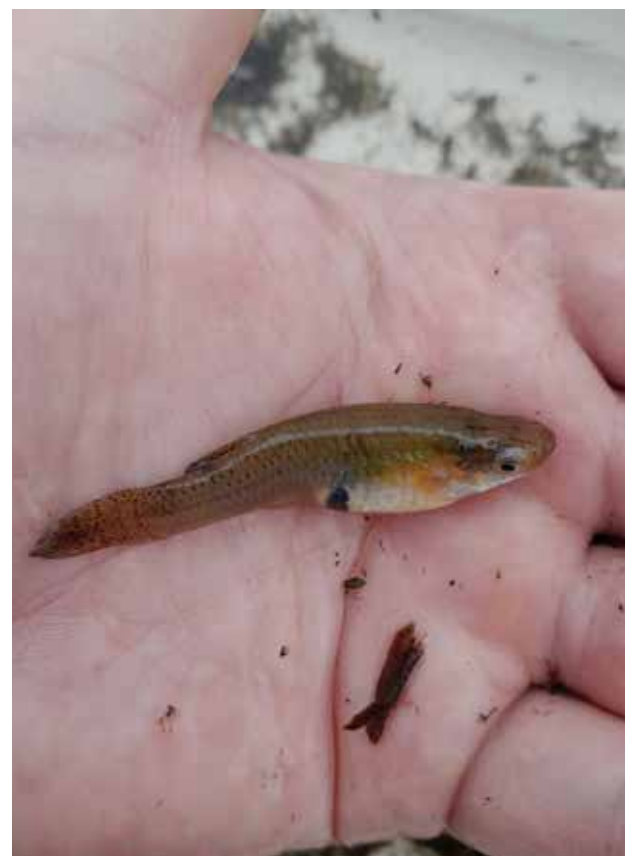
Large numbers of the pest fish Eastern gambusia were caught during waterbug surveys. These included some large, breeding females that are easily identified by a large black spot on their belly. Waterwatcher and fish enthusiast, Tony Patis, also reported large numbers of Eastern gambusia and European carp at the downstream site at MOL295.

Large female Eastern gambusia with distinctive black belly spot, caught at MOL295 in October

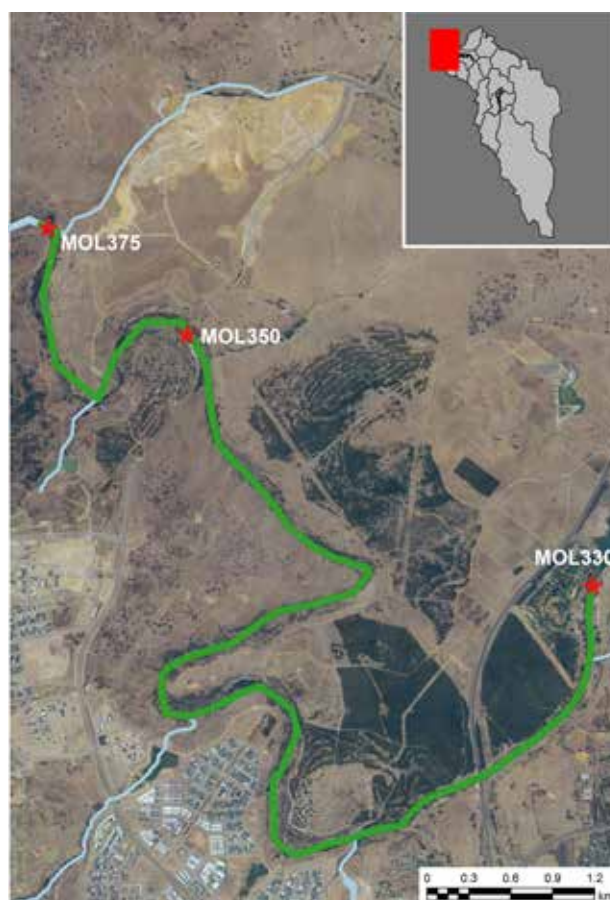
Ongoing development appears to be changing upstream conditions in this reach and contributing to erosion issues, exacerbated by periods of high rainfall. The small creeks that drain into this section of the Molonglo River such as Yarralumla, Weston and Deep Creek, and the unnamed ephemeral creek downstream of Denman Prospect sediment ponds, all experienced significant bank erosion. Gully erosion upstream of MOL375 continues to be an issue but vegetative cover is returning after three years of construction works at Namarag-Molonglo River Reserve.

Erosion on Deep Creek near MOL375 has been worsening in recent years

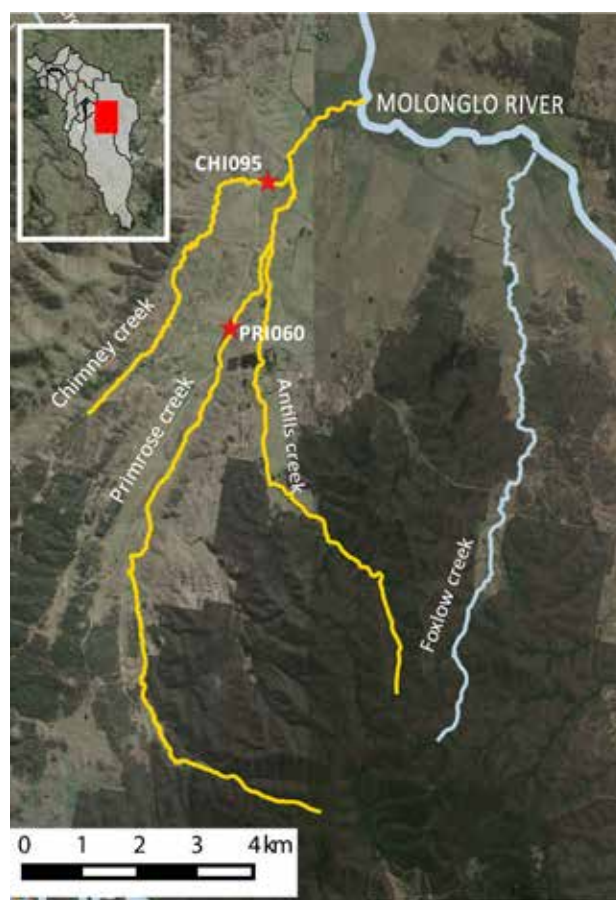
A lack of canopy and mid-storey vegetation layers along Chimney Creek gives this reach one of the worst riparian condition scores in the Molonglo catchment. Access to the creek by stock further exacerbates this issue, as native plants struggle to regenerate amongst trampling hooves, hungry sheep, and fast-growing invasive weeds. Bank erosion on the lower sections of Primrose Creek continues to be an issue with poor riparian coverage resulting in unstable riverbanks and soil being washed into the creek during periods of high flow. Young stands of *Acacia dealbata* are maturing in stock-free sections upstream of PRI060, which we hope will help stabilise banks into the future.

A lack of canopy and mid-storey vegetation is evident on Chimney Creek (CHI095)

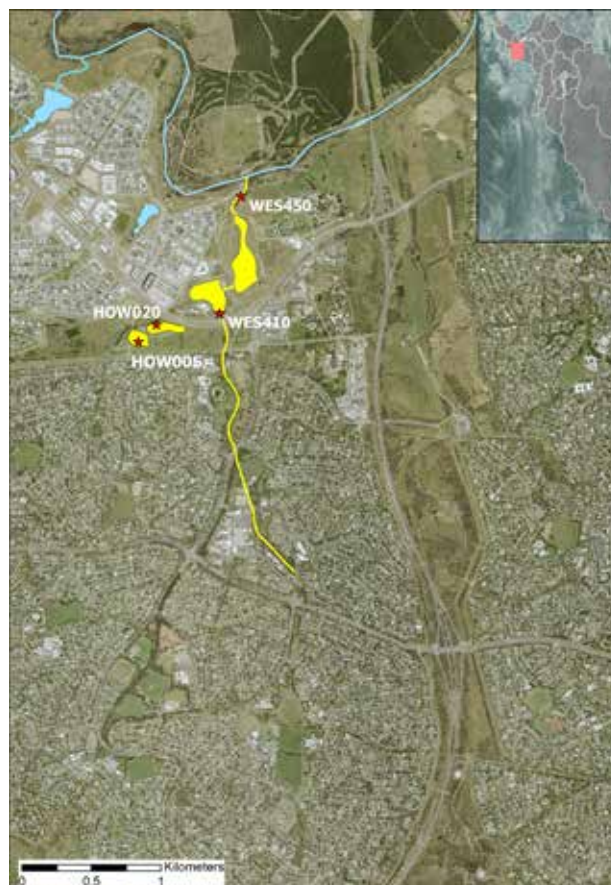
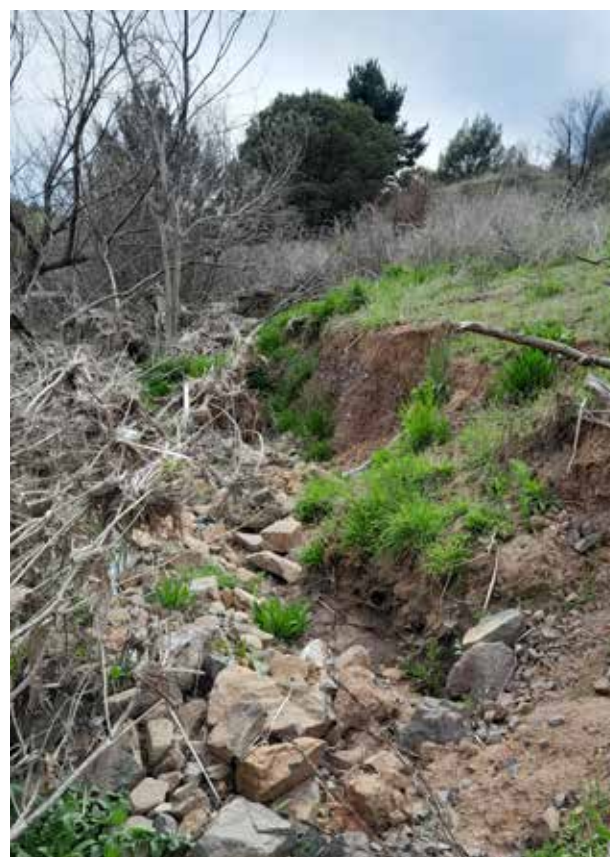
The rock installed to armour the bank against erosion on the lower section of Weston Creek has been breached. High flows flooding the channel and spilling around the rocks have caused considerable erosion on the eastern bank and deposited large amounts of sediment into the Molonglo River. Large established reed beds upstream of WES450, (below the outlet of the North Eastern Pond) help to buffer higher flows but not enough for this year's above average rainfall. Flows can increase considerably during periods of high rainfall in catchments consisting of lots of impermeable surfaces such as roofs, roads and concrete stormwater channels.

Erosion on Weston Creek near WES450 in October

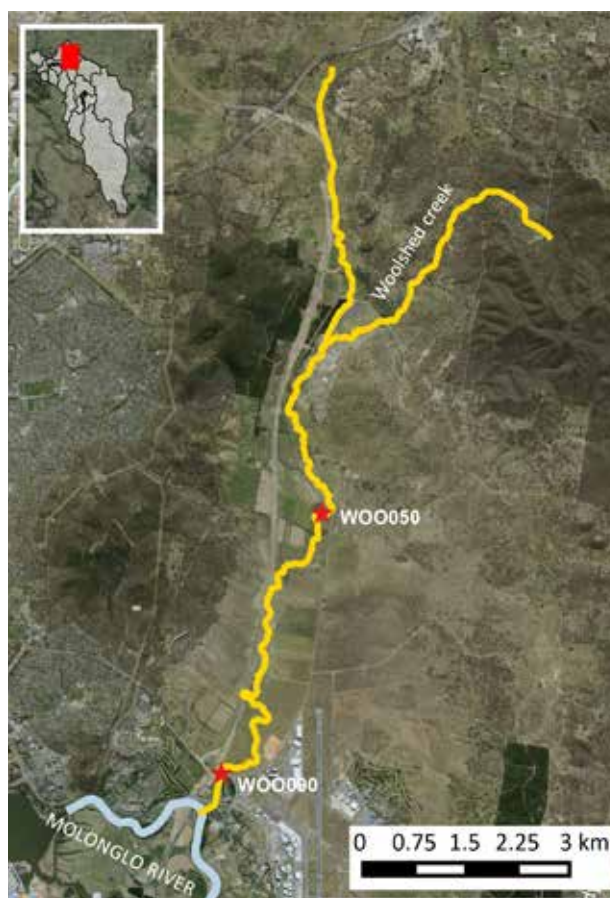
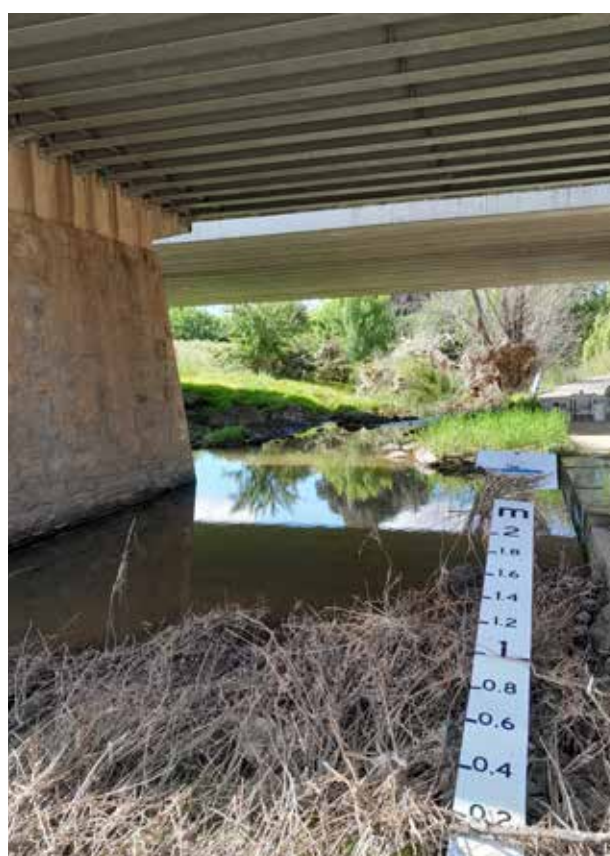
Large flows noted by Terry in October caused some havoc, flattening the flood depth marker under Majura Road and helping disperse blackberry brambles that are starting to take hold in the downstream section at WOO090.

Evidence of high flows at WOO090 on Woolshed Creek in November

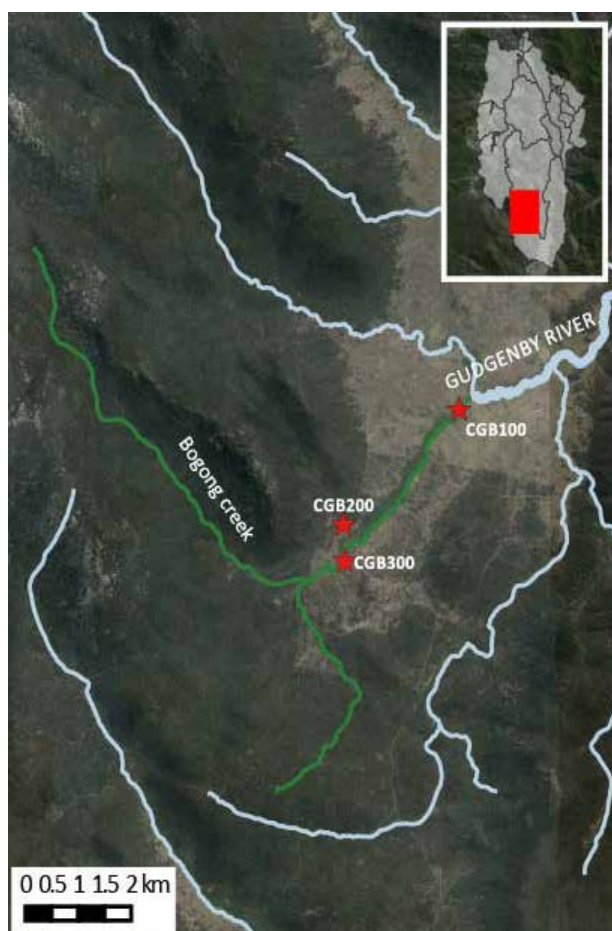
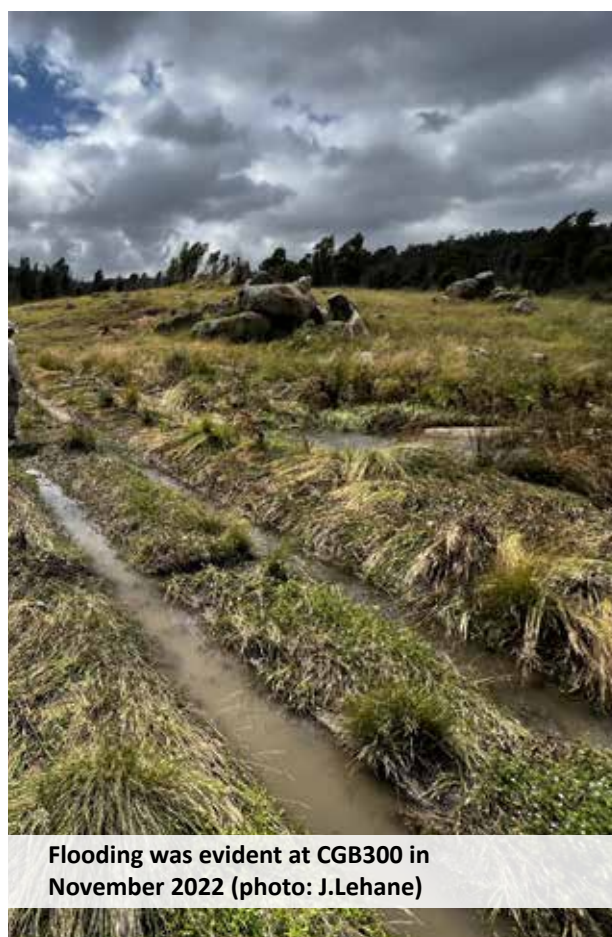
Flooding was evident at CGB300 in November 2022 (photo: J. Lehane)

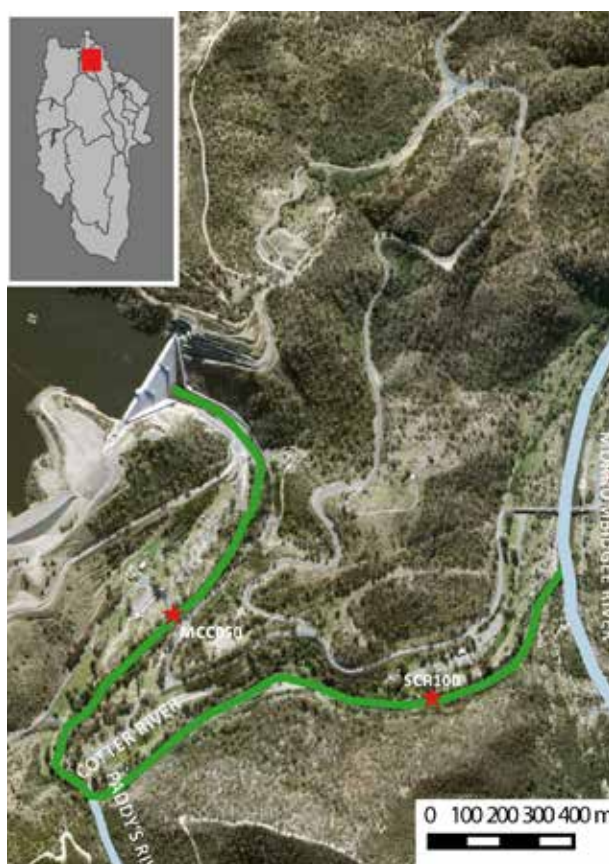
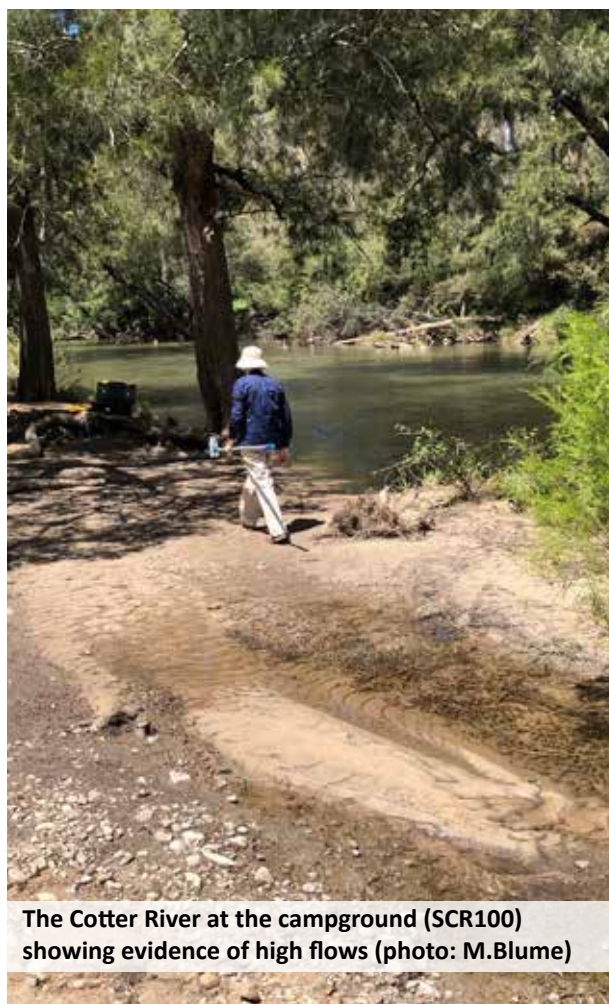
Jill and Maree observed in December at the Cotter campground (SCR300) that there were '*adventitious roots visible around the base of the Casuarina*'. This is a fibrous root system, often red in colour, that can appear above the ground on Casuarinas if they are stressed from excess flooding.

The Cotter River at the campground (SCR100) showing evidence of high flows (photo: M.Blume)

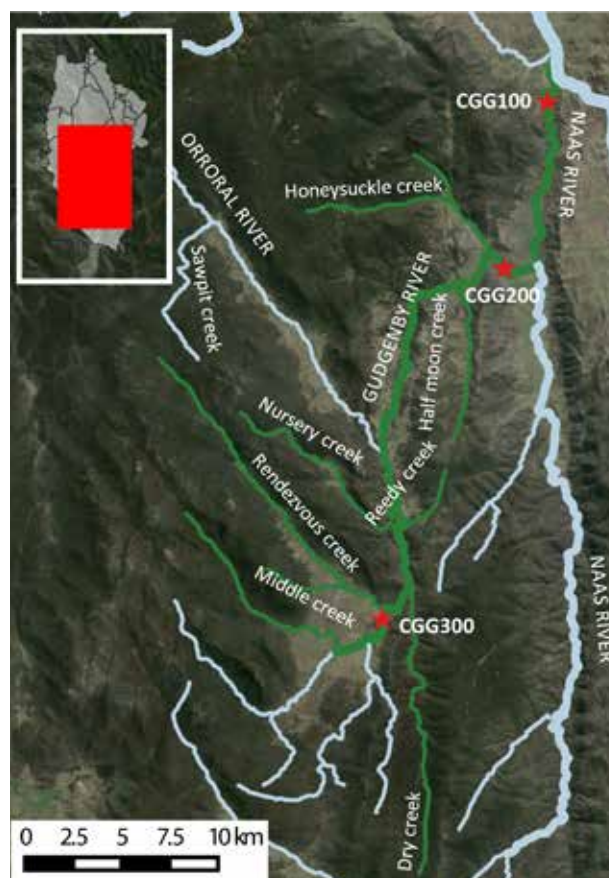
The riparian vegetation in the rural stretch lacks significant native tree cover and understory. The riparian vegetation in the national park is still very much affected by the 2020 fires. A riparian assessment at the most upstream site (CGG300) in November found some regrowth of native canopy and midstorey shrubs, increasing leaf litter and, as expected, lots of fallen, dead logs.

The impact of the bushfires is still evident in the upper sections of the Gudgenby River (photo: J.Lehane)

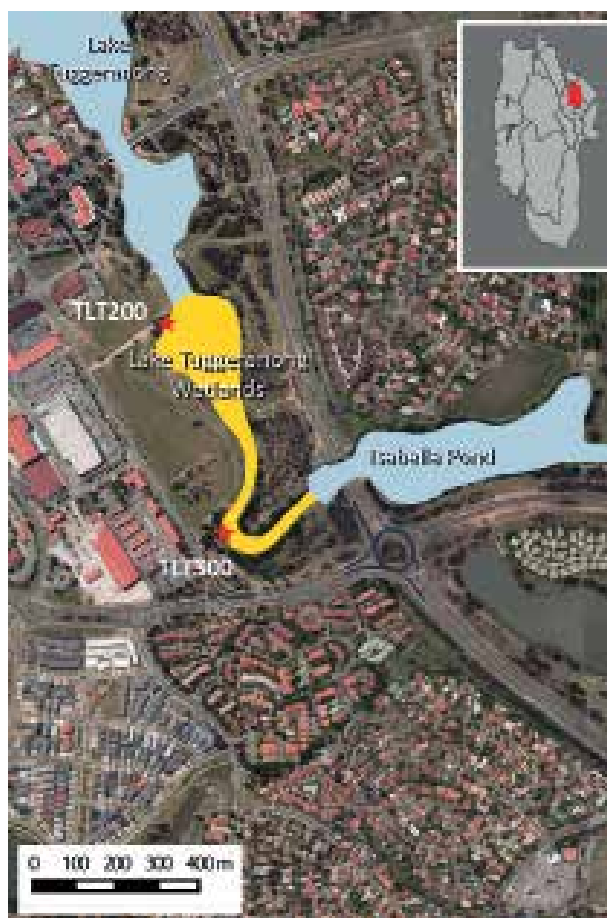
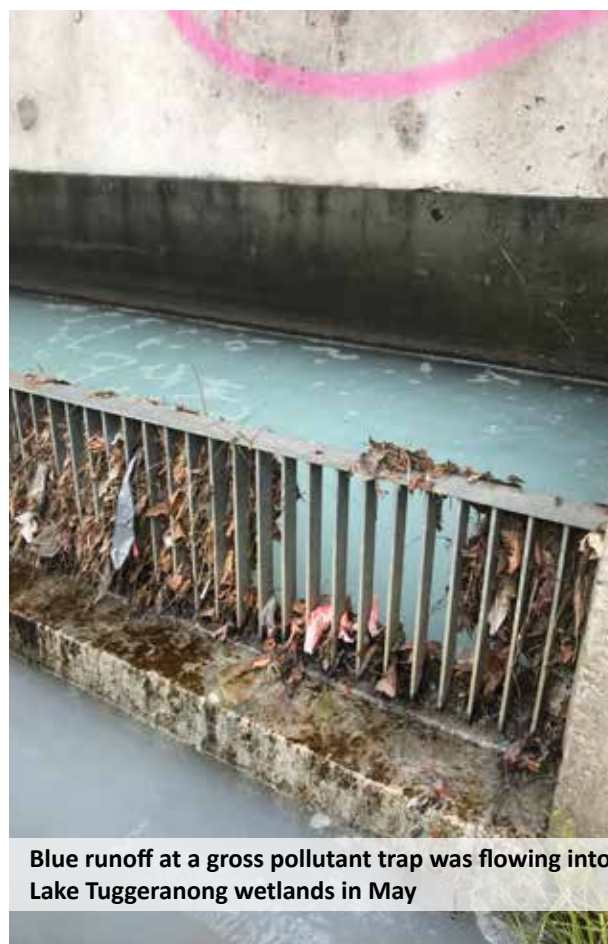
In May, while conducting the waterbug survey, light-blue, soapy water was noted flowing from a drain off Anketell Street. A search of the nearby building works, with the help of the site manager, found no obvious source. The Environment Protection Agency was duly notified.

Blue runoff at a gross pollutant trap was flowing into Lake Tuggeranong wetlands in May

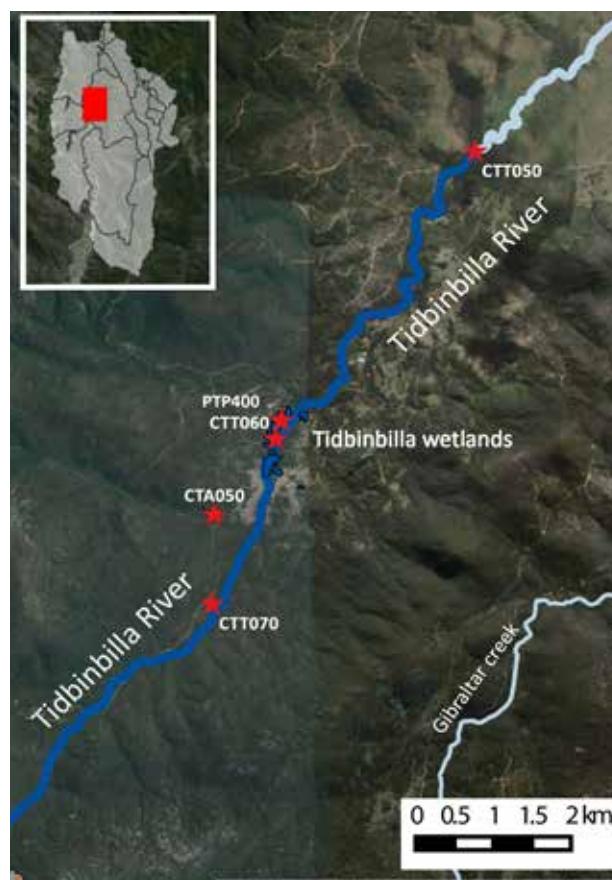
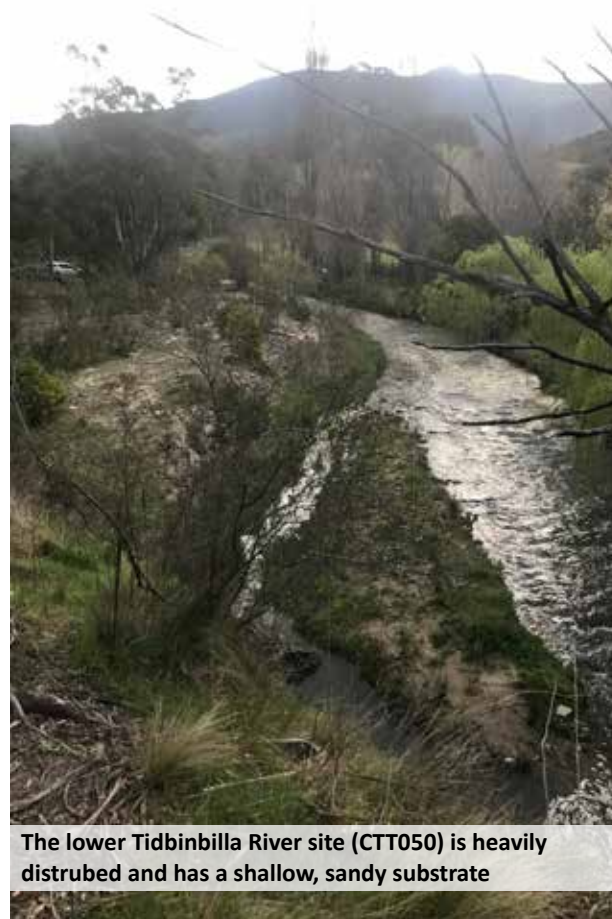
The lower Tidbinbilla River site (CTT050) is heavily disturbed and has a shallow, sandy substrate

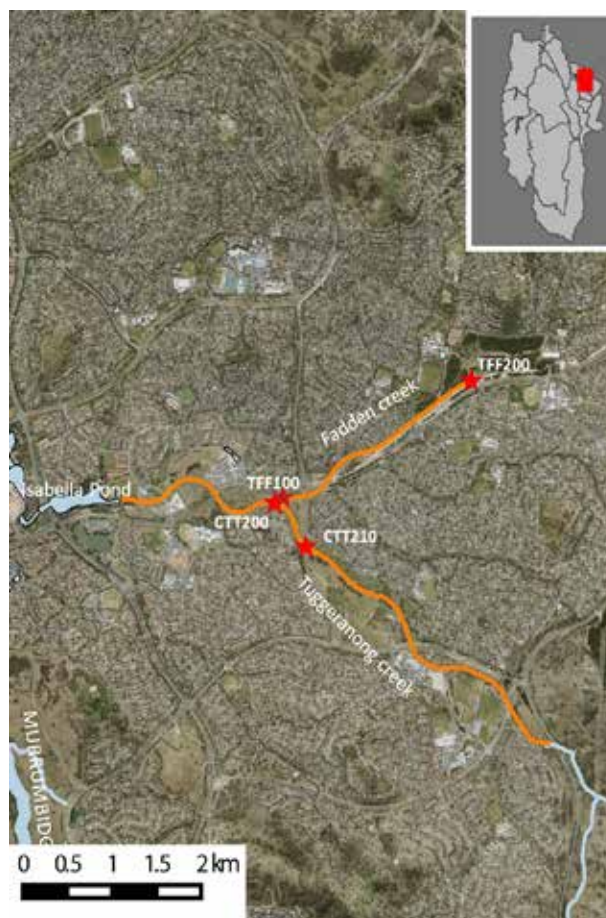
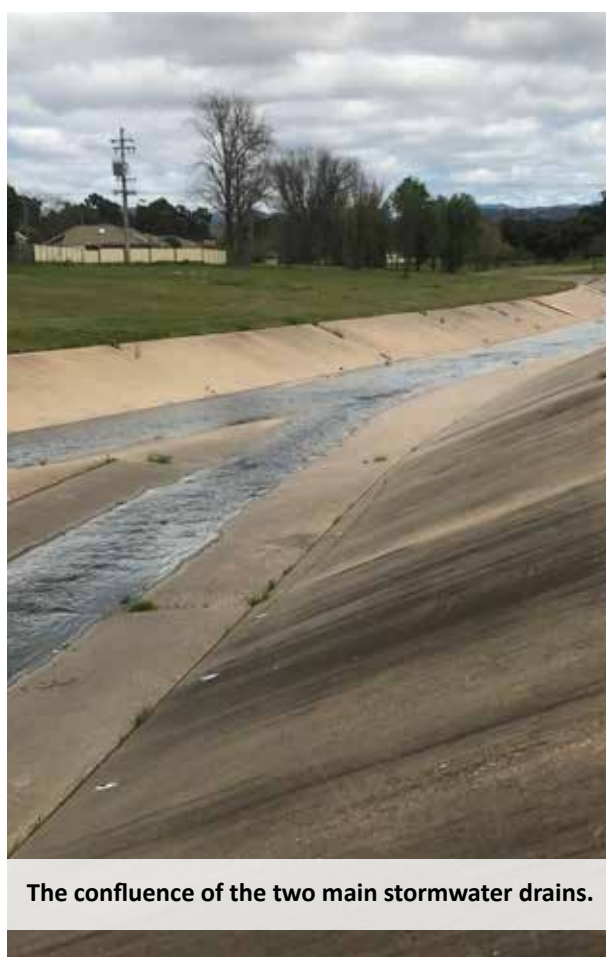
The flushing rainfall this year had a positive effect on turbidity and dissolved oxygen levels. High concentrations of dissolved salts and minerals, measured as electrical conductivity, was detected in both drains and high nitrate loads continued to be an issue from the Fadden arm with a spike in nitrates (7.5mg/L) measured there in March.

The confluence of the two main stormwater drains.

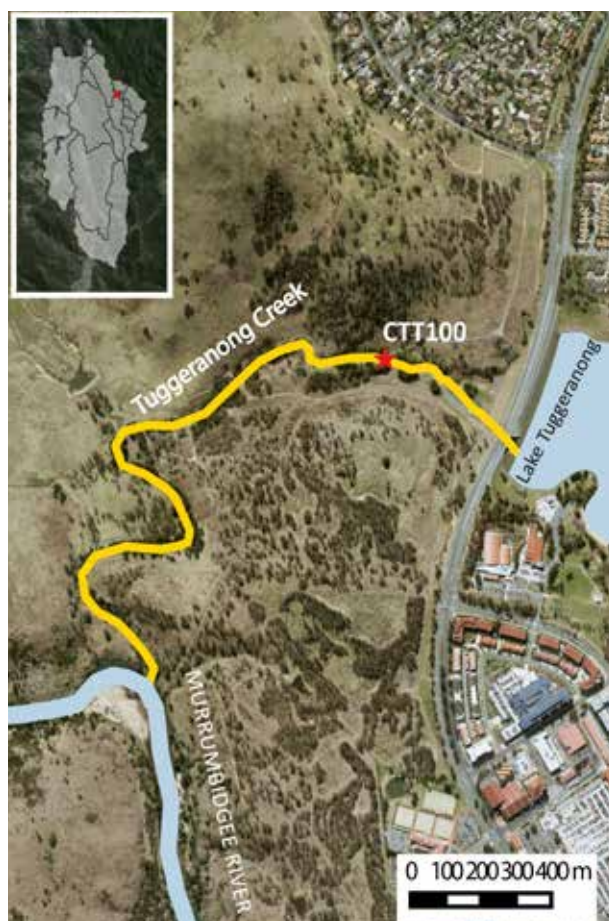
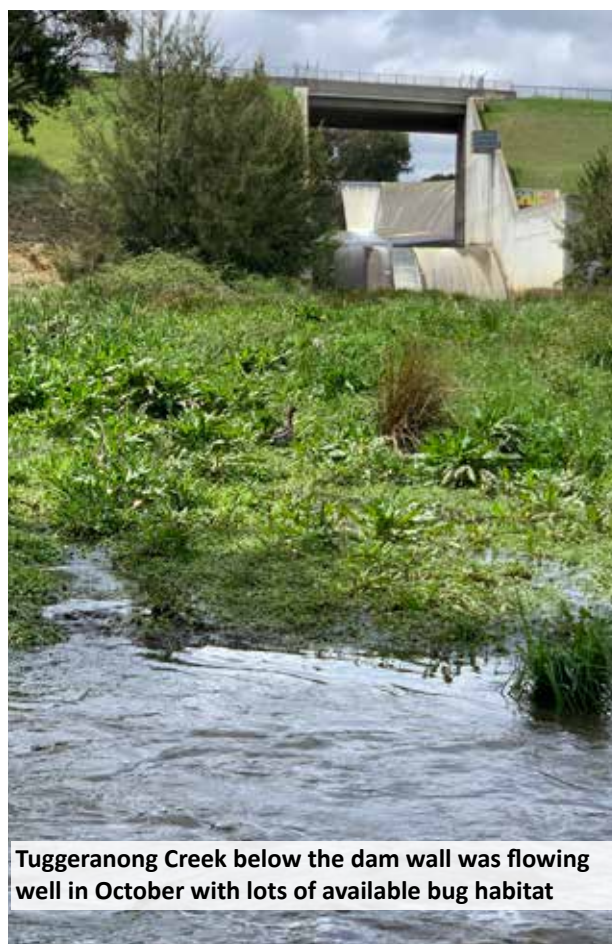
Tuggeranong Creek below the dam wall was flowing well in October with lots of available bug habitat

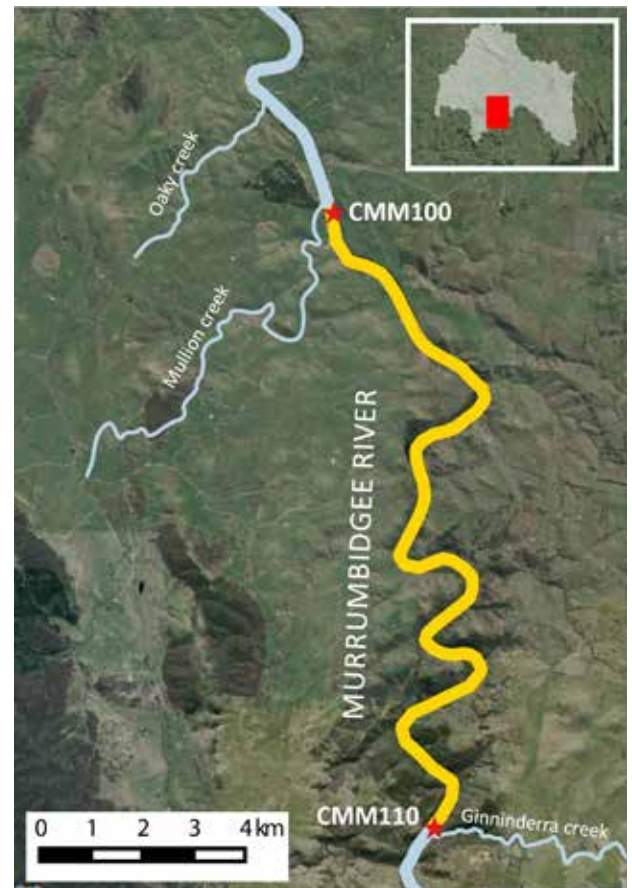
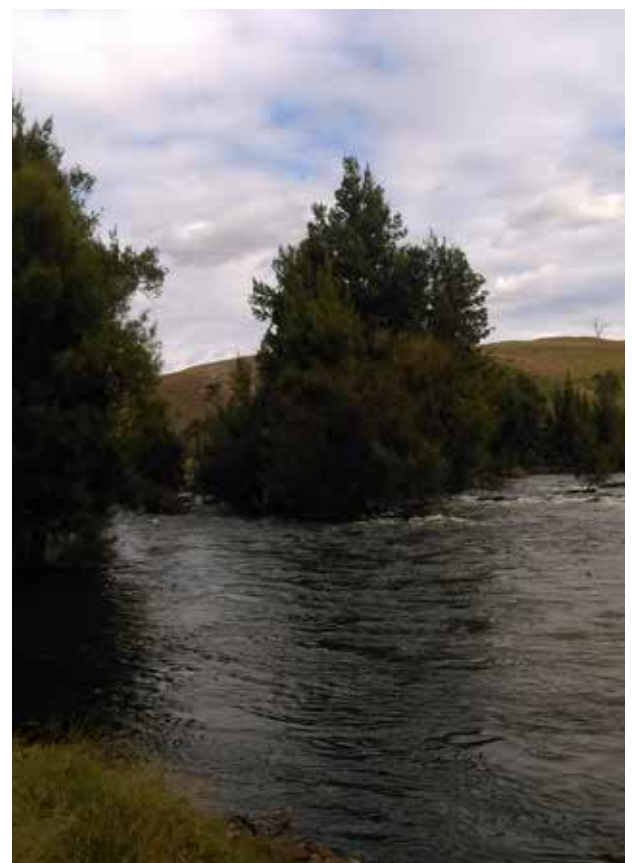
The high flows, however, have also likely affected the low numbers and diversity of waterbugs, with only six and seven Orders found at the Autumn and Spring surveys, respectively. Despite this, it was encouraging to find a stonefly during the Spring survey, a first for this reach. This is another indication that the water quality has improved enough in recent years to support these pollution-sensitive waterbugs.

High water levels above CMM100 made sampling difficult the during Spring bug survey

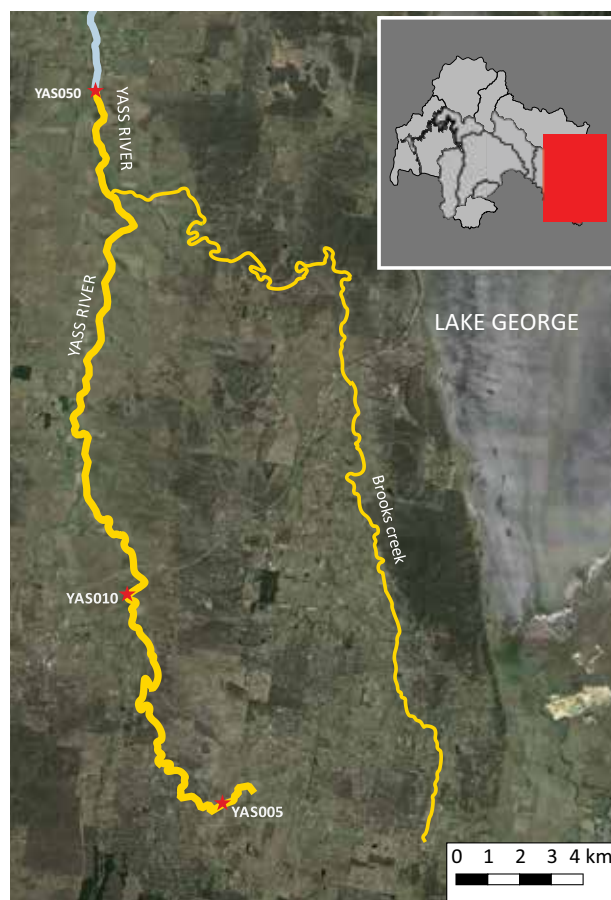
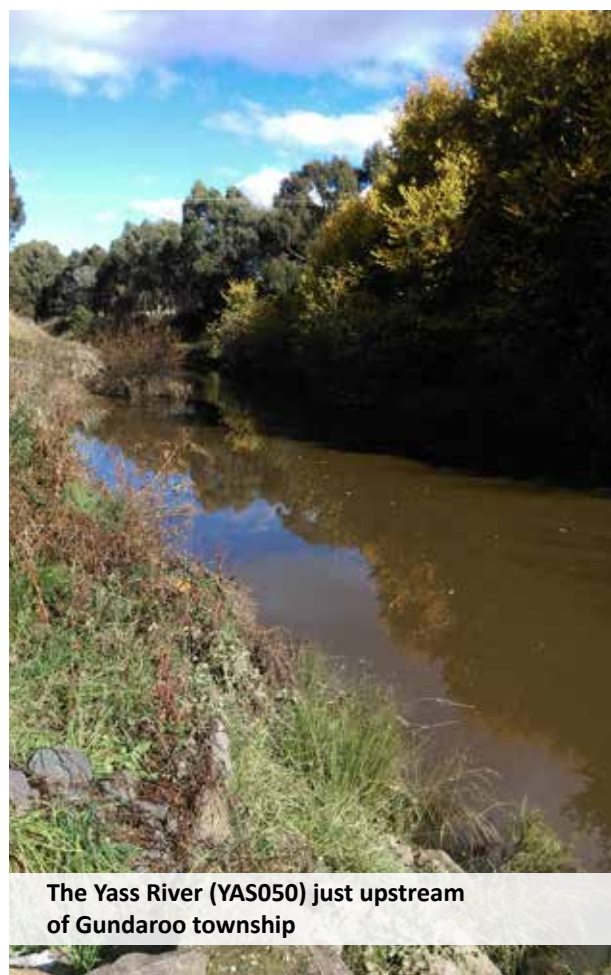
The Yass River (YAS050) just upstream of Gundaroo township

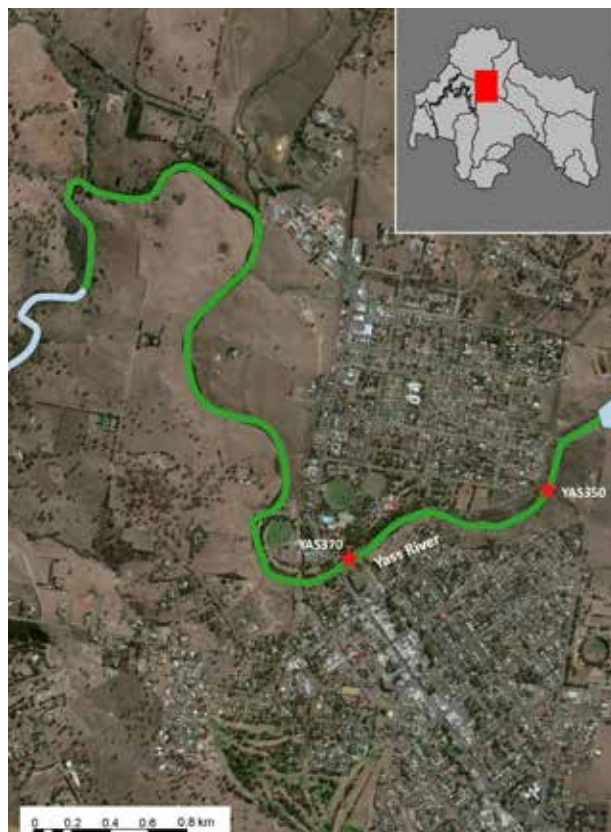
High flows and flooding was observed throughout the year with Waterwatcher Rebecca making several notes of eroding banks as well as deposits of silt and debris including two large trees falling into the river near her site, YAS370. Waterwatchers recorded turbidity as high as 55NTU and a huge range in electrical conductivity readings of 330µS/cm- 1430µS/cm.

**Turbidity and unstable riverbanks were noted at YAS370 throughout 2022**

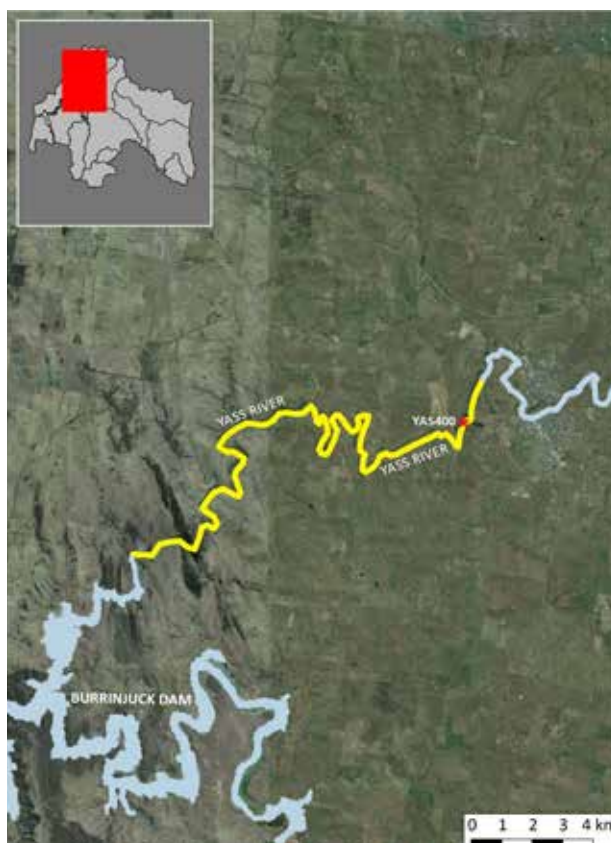
In 2022, continuing wet conditions with multiple flood events caused erosion of the riverbanks, with trees uprooted and rocks shifted by the strength of the flows. The high water levels also submerged most of the in-stream vegetation which provides habitat for waterbugs. The waterbug surveys recorded fewer bug types than in previous years, with eight different Orders detected.

**Willows and large rocks were mobilised during floods at Hattons Corner, March 2022 (photo: R.Widdows)**
