Catchment Health Indicator Program

2018

Two primary functions of the Waterwatch program are to facilitate community engagement through the monitoring and care of local waterways, and to use the data (water quality, macroinvertebrate [water bug] and riparian condition) as an early warning system for aquatic ecosystem health issues. A key output of this program is the annual Catchment Health Indicator Program (CHIP) report, which provides a numerical score of catchment health, displayed in individual reach report cards, using data collected by Waterwatch volunteers.

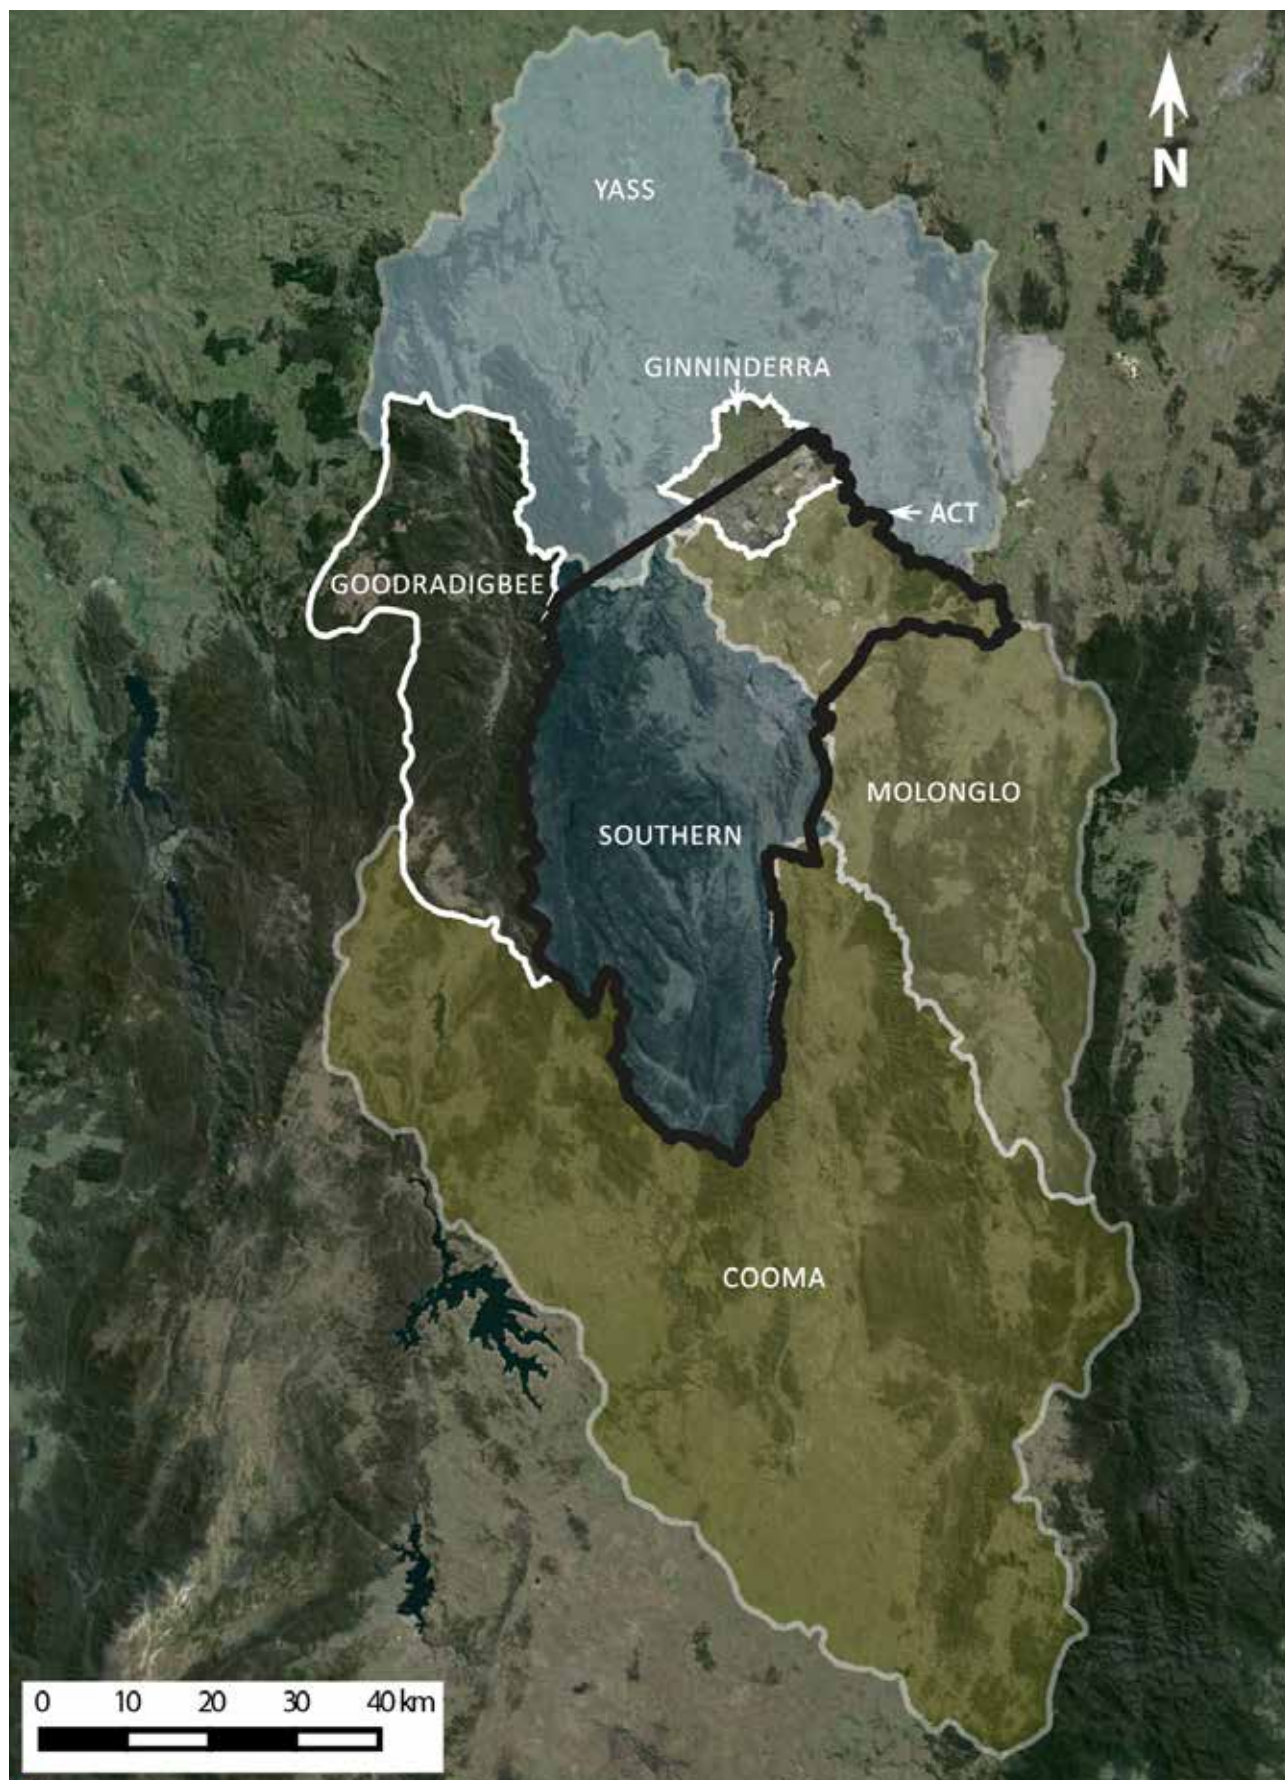
Figure 1. Overview of the Upper Murrumbidgee River catchment, outlining the five major sub-catchment areas represented in this report. The Goodradigbee catchment is not included in this report.

Four Waterwatch coordinators support volunteers in the major sub-catchments of Cooma, Molonglo, Southern ACT, Ginninderra and Yass (see Figure 1). Each of these sub-catchments will make up sections I – V of this report. This year, the Yass catchment has increased to six report cards, and continues to be an area of growth for the program.

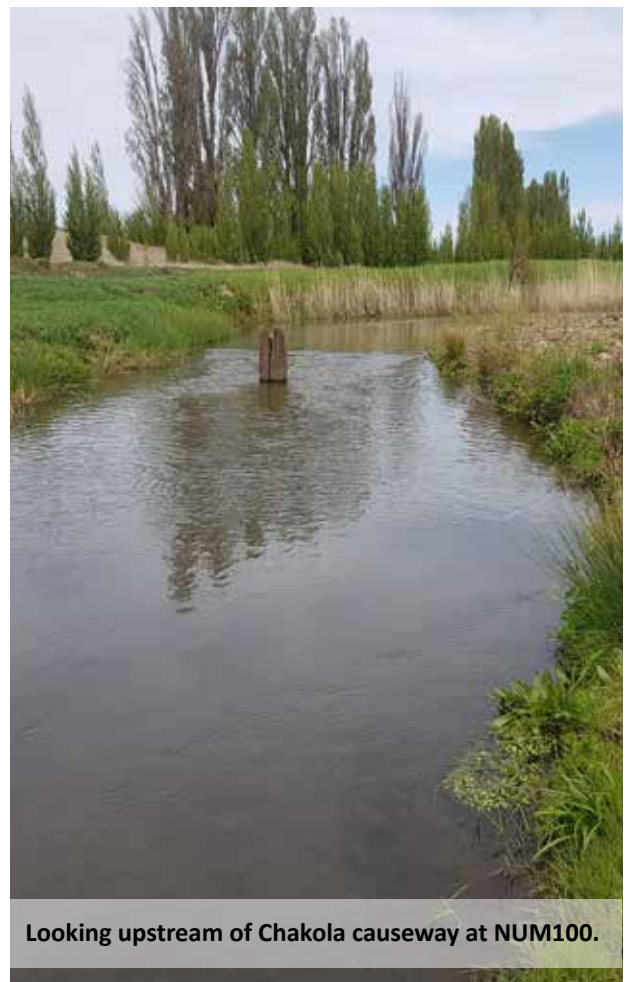
Looking upstream of Chakola causeway at NUM100.

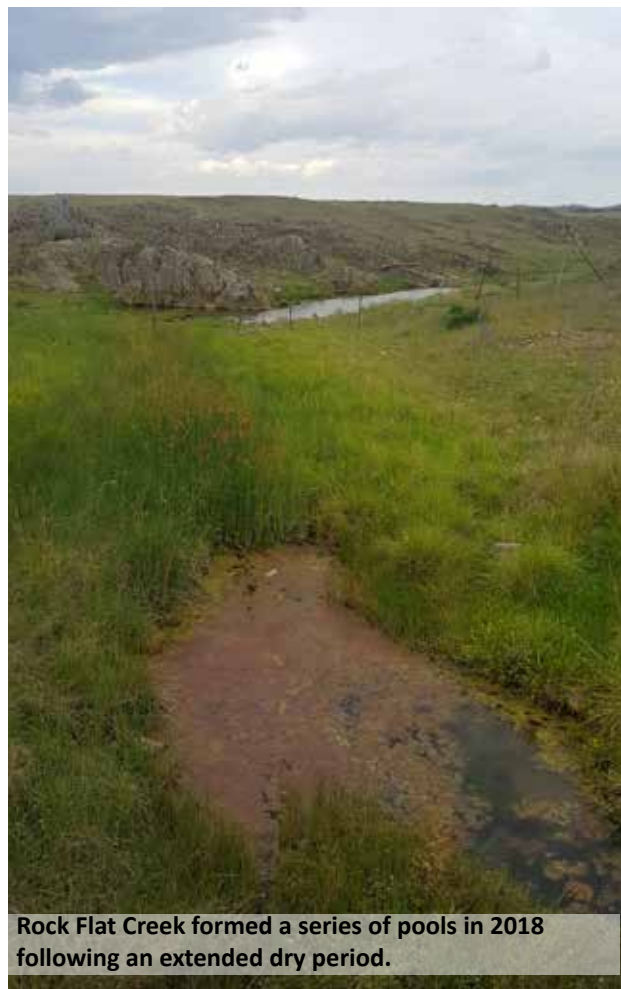
Rock Flat Creek formed a series of pools in 2018 following an extended dry period.

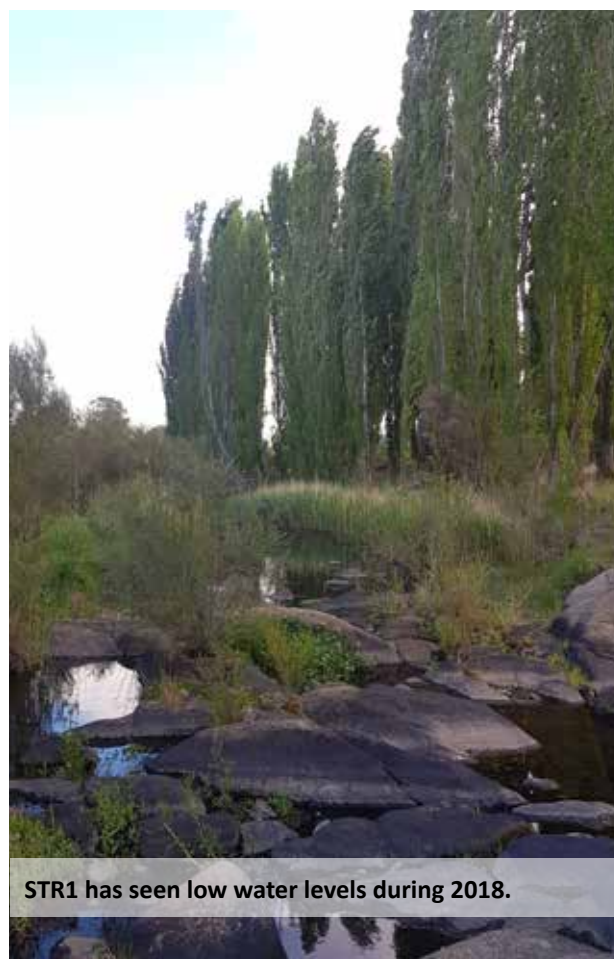
STR1 has seen low water levels during 2018.

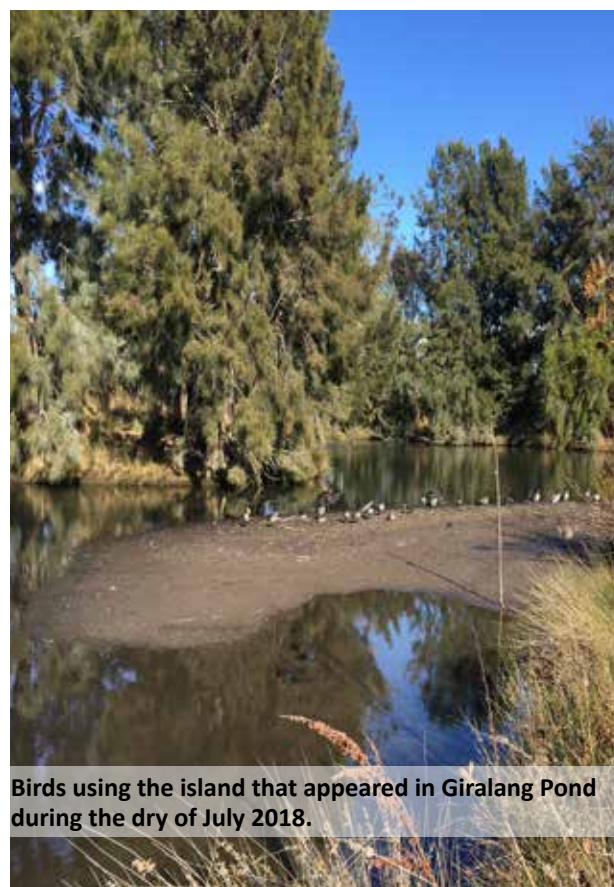
Birds using the island that appeared in Giralang Pond during the dry of July 2018.

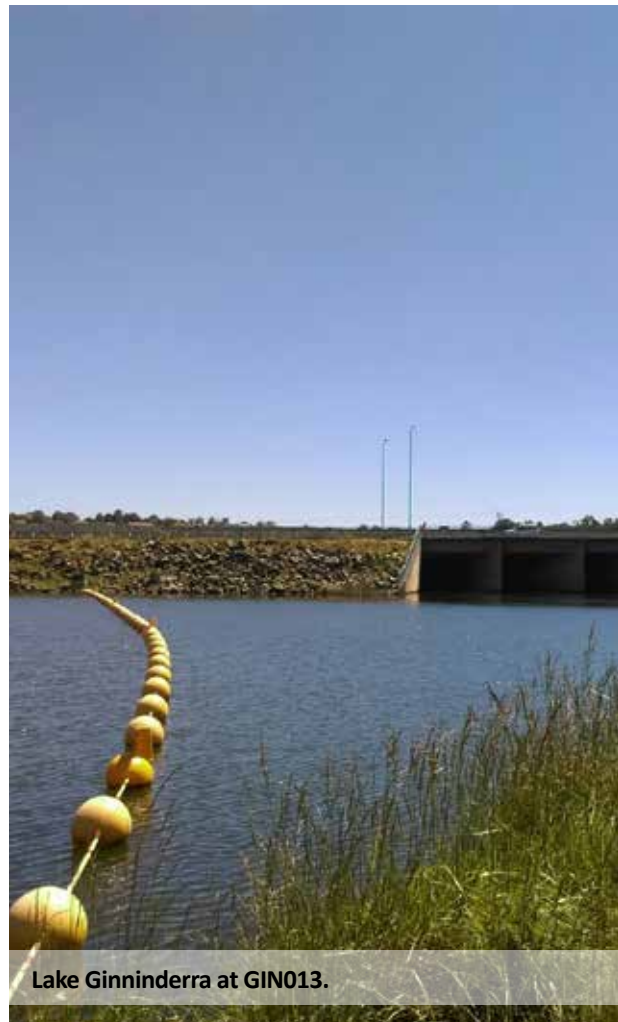
Lake Ginninderra at GIN013.

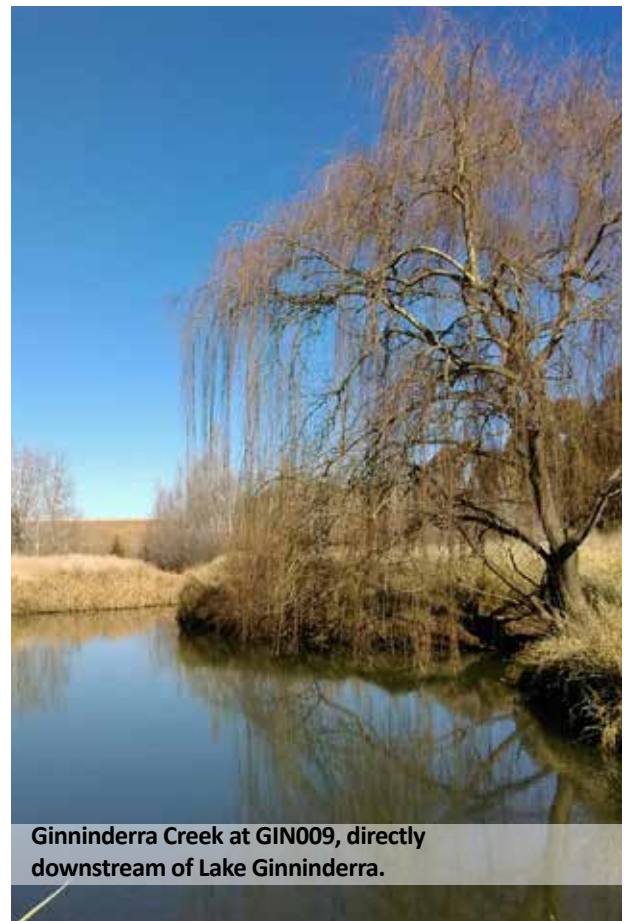
Ginninderra Creek at GIN009, directly downstream of Lake Ginninderra.

Even though there is a moderate presence of trees along the edge of Ginninderra Creek in this section, the majority are introduced species like Poplars and Willows. Some areas the Creek (GIN009) are choked up with them. They drop large amounts of leaf litter into the waterways in Autumn causing unwanted spikes in nutrients within the system.

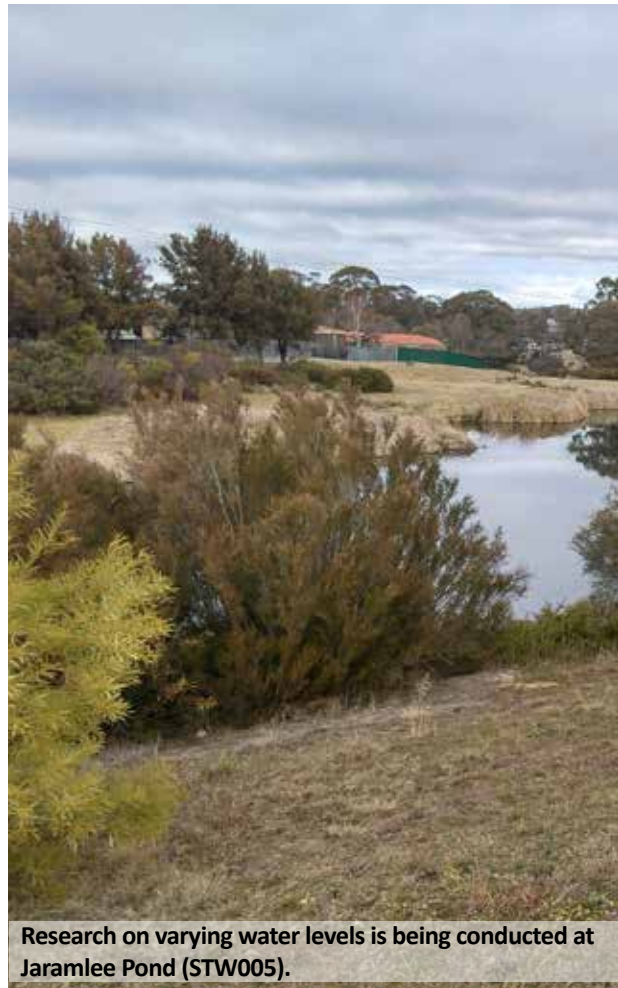
Research on varying water levels is being conducted at Jarramlee Pond (STW005).

The ACT Healthy Waterways Project are conducting research at Jarramlee Pond (STW005) looking at how varying the water level in urban wetlands can improve their ability to trap pollutants. The level of Jarramlee Pond was deliberately lowered in March by about 1.5 metres as part of this study.

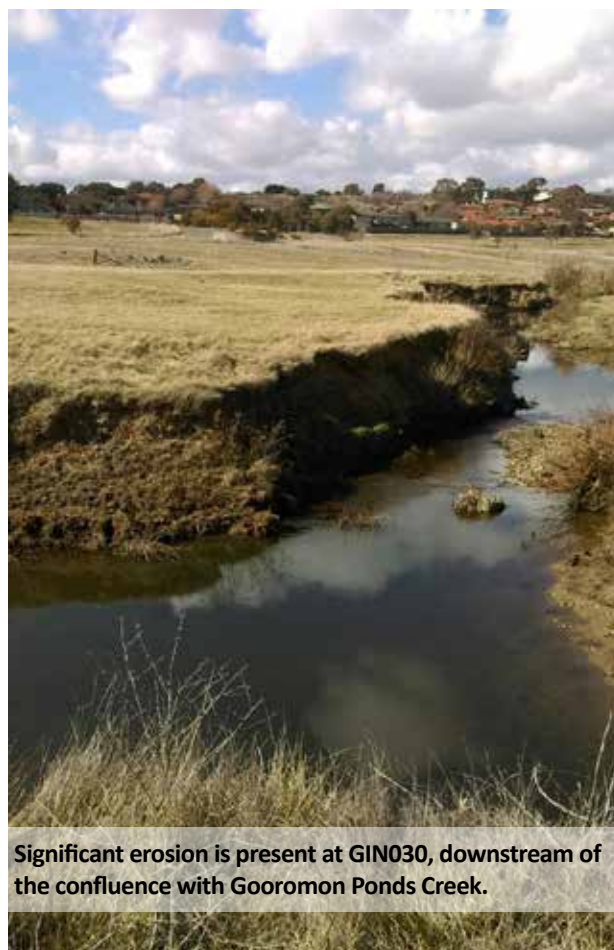
Significant erosion is present at GIN030, downstream of the confluence with Gooromon Ponds Creek.

Erosion continues to be a problem downstream of the confluence of Ginninderra Creek and Gooromon Ponds (GIN030). It's positive to note, however, the regeneration of native shrubs plus some habitat such as fallen logs, along the edge of the creek at Kilby Homestead. This provides essential refuge for small vertebrates such as frogs and lizards.

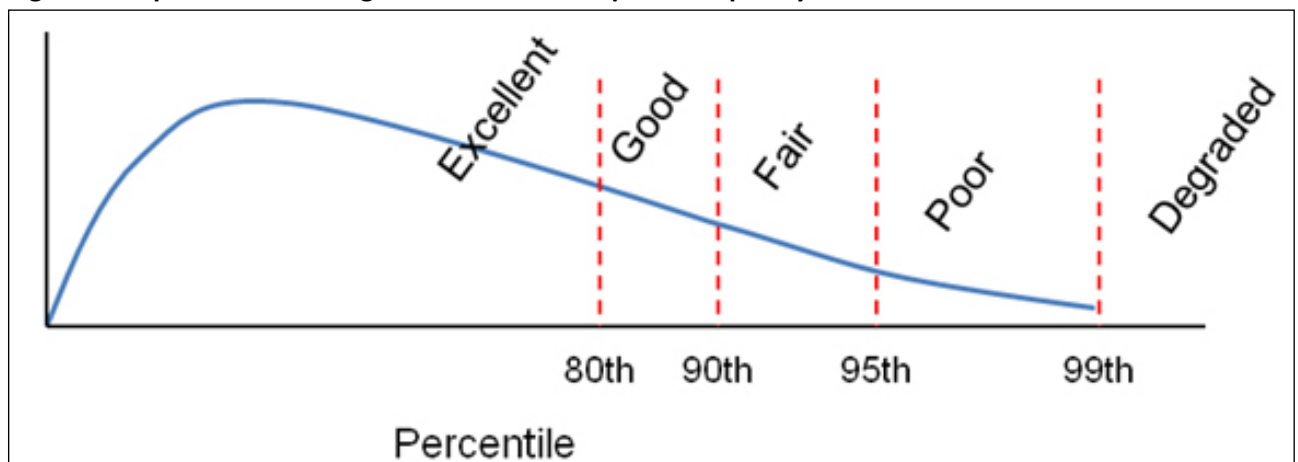
Our approach is outlined in figure 2. After creating a frequency histogram from reference condition data, the threshold values for each parameter are defined using the 80th (Excellent), 90th (Good), 95th (Fair), 99th (Poor) and >99th (Degraded) percentiles. The implicit assumption is that parameter values that occur in excess of 80% of the time in the reference sites reflect excellent quality, with rarer occurring events being of lower quality. Finally, it is assumed that 'degraded' water quality would only be observed <1% of the time in a reference condition site.

Figure 2. Depiction of defining thresholds based upon a frequency distribution of data.
