Catchment Health Indicator Program

2016–17

Executive Summary

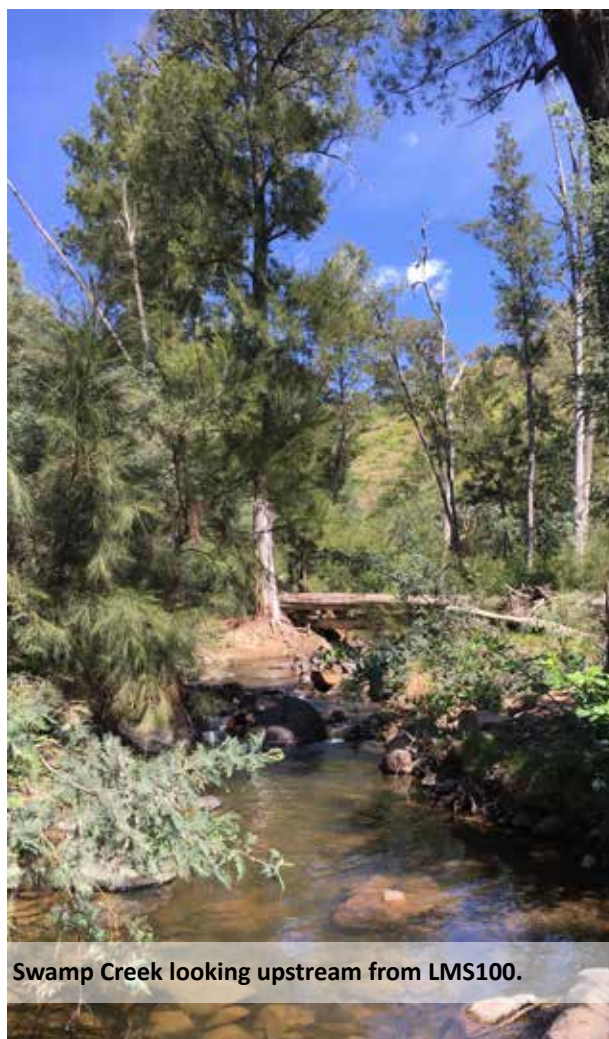
Swamp Creek looking upstream from LMS100.

Swamp Creek scored the same water quality as upland streams and rivers in the southern ACT. Riparian vegetation at the monitoring site is in 'fair' condition but lacks the in-stream and edge vegetation required to host a variety of water bugs. This became apparent in the Spring bug survey where there were high numbers of the pollution sensitive bugs including stoneflies, 100+ caddisfly and 100+ mayfly – all bugs found in the clean riffle zone. Overall, however, only six types of bugs were found, highlighting the need for a variety of habitats to maintain diversity.

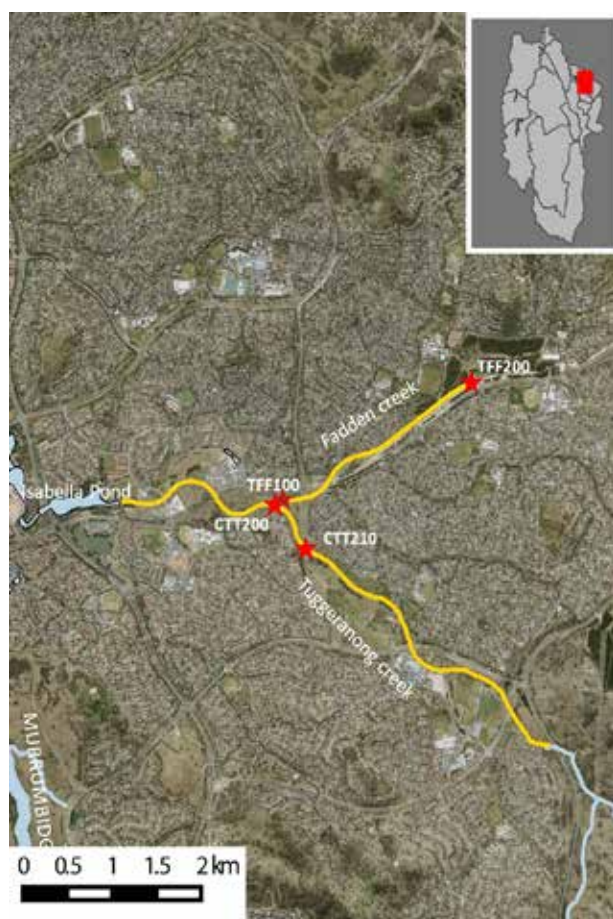
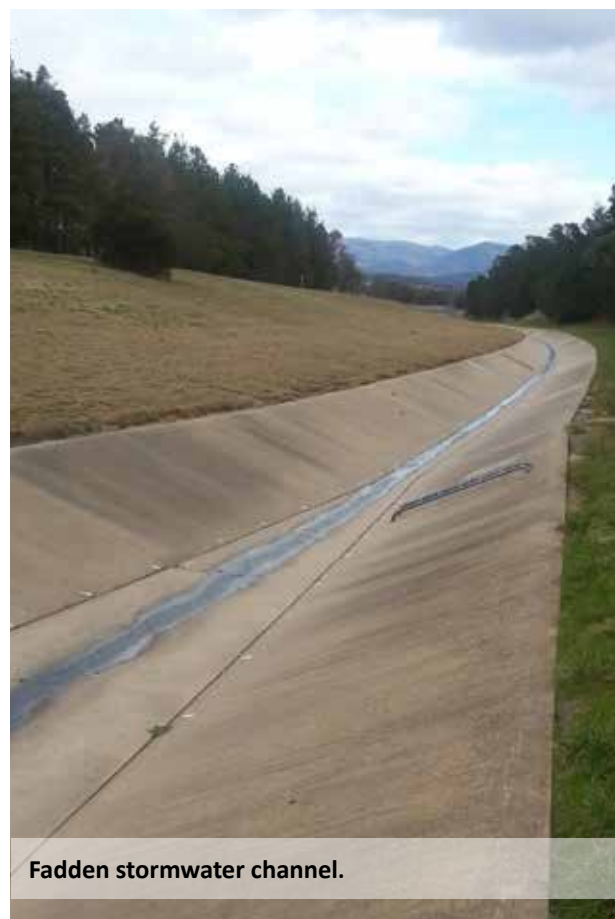
Fadden stormwater channel.

Over the hottest months when many Waterwatch sites across the catchment are experiencing low dissolved oxygen, all four sites in this reach experienced 'super-saturation' of around 120%. Why? The continuous flows maintained an array of algae in the channel over the Summer months which go crazy photo-synthesising when the water is clear and warm. A by-product of this process is oxygen which can be detrimental when it occurs at such extreme levels as this. Interestingly, another effect of photo-synthesis is that it can drive up pH levels and, again, all four sites experienced pH readings of 8 or higher during those hot months.

Of course, no matter how interesting the water quality result, it doesn't change that this is a concrete channel and does not measure up as habitat. No riparian vegetation and almost no aquatic organisms were found in this reach.

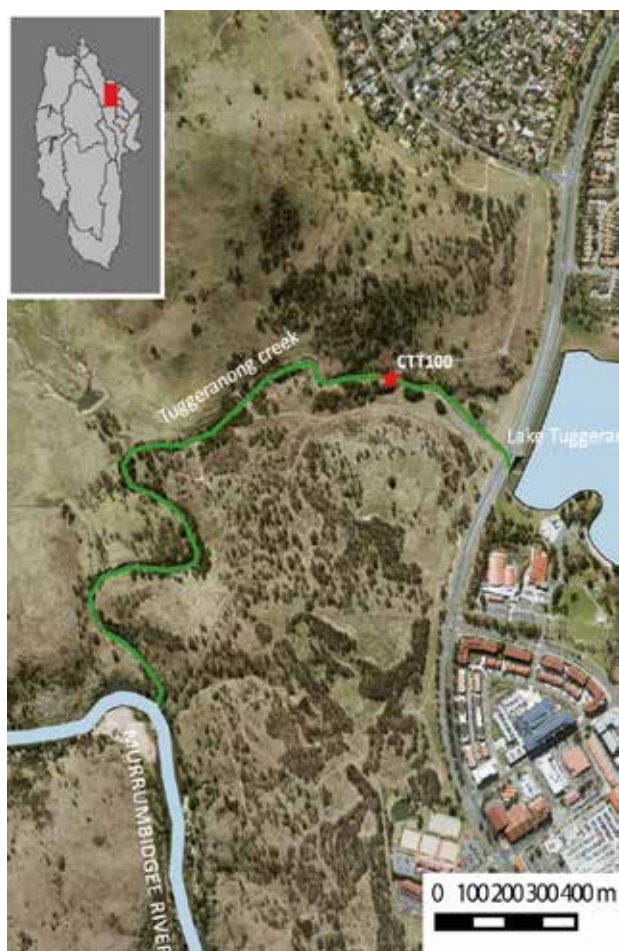
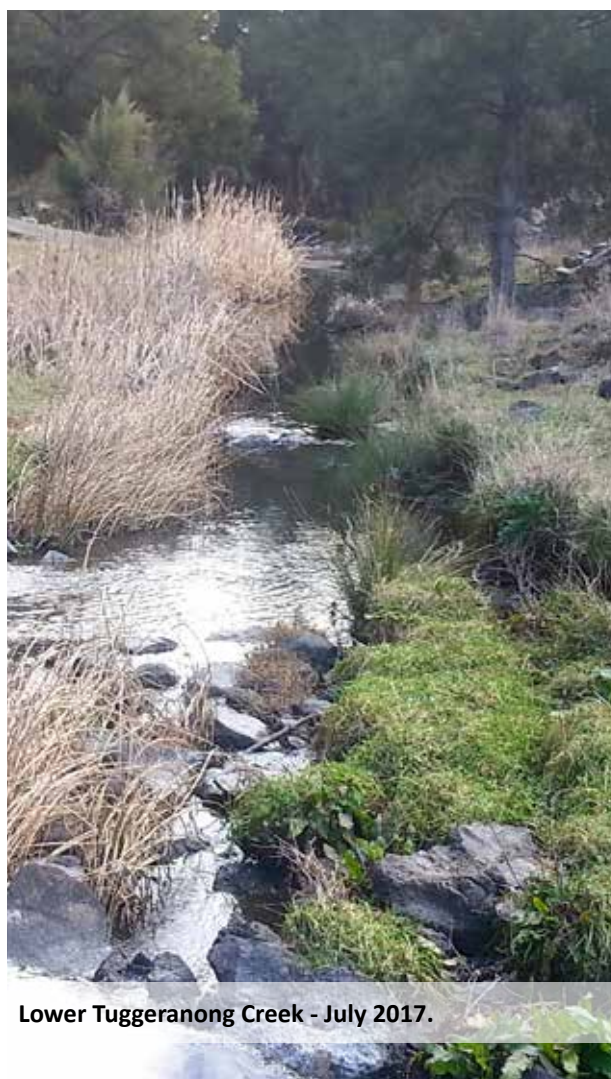
Lower Tuggeranong Creek - July 2017.

Water quality was affected by the same seasonal issues that occurred in our other small creeks. In particular; low oxygen and higher than optimal nutrients and electrical conductivity. In February an oxygen super saturation event was captured. The expert prognosis was that:

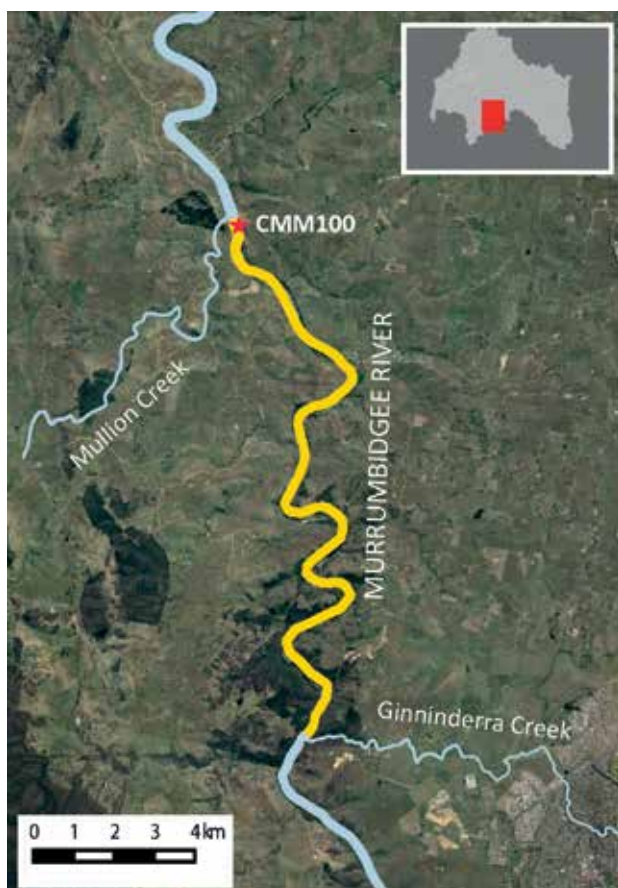
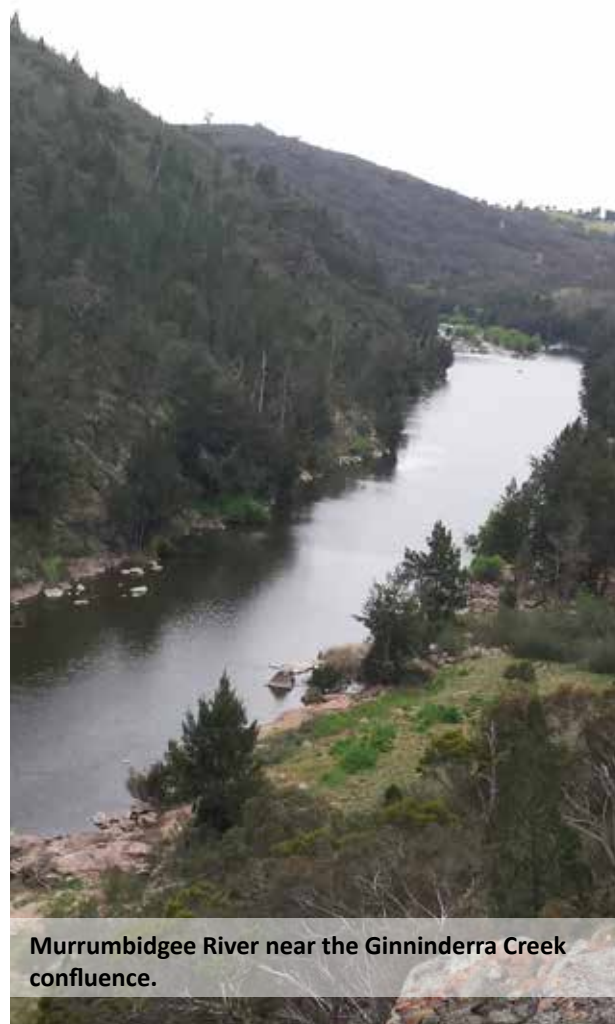
Murrumbidgee River near the Ginninderra Creek confluence.

Electrical conductivity showed some high readings during low flows (350 and 420 $\mu\text{S}/\text{cm}$). Nitrate had consistently high readings with the highest being in late February of 25 mg/L, the highest reading recorded in the Yass and Ginninderra region. This February reading coincided with some particularly low flows and while CMM100 is 18 km downstream of the Lower Molonglo Water Quality Control Centre (LMWQCC), it would appear that the effects are felt a substantial way downstream when conditions dictate. The high nitrate continued to be felt all the way downstream to our lowest Murrumbidgee site at Taemas Bridge (CMM010 – see report card CMM13) just above Burrinjuck Dam. The volunteer contacted the Environmental Protection Agency (EPA).

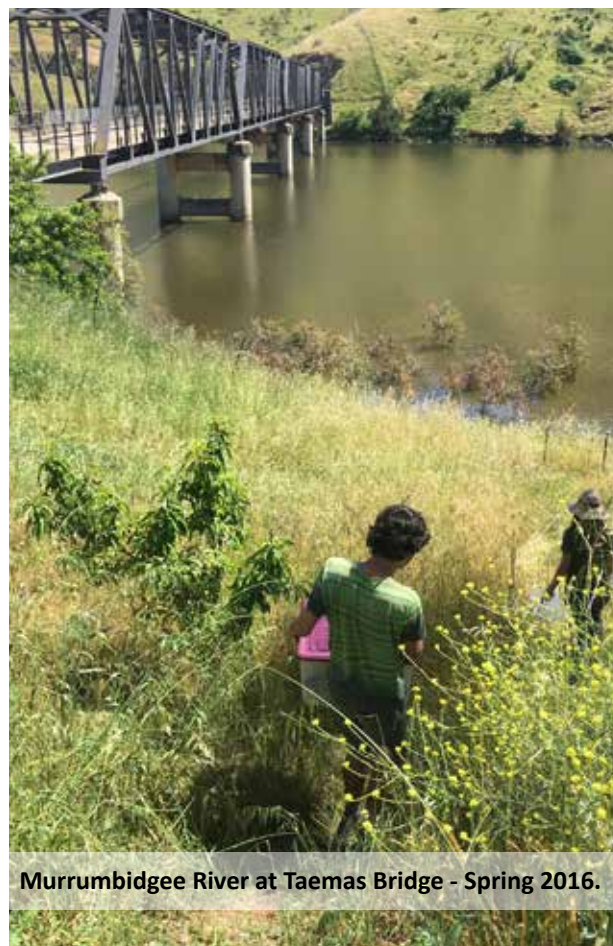
Murrumbidgee River at Taemas Bridge - Spring 2016.

The site at Taemas Bridge was transformed after good Winter and Spring rains. Usually lacking in edge and in-stream vegetation, the back fill from Burrinjuck Dam flooded the young adjacent eucalypts and provided some habitat for water bugs. While the majority of bugs recorded were tolerant species, with high numbers of backswimmers, water striders and water boatmen, there were some caddisflies and mayflies caught which is a nice change for this rather depauperate site.

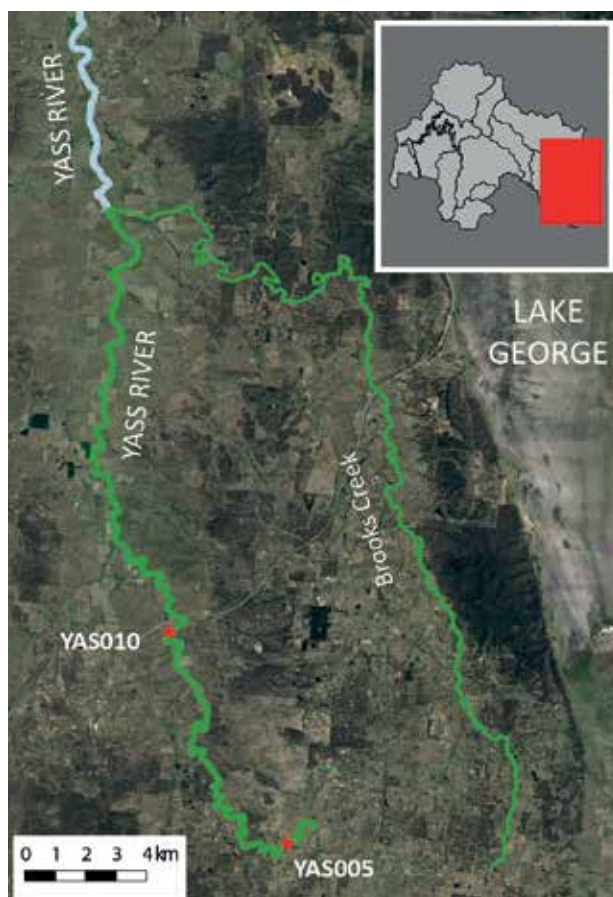
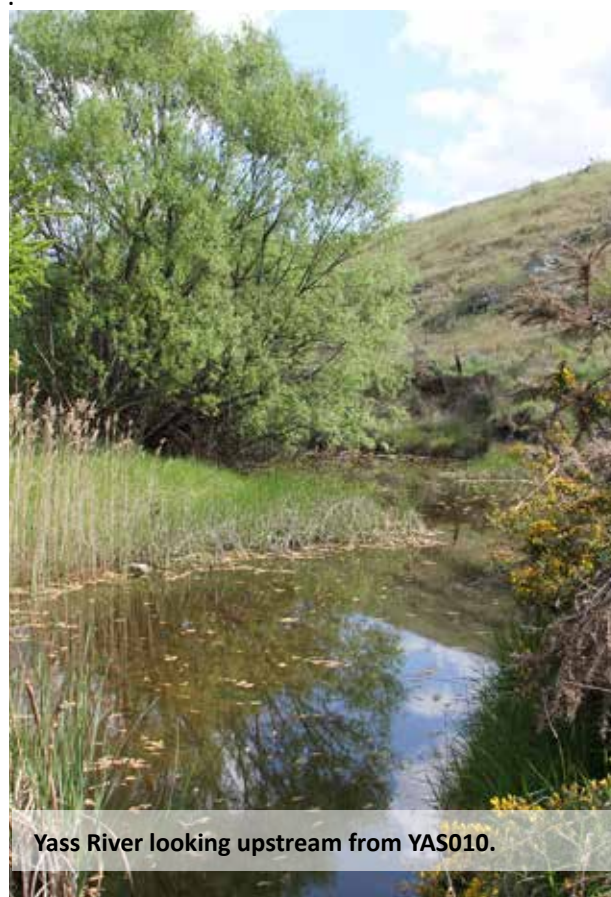
Yass River looking upstream from YAS010.

Water level regularly fluctuates on this section of Yass River. In some occasions, there was no visible flow and the River formed isolated pools. Electrical conductivity continues to be a problem in this reach and understandably, is worse when those pools have formed and the salts and minerals are more concentrated. The electrical conductivity has deteriorated compared to last year and got as high as 1110 μ S/cm in March after a dry, hot Summer.

Volunteers have commented on the “very lush surroundings” at YAS010, and it has been noted the presence of bulrushes, reeds, and water milfoil. Although a good ground cover is present throughout this reach, the amount that is native is still limited.

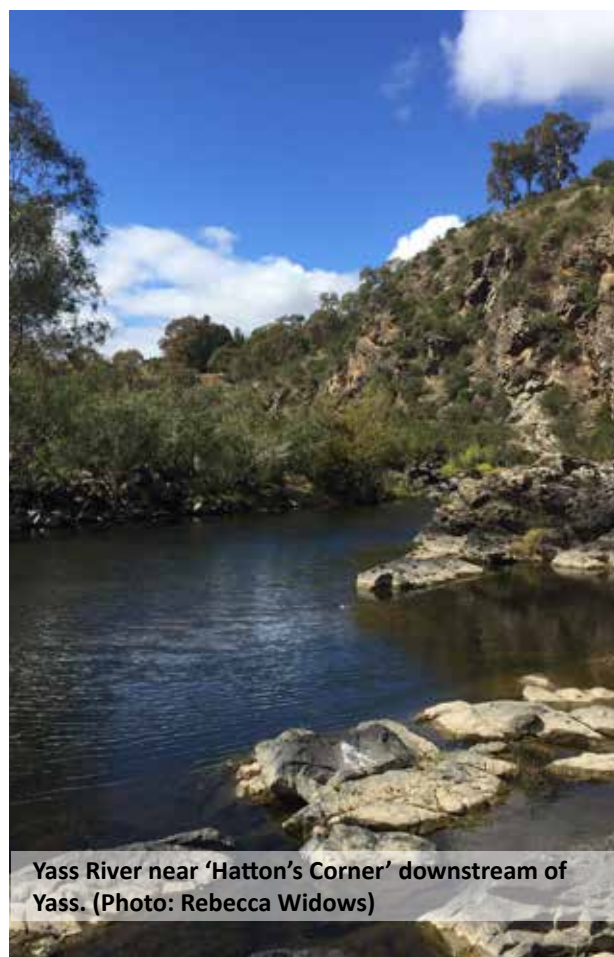
Yass River near 'Hatton's Corner' downstream of Yass. (Photo: Rebecca Widows)

Elevated electrical conductivity readings, ranging from 420-950 μ S/cm, were recorded during medium to low flow. Values fell to 90-210 μ S/cm after floods which diluted the River. Nitrate were also considered high, especially in Hattons Corner and Chinaman's Creek (5 mg/L).

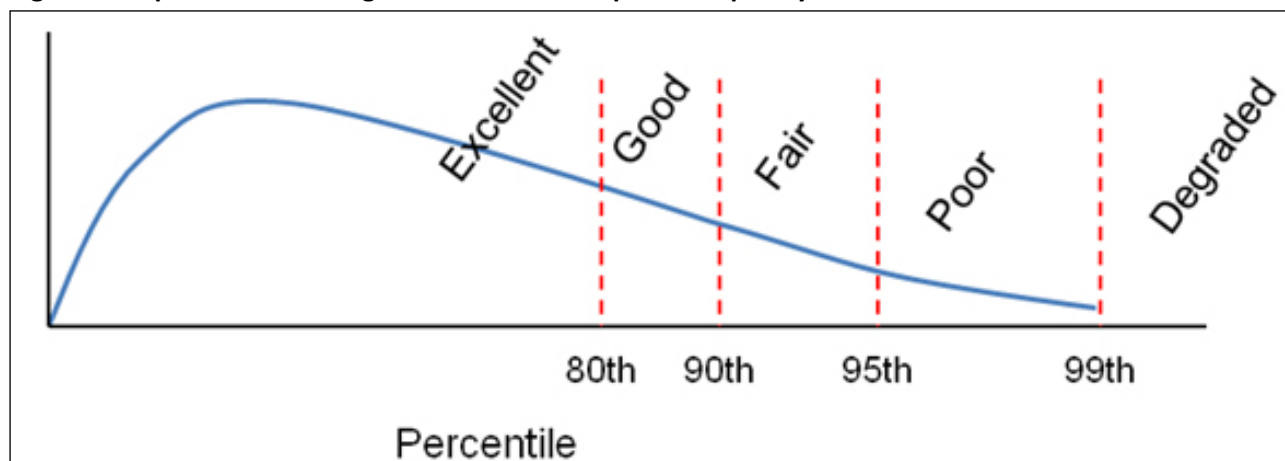
Figure 2. Depiction of defining thresholds based upon a frequency distribution of data.

Our approach is outlined in figure 2. After creating a frequency histogram from reference condition data, the threshold values for each parameter are defined using the 80th (Excellent), 90th (Good), 95th (Fair), 99th (Poor) and >99th (Degraded) percentiles. The implicit assumption is that parameter values that occur in excess of 80% of the time in the reference sites reflect excellent quality, with rarer occurring events being of lower quality. Finally, it is assumed that 'degraded' water quality would only be observed <1% of the time in a reference condition site.
