# Catchment Health Indicator Program 2021

This document can be cited as: Upper Murrumbidgee Waterwatch (2022) Catchment Health Indicator Program: Report Card 2021. Canberra.

Two primary functions of the Waterwatch program are to facilitate community engagement through the monitoring and care of local waterways, and to use the data (water quality, macroinvertebrate [waterbug] and riparian condition) as an early warning system for aquatic ecosystem health issues. A key output of this program is the annual Catchment Health Indicator Program (CHIP) report, which provides a numerical score of catchment health, displayed in individual reach (sections of waterway) report cards, using data collected by Waterwatch volunteers.

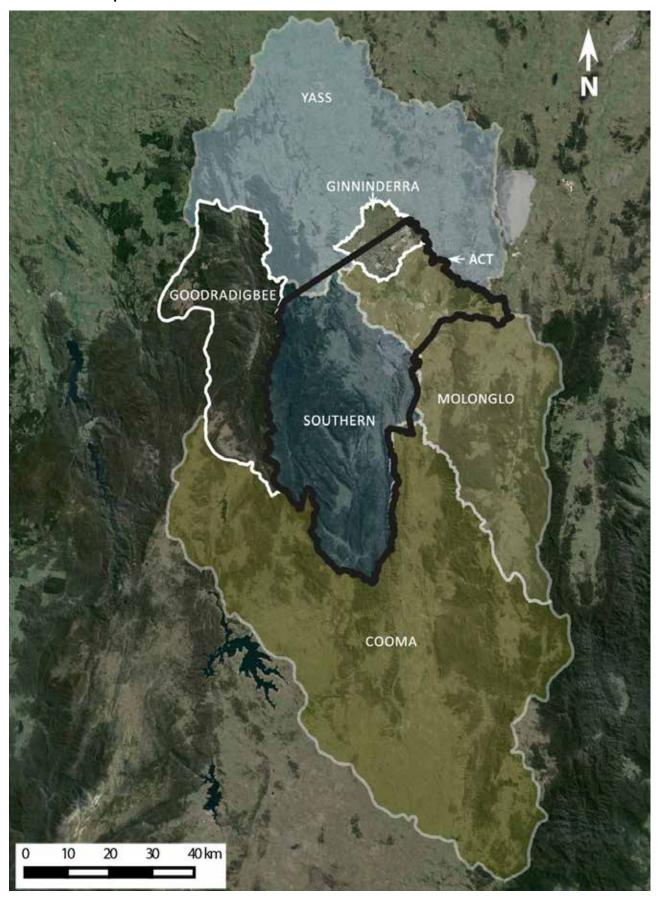
Figure 1. Overview of the upper Murrumbidgee River catchment, outlining the five major sub-catchment areas represented in this report as well as the border of the ACT. The Goodradigbee catchment is not included in this report.

Four Waterwatch coordinators support volunteers in the major sub-catchments of Cooma, Molonglo, Southern ACT, Ginninderra and Yass (see Figure 1). Each of these sub-catchments make up sections I – V of this report.

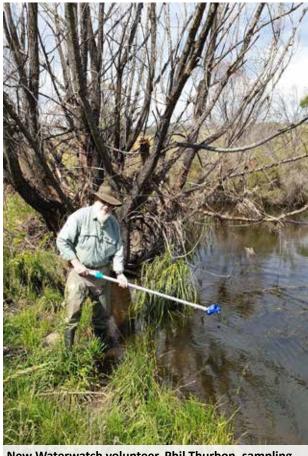
New Waterwatch volunteer, Phil Thurbon, sampling at BRD300 which was impacted by the fires.

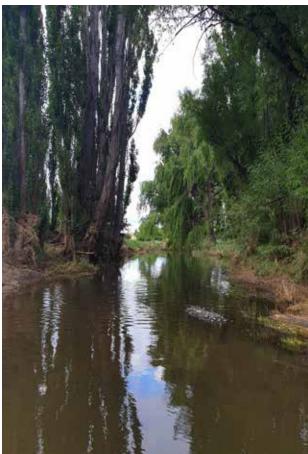
The Cooma Creek at COO625 has little in-stream habitat which negatively affected the waterbug score.

At COO625 we saw large amounts of sediment and organic matter deposited towards the end of the year when higher flow events were experienced. The deposited sediment smothered in-stream waterbug habitat and this is reflected in the waterbug survey results, which declined compared to 2020.

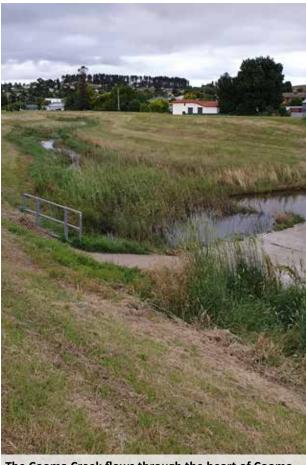
The Cooma Creek flows through the heart of Cooma and levee banks assist with flood management.

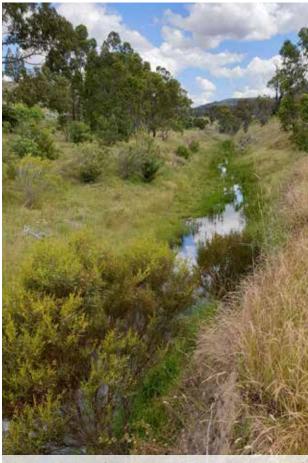
Looking upstream from GUD100 showing the recovery of in-stream vegetation since the 2020 bushfires.

The entire catchment was impacted by bushfires in February 2020 with riparian vegetation and in-stream reed beds being entirely burnt along the creek. Recovery has been assisted by good flows throughout 2021 and saw condition improve from *fair* to *good*. Water quality improved overall except for electrical conductivity which is naturally high due to geological sources (as high as  $810\mu$ S/cm in May). Improved water quality and the full recovery of in-stream vegetation are reflected in the waterbug survey score. Weeds, however, such as mint, have become more prolific following the disturbance caused by the bushfires.

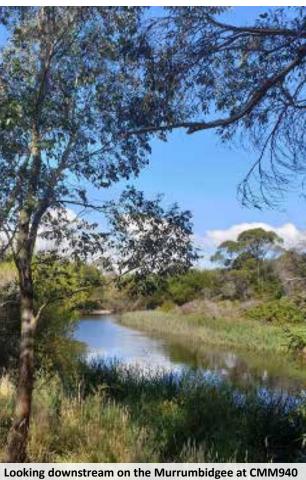
Looking downstream on the Murrumbidgee at CMM940 showing good in-stream and riparian habitat.

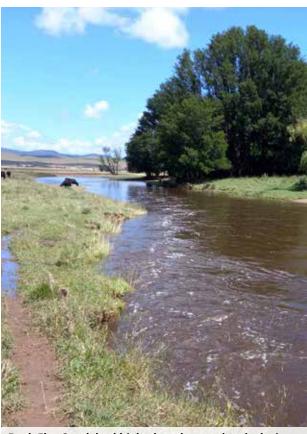
Rock Flat Creek had high phosphorous levels during spring and summer flows (Photo: M. Mannile).

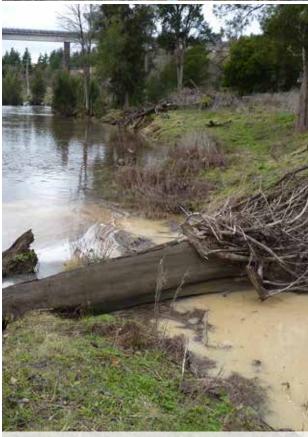
Turbid water flowing into the Molonglo River from Denman Prospect just downstream of Coppins Crossing.

Turbidity in the reach was again a problem in 2021, with turbid water noted coming from Deep Creek due to continued development upstream in the suburb of Whitlam. Erosion issues were noted upstream of the Deep Creek confluence with large gullyerosion channels forming at the newly established Namarag-Molonglo River Reserve. Downstream of Butters Bridge, extreme bank erosion was noted on the unnamed ephemeral creek that takes run-off from the Denman Prospect sediment ponds, further contributing to high turbidity readings.

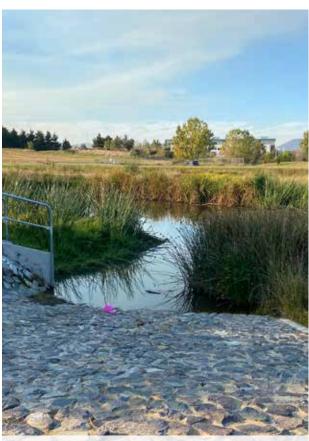
The new Holder Wetlands are proving effective at treating stormwater that flows off the surrounding suburbs.

High phosphorous and nitrate concentrations were evident across this reach through the year. Waterwatcher Gail Newman regularly recorded phosphorous levels of over 0.15mg/L at her two sites (WES450 and WES410). The Holder Wetlands, however, demonstrated their effectiveness in treating water quality. In June 2021 for example, nitrates were detected at 10mg/L and phosphorus at 0.1mg/L at the inlet. This dropped to 1mg/L and 0mg/L respectively at the outlet.

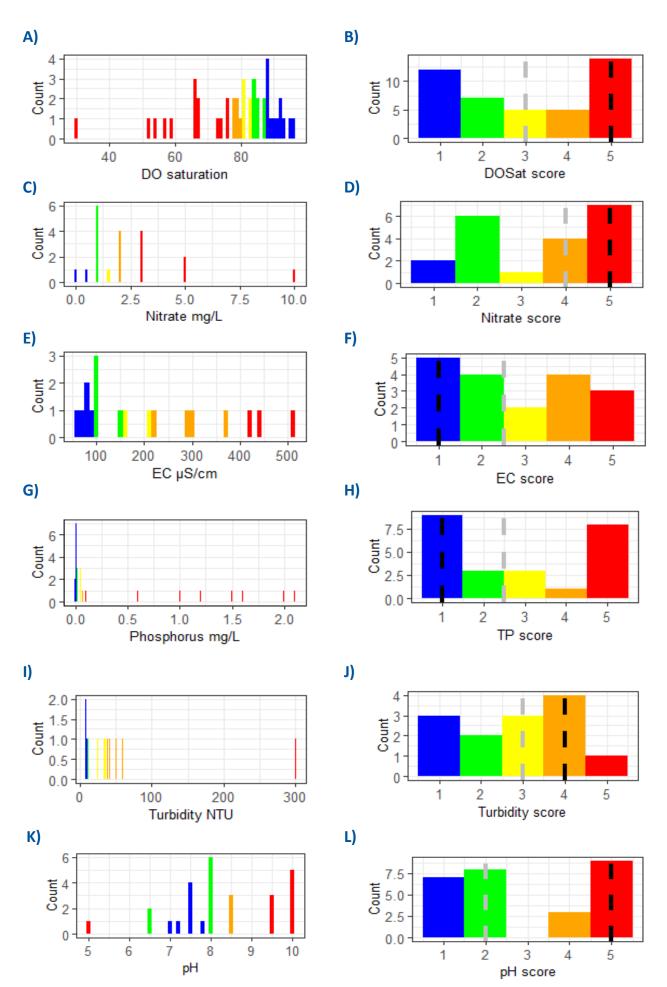
Figure 1. Results for water quality parameters. Raw data are displayed in figures A, C, G, I and K. Data transformed into scores based on CHIP parameter thresholds are displayed in figures B, D, F, H, J and L. Grey line refers to median and black line refers to mode in figures B, D, F, H, J and L.

The method of assessing central tendency can have a large effect on the outcome of analysis. When the framework for calculating CHIP scores was established in 2013, mode was established as the method to calculate central tendency for the water quality scores. This method was used based on a literature review and analysis of what other similar programs were using. Some of the analysis for the 2020 CHIP report uncovered some unexpected outcomes from the water quality calculations and led to questioning if mode was the best method for calculating the water quality score.

A review of the calculation of the water quality parameters was conducted which included testing different methods of calculating central tendency. As mean is not an appropriate statistical method for use on Waterwatch data, a comparison between the result of analysing the water quality data using mode and median was undertaken. The UMWW 2020 data was used to compare the methods. An example of the results from this comparison for each of the water quality parameters can be seen in Figure 1. It is noted that the examples chosen are from reaches where the median and mode were not aligned, however this was not the case for all reaches. Despite this, the examples show that using median rather than mode as a means of calculating central tendency produced results that were more representative results of the water quality in the catchment and that this can have a relatively large effect on the score for that parameter for the reach.

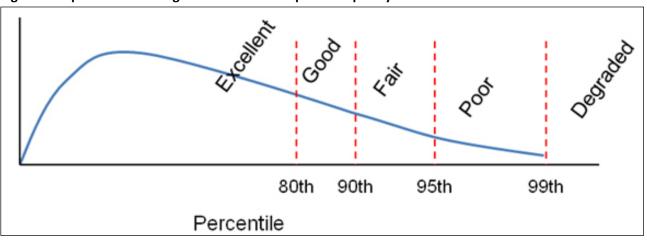
Figure 2. Depiction of defining thresholds based upon a frequency distribution of data.

Our approach is outlined in figure 2. After creating a frequency histogram from reference condition data, the threshold values for each parameter are defined using the 80th (*Excellent*), 90th (*Good*), 95th (*Fair*), 99th (*Poor*) and >99th (*Degraded*) percentile. The implicit assumption is that parameter values that occur in excess of 80% of the time in the reference sites reflect *excellent* quality, with rarer occurring events being of lower quality. Finally, it is assumed that *Degraded* water quality would only be observed <1% of the time in a reference condition site.
