Rapid Appraisal of Riparian Condition

Technical guideline for the southern tablelands of New South Wales

Amy Jansen, Alistar Robertson, Leigh Thompson, Andrea Wilson and Fleur Flanery

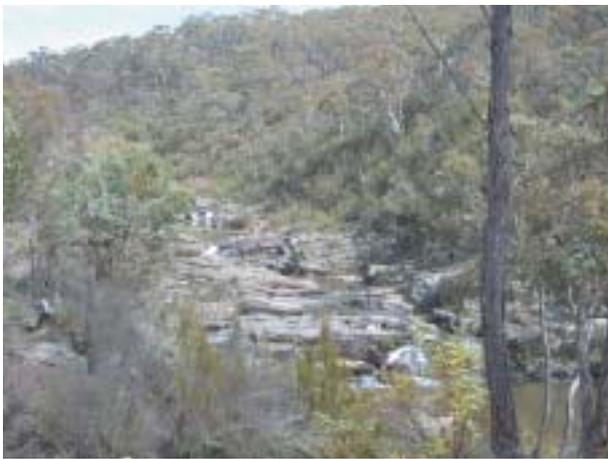
Photo 1. A site in excellent condition on the Upper Murrumbidgee River (RARC score = 46; this site includes continuous vegetation along the riparian zone, standing dead trees and fallen logs, native shrub understorey and regeneration of canopy trees). Photo Greening Australia.

Photos 1 and 2 show contrasting sites in excellent and very poor condition. Details of the scoring for these sites can be found in the box below.

Example of scoring indicators for the sites shown in Photos 1 and 2 (see Table 2 for indicators and details)				
Sub-index	Excellent condition site (Photo 1)		Very poor condition site (Photo 2)	
Habitat	4 + 4 + 3 =	11	0 + 0 + 0 =	0
Cover	3 + 3 + 3 + 3 =	12	1 + 0 + 3 + 2 =	6
Natives	3 + 3 + 3 =	9	1 + 0 + 1 =	2
Debris	3 + 3 + 1 + 0 + 1 =	8	1 + 1 + 1 + 0 + 0 =	3
Features	2 + 1 + 2 + 1 =	6	1 + 0 + 0 + 0 =	1
Total		46		12

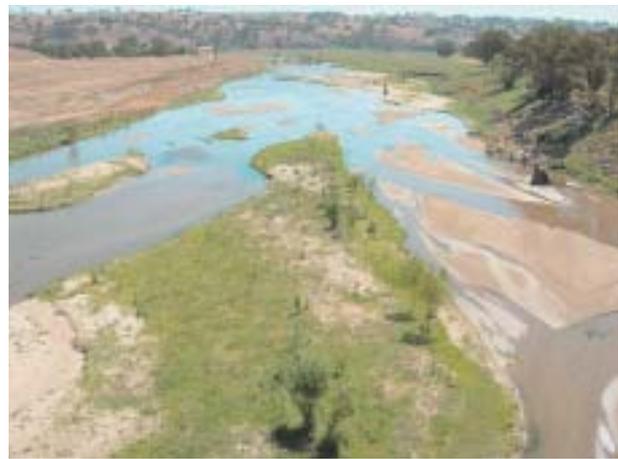
Photo 2. A site in very poor condition on the Murrumbidgee River from Tamar's Bridge (RARC score = 12; note limited native overstorey, lack of understorey and no native regeneration). Photo Greening Australia.

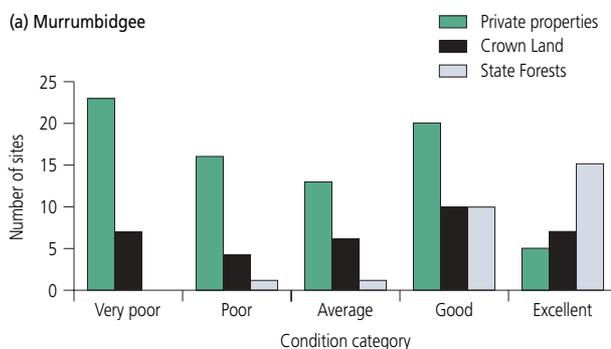
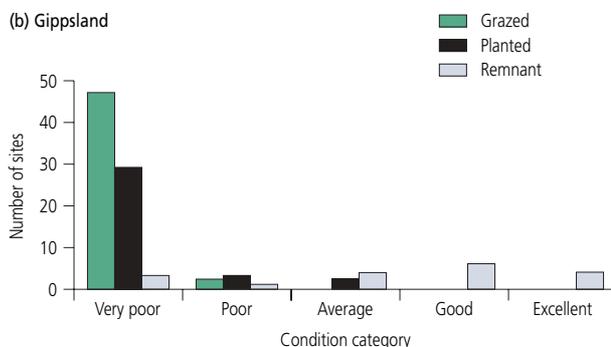
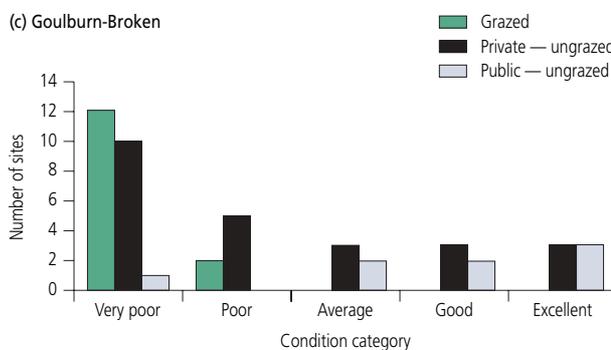
Figure 2. The number of sites scoring in each category (< 25 very poor, 25–30 poor, 30–35 average, 35–40 good and > 40 excellent) of the RARC index for three regions: (a) Murrumbidgee River, (b) West and South Gippsland, and (c) upper and mid-Goulburn-Broken catchment.

A total of 138 sites (each 1 kilometre in length) were surveyed between Gundagai and Hay, on private properties, crown land and State Forests (Jansen & Robertson, 2001a). The majority of sites on private property were in very poor condition, while sites on Crown Land (mainly Travelling Stock Reserves) were very variable. Most State Forest sites were in good to excellent condition (Figure 2a).

A total of 108 sites (each 150 metres in length) were surveyed in West and South Gippsland, at three types of sites — grazed paddocks on private properties, planted and fenced riparian areas on private properties, and remnant patches of uncleared native vegetation both on private properties and in reserves (Thompson et al., 2003). All private property sites were on dairy farms. The majority of sites were in very poor condition, with only remnant sites scoring above average (Figure 2b). It should be noted that most planted sites were relatively recently fenced, and their condition can be expected to improve as the plantings mature.

A total of 46 sites (each 200 metres in length) were surveyed in the upper and mid-Goulburn-Broken catchment, at grazed and ungrazed sites on private properties, and at ungrazed sites in reserves (Wilson et al., 2003). Again, the majority of sites were in very poor condition (Figure 2c). Like the Gippsland planted sites, many of the Goulburn-Broken ungrazed sites on private properties were relatively recently fenced, and their condition can be expected to improve as plantings mature.

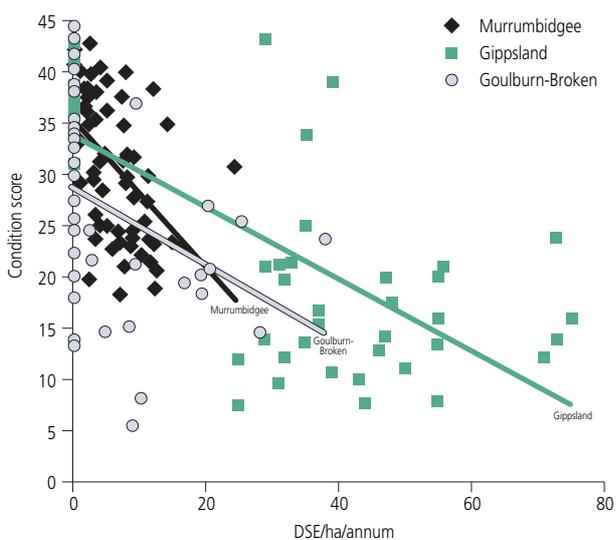
Figure 3. RARC condition scores in relation to stocking rates (DSE/ha/annum) for three regions: Murrumbidgee River, West and South Gippsland, and upper and mid-Goulburn-Broken catchment.

In all three regions, we examined the relationship between stocking rates and riparian condition, with Figure 3 below showing our results. Clearly, riparian condition declined with increased stocking rates, across all regions and a large range of stocking rates. Given the large number of sites in poor condition in all catchments, this suggests that stocking rates commonly used on private properties are too high to maintain riparian zones in good condition.

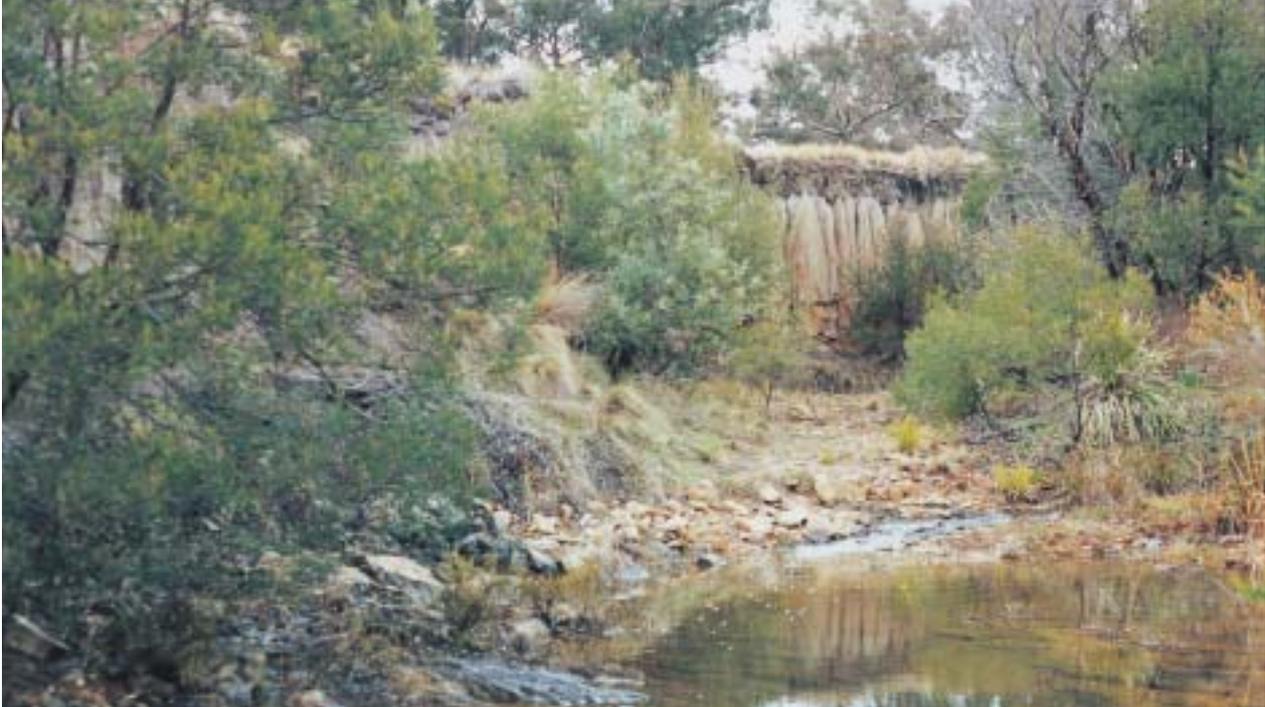
This creek is in excellent condition with an intact understorey, logs and other debris for wildlife habitat and shade over the water. Stock are not allowed into the area. Photo Lori Gould.

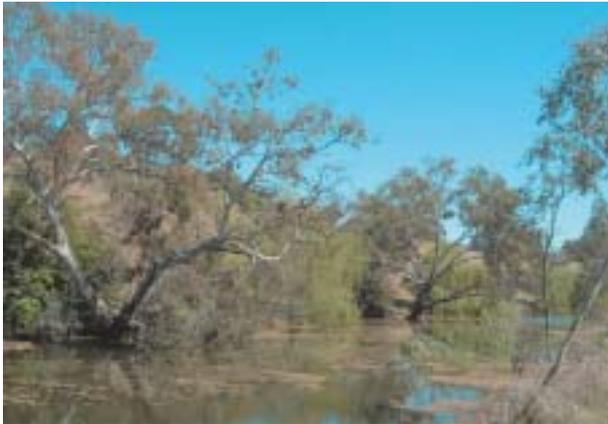
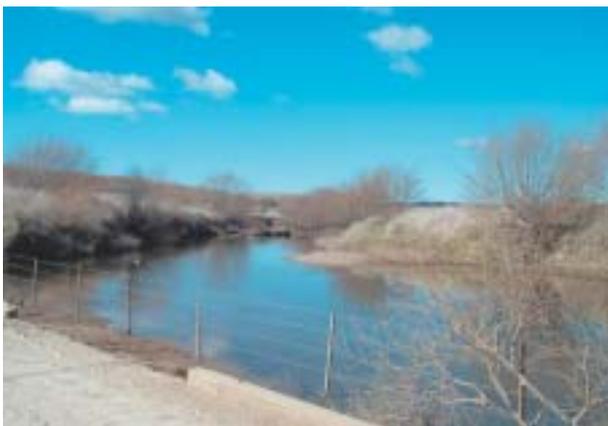
Two sections of the Yass River approximately 2 kilometres apart. Riparian areas can change dramatically depending on their management. To get an accurate assessment of the general condition of the riparian zone along a river, several RARC assessments should be conducted at randomly selected sites. Both these riparian areas are in poor condition due to stock grazing and the vegetation being cleared from along the banks. The RARC assessment can assist woolgrowers work out which management strategies can be used in these situations to improve riparian and in-stream health. Photos Greening Australia.

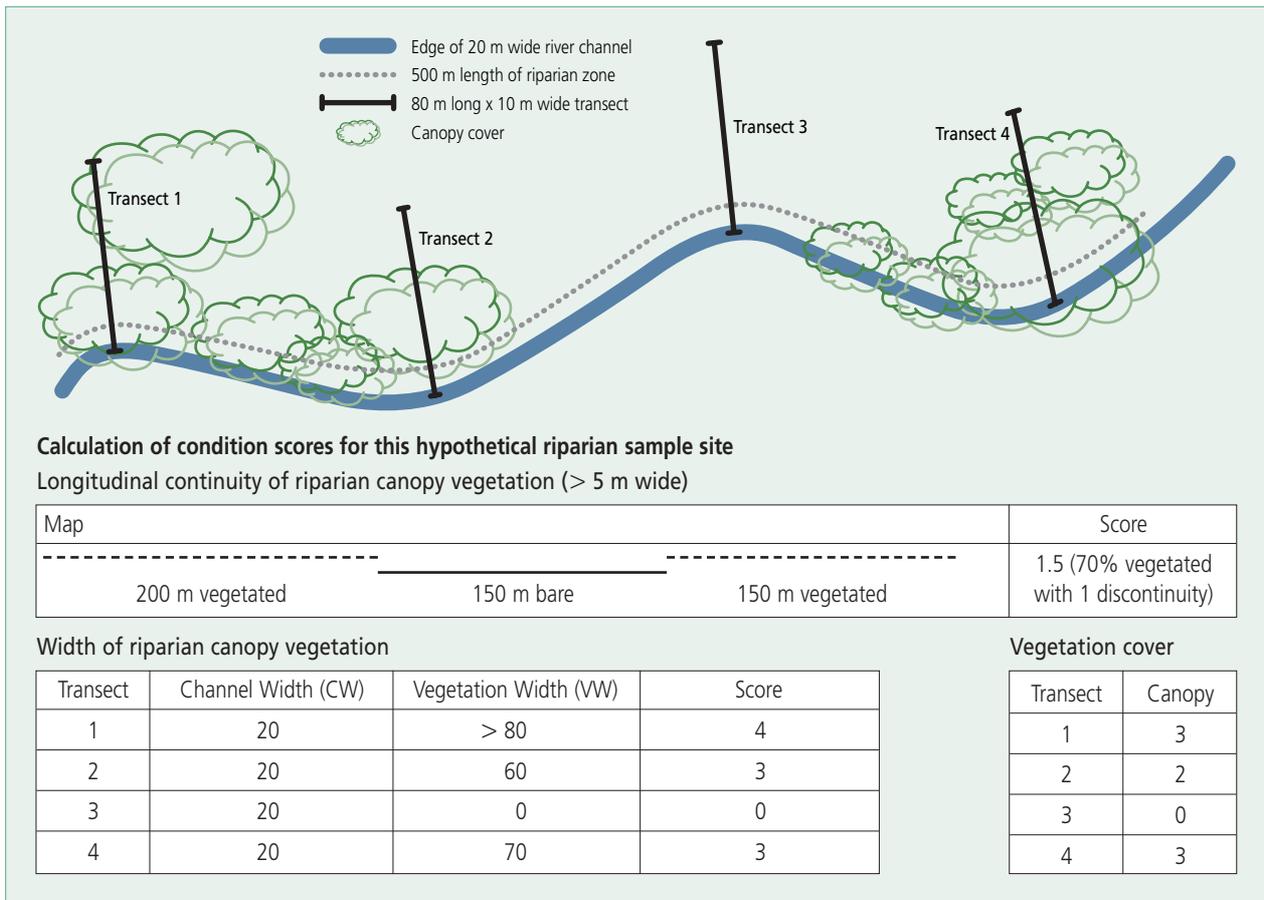
Figure 4. Hypothetical river with length and transects marked. The scoring for the indicators in this diagram is shown (see page 16 for full score sheet).

The transects at each site should ideally traverse the width of the riparian zone. However, this is not always easy to determine in the field. To simplify this, we use a transect length determined by the width of the river channel — 40 metres long for channels < 10 metres wide, and four times the channel width for larger rivers. A minimum width of 40 metres should be assessed, unless there is a very clear distinction between riparian and non-riparian areas. Where the riparian zone is clearly narrower than 40 metres or four times the channel width (for example, in a gorge), the transect length should be adjusted accordingly. Where the riparian zone is much wider than this (for example, on a lowland floodplain river), four times the channel width should be adequate to represent the riparian zone. Figure 4 illustrates a hypothetical river with the layout of the survey area and the transects indicated.

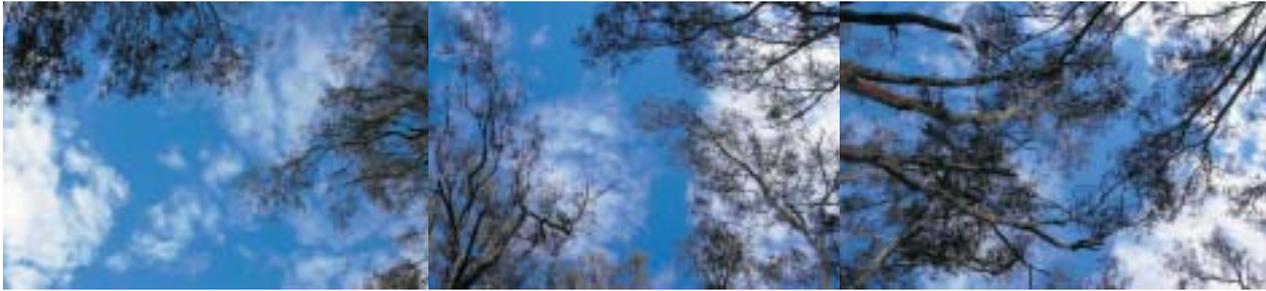
Photo 3. Canopy cover increasing from 1 to 3 (left to right). Photos Amy Jansen.

COVER (see photo 3 overleaf)

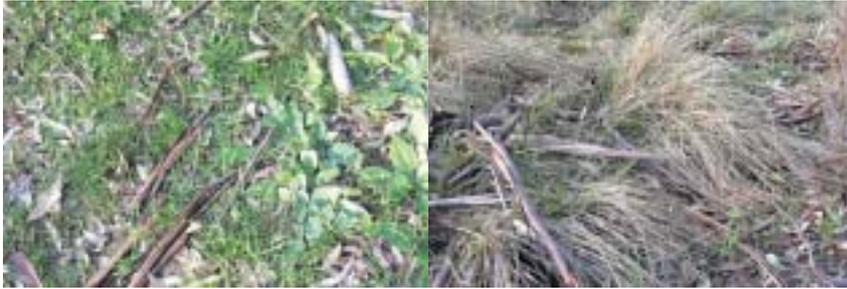
Tussocky perennial (long-lived) grasses tend to be native species while annual (short-lived) grasses tend to be exotic species (with a few obvious exceptions such as *Phalaris* which is a perennial exotic species).

Photo 4. Exotic annual ground cover (left) versus native perennial tussock ground cover (right). Photos Amy Jansen.

NATIVES (see photo 4 above)

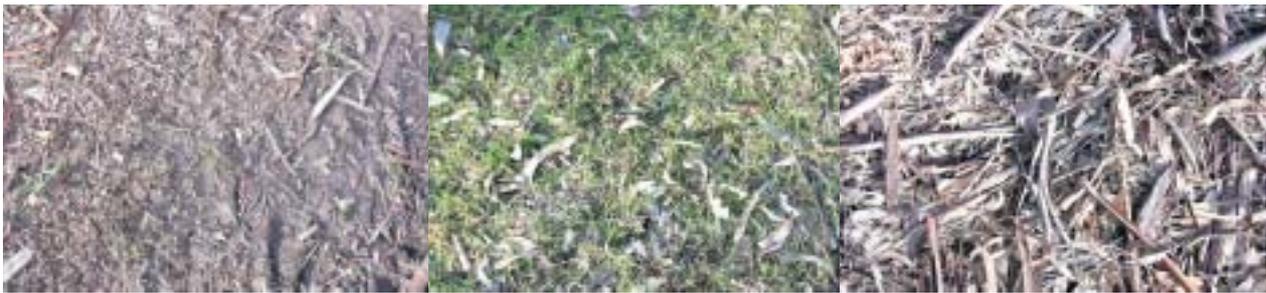
Photo 5. Leaf litter cover increasing from 1 to 3 (left to right). Photos Amy Jansen.

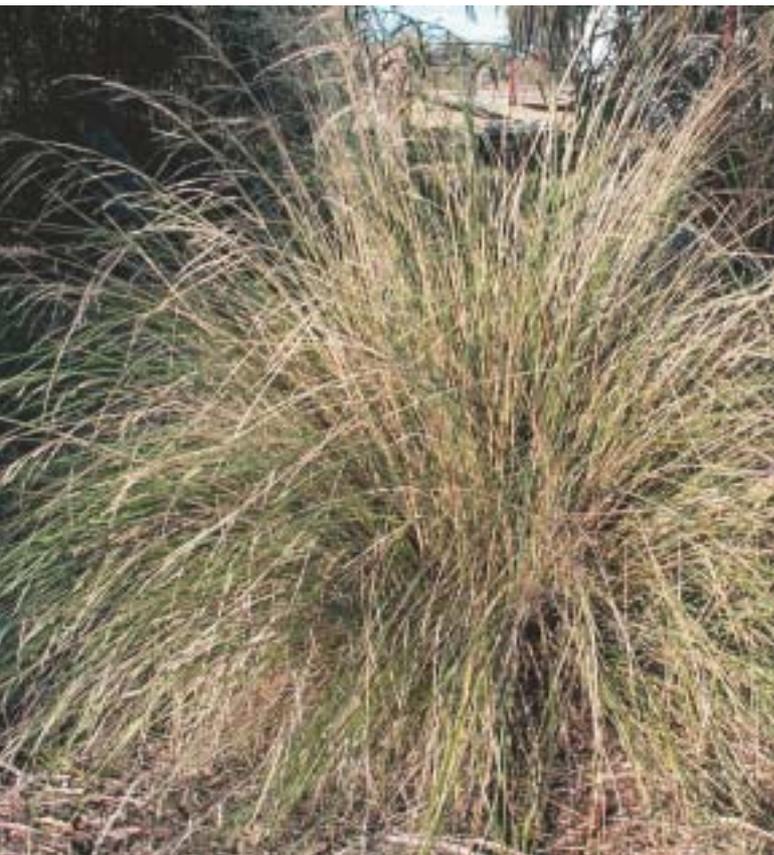
Photo 6. *Poa labillardieri*, an example of a large native tussock grass found in riparian zones. Photo Amy Jansen.

The abundances of large native tussock grasses (species such as *Poa labillardieri*) and reeds (species such as *Phragmites*, *Typha* (Cumbungi) and *Carex* which are normally only found on riverbanks or in swampy areas) are scored as follows:
